OFFICE OF INSPECTOR GENERAL

AUDIT REPORT

DOE-OIG-18-47

SOUTHWESTERN POWER ADMINISTRATION'S ASSET PROTECTION

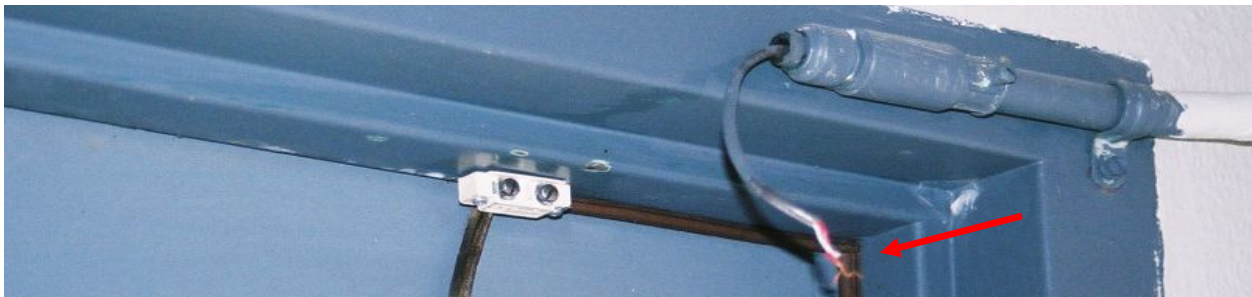
Additionally, during our site visit, we found a vulnerability that had been reported in a 2004 assessment performed by Southwestern that remained uncorrected and was still a vulnerability almost 13 years later. Specifically, during the assessment process, Southwestern conducted site surveys for each of its assets to look at potential vulnerabilities and likely attack scenarios. In the site survey for one of its switching stations, Southwestern found that the door alarm contact for the side door to the control building had been disconnected. The assessment included a specific recommendation to repair/rewire the door alarm contact. During our walk-through of the switching station in July 2017, we found that the previously identified door alarm contact remained disconnected. See the 2004 and 2017 images of the disconnected door contact below:

Switching Station Door Alarm Contact – 2004 Assessment Image

As illustrated in the pictures above, the door had since been painted; however, the alarm contact remained disconnected. Subsequent to our review, we were informed that Southwestern officials had taken corrective actions and had the door alarm reconnected. Additionally, Southwestern officials indicated that as of March 2018, the Division of Maintenance had instructed its employees to test all door alarms at the control buildings during the bi-monthly inspections.

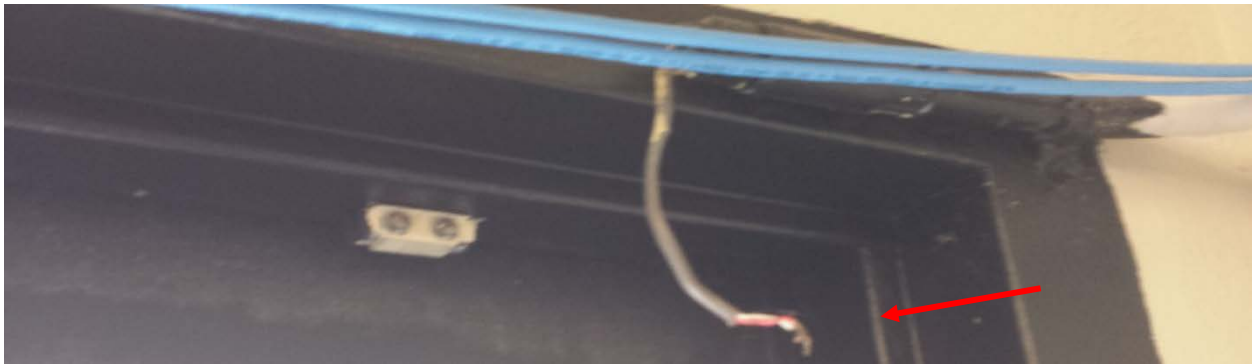
Switching Station Door Alarm Contact – July 2017 Site Walk-Through

Management Response: Concur. Southwestern's Director of Maintenance issued direction to staff March 29, 2018, instructing that each alarmed door be checked individually and that each alarm test result be verified with Operations Dispatch during the bi-monthly inspections. The Southwestern Administrator recently issued a memo to the Director of Maintenance providing

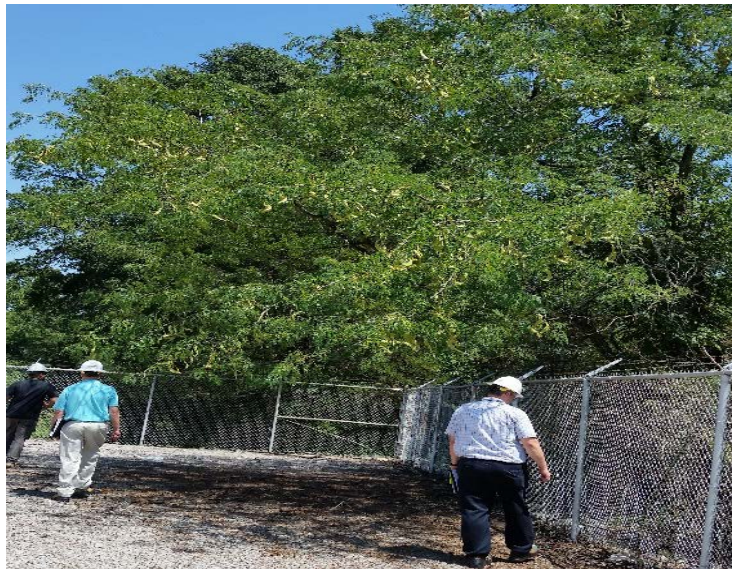
Trees hanging over fences at a switching station could potentially damage the fence, allow someone to climb the tree and gain access, and pose a fire hazard.

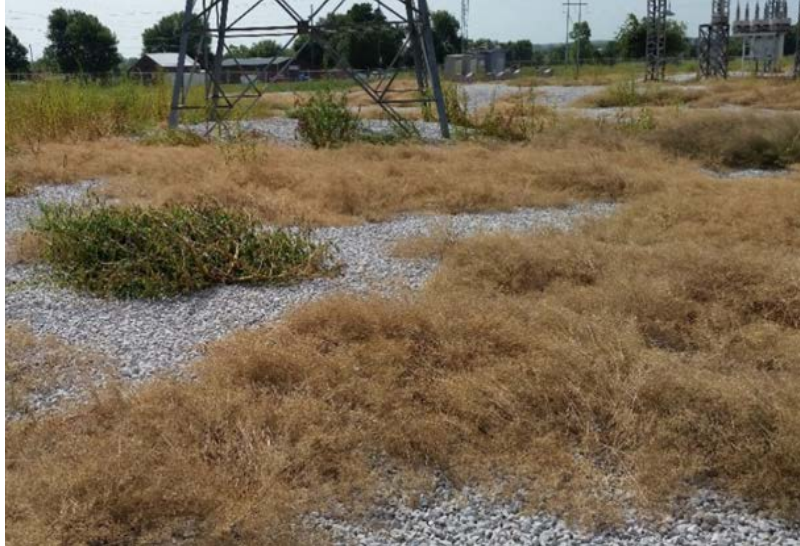
Overgrown vegetation poses potential fire hazard and limits visibility at a substation.

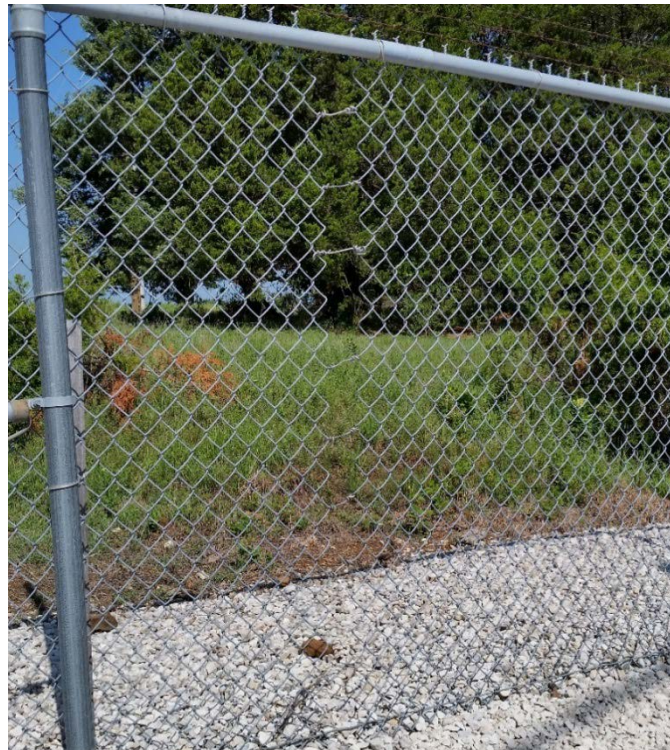
Poor fence repair at the site of a previous break-in compromises security at a tap station and makes it easier to gain access to the asset.

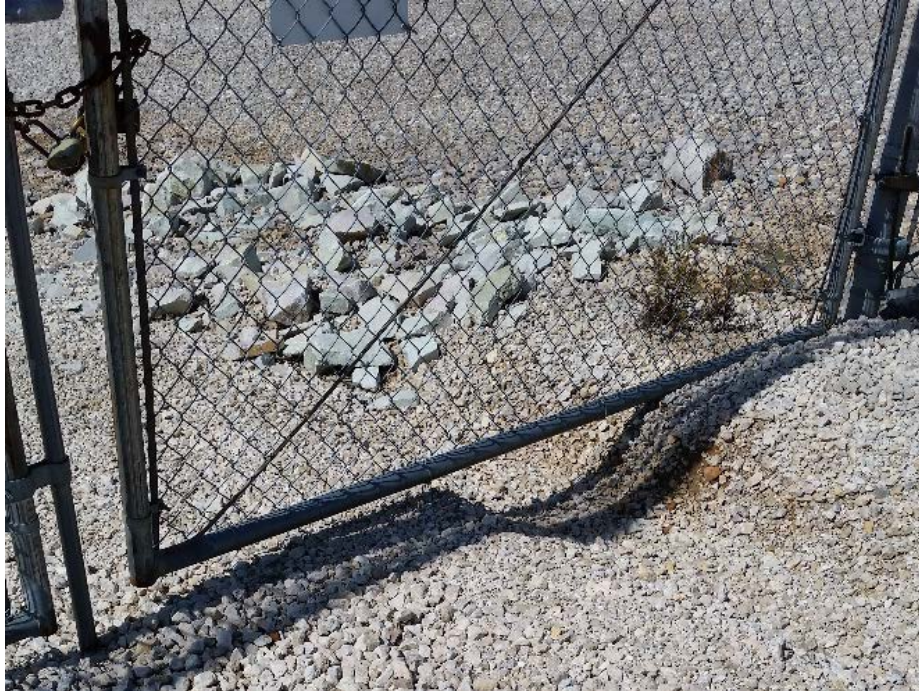
A gap under the fence at a tap station could allow access by a person or animals.

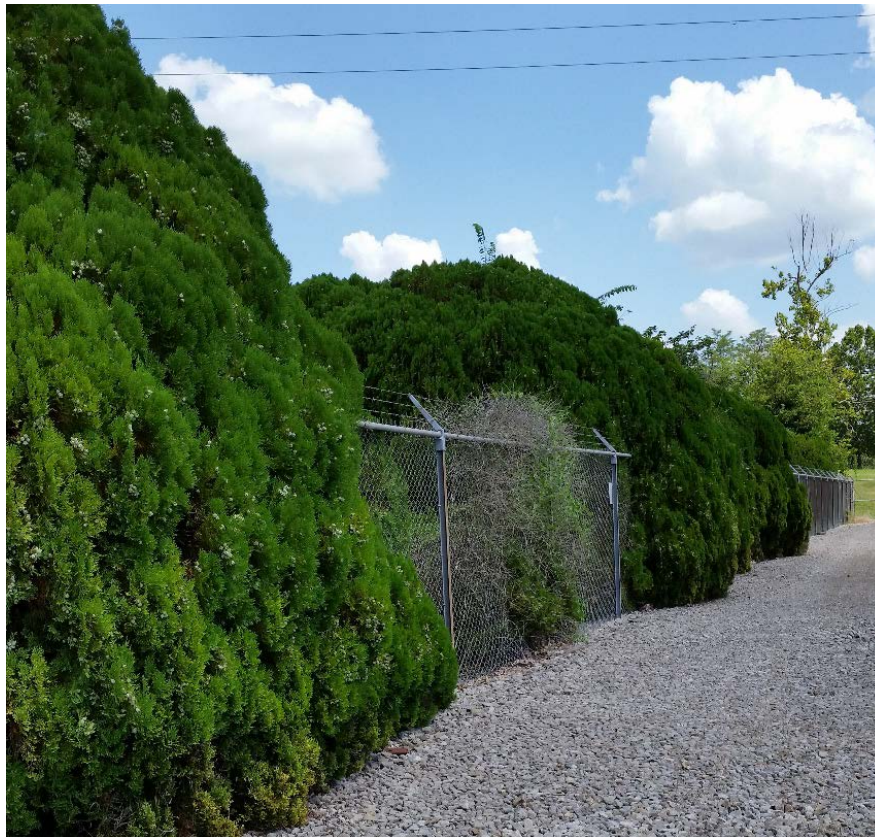
Bushes growing through a fence at a substation create a fire hazard, provide cover to potential intruders, and impair the vision of anyone monitoring the substation.
