**September 1996**

**Type A Accident  
Investigation Board Report  
August 13, 1996  
Electrical Shock  
at  
TRA-609, Test Reactor Area,  
Idaho National Engineering Laboratory**

**Idaho Operations Office**

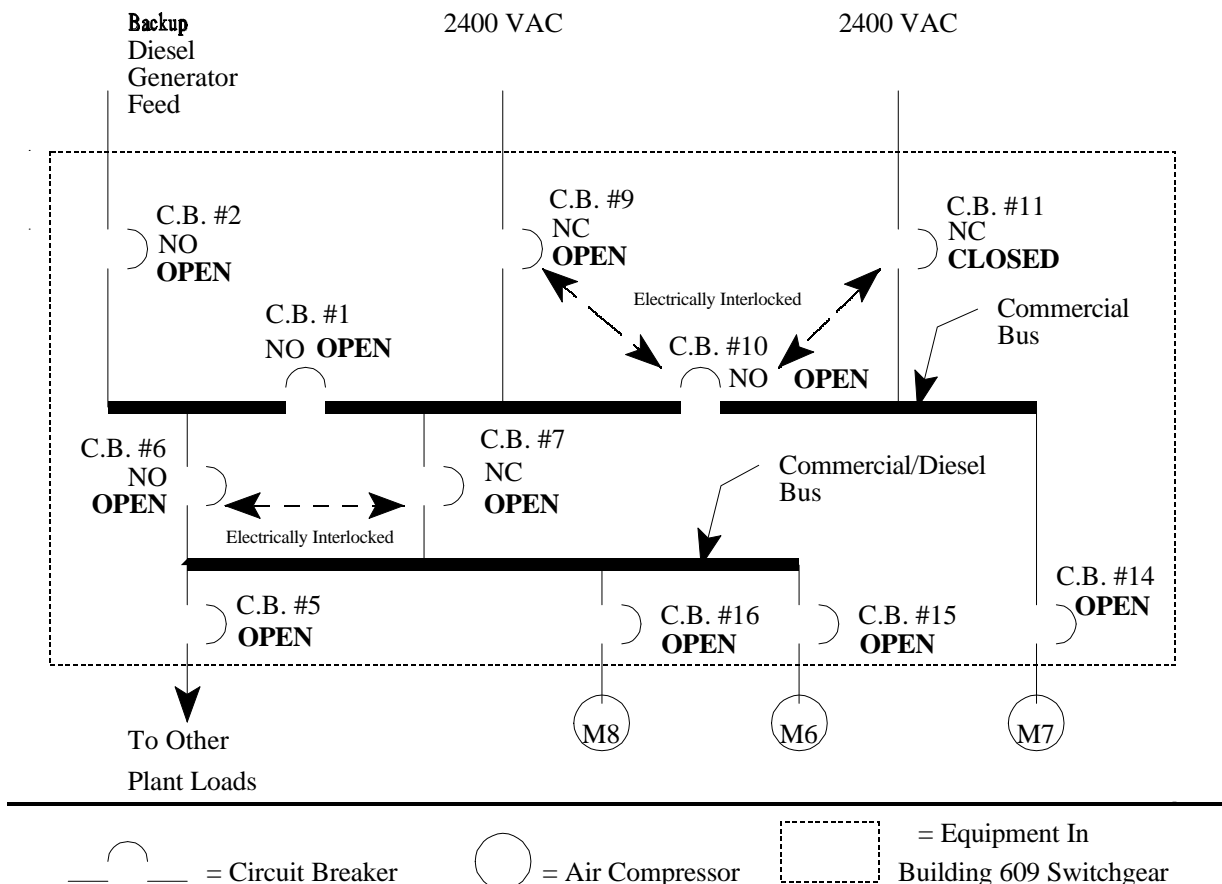
**Figure 2.1 TRA Switchgear Configuration**  
(**Bold** indicates conditions at the time of the accident.)

*Planned lockout/tagout was performed, leaving the M-7 bus energized.*

to other electric loads including the demineralized water supply pumps for the ATR and the ATR Canal, and for TRA area and perimeter lighting. This was considered acceptable since the limited work to be performed related to the M-7 compressor was intended to be done by opening only the potential transformer drawer, leaving intact the physical barriers limiting access to the energized 2400 VAC bus.

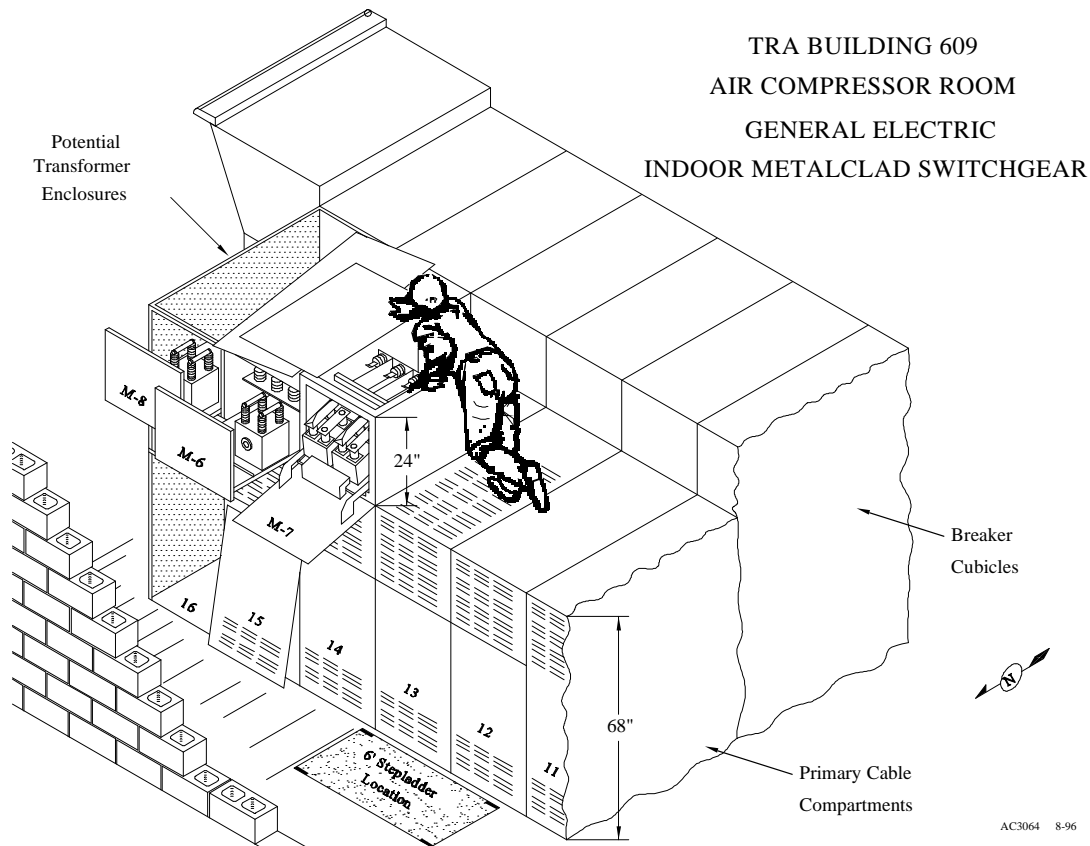
**Figure 2.2 CFA Electrician's Work Location**

At about 11:15 AM, concern was expressed by the Utility Area Controller that the temporary, portable air compressor might be having overheating problems. The Utility Area Controller asked what could be done to restart one of the site air compressors quickly, if necessary. The Leadman informed the Utility Area Controller that it would be difficult to restore M-6 or M-8 quickly. He indicated that he would expedite the M-7 work, since there was limited work to do and the M-7 compressor could be returned to service more quickly than the other two. The Leadman went to the other side of the switchgear to look at prints, and the CFA electrician went around to the back of the switchgear to start the work in the M-7 potential transformer drawer (See Figure 2.2).

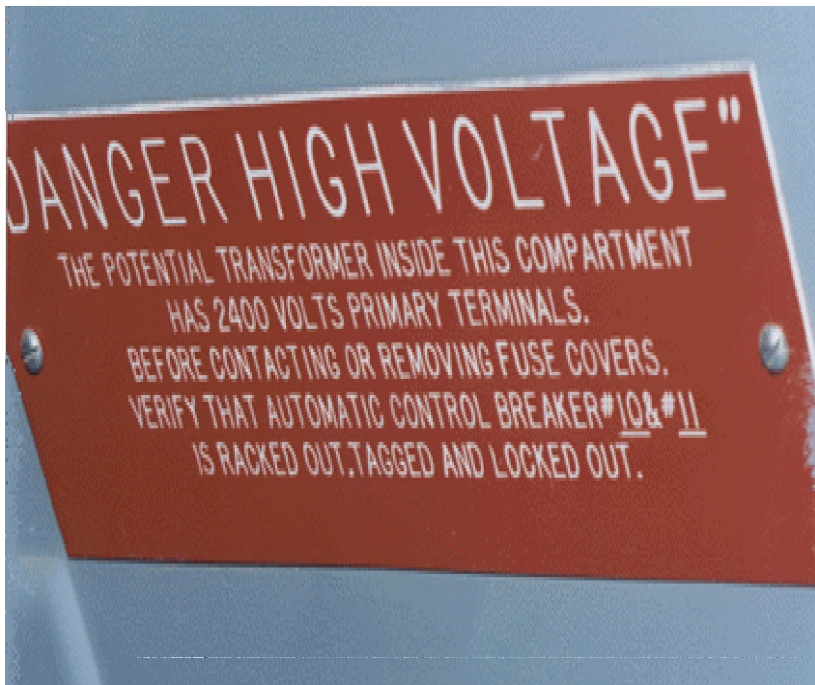
**Figure 2.3 Safety Placard (Operator Aid)**

The CFA electrician used a ladder to climb on top of the adjacent enclosure and then removed the cover from above the M-7 drawer. A red danger placard on the front of the M-7 drawer, not visible from the CFA electrician's position, indicated that work should not be performed on components in this drawer unless the 2400 VAC bus had been de-energized by opening, racking out and tagging out/locking out two particular breakers (See Figure 2.3). The CFA electrician stated that he did not notice this warning. The CFA electrician stated that he had noted earlier that access to the required components was not available through the tilted M-7 drawer. He stated that he recalled talking about it to the Leadman and informing him that removing the cover over the M-7 drawer space would be required. The Leadman does not recall this conversation. Removing this cover removed a crucial safety barrier and allowed direct access to energized 2400 VAC bus components in the area under the removed cover.

*In an effort to expedite placing the M-7 compressor back in service, the CFA electrician removed the enclosure cover, exposing energized electrical components.*

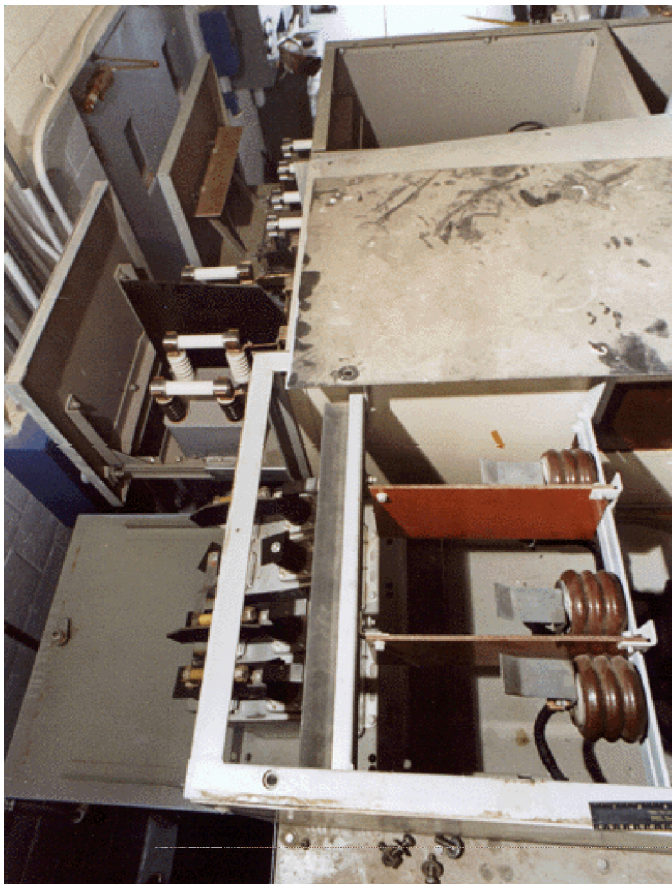
**Figure 2.4 M-7 Drawer**

Upon their return from lunch about 12:45 PM, the Leadman continued his work in the front of the switchgear and the CFA electrician returned alone to the back of the switchgear to complete the work on the M-7 drawer. The CFA electrician thought that the 2400 VAC bus supplying M-7 was de-energized and tagged out. He did not recognize the three large flat metal “stabs” in the back of enclosure (that mate up with similar stabs on the drawer when fully inserted) as electrical components connected to the main bus by cable (See Figure 2.4).

At approximately 12:49 PM, as he reached in from the top of the enclosure to clip some small wires in the M-7 drawer, the CFA electrician's right forearm, near the wrist, contacted a phase stab on the energized 2400 VAC bus (calculated at 1385 VAC phase to ground). He received a severe electrical shock that physical evidence indicates was primarily grounded through his right elbow to the cabinet frame. He immediately cried out, briefly retained consciousness, and then blacked out.
