**U.S. Department of Energy
National Nuclear Security Administration
and
Office of Health, Safety and Security**

Type A Accident Investigation Report

**June 26, 2009 Vehicle Fatality Accident at
Lawrence Livermore National Laboratory**

October 2009

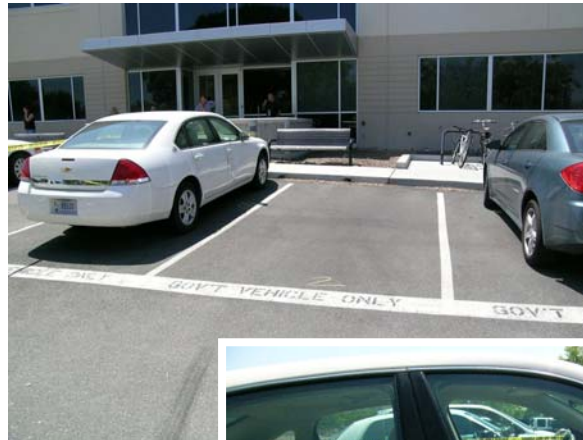
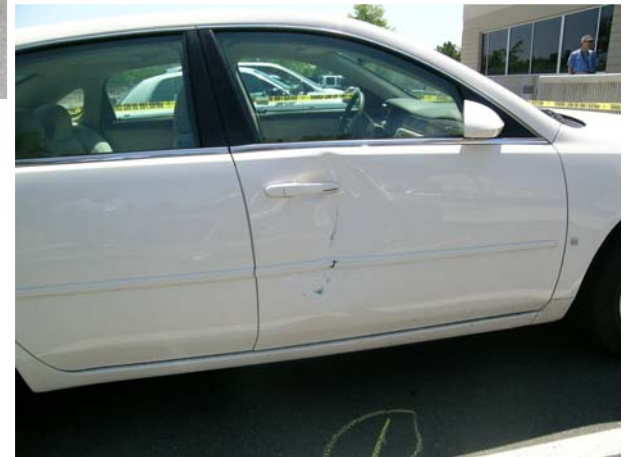
Impala (V2) was parked next to and east of V1 (on the driver's side of V1) [see Figure 2-4: Chevrolet Impala (V2) with Damage to Front Passenger Door]. A line of parking spaces were to the north of and parallel to the V1 parking space. On the west end of this parallel line of parking spaces was a privately-owned Toyota Celica (V3) [see Figure 2-5: 2002 Toyota Celica (V3) with Damage to Front End] and a privately-owned Honda CBR600 motorcycle (V5) [see Figure 2-6: Honda CBR600 Motorcycle (V5)] was parked on the end of the row adjacent to and west of V3. At approximately 10:31 A.M., LE1 loaded a hand truck from Building 235 into the bed of

Figure 2-4: Chevrolet Impala (V2) with Damage to Front Passenger Door

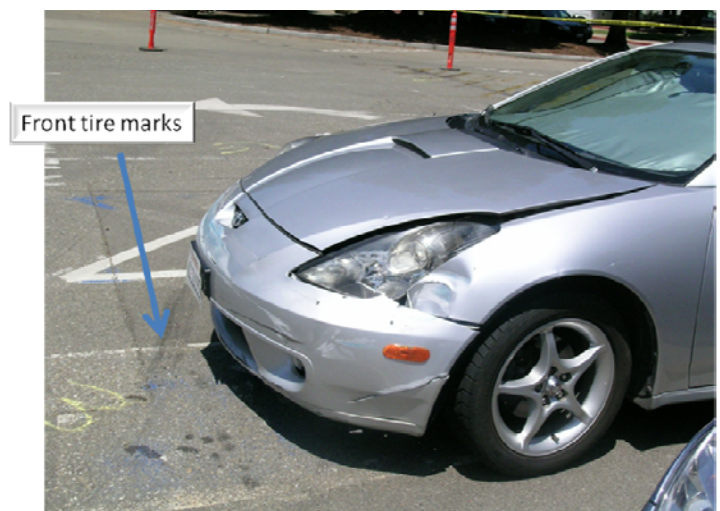
Figure 2-5: 2002 Toyota Celica (V3) with Damage to Front End

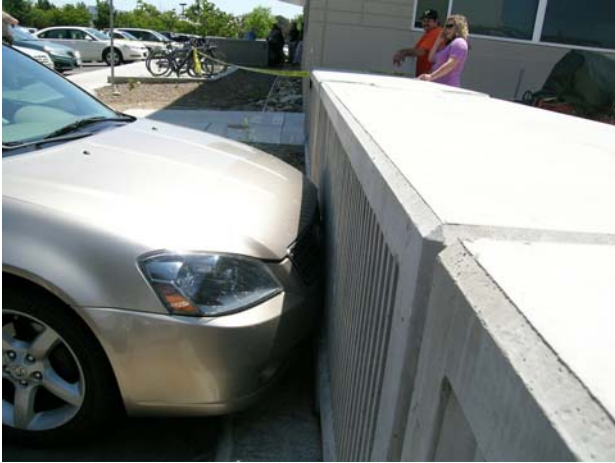
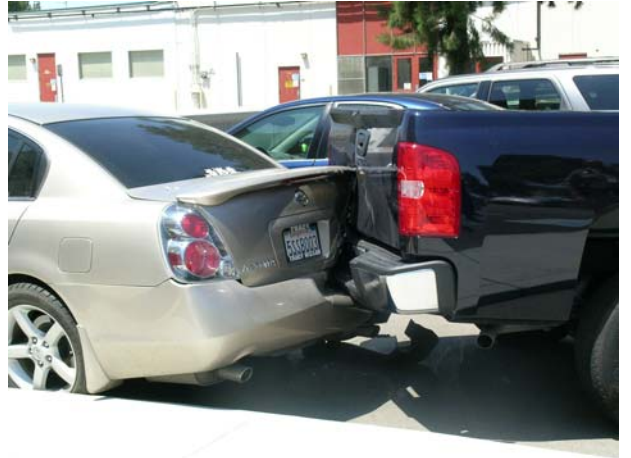
Figure 2-7: 2005 Nissan Altima (V4)

his way to the pavement. V1 stopped when the rear bumper of V1 impacted with the rear bumper of a privately-owned 2005 Nissan Altima (V4) that was parked parallel to where V1 was parked and several spaces west of the V1 parking space [see Figure 2-7: 2005 Nissan Altima (V4)]. V4 was crushed between a concrete barrier and V1 and was totaled by the impact [see Figure 2-8: 2008 Chevrolet Silverado 1500 Extended Cab Truck (V1) after Impact with V4, Driver Door Over-Extended]. A LLNS Security Police Officer (SPO) turned off the engine of V1, placed the transmission in Park, and put the ignition key on the seat. The driver's side safety belt in V1 was not engaged.

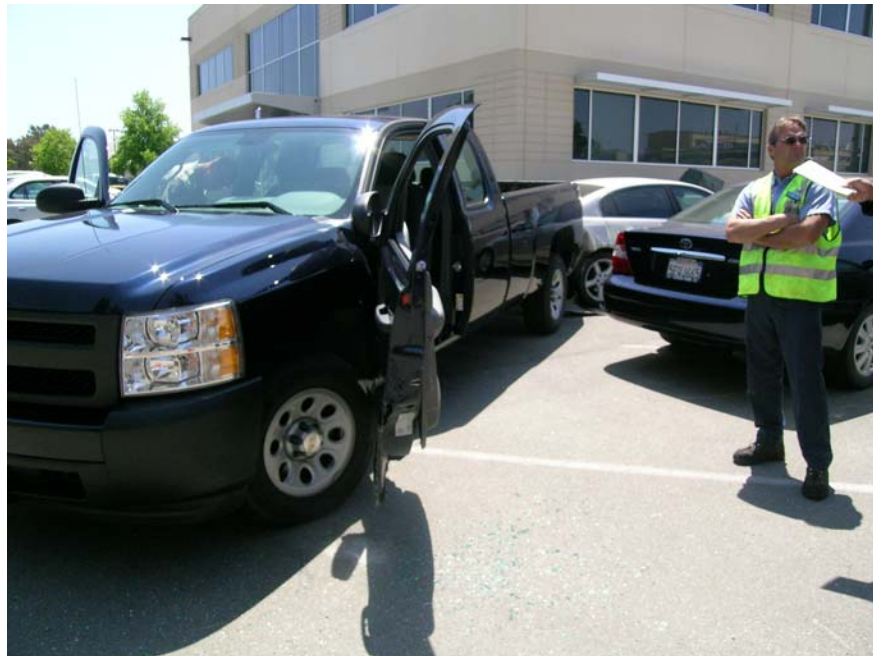
Figure 2-8: 2008 Chevrolet Silverado 1500 Extended Cab Truck (V1) After Impact with V4, Driver Door Over-Extended

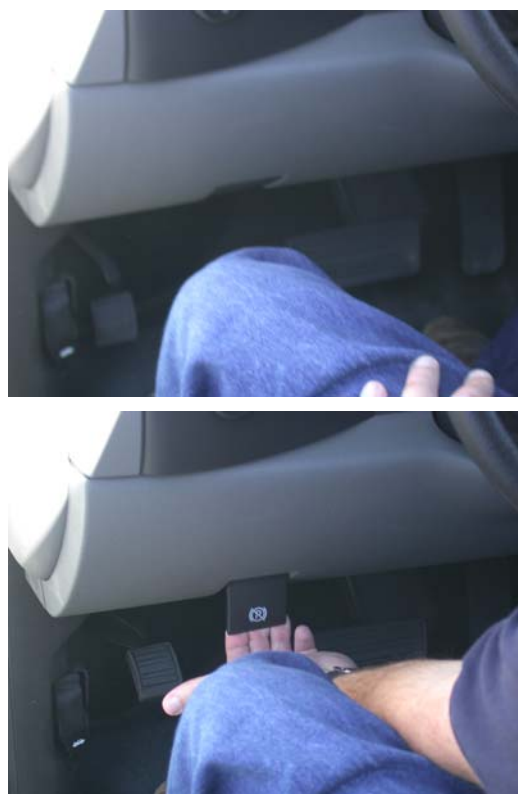
Figure 2-9: Location of Parking Brake on 2008 Chevrolet Silverado (V1)

During mid-morning on June 26, 2009, LE1 was preparing to move six boxes of office materials from one office to another. After entering, starting and putting the truck in reverse gear, the individual either realizes that the truck's emergency brake was on, has difficulty locating the brake release [see Figure 2-9: Location of Parking Brake on 2008 Chevrolet Silverado (V1)], and opens the driver door to aid in looking for the release or, due to the blind spots associated with a full-sized pickup truck, opens the driver's door to peer backwards to assist in backing the truck up. The opened truck door then contacts the front passenger door of an adjacent, parked vehicle (V2) and dents the vehicle's door. The contact of the

two vehicle doors likely startled the individual who then attempts to stop the truck.

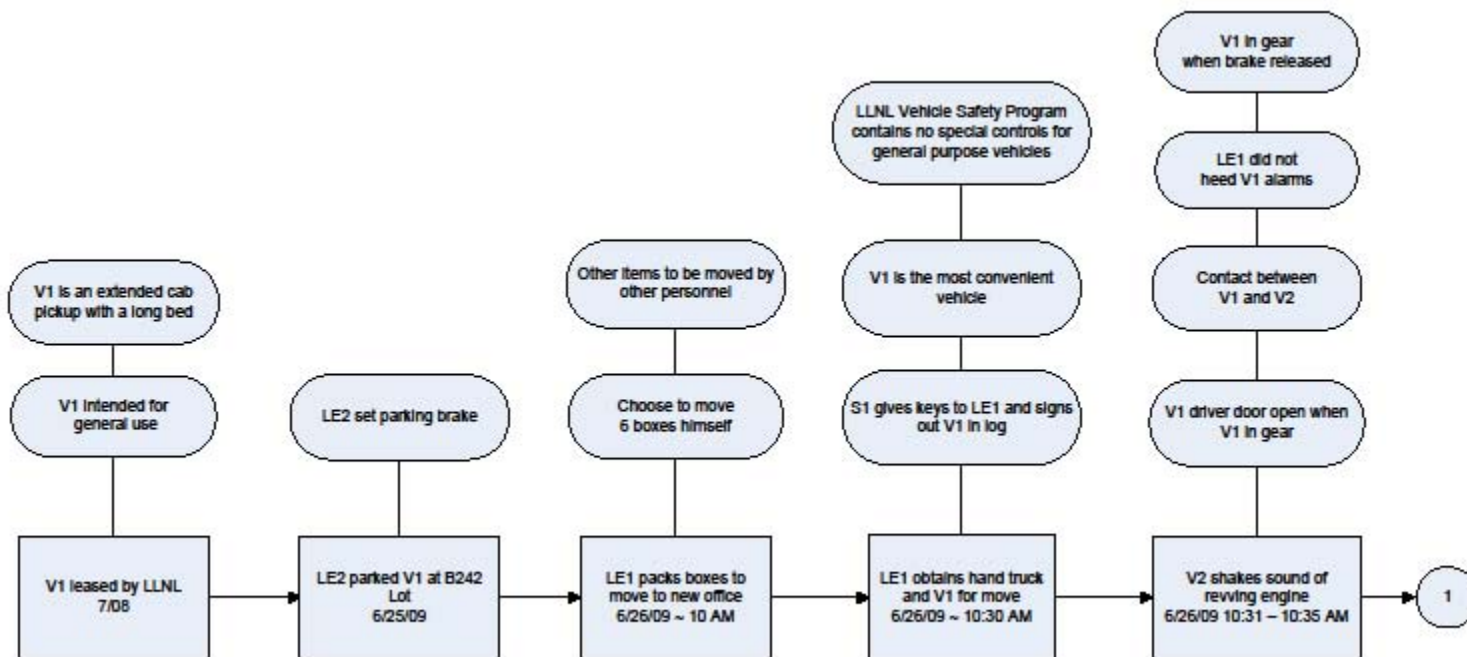
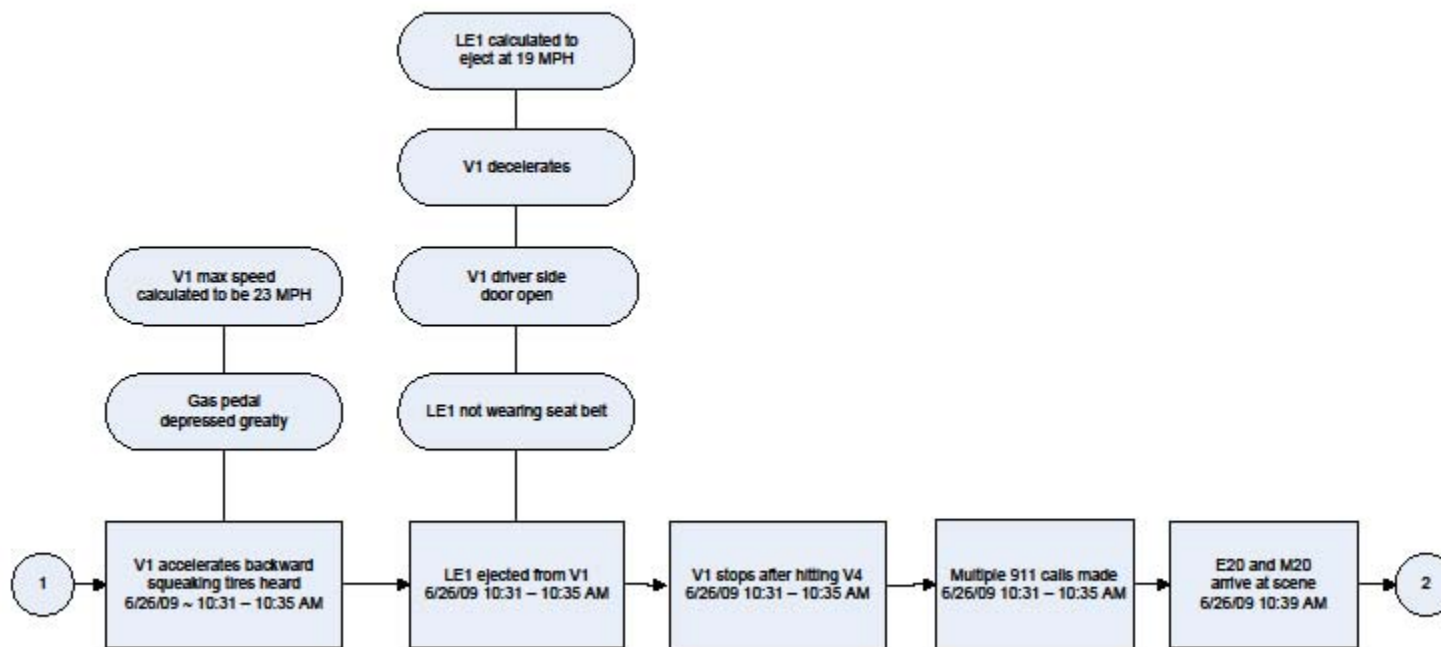
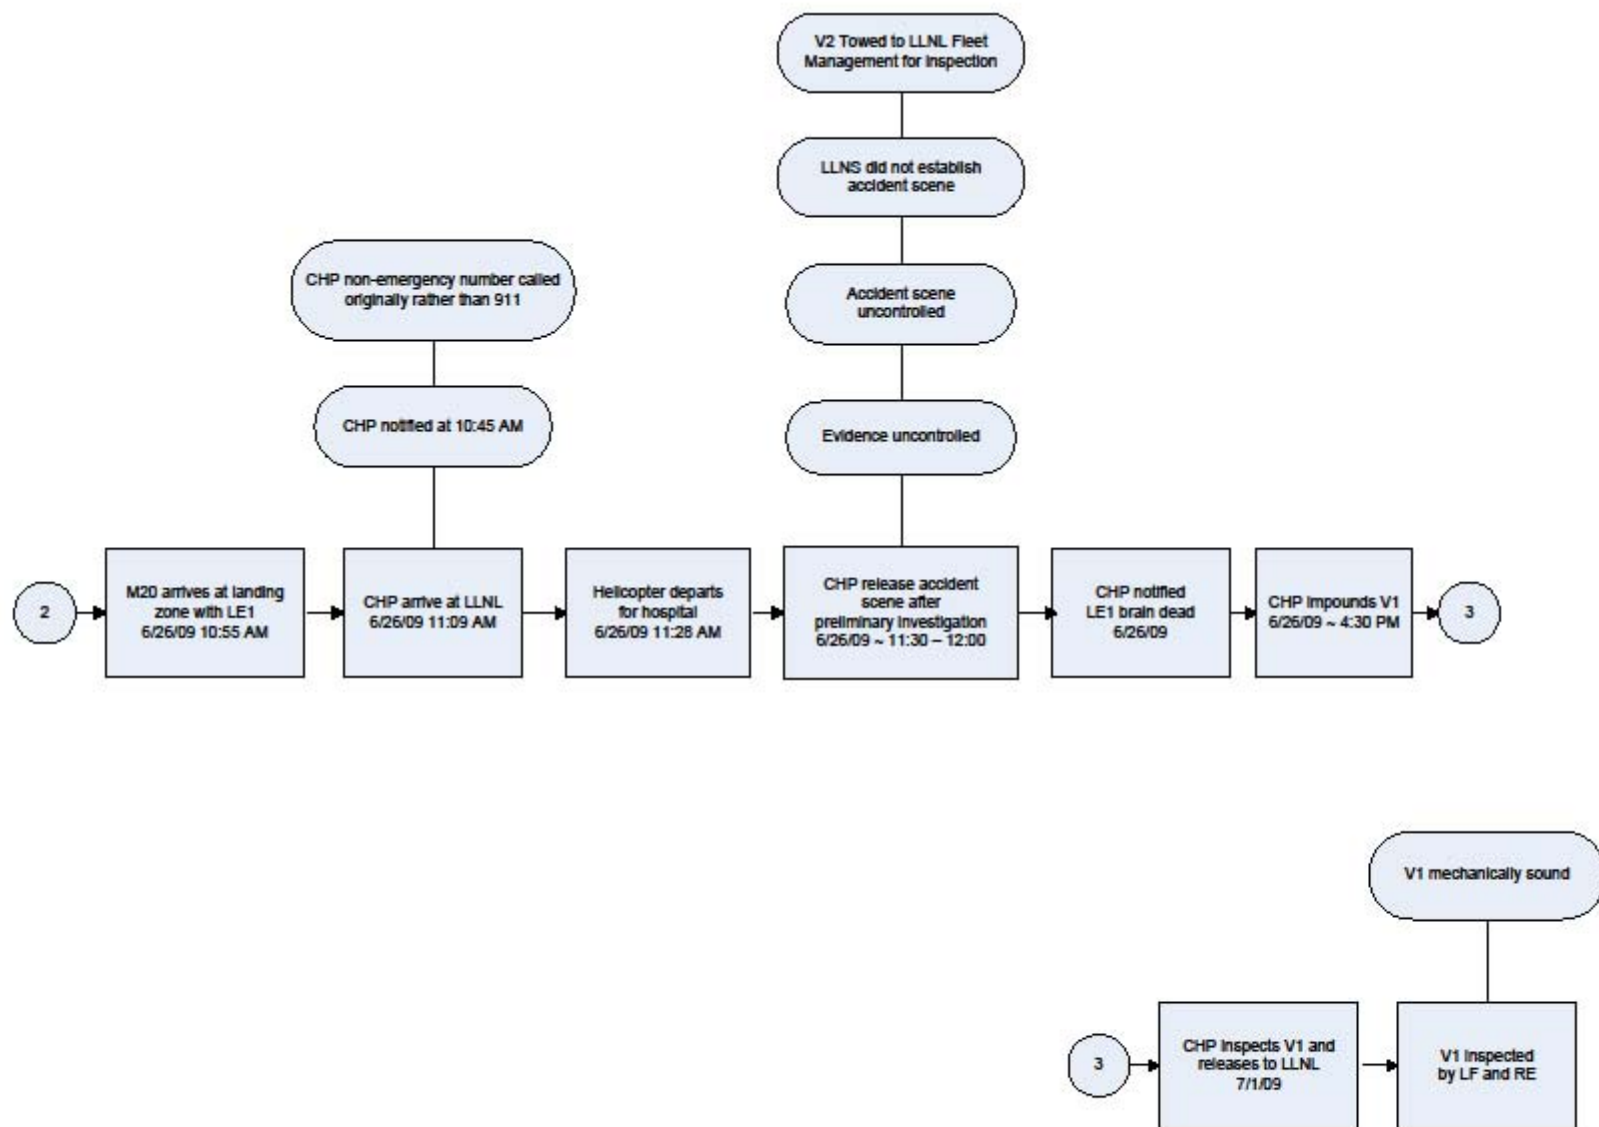
An events and causal factors analysis was performed in accordance with the DOE Workbook *Conducting Accident Investigations*. The events and causal factors analysis requires deductive reasoning to determine those events and/or conditions that contributed to the accident. Causal factors are the events or conditions that produced or contributed to the accident, and they consist of direct, contributing, and root causes. The direct cause is the immediate event(s) or condition(s) that caused the accident. The contributing causes are the events or conditions that, collectively with the other causes, increased the likelihood of the accident, but which did not solely cause the accident. Root causes are the events or conditions that, if corrected, would prevent recurrence of this and similar accidents. The causal factors are identified in Figure D-1: Events and Causal Factors Analysis on pages D-1 through D-3.
