**U.S. Department of Energy
Office of Environmental Management**

Type B Accident Investigation Report

**Radiological Contamination Event
During Separations Process Research
Unit Building H2 Demolition
September 29, 2010**

November 23, 2010

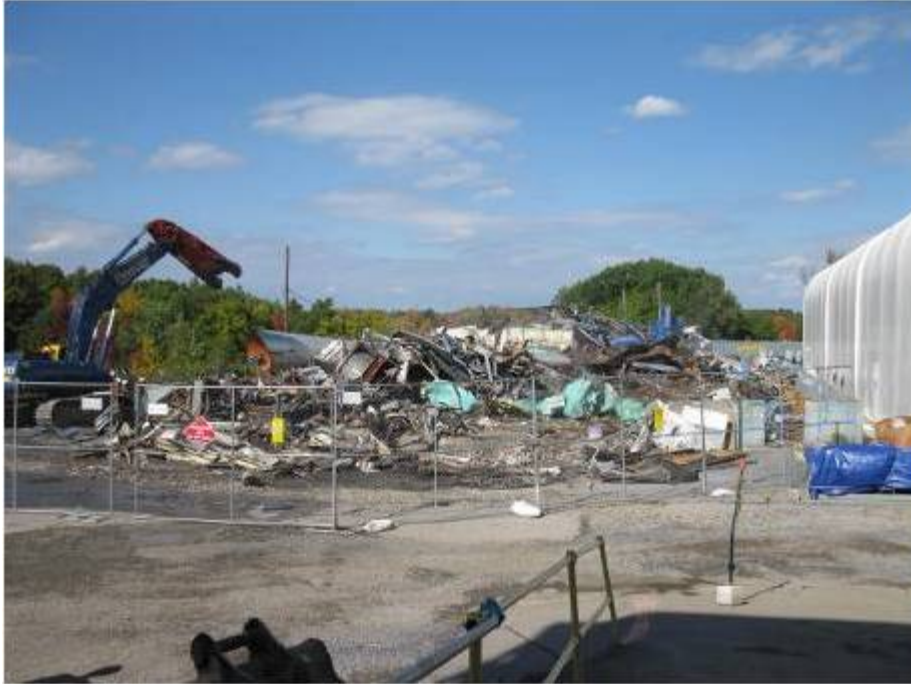
Figure 2-1: Facing North of the Building H2 on the Afternoon of September 25, 2010

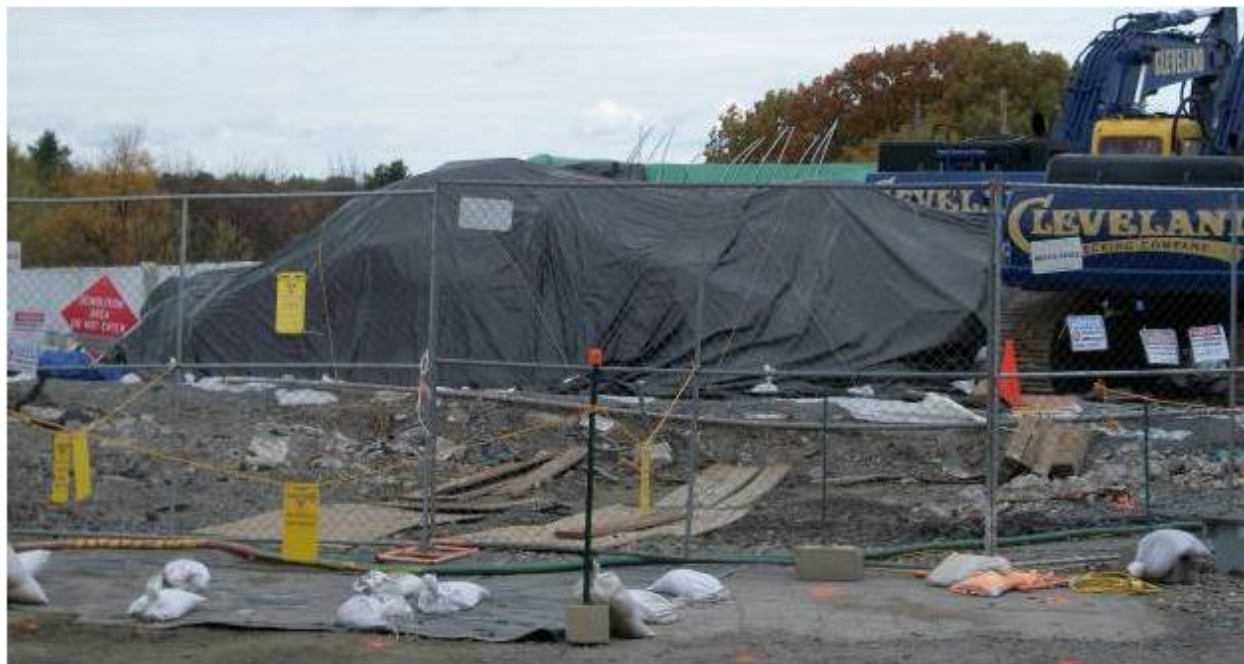
Building H2 debris was stabilized by moving all of the waste into a pile within the footprint with heavy equipment. Fixative was liberally applied to the pile several times. After Tropical Storm Nicole passed, openings in process system columns were covered. Several days later the sharp edges were mitigated by placing pallets and hay bales where potential problems were identified prior to covering the debris pile with tarps. Layers of tarps were then placed over the pile and secured with sandbags. A John Deere excavator was surveyed and released from the area to the south end of the building. Building H2 footprint remains posted as a Contamination Area. D&D operations remain suspended, pending completion of a comprehensive corrective action plan.

Figure 2-4: Building Footprint Taken Afternoon of October 23, 2010

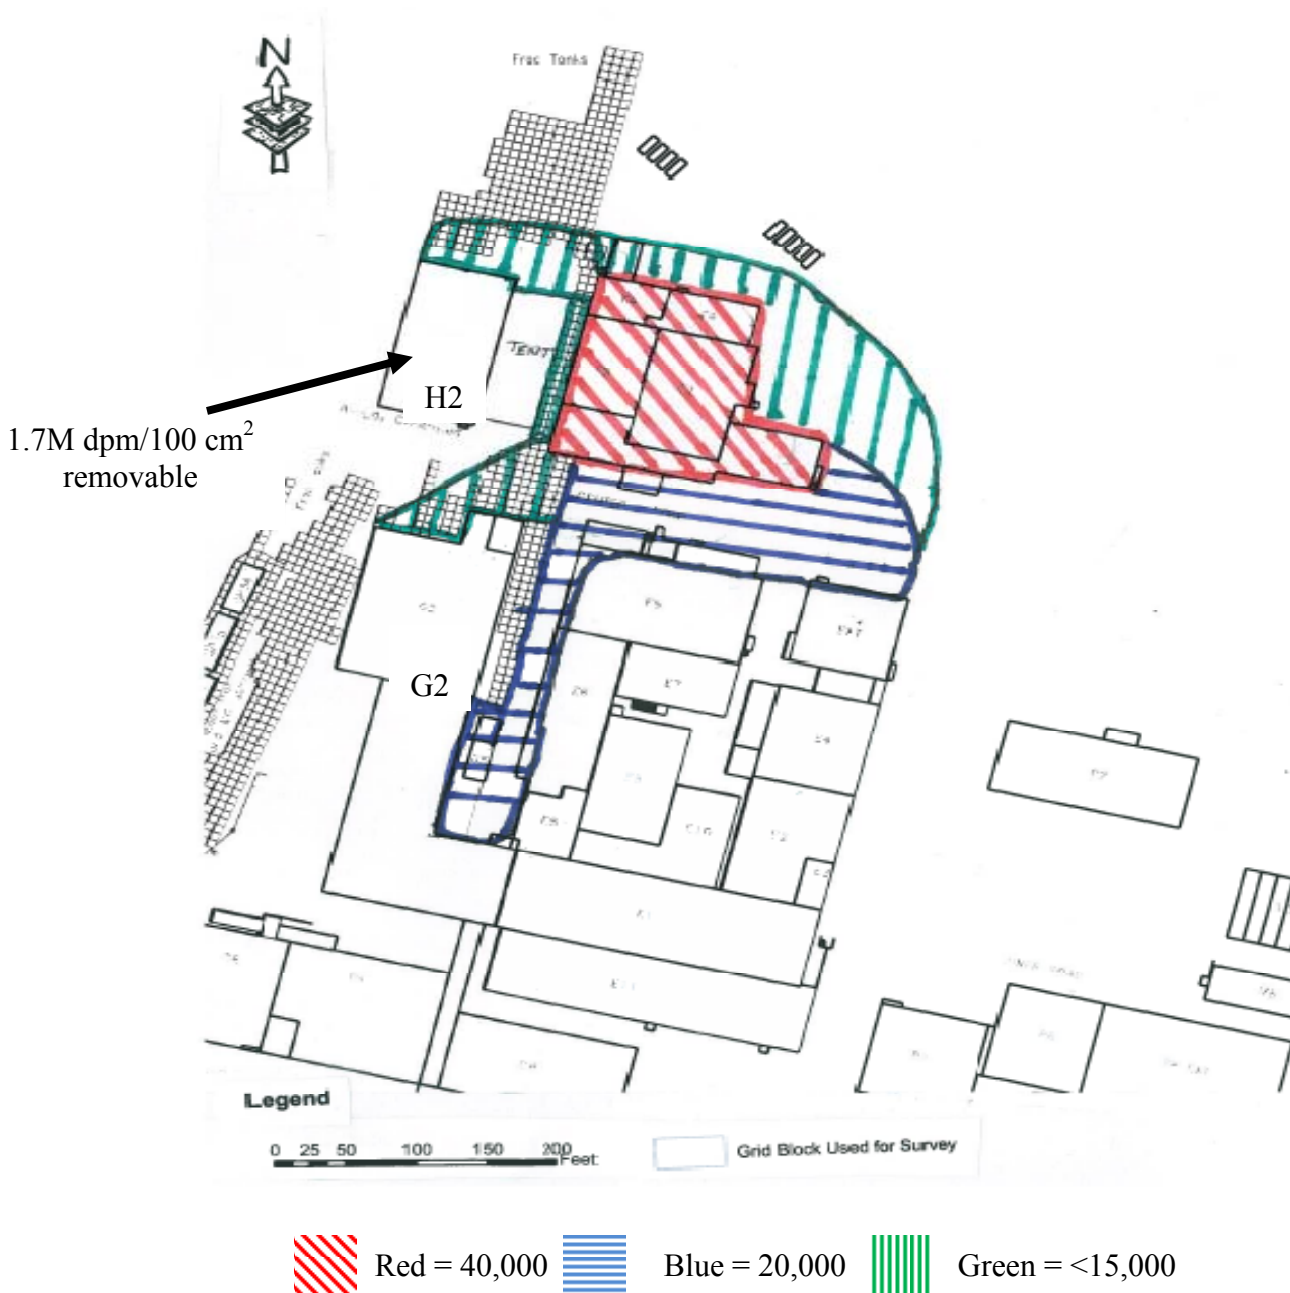
An NRLFO representative stated that contamination was found over an area of approximately 104,000 square feet on the KAPL site as a result of the incident. Review of KAPL post September 29, 2010, survey results shows that there were numerous small areas spread over approximately one half of the 104,000 square feet that had average readings of 20,000 to 40,000 dpm/100 cm² beta/gamma. There was one small area with an elevated reading of approximately 150,000 dpm/100 cm² beta/gamma.

direct readings in dpm/100 cm² beta/gamma

Figure 2-5: Approximate Area of Contamination

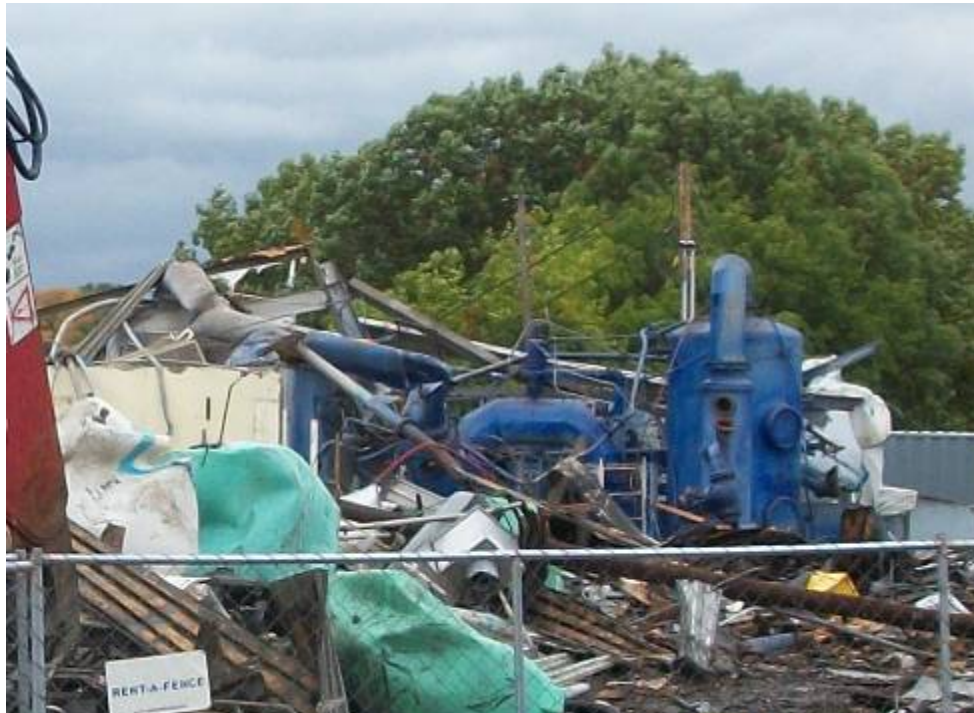
The spraying of “fixative” appears to have been associated with a belief that doing so would preclude the possibility of any spread of radioactive contamination, so much so, that the term “locked down” was frequently and generally used by management, staff, and workers to describe how the fixative was used for contamination control; a clear over-reliance on the application methodology. The Board noted that Figure 2-3, Figure 3-1 and Figure 3-2 illustrate that fixative was not applied to several surfaces of the evaporator system components.

Figure 3-1: Incomplete Application of Fixative to Separator Columns September 29, 2010

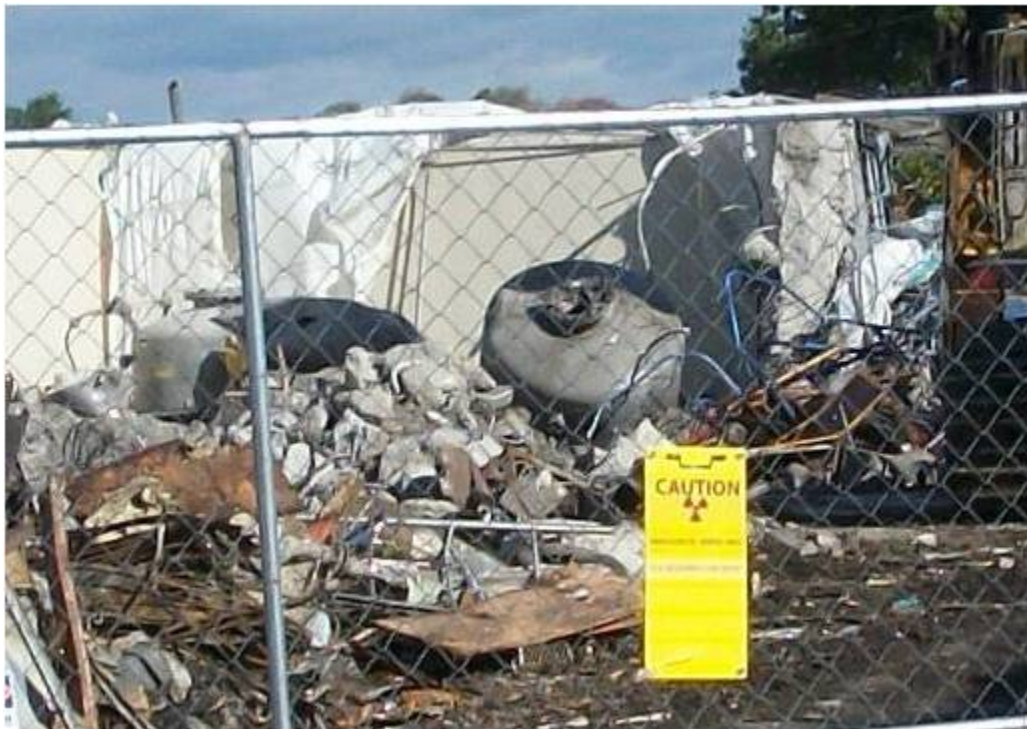
Figure 3-2: September 29, 2010 Post Column 113-A Removal
