Type A Accident Investigation Report

**Vehicle Fatality Accident, July 1, 2008
59th Avenue NE and Highway 117
West of Cando, North Dakota**

August 2008

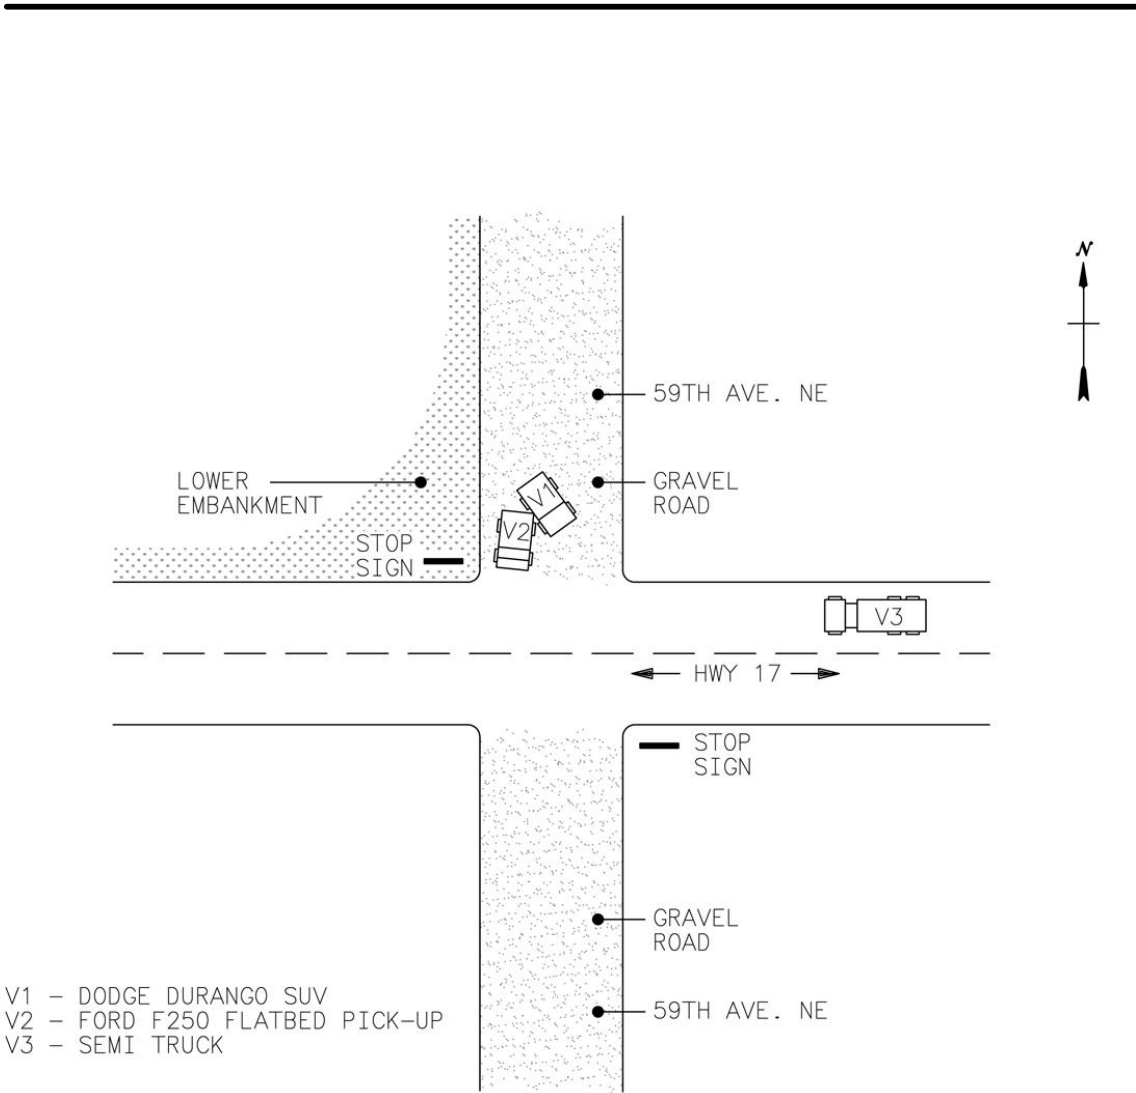
Figure 4 - Actual crash diagram

Both vehicles had been participating in various field site visits and were enroute to their next destination. The lead vehicle (V2) produced heavy dust due to dry road conditions. V2 stopped at the intersection, angled slightly to the west, waiting for cross traffic before making a right hand turn onto Highway 17. When V1 saw V2 through the dust cloud stopped at the intersection, V1 was too close to stop, swerved to the left to avoid V2 and collided with V2 from behind (rear-ended).

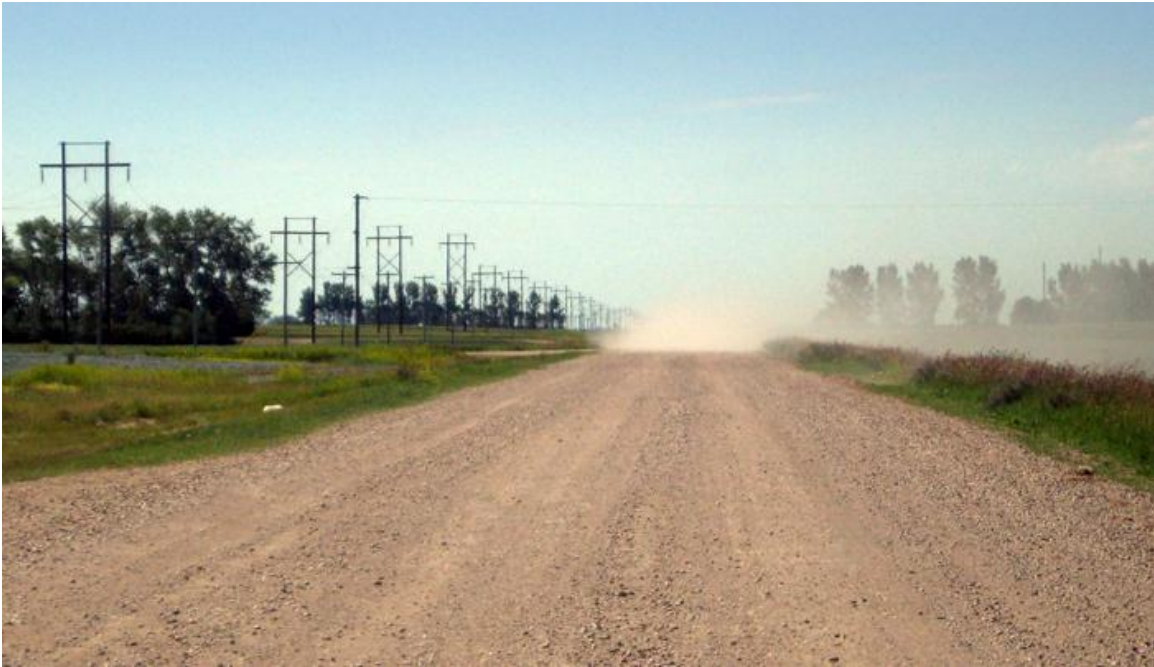
South on 59th Avenue, heading south simulating road conditions.

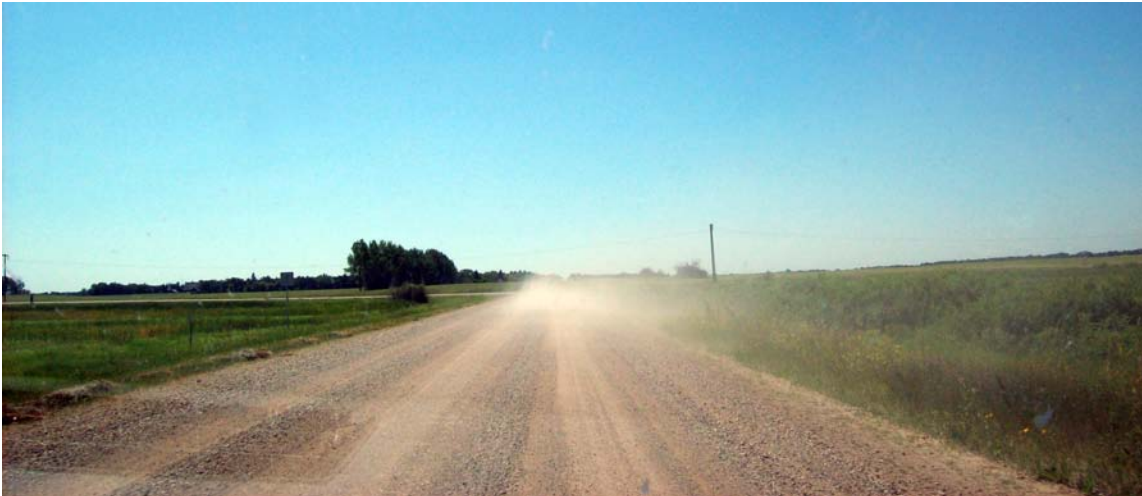
Simulated road conditions heading south on 59th Avenue approaching the intersection at Highway 17.

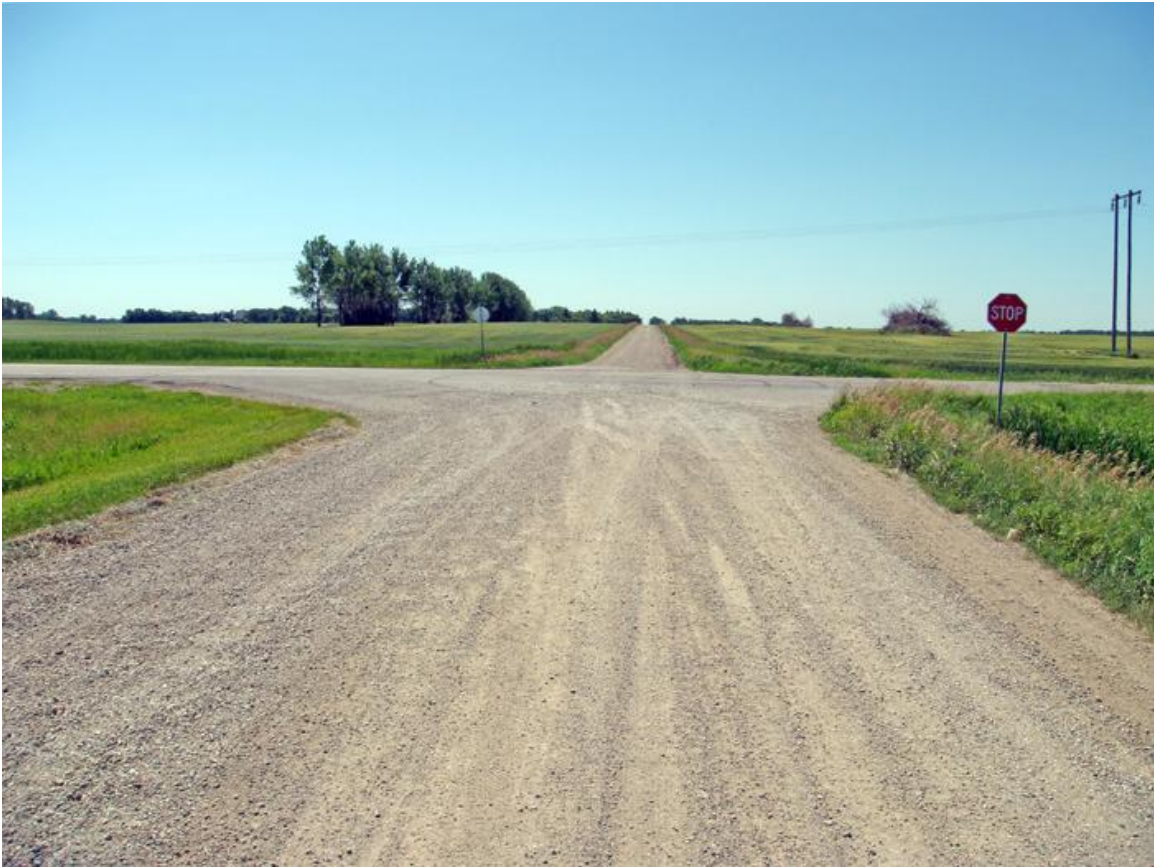
Normal road condition at Intersection 59th Avenue and Highway 17.

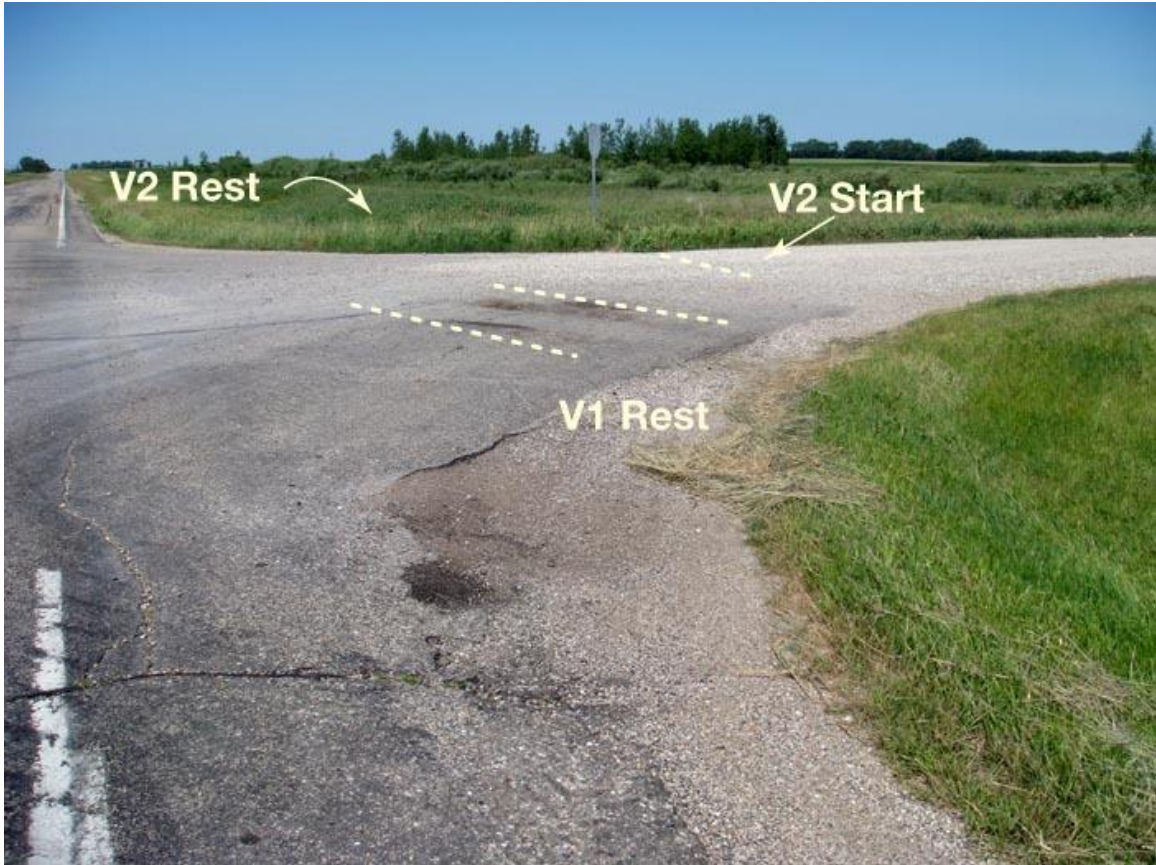
Photo diagrams where V2 started and both vehicles' final resting spots.

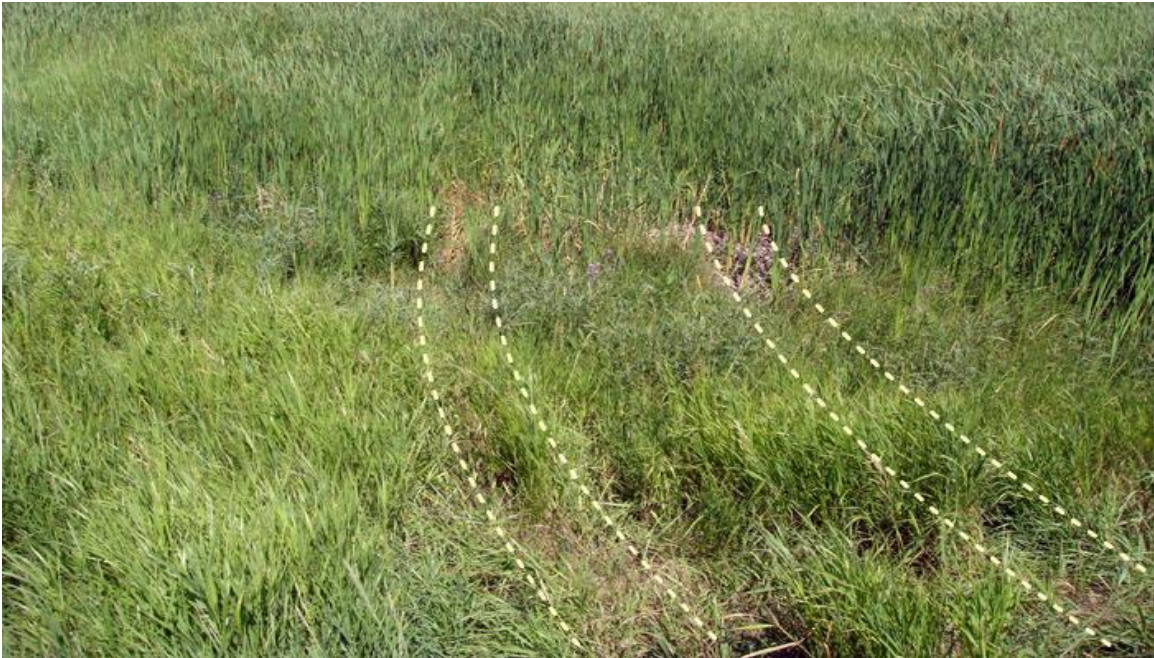
Dotted lines indicate where V2 final resting spot in embankment on northwest corner of intersection.

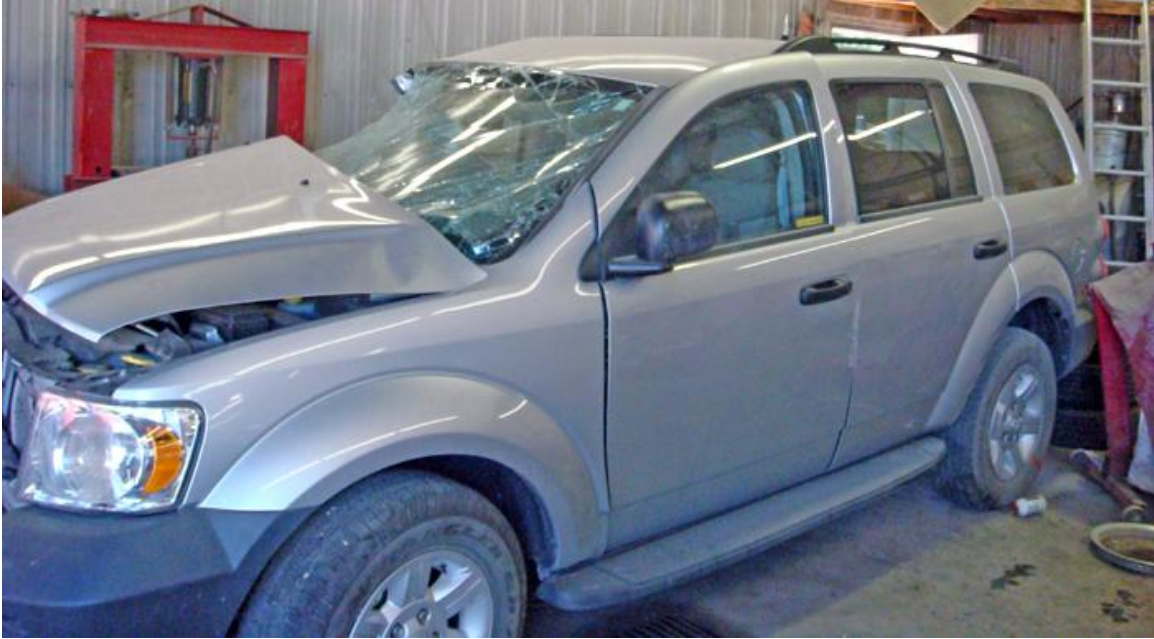
Driver side front view of V1.

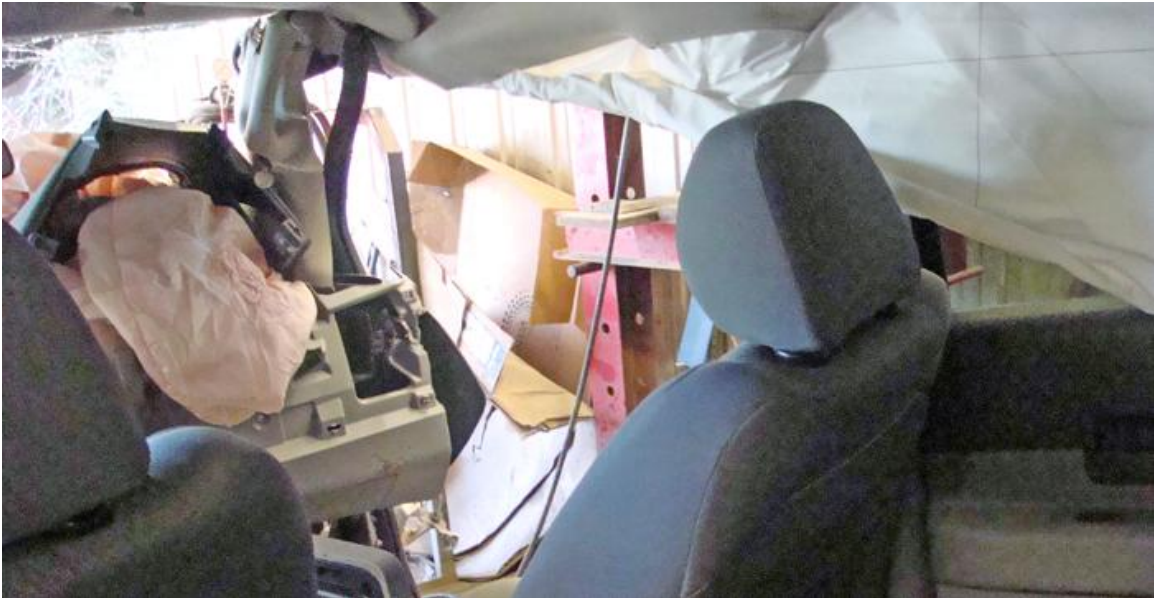
Photo shows that all airbags deployed on impact.

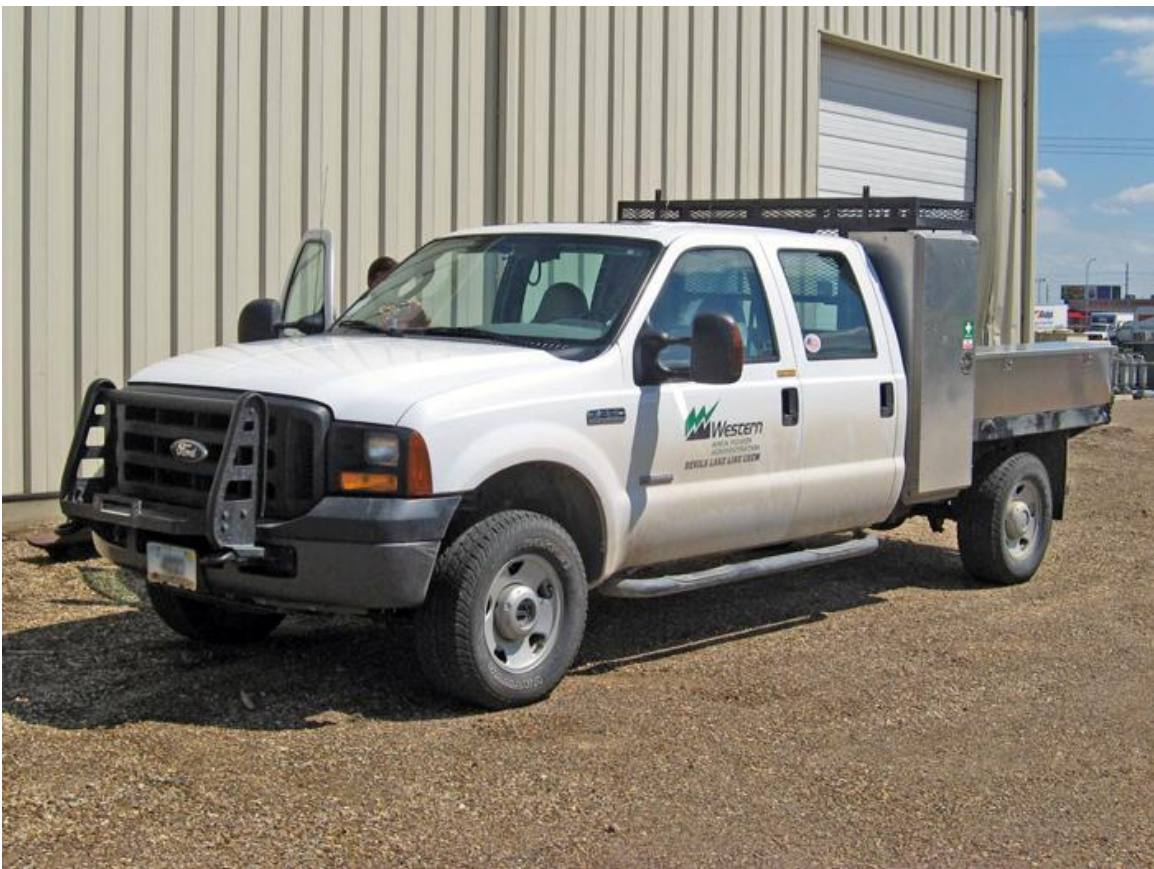
Front view of V2.

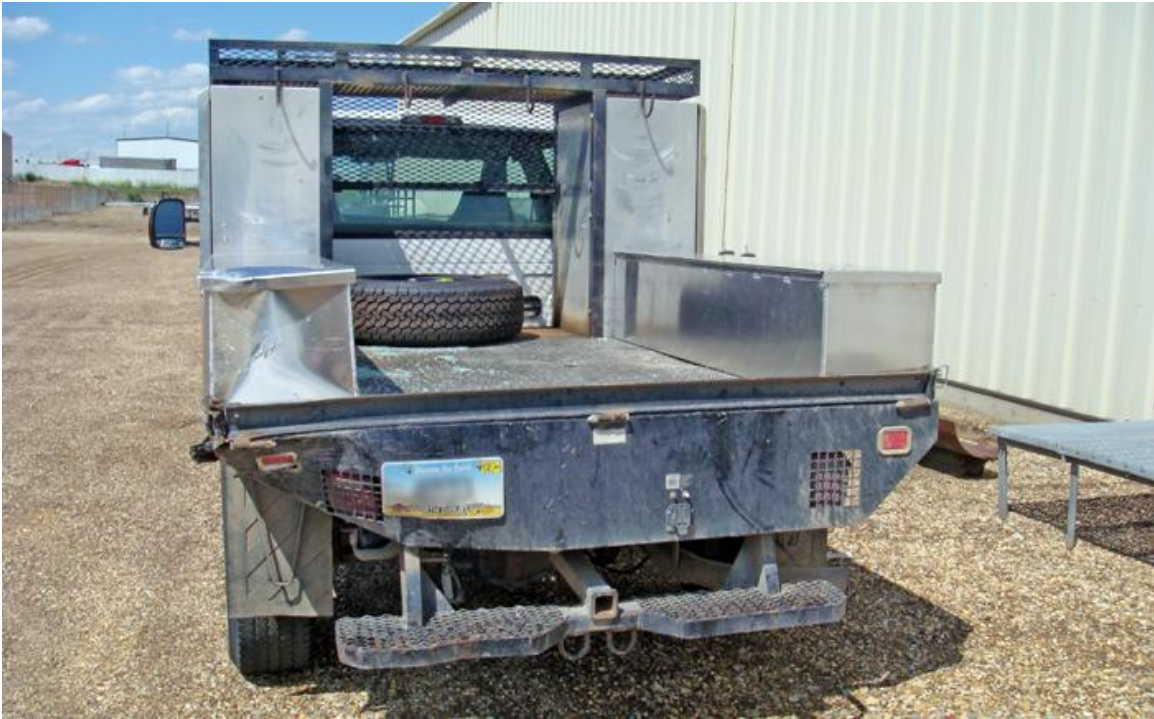
Photographs 11 and 12

Photos show damage from crash to V2.
