**U. S. Department of Energy  
Oak Ridge Operations Office**

**Type B  
Accident Investigation Board Report  
of the  
UT-Battelle, LLC,  
Contractor Employee Injuries  
from a September 7, 2001,  
Burn Accident  
at the  
Oak Ridge National Laboratory,  
Building 9210**

***October 2001***

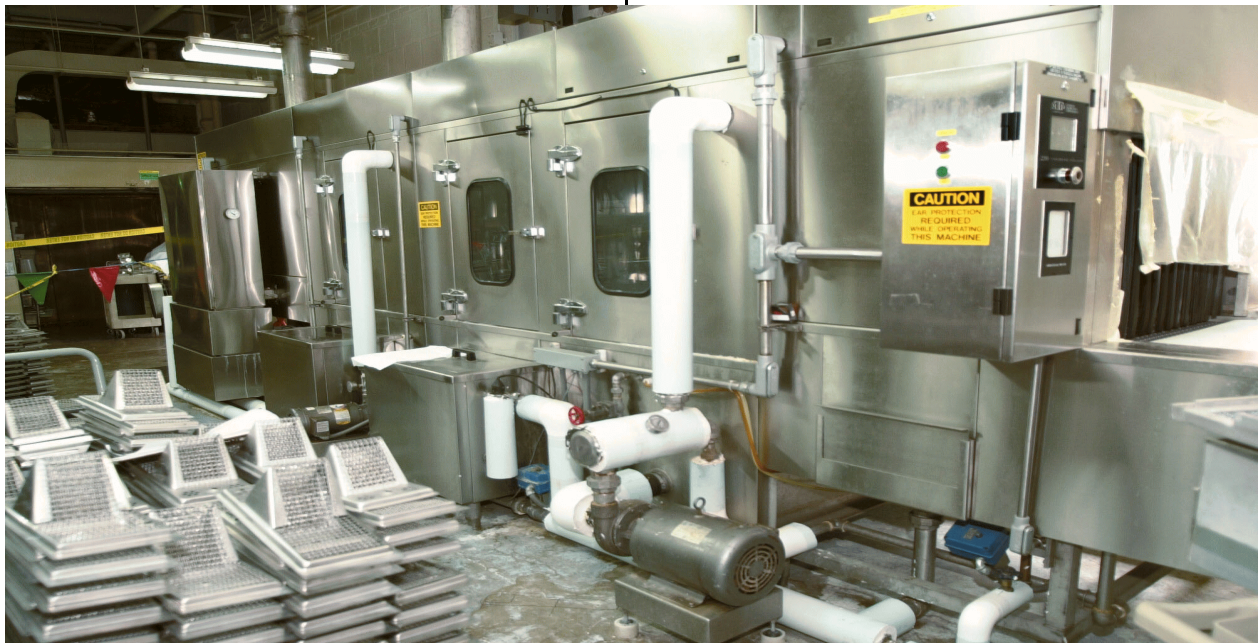
Exhibit 2-1. Tunnel Washer

The end cap on the filter assembly came off during contact with the worker or the cart the worker was using. The injured worker was

unclear as to exact action which released the filter assembly latch. Water that was normally

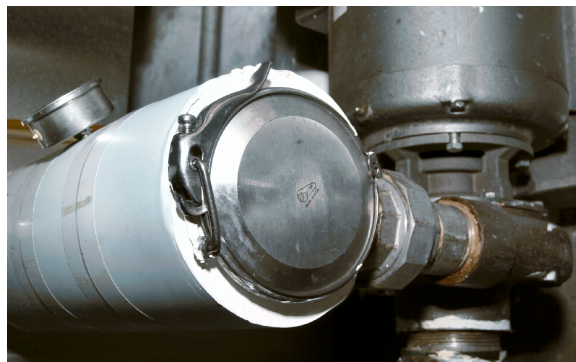
Exhibit 2-2. Latch and Filter Assembly

heated above 180°F degrees and under approximately 30 pounds of pressure was immediately released onto the worker. The filter assembly clamp could be opened with as little as ten pounds of pressure. It was an original piece of equipment. The equipment was an optional component that, as installed, protruded slightly into the work area. The normal setup had the assembly perpendicular to the washer. According to the schematics, it could have been installed parallel to the washer.

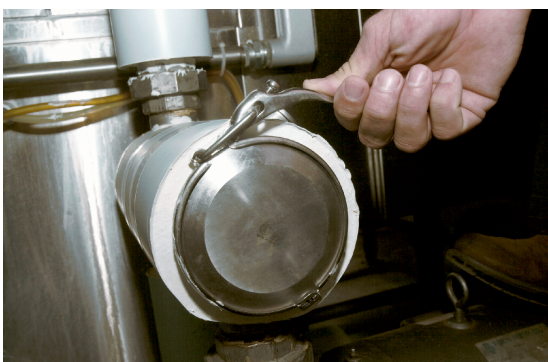
Exhibit 2-3. Filter Assembly Clamp

system. There was no audible alarm because the filter assembly that was inadvertently opened had no pressure-sensitive alarm. The worker's injury was exacerbated because hot water continued to spray the worker for the brief time she was in front of the assembly. The filter assembly that inadvertently opened did not have an automatic cutoff.

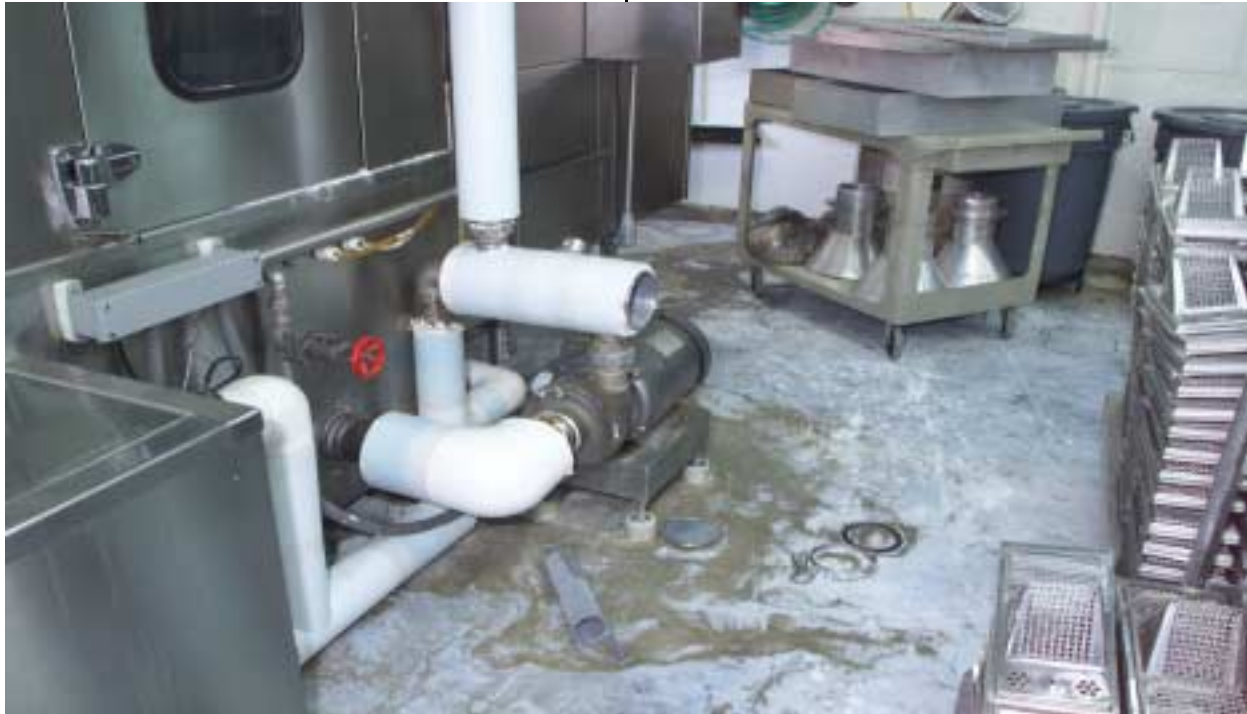
Exhibit 2-4. Hot Water Pipes

warranty period of one year. There was no record of any maintenance actions during the first year of operation. Since Y-12 assumed responsibility, there has been a limited amount of corrective maintenance but no recorded preventive maintenance. Pipes around the filter assembly and other exposed piping were partially insulated because employees had complained of the pipes being hot to the touch. A water leak in the piping near the filter assembly was fixed.

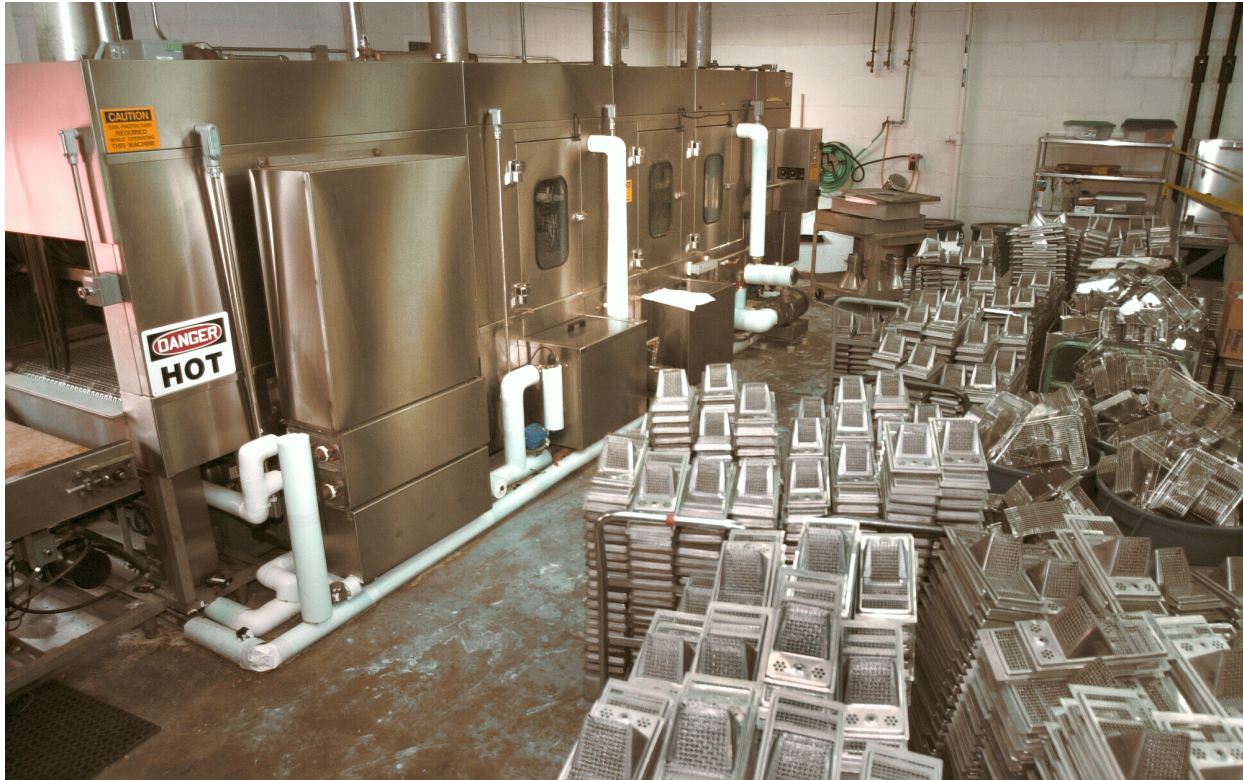
Exhibit 2-5. Room 235 Crowded with Carts of Cages and Cage Tops

Prior to July 23, 2001, there was one documented inspection report of room 235 being in an overcrowded condition similar to that found on September 7, 2001. The interviewees stated that occasionally there was a buildup of carts in the room, but they had seen nothing similar to the conditions that existed on September 7, 2001.

Yellow lines were marked on the floor of room 235 to indicate the path of travel and the location to store dirty equipment awaiting washing. Carts containing dirty equipment were located throughout the room, obscuring the yellow lines. There were so many carts in the room (i.e., 22) that inadequate travel space remained for the worker to travel safely from the clean end of the wash machine to the dirty end. This congestion contributed to the occurrence of the accident.

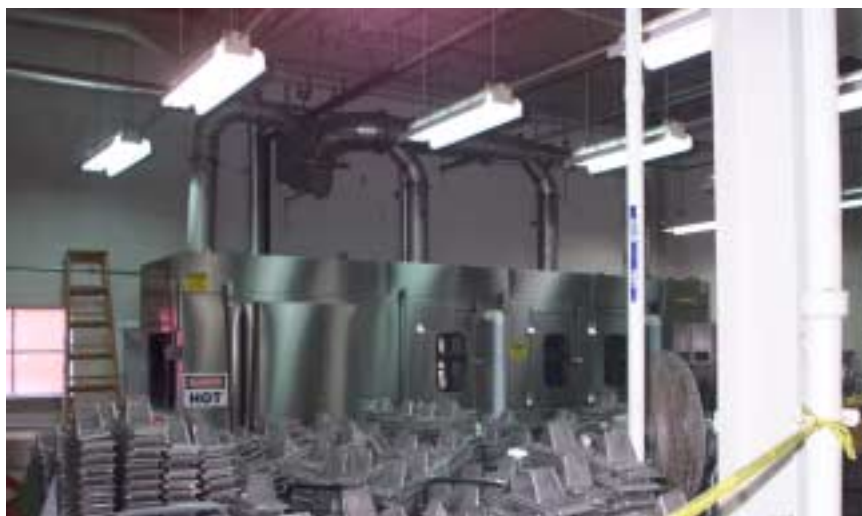
Exhibit 3-1. Exhaust Fan and Motor above the Tunnel Washer

During installation of the tunnel washer, the exhaust fan and motor were located above the washer, which created a noise hazard to the equipment operators.

The fan and motor should have been located outside of the room/building, which would only have required an additional 10 feet or less of duct work. Placing the fan over the tunnel washer created a high noise area, and the employees were required to wear hearing protection. The high noise level also made it difficult for people outside the room to hear the injured worker call for help. After the worker sustained severe burns, she had to travel approximately 50 feet to exit the room to obtain help.

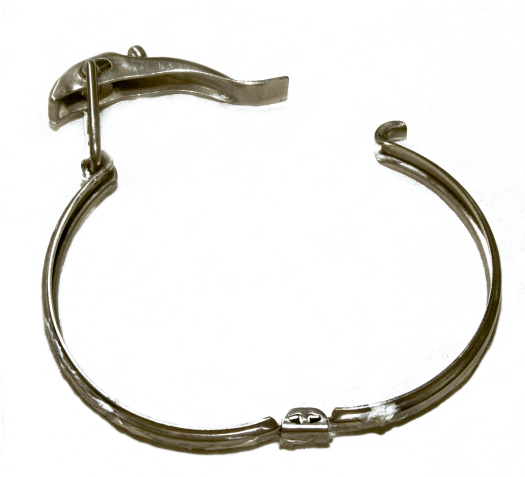
Exhibit 3-2. Filter Latch Assembly

The less-than-adequate design of the latch assembly for the automatic self-cleaning debris filter was a primary factor in the accident. The access assembly consisted of three parts (i.e., an outer plate, a rubber seal, and a hinged clamp with a levered latch that secured the outer plate and seal). When the levered latch was in a relaxed state (open), the outer plate and seal immediately fell to the floor.

The tip of the levered latch protruded approximately 1/8 inch beyond the end of the filter access assembly.
