Final Report

**Type B Accident
Investigation Board Report
August 5, 1998
Load Haul Dump Accident
at
U16b Tunnel
Nevada Test Site**

Nevada Operations Office

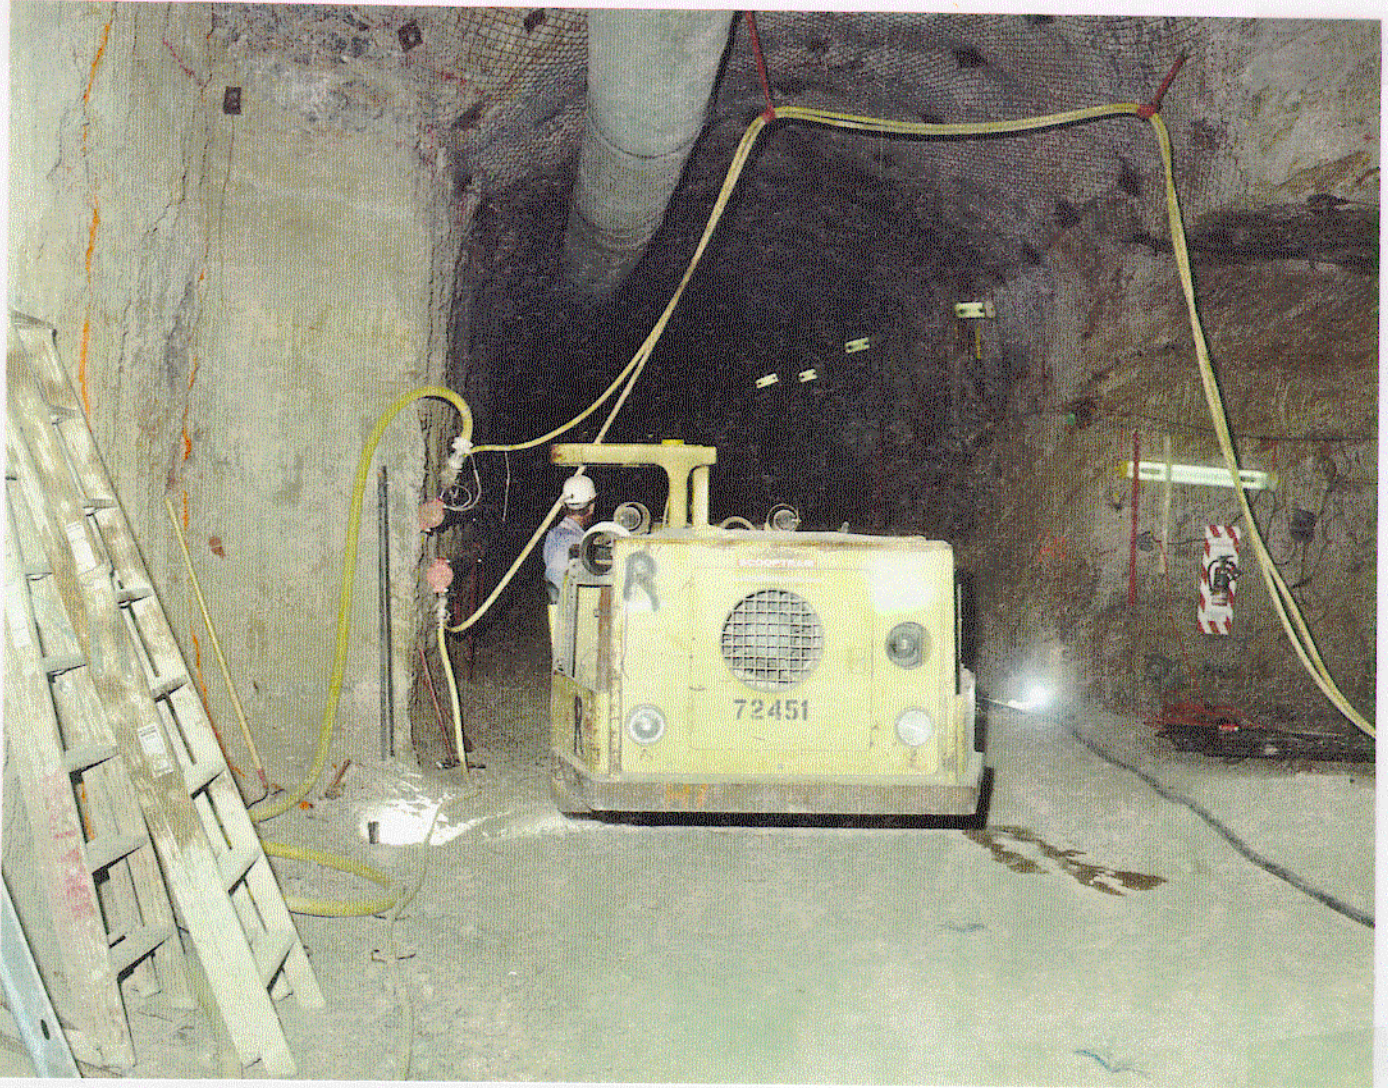
Figure 3, Photograph of Best Accident Reconstruction

Miner to a muck pile in the tunnel. He had successfully completed 11 round trips and was returning to the Alpine Miner for another load when the LHD's rollover protective structure (ROPS) snagged and stretched a water hose that had been strung across the tunnel's back in support of the keyway construction. A best reconstruction revealed that the hose was approximately 40 inches from the tunnel's left rib at the height of the ROPS on top of the LHD (figure 3).

The accident happened when the LHD snagged the water hose at CS 1+96 as the LHD was returning to the Alpine Miner for the twelfth load. The hose was stretched by the moving LHD until the threaded 1-inch steel pipe nipple holding the valve at the end of the hose to the 4-inch steel water pipe failed. The tension on the hose also permanently stretched the nylon straps used to support the hose about one inch, and deformed the wire mesh bolted to the tunnel back, and to which the nylon straps were hooked, about 6 inches. The 4-inch steel water pipe was rotated about 45 degrees by the tension on the hose. It is not known how far the LHD traveled after snagging the hose before the pipe nipple broke, but the injured employee's safety glasses were found on the invert about 23 feet in the direction of travel at CS 2+19.

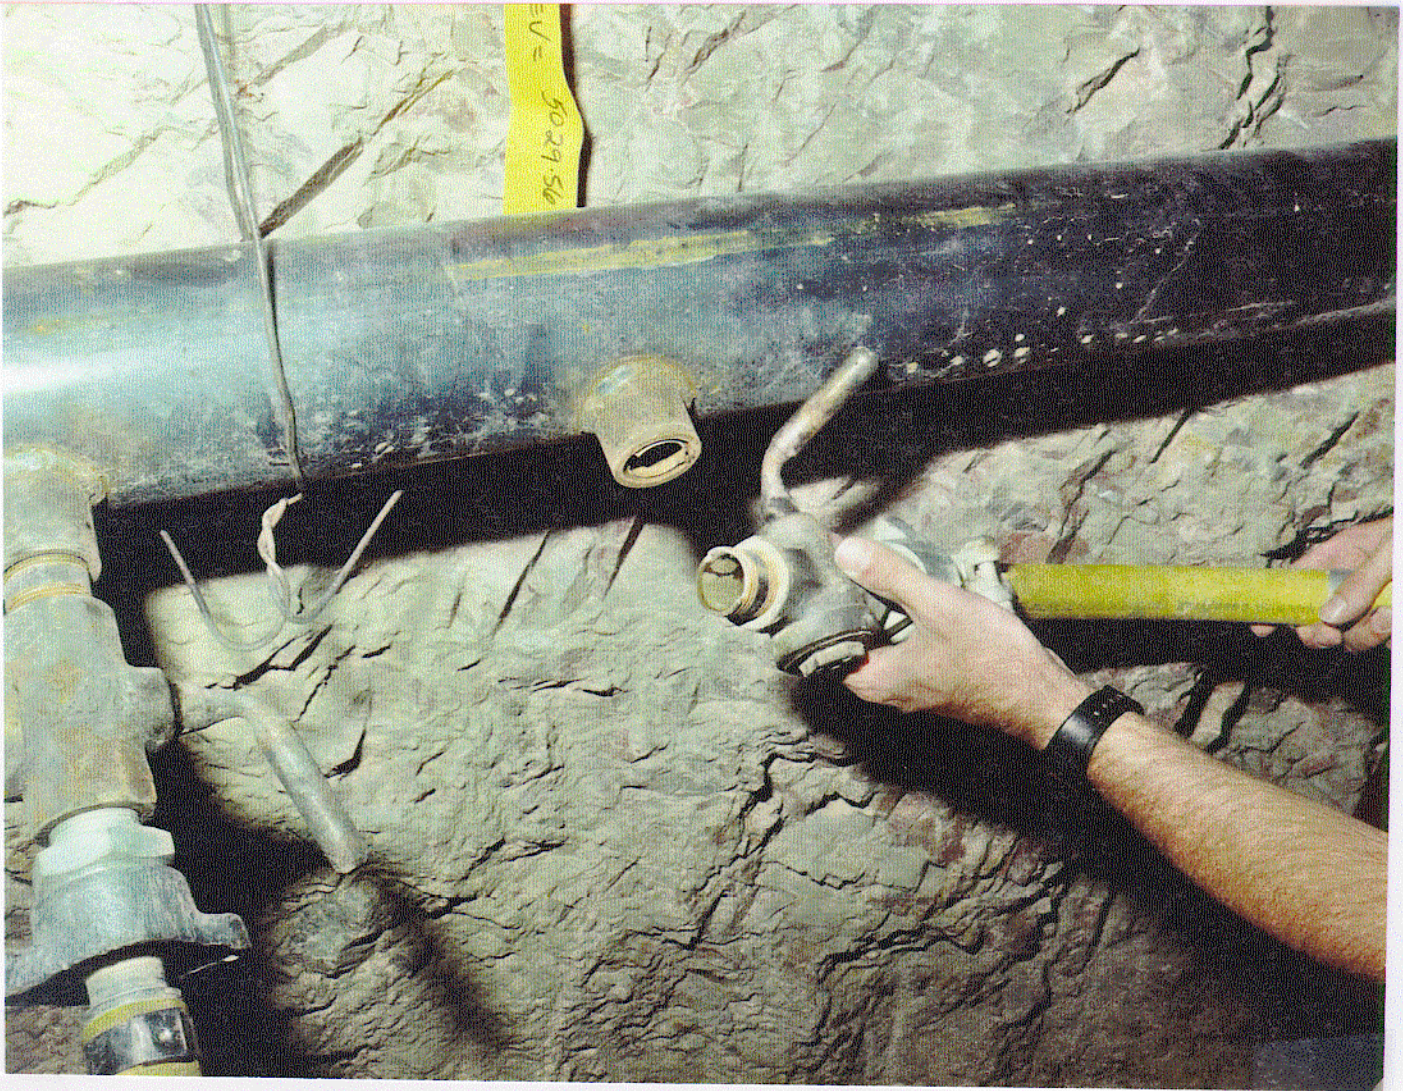
Figure 4, Photograph of Valve Assembly, Water Pipe, and Failed Nipple

Tension on the hose caused failure of the steel pipe nipple which connected the valve assembly at the end of the hose to a 4-inch steel water supply line (figure 4). When the nipple failed, the valve assembly was propelled toward the LHD by the contracting hose. The valve assembly struck the LHD operator (injured employee) on the back of the head. The LHD and injured employee proceeded to travel forward to CS 2+76 where it struck the conveyor attached to the back of the Alpine Miner. When the LHD struck the conveyor it damaged the conveyor frame, partially severed the 480 volt electric trailing power cable to the Alpine Miner energizing the LHD frame, and knocked the Alpine Miner operator (Miner A) from the Alpine Miner. The collision with the Alpine Miner also caused the injured employee to be partially ejected from the LHD.

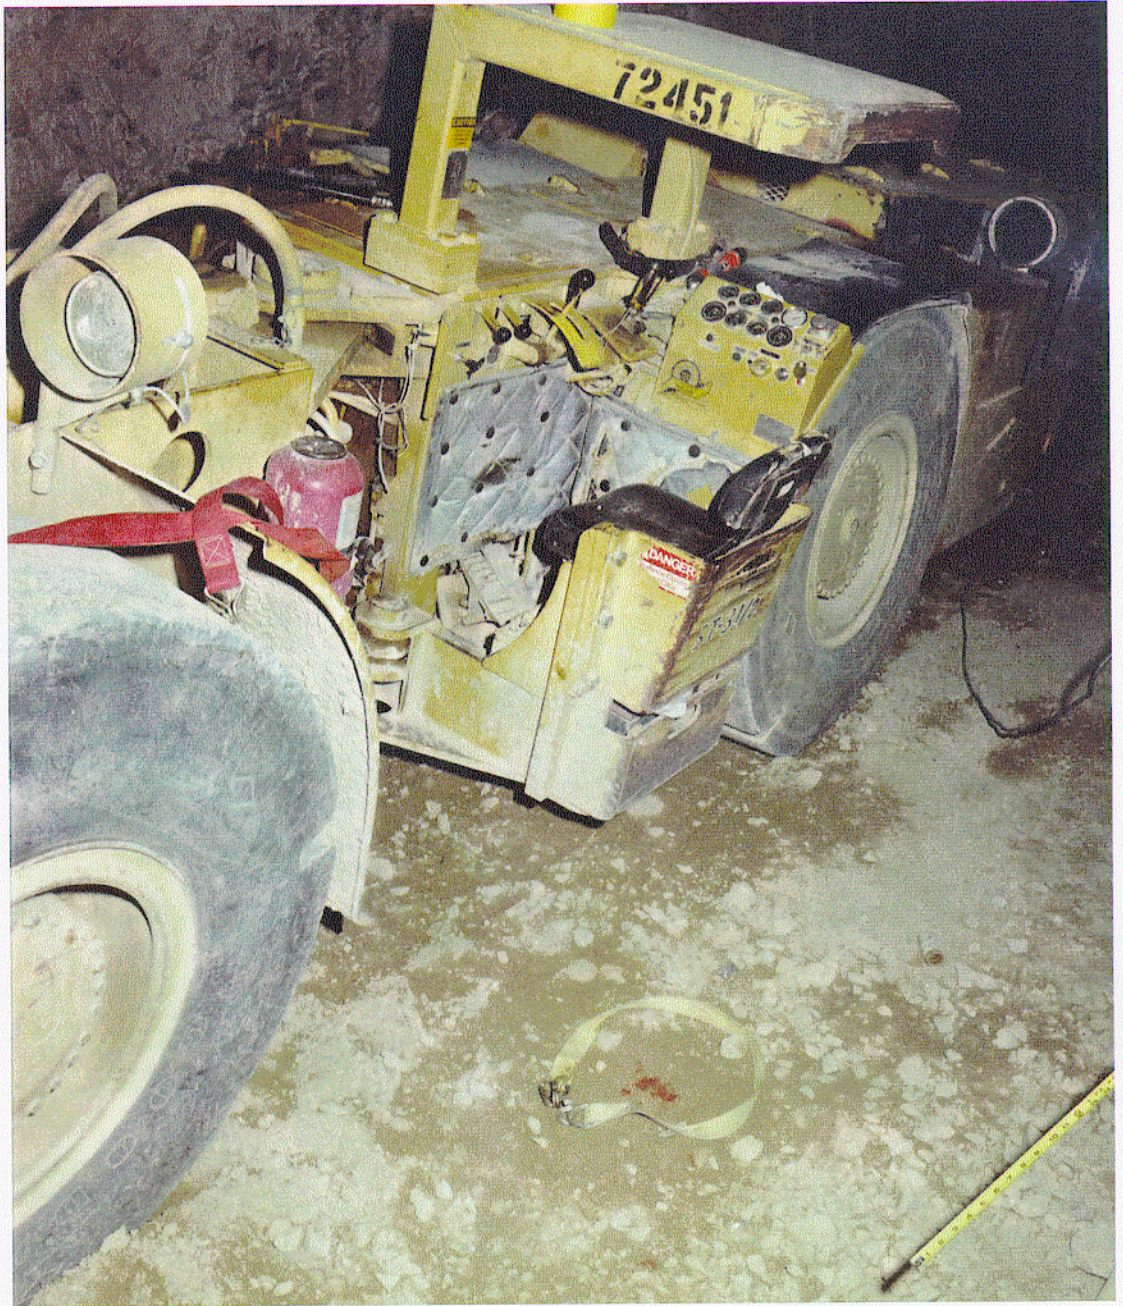
Figure 5, Photograph of LHD Operator's Cab

Miner A went around to the back of the Alpine Miner where he observed the LHD in contact with the conveyor and the injured employee lying on his back on the invert with his legs still in the operator cab (figure 5). Miner A called for help and Miners B and C, who were working on the keyway in the alcove responded. Miner A then observed that the injured employee was not breathing and directed Miner C to call for emergency medical assistance. Miner C went to the tunnel's public address (PA) system and made an emergency announcement for medical assistance while Miner B assisted Miner A in removing the injured employee from the LHD. During the course of removing the injured employee from the LHD, Miner B received three separate electric shocks when he made contact with the LHD. Miners A and B checked the injured employee and were not able to detect any vital signs. Accordingly, they started cardiopulmonary resuscitation (CPR).

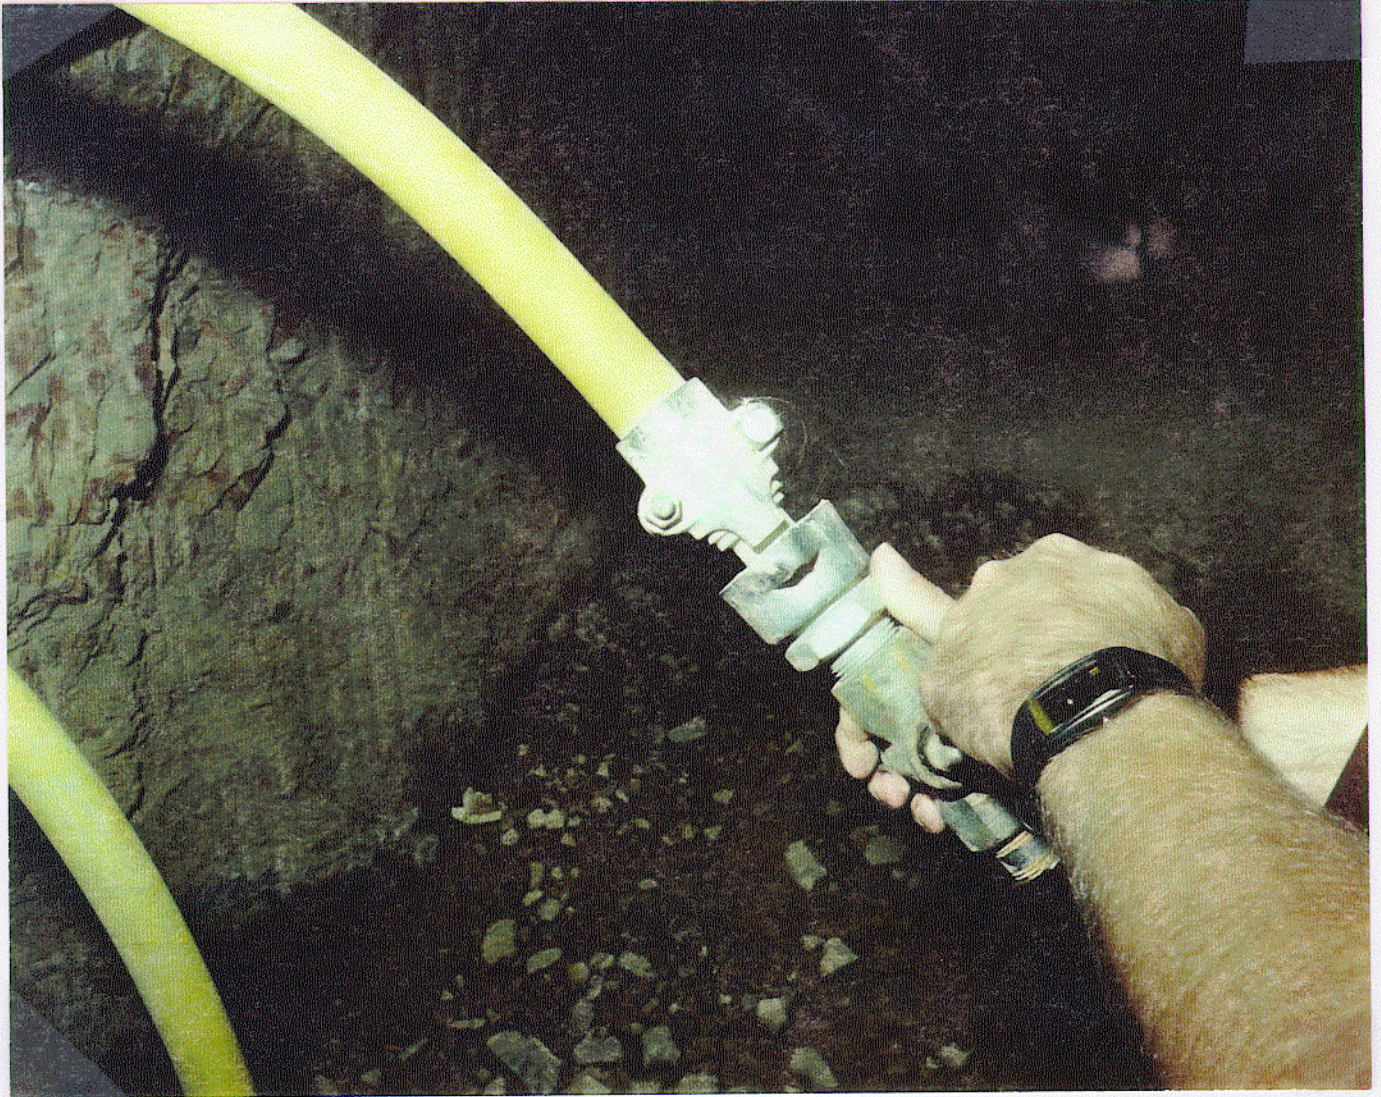
Figure 6, Photograph of Hair Adhering to Valve Assembly

When the nipple failed, the valve assembly on the broken end of the hose was propelled by the rapidly contracting hose toward the LHD striking the operator on the back of the head. During the investigation, hair was found adhering to the clamp which attached the valve to the hose (figure 6). After investigating the accident scene, and reconstructing the hose arrangement to its best ability, the Board concluded that it is unlikely that the LHD traveled more than 10 feet after snagging the hose before the pipe nipple broke. The LHD continued to travel down the tunnel with the injured employee on board until it collided with the conveyor at the back of the Alpine Miner at CS 2+76.

It should be noted that a crucial piece of physical evidence was the several pieces of human hair found adhering to the clamp that attached the valve assembly to the hose. Without this evidence it may have been impossible to determine if the head injury was caused by the hose or ejection from the LHD on impact. The Board commends the BN investigators for finding and preserving this evidence early in their investigation.

Hair was found adhering to the clamp on the end of the broken hose.

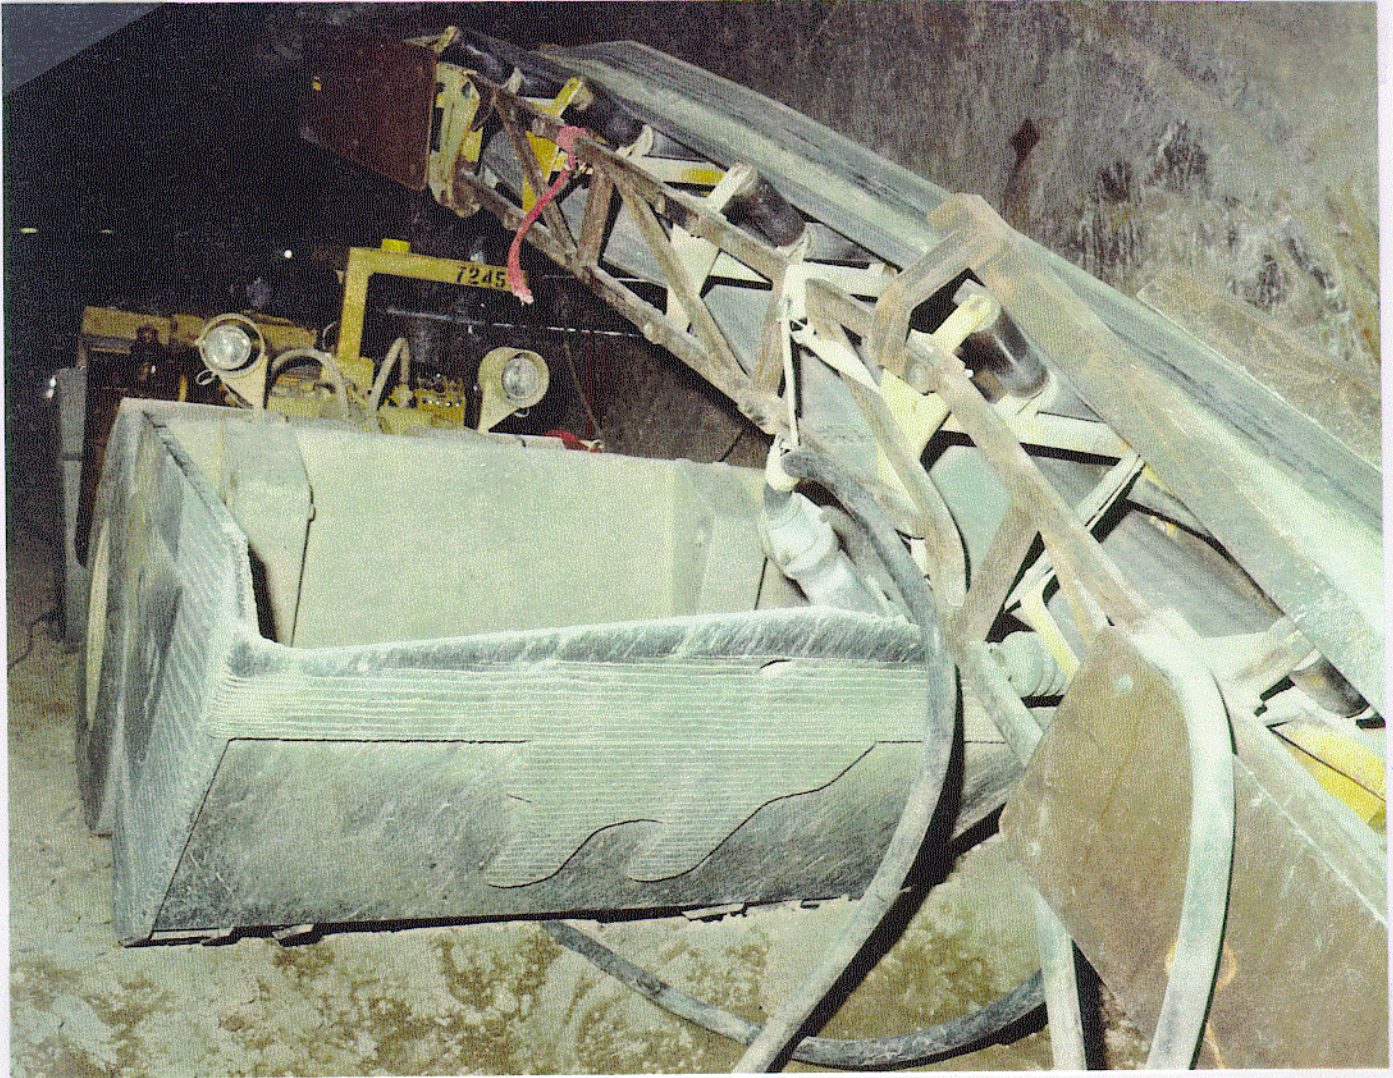
Figure 7, Photograph of LHD in Contact with Alpine Miner

The LHD bucket dented the Alpine Miner's conveyor frame causing less than \$10,000 in damage. The bucket also impacted the Alpine Miner's 3-phase 480 volt trailing power cable which was suspended on straps attached to the conveyor, breaking one of the straps and cutting through the cable's protective outer jacket and the insulation on the B-phase conductor (figure 7). When the LHD came to rest the trailing power cable was pinched between the conveyor frame and the LHD bucket. The bucket was in contact with the trailing power cable, but not with the frame of the Alpine Miner's conveyor (figure 8).

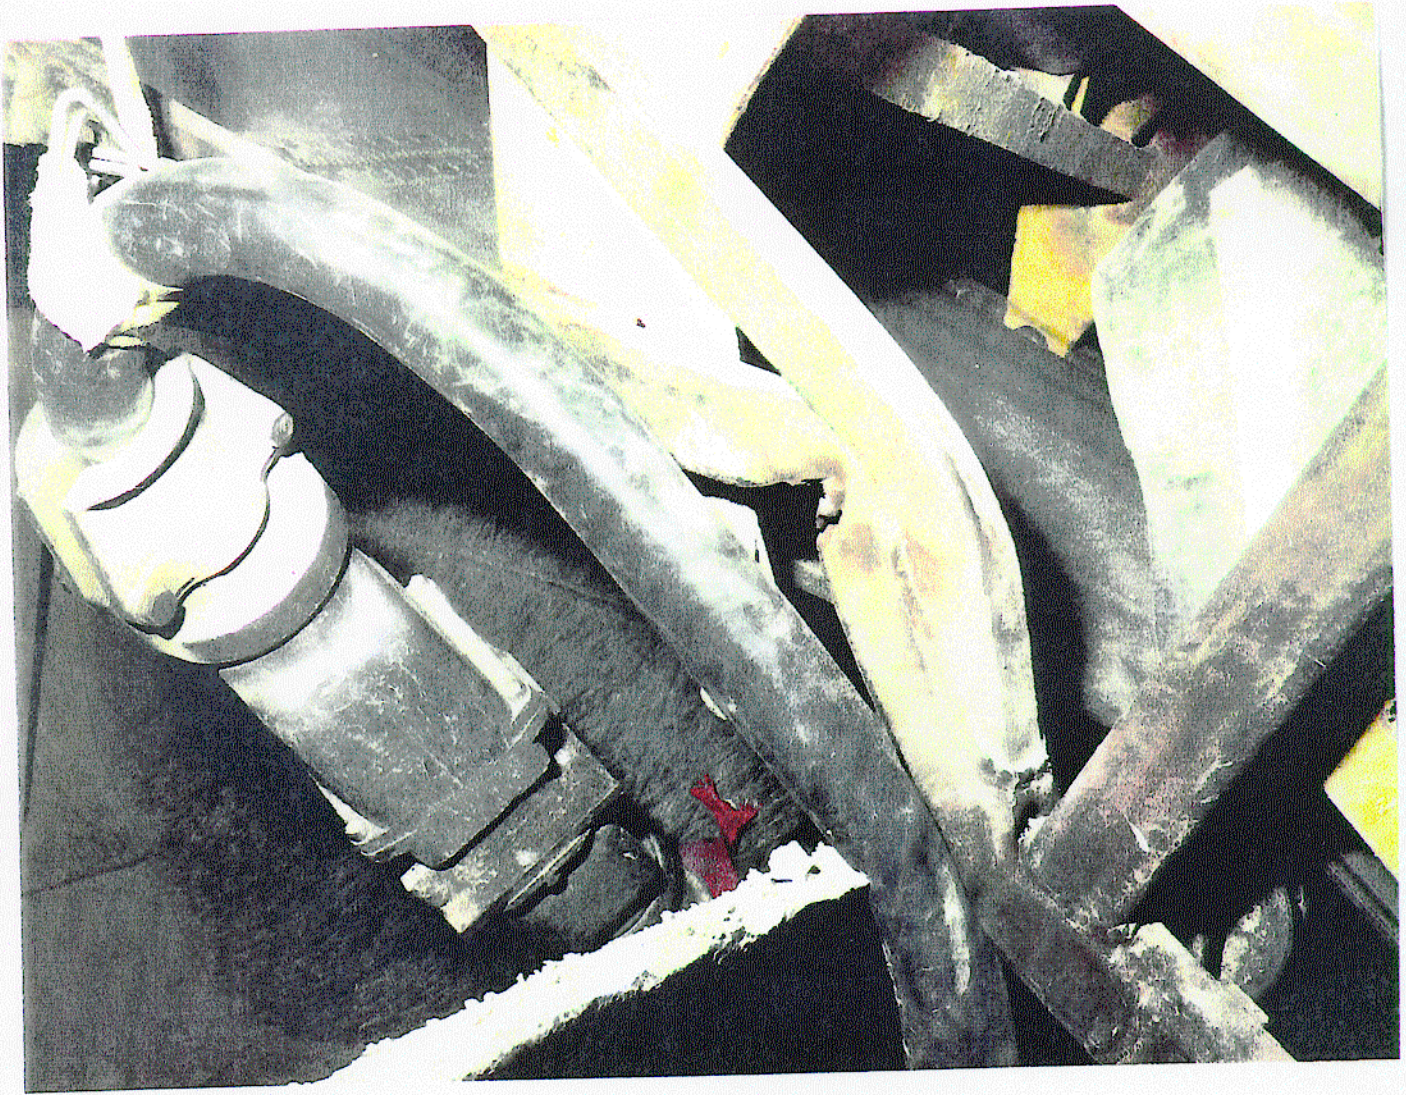
Figure 8, Photograph of Power Cable Damaged by LHD

First, the damage to the Alpine Miner's trailing power cable was not observed prior to attempting the removal of the injured employee from the LHD, and electric power to the Alpine Miner was not deenergized as soon as it was known that the LHD frame was energized. When Miner B received the first shock he recoiled and tried to reach the injured employee's legs from a slightly different angle. Upon receiving the second shock he recoiled and decided that he was going to remove his injured coworker even if that meant receiving additional shocks. Failure to deenergize the Alpine Miner power supply as soon as the LHD frame was found to be energized had the potential to result in severe injury or electrocution.

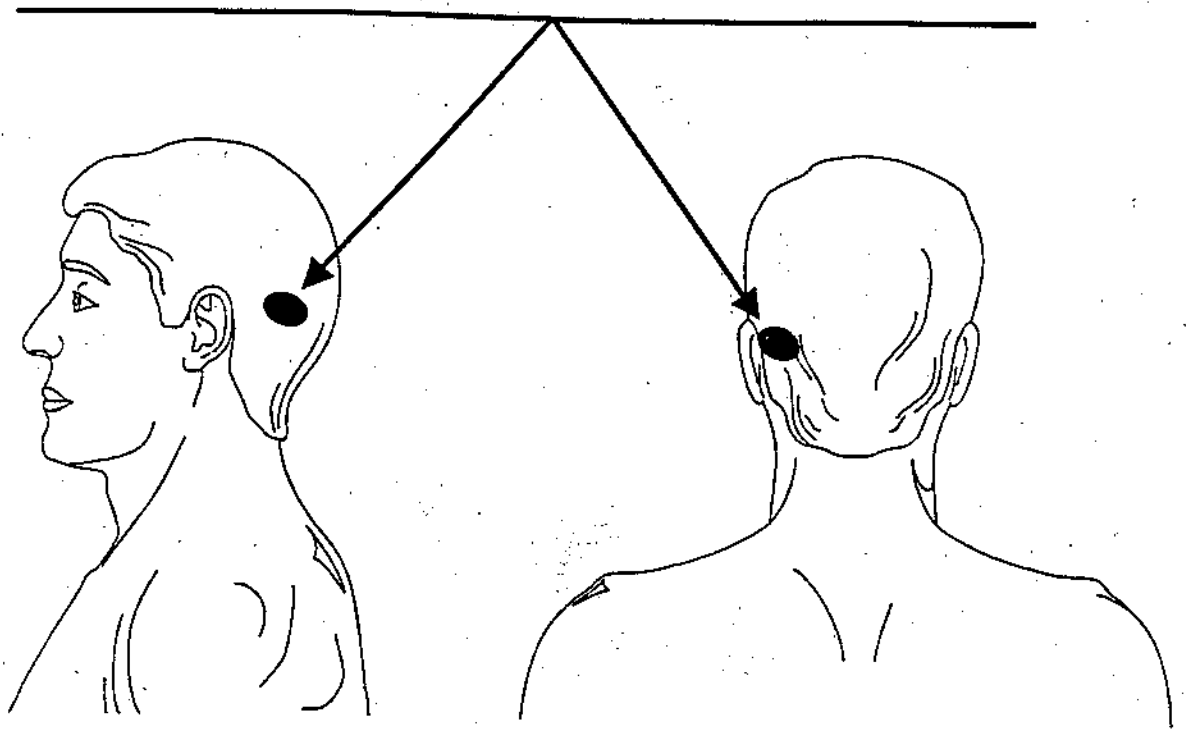
Figure 9 Drawing of Location of Head Injury

The day of the accident was the first day back at work after the injured employee had taken leave to attend the funeral of his mother in Ohio. The employee appeared normal to his coworkers the day of the accident. The injured employee was highly respected as a safe and skillful equipment operator. Virtually all of the injured employee's coworkers were of the opinion that he was probably unconscious prior to contacting the water hose. The Board found no evidence to support this but the possibility cannot be ruled out. The injured employee was not wearing the LHD's installed seat belt. The Board could not determine if the injured employee was wearing a hard hat. The injury was to a part of the head not normally protected by a hard hat (figure 9).

The Board determined that the injured employee was struck on a part of the head not normally protected by a hard hat. The injured employee's hard hat met the ANSI approved standard for mining activities. There is no substantiated evidence that the injured employee was not wearing his hard hat. The injured employee's hard hat is not considered a failed physical barrier.
