**Type B Accident Investigation Board
Report of the
September 1, 1999, Plutonium Intakes
at the
Savannah River Site FB-Line**

Type B Accident
Investigation Report of
the September 1, 1999,
Plutonium Intakes at the
Savannah River Site
FB-Line

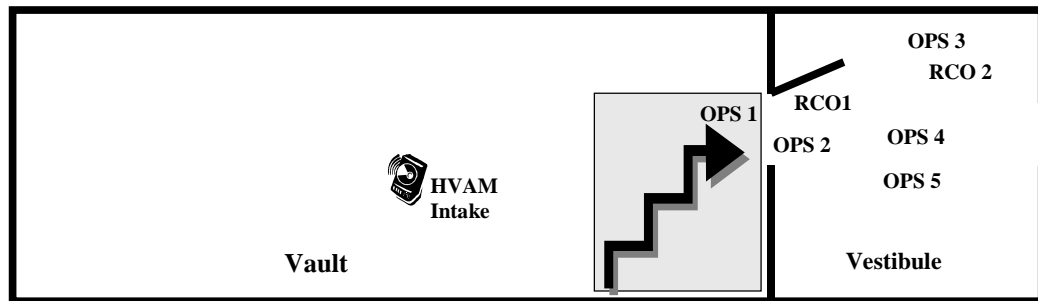
Figure 2-1 Diagram of Vault/Vestibule Area

At 0942 hours on September 1, 1999, eight personnel entered the FB-Line vault stairway to perform two tasks: batching and transporting characterization samples per Standard Operating Procedure (SOP) 221-FB-1781-NS, and packaging bagless cans containing plutonium-bearing materials into shipping containers per SOP 221-FB-1186-H-NS. The workers included six FB-Line operations personnel and two RCO inspectors. (To trace and identify activities in this report, these individuals are designated as OPS 1, OPS 2, OPS 3, OPS 4, OPS 5, OPS 6, RCO 1, and RCO 2.) At 0944 hours, OPS 6 remained stationed in the vault stairway and the remaining seven personnel entered the vault/vestibule area (Figure 2-1).

- Ventilation in the vault and vestibule was near stagnant when the vault door was open. This condition was noted by numerous personnel interviewed and was documented in two air studies (ESH-HPT-94-0219, Rev. 1, September 13, 1994; and EHS HPT-98-0517, October 20, 1998). Air was not supplied to either the vault or vestibule (only vault exhaust was provided). A fire protection project replaced the floor hatch in the vestibule. Additionally, vault supply ducts were blanked off (FBL-TMC-96-014), the supply duct for the vestibule was decoupled from the supply duct for the vault, and air was drawn through cracks and crevices when the vault door was closed.

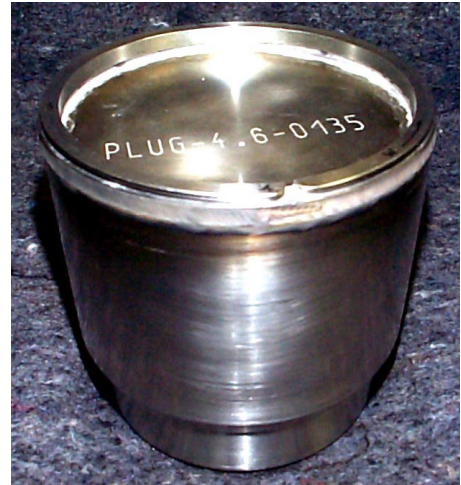
Figure 2-2 Representative Bagless Can

- The bagless canister design consists of an American Iron and Steel Institute Type 304L stainless steel cylindrical canister (*Figure 2-2*). The process calls for the canister to be back-filled with helium, automatically seal-welded to an internal hollow plug using a single-pass, fillerless Gas Tungsten Arc/Tungsten Inert Gas weld, and cut into two parts, with one part remaining as the glove box seal and the other part (containing plutonium) placed into storage.

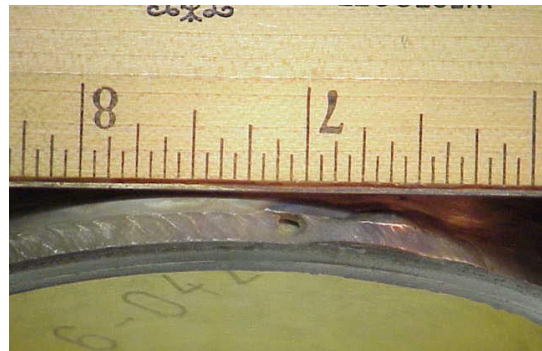
Figure 2-3 Weld Defect

- Can FBL-BC-00279, the fifth can to be packaged on September 1, contained a weld non-conformity/defect (*Figure 2-3*).
- Production records disclosed that on July 14, 1998, can FBL-BC-00279 was welded and cut by one operator, and inspected by a second operator (OPS3). Three checks of weld integrity were performed on can FBL-BC-00279 before it was placed in a vault for storage, as provided for by operating procedures. These checks, performed in sequential order, were (1) visual inspection by the equipment operator, (2) non-helium volumetric gross leak test, and (3) helium leak test.
- Visual examination failed to detect the weld defect in can FBL-BC-00279.
- The Volumetric Gross Leak Test and Helium Leak Test Systems failed to detect the weld defect.
- Interviews disclosed that canisters were also visually inspected and checked for contamination upon acceptance into the storage vault.

The SRTC evaluation of the weld defect concluded that the weld defect was created at the time of welding, not as a result of subsequent handling. The hole and bulge discontinuities should have been evident during the visual examination prior to the leak test. Failure of the visual inspection may have been caused by the obstructed view afforded by the air-fed hood worn by the operators. A successful visual weld inspection relies on an unobstructed, magnified view of the weld, elements that were not provided in the room where the cans were welded. A direct pathway from the plutonium metal to the can exterior existed at the time of inspection. The lack of contamination release during the leak tests and subsequent transport to the vault supports the observation that oxide was not present. Only during the 14 months of storage in the vault was oxide generated that was released by movement of the can. The lack of a contamination spread from the vented can prior to movement can be attributed to the near stagnant nature of vault ventilation.

The weld thinning before the hole is characteristic of a weld 'blowout.' The defect originated with the original tack weld, which was not covered by the overpass closure weld. The remainder of the can weld was satisfactory.

SRTC's report discusses the potential root cause of the weld failure. The report concludes that there is no evidence to identify a single condition as the root cause. The report identifies overpressurization of the can during welding (possibly due to lack of venting) as the most likely cause of the weld failure. This conclusion has been reviewed by the Board and the Board is in agreement with SRTC.
