TYPE B ACCIDENT INVESTIGATION

JANUARY 28, 2003

FALL AND INJURY AT THE

STANFORD LINEAR ACCELERATOR CENTER

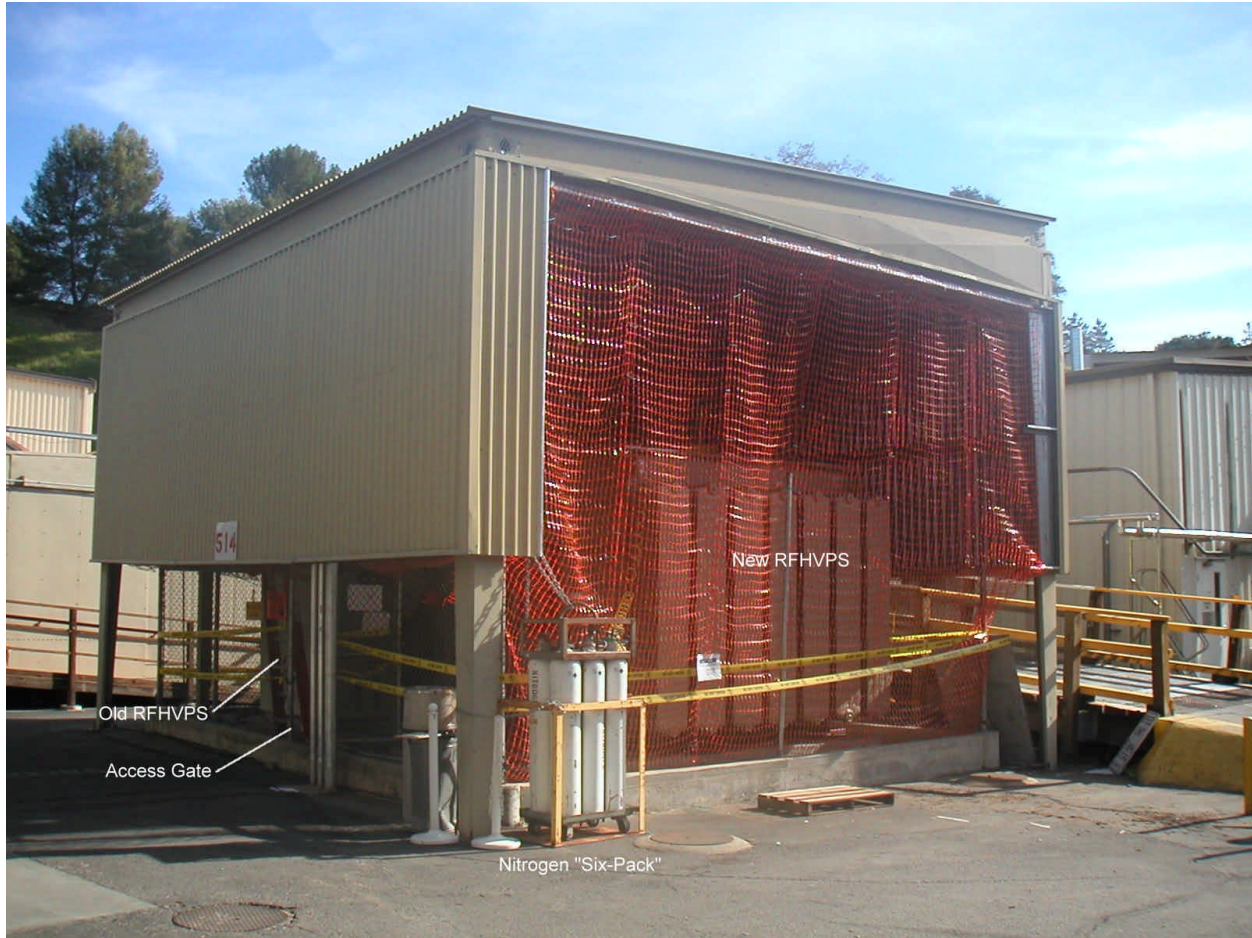
Exhibit 2-1 Building 514

Building 514 is a fenced and covered concrete pad area that houses two RFHVPS units. A weather cover extends approximately 10 feet above an 8-foot high chain link fence on all four sides, terminating in a sloped roof. Prior to the accident, one side of the chain link fence and weather cover were removed to allow the demolition (removal) of an old RFHVPS and the installation of a new unit. The RFHVPSs are installed on raised concrete pads within the building. One of the old RFHVPSs was removed in July 2002. Part of the new RFHVPS had been placed on the raised concrete pad and welded in place on Tuesday, January 14, 2003. No electrical connections were made to the new RFHVPS. The building floor has a raised curb at

the outer edge that acts as a containment in case of oil leakage from an RFHVPS. During construction activities, orange "construction fencing" (also called "bird netting") was used to replace the chain link fence and weather cover on the open side. Building 514 is posted as a "Hard Hat Required" area and as a High Voltage area (See Exhibit 2-1, Building 514).

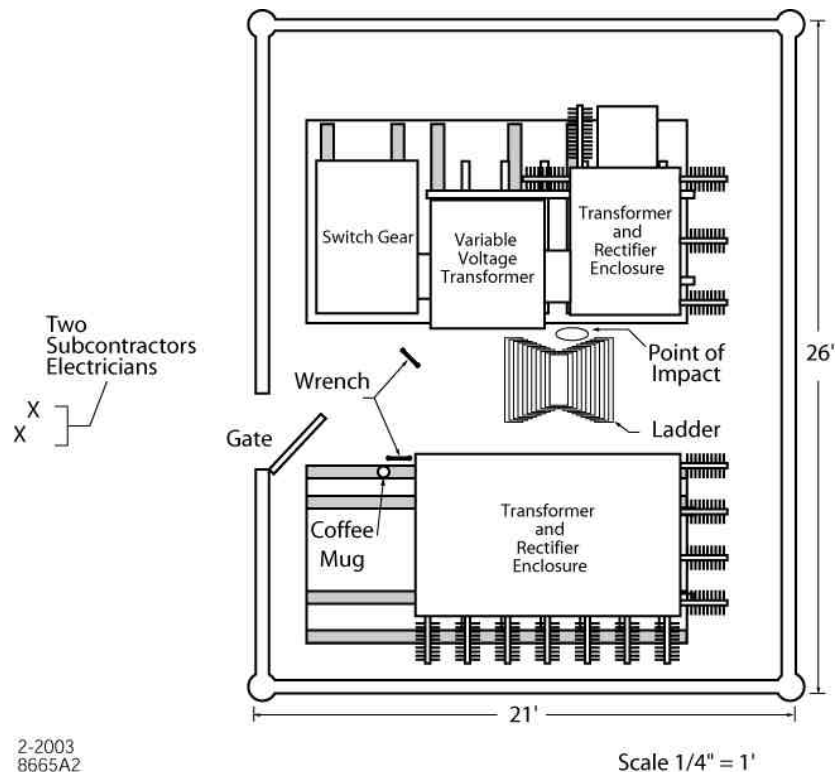
Exhibit 2-2 Accident Scene

On the morning of Tuesday, January 28, 2003, two SLAC subcontractor electricians were standing near the entrance to Building 514 that houses the RFHVPS switchgear and enclosures. The sub-contractors were in the area reviewing work unrelated to this accident. About 9:25 a.m., the Systems Engineer passed the electricians on his way from the SPEAR OCR in Building 117, to Building 514. The electricians noted that the Systems Engineer was carrying a plastic mug in his left hand. Both electricians stated that within 5-10 seconds after the Systems Engineer had passed by them, one heard a high-pitched sound and both heard a hollow "thud". The electricians entered Building 514 and saw the Systems Engineer lying on the concrete floor in a fetal position, beneath the stepladder. One electrician ran to the SPEAR OCR in Building 117 to call for emergency help while the other electrician stayed with the Systems Engineer. (See Exhibit 2-2, Accident Scene.)

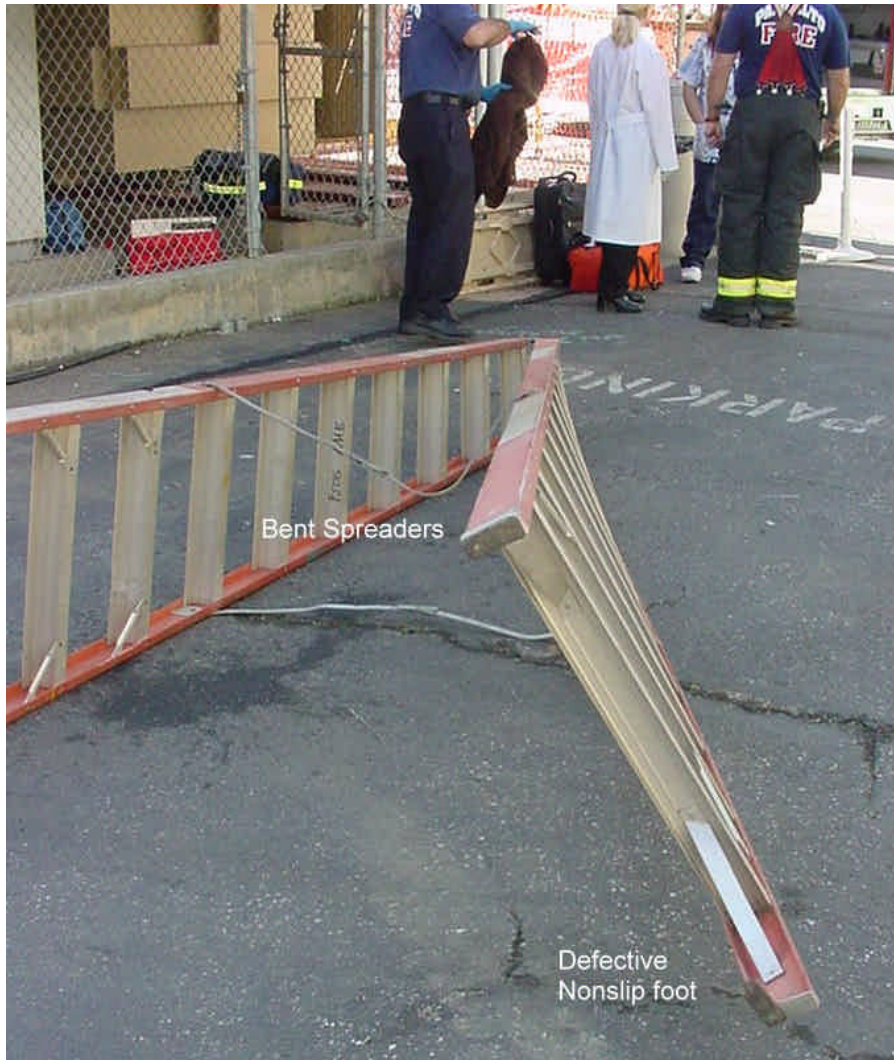
Exhibit 2-3 Ladder Showing Defective Nonslip Foot

The Board conducted a limited engineering evaluation of static loading conditions applied to the ladder to understand the forces imparted to the ladder the day of the accident. The ladder was visually inspected and photographs were taken to document its condition. The ladder inspection revealed longitudinal cracks in one of the side rails near the top, damaged and worn non-slip rubber bases (see Exhibit 2-3, Ladder Showing Defective Non-slip Foot and Exhibit 2-4, Ladder Showing Bent Spreaders), two bent spreaders, one deformed step, painted sections of the rails, and a manufacturer's label. The inspection also revealed the markings "PSOG AME" underneath one step.

- Although the ladder displayed signs of longitudinal cracking, damage to its rails, a step, and the non-slip rubber bases, the ladder did not fail from being loaded by the weight of the Systems Engineer. However, a pre-use inspection should have precluded the use of the ladder.

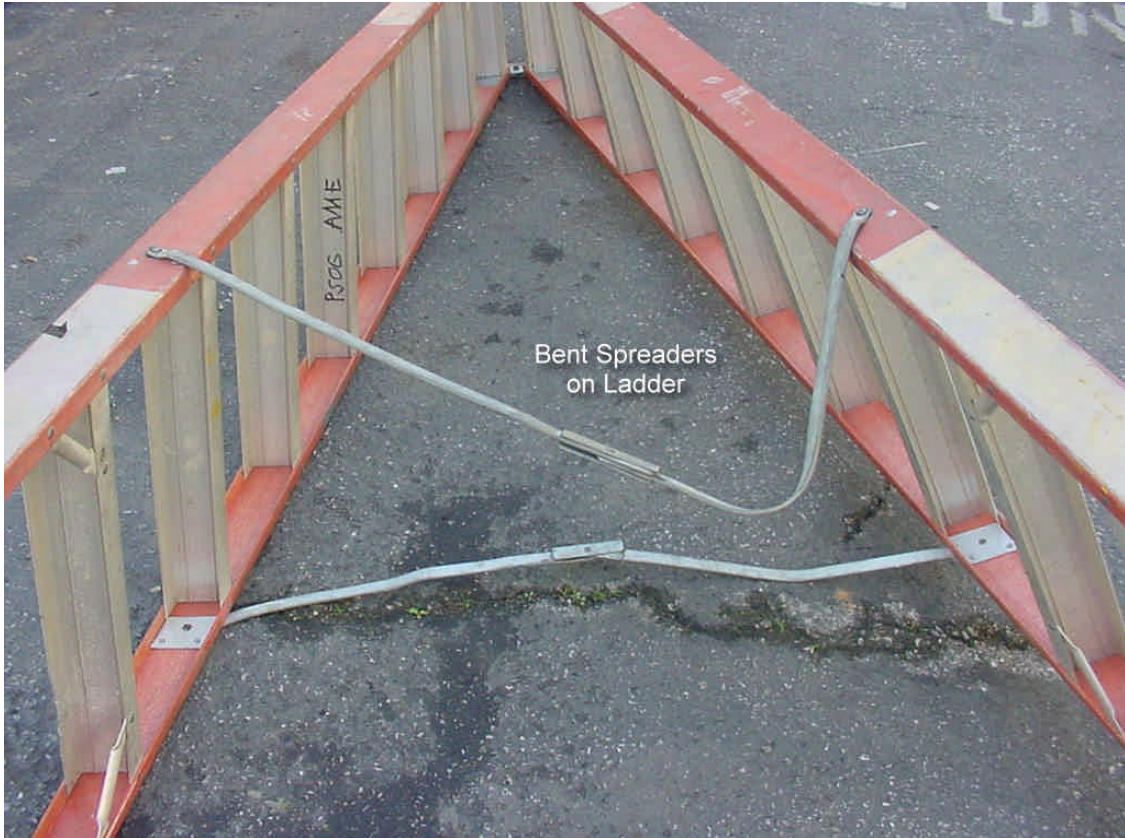
Exhibit 2-4 Ladder Showing Bent Spreaders

- Damage to the spreader nearest the old RFHVPS was consistent with a tipping of the ladder resulting from exerting a horizontal force against the ladder in combination with a fall from a height above the spreader

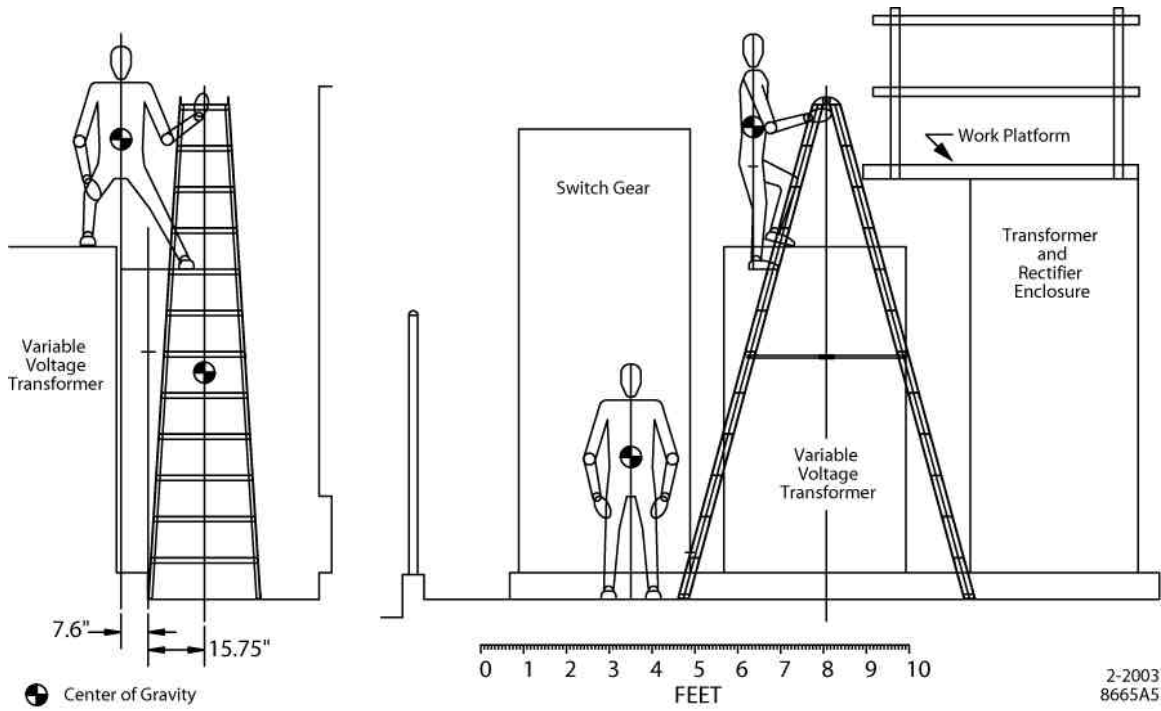
Exhibit 2-5 Static Loading Condition

- For the Systems Engineer to locate his center of gravity 7.6 inches outside the foot print of the ladder legs he would have moved off the ladder near the top of the ladder (See Exhibit 2-5, Static Loading Conditions and Exhibit 2-6, Similar Ladder).

The Board concluded that the results of the limited engineering evaluation indicate the Systems Engineer could have moved from the ladder while attempting to access the top of the VVT section of the old RFHVPS or the Systems Engineer encountered circumstances that caused him to move off the ladder. In either case the Systems Engineer would have fallen.
