Type B Accident Investigation Board Report

**Grounds Worker Injury At The
Pacific Northwest National Laboratory
October 8, 2004**

November, 2004

Pacific Northwest Site Office
U. S. Department of Energy
Richland, Washington

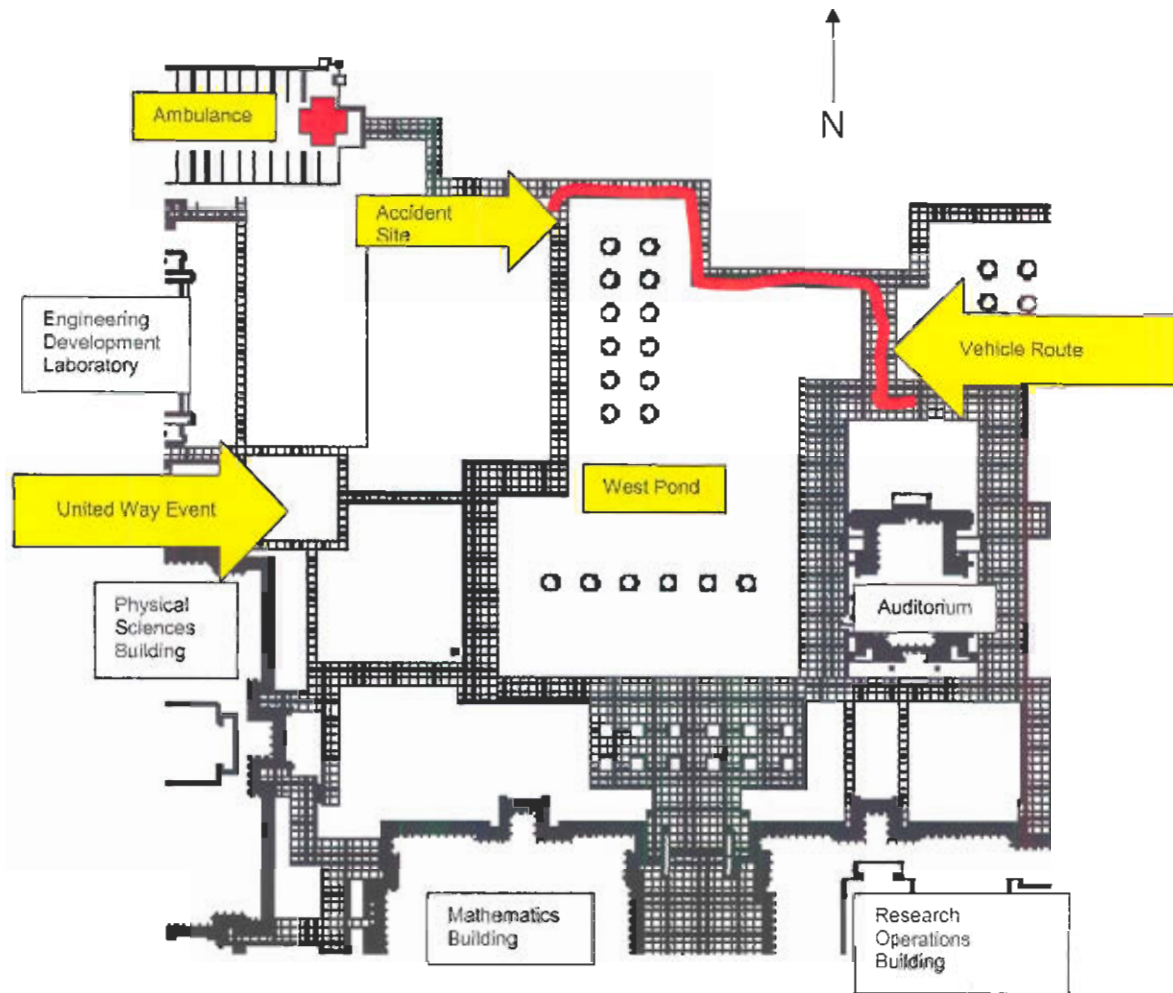
Figure 2. Accident scene

The two Grounds workers drove north from the Auditorium, then west along the sidewalk as it followed the pond, then turned to the south when they reached the west side of the pond (Figure 2). As the vehicle rounded the corner to turn south, Grounds Worker A began to slide down the passenger seat and fall out of the vehicle. When Grounds Worker A realized he was falling from the vehicle he attempted to position himself for the pending fall by planting his right foot on the concrete sidewalk. The right foot of Grounds Worker A made firm contact on the concrete walkway and torsional movement caused a fracture of his right leg above the ankle. Grounds Worker A fell and came to rest on the lawn adjacent to the concrete walkway on which the vehicle was driving.

Grounds Worker B (driver) immediately stopped the utility vehicle and observed Grounds Worker A laying face up on the lawn. One of the participants in the United Way event witnessed Grounds Worker A fall from the utility vehicle and ran toward the accident site. Grounds Worker B motioned for her to phone for emergency medical assistance (See Emergency Response below).

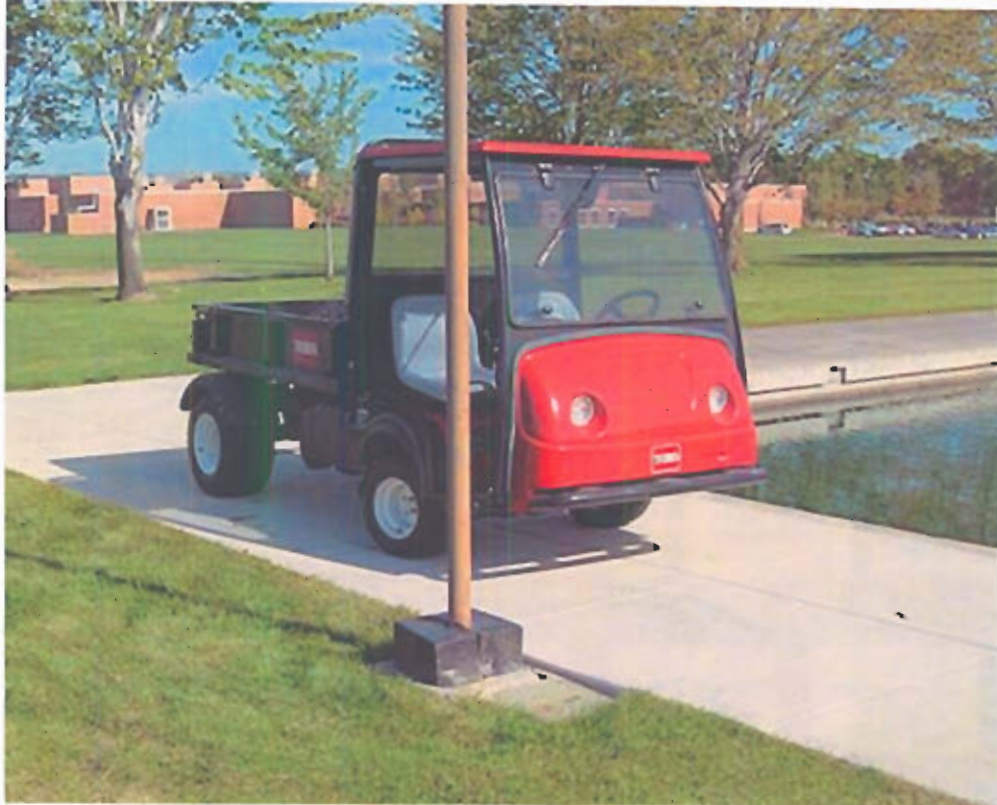
Figure 3. Photo of Toro Workman 3200 at accident scene

The Building Manager for this area and the PNNL Vehicle Safety Representative secured the accident scene (Figure 3) and began preliminary investigation. The event was classified under the DOE Occurrence Reporting system as a 2A(6)(b), "any single occurrence resulting in a serious occupational injury. A serious occupational injury is an occupational injury that results in a fracture of any bone." The PNNL Maintenance and Fabrication Services Manager issued a verbal order to stop the use of all Grounds utility vehicles. PNNL held a critique of the event on October 11, 2004. The PNSO Manager appointed an Accident Investigation Board on October 15, 2004.

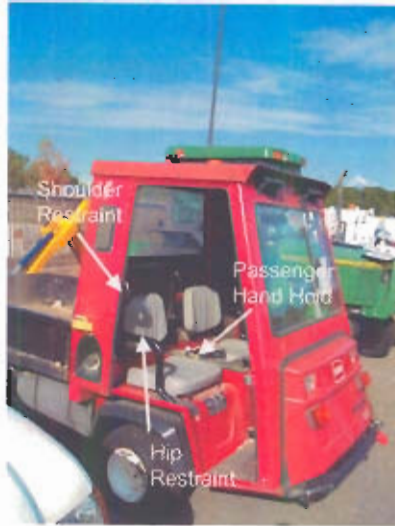
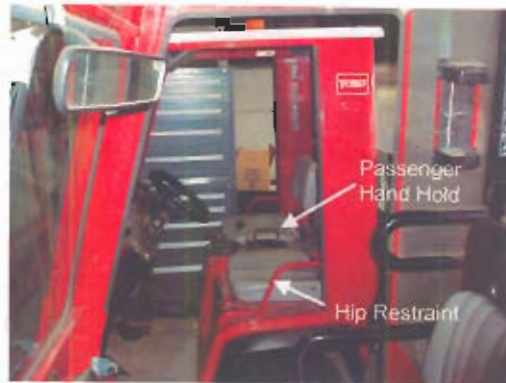
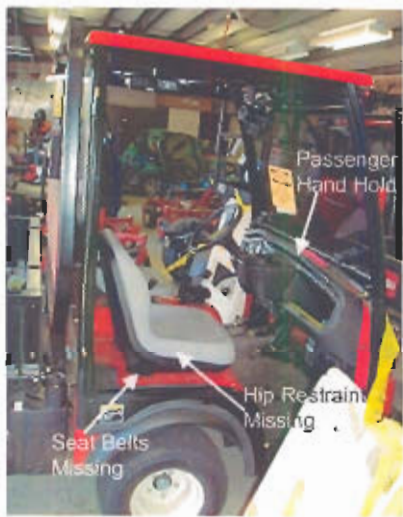
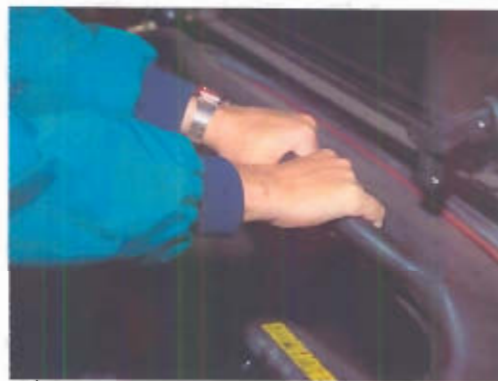
Figure 5. Top: existing Toro Workman 3200; bottom: new Toro 3200 (left) and detail of hand hold (right)

After the Toro Workman vehicles had been offloaded, Storekeeper 1 verified that they were configured as specified in the PNNL Purchase Order. Storekeeper 1 verified that each vehicle had a cab, tachometer, and heater. One vehicle had a flatbed and the other had a vertical lift. He also checked that they appeared to be in an undamaged condition, in accordance with Section 3 of the *Shipping, Receiving, and Transportation Logistics* subject area procedure under SBMS and Section 4, "Shipping and Receiving Material Directly from the Field," in the internal Logistics Desk Procedure. The regional distributor's driver presented the delivery paperwork to Storekeeper 1, who then signed it without reviewing it. Storekeeper 1 did not notice whether or not the seat belts and hip restraints were present in the vehicles.

Both the 1993 and 2000 revisions of American Society of Mechanical Engineers/American National Standards Institute (ASME/ANSI) B56.8, Safety Standard for Personnel and Burden Carriers, require the provision of handholds and hip restraints for the driver and each passenger. These features are to assist in preventing occupants from falling or being thrown by momentum out of the vehicle. The four older utility vehicles in use by the Grounds Workers were found to be in compliance with ASME/ANSI B56.8. In addition, each of the older utility vehicles was provided with a shoulder restraint bar to provide additional stability to the driver and passenger. ASME/ANSI B56.8 does not require seat belts. The manufacturer of the four older utility vehicles offered seat belts as optional equipment; however, the reason why seat belts were not purchased for the four older utility vehicles could not be determined during the investigation. This design is not the same on the newly purchased utility vehicles. The manufacturer is not providing a shoulder restraint. The new utility vehicles are fitted by the manufacturer with a hip restraint, but now seat belts are installed as standard equipment.

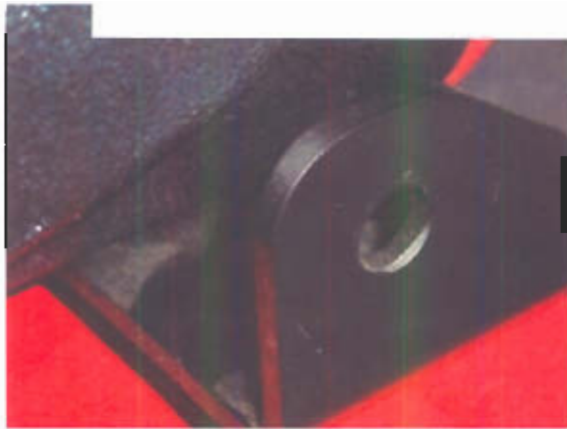
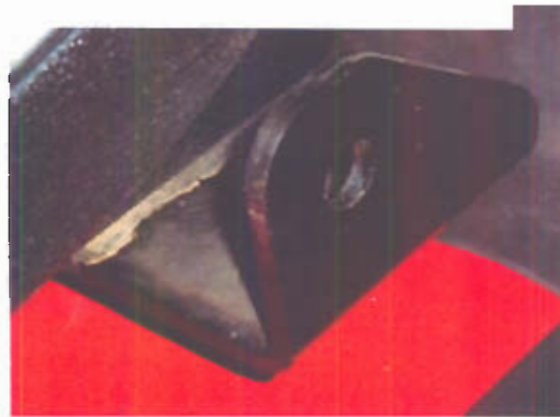
The cab and heater for the Workman 3200 vehicles are not installed at the factory by Toro, but rather at the regional distributor. The cab and heater are manufactured by Toro and installed by the distributor using an installation manual provided by Toro. This cab was much more substantial than some other after-market cabs that might have plastic and canvas for the sides. This cab consisted of a sturdy square-tube steel frame to which solid tempered glass doors with handle-operated locking mechanisms were attached. The cab installation procedure required the replacement of the front main suspension spring with a stronger spring. This procedure required the seats and seat-mounting hardware be removed for access. The instructions also required that the heater be installed prior to the cab installation. The installation instructions state that the cab reduces the vehicle load-carrying capacity by 420 pounds. The instructions specify that after installation of the spring and heater, the equipment removed be re-installed in the reverse order. Figure 5 compares existing and new versions of the Workman 3200. There is evidence that at sometime the bolt securing the seat belt was installed, as shown in Figure 6. The manufacturer's service representative informed the Accident Board Chairperson that seat belts and hip restraints are installed at the factory. PNNL staff who operate and maintain the vehicle stated that they did not remove the seat belts and hip restraints.

Figure 6. Seat belt attachment bracket (note missing paint in hole and circular scratch marks)

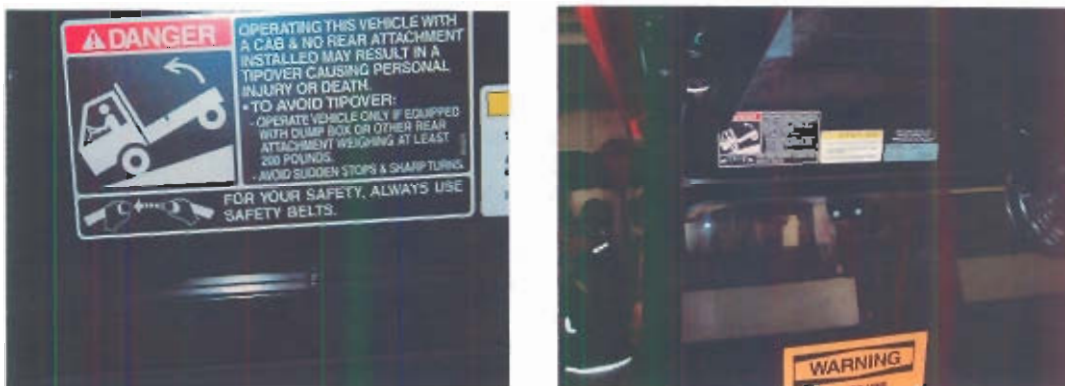
Figure 7. Safety Instruction decal above windshield on driver side of cab

The operators of the utility vehicle were not aware of the changes to safety equipment nor did they heed the safety decals requiring seat belt use.	F&O needs to ensure that workers are knowledgeable of the hazards in their work environment.
F&O management had not verified that the Grounds Supervisor was aware of all pertinent requirements and responsibilities.	F&O needs to develop and implement a process to ensure that line managers are knowledgeable of their ES&H roles and responsibilities as documented in SBMS and other applicable laboratory documents.
Self-assessments conducted in F&O did not identify optional safety equipment for grounds vehicles.	PNNL's Office of Audit and Oversight needs to conduct a sampling of organizations to determine if similar deficiencies in documented hazard analyses and personnel's knowledge of workplace hazards exist.
Grounds Supervisor and ESH personnel conducted various tests on the utility vehicle involved in the accident without consideration of preventing another accident.	The PNNL accident readiness measures need to ensure that subsequent Laboratory investigation efforts do not create additional unsafe situations.
