OPERATING EXPERIENCE SUMMARY

OE Summary 2014-05

Fatality While Driving Gradall Material Handler on a Remote Forest Service Road

Lithium Fire at the Sandia National Laboratories' Plasma Material Test Facility Highlights Opportunities for Improvement in Work Planning and Hazards Analysis

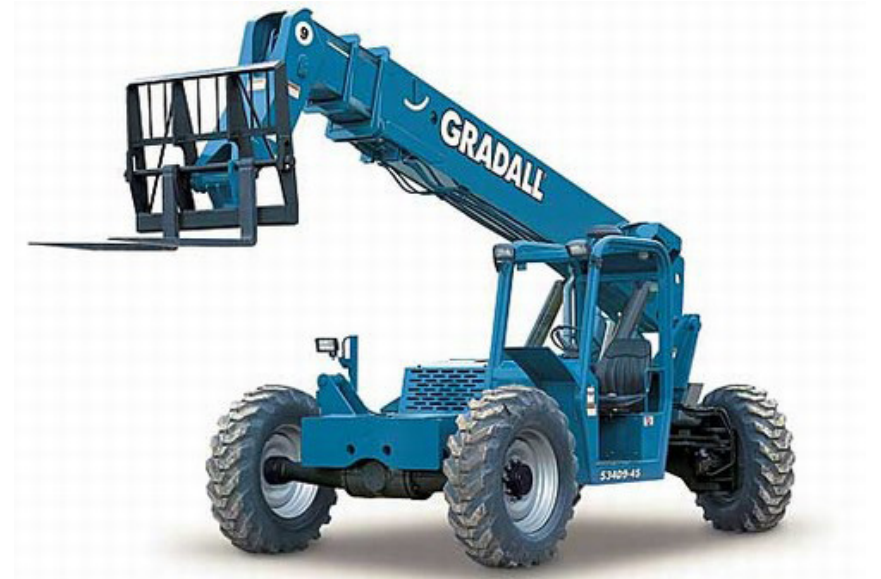
Figure 1-3. Gradall Model 534D9-45 Material Handler with ROPS

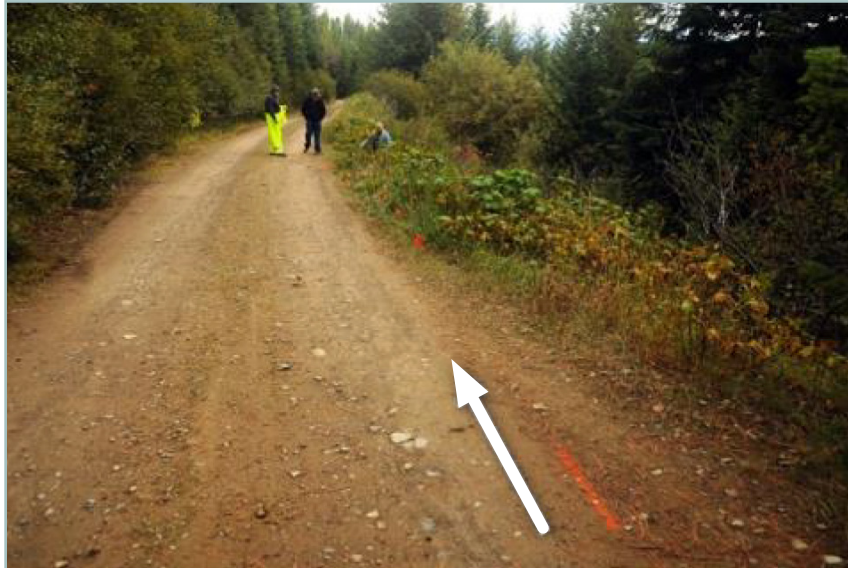
Because the Gradall had traveled 4 miles in 56 minutes, (an average speed of about 4 miles per hour, which complied with the SSSP 5-mile-per-hour limit), the Board concluded that speed was not a factor in the accident. The Forest Service Road was 12 feet wide; dry, hard gravel; generally straight and in good condition; with less than a 2 percent grade at the accident location. The Board could not determine, based on available evidence, why the Gradall left the roadway. Figure 1-4 shows the road at the accident site.

Figure 1-4. Personnel are standing at point of rollover (white arrow indicates the direction of Gradall's travel and orange marks indicate Gradall's tire tracks leaving roadway)

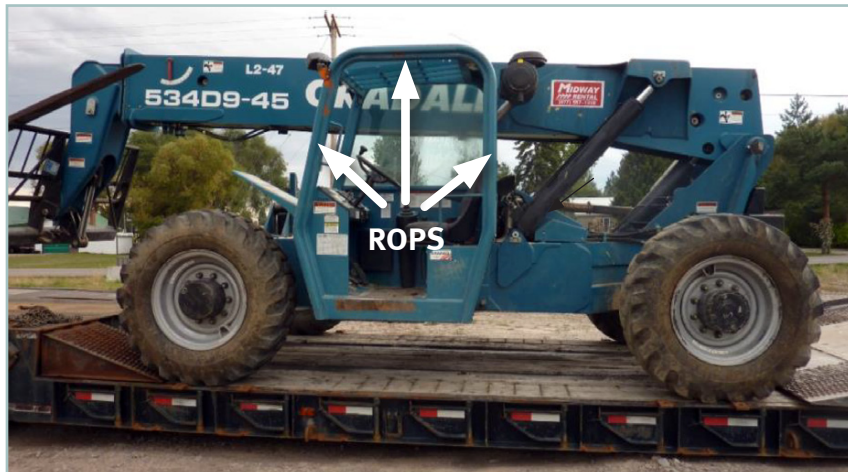
The Gradall was equipped with a ROPS that included an operator seatbelt as part of the system. After the accident, BPA inspected the ROPS and found it was undamaged (Figure 1-5). The seatbelt was also inspected and it appeared to be in good condition. The Board determined that if the TLE had used the seatbelt and stayed within the ROPS framework,

Figure 1-5. Gradall on flatbed after recovery from accident scene shows ROPS intact
