## PG to Glycerin – Lessons Learned

Y-12 Fire Protection Program Lead, Fire Protection Engineering

## Y-12's AFLs

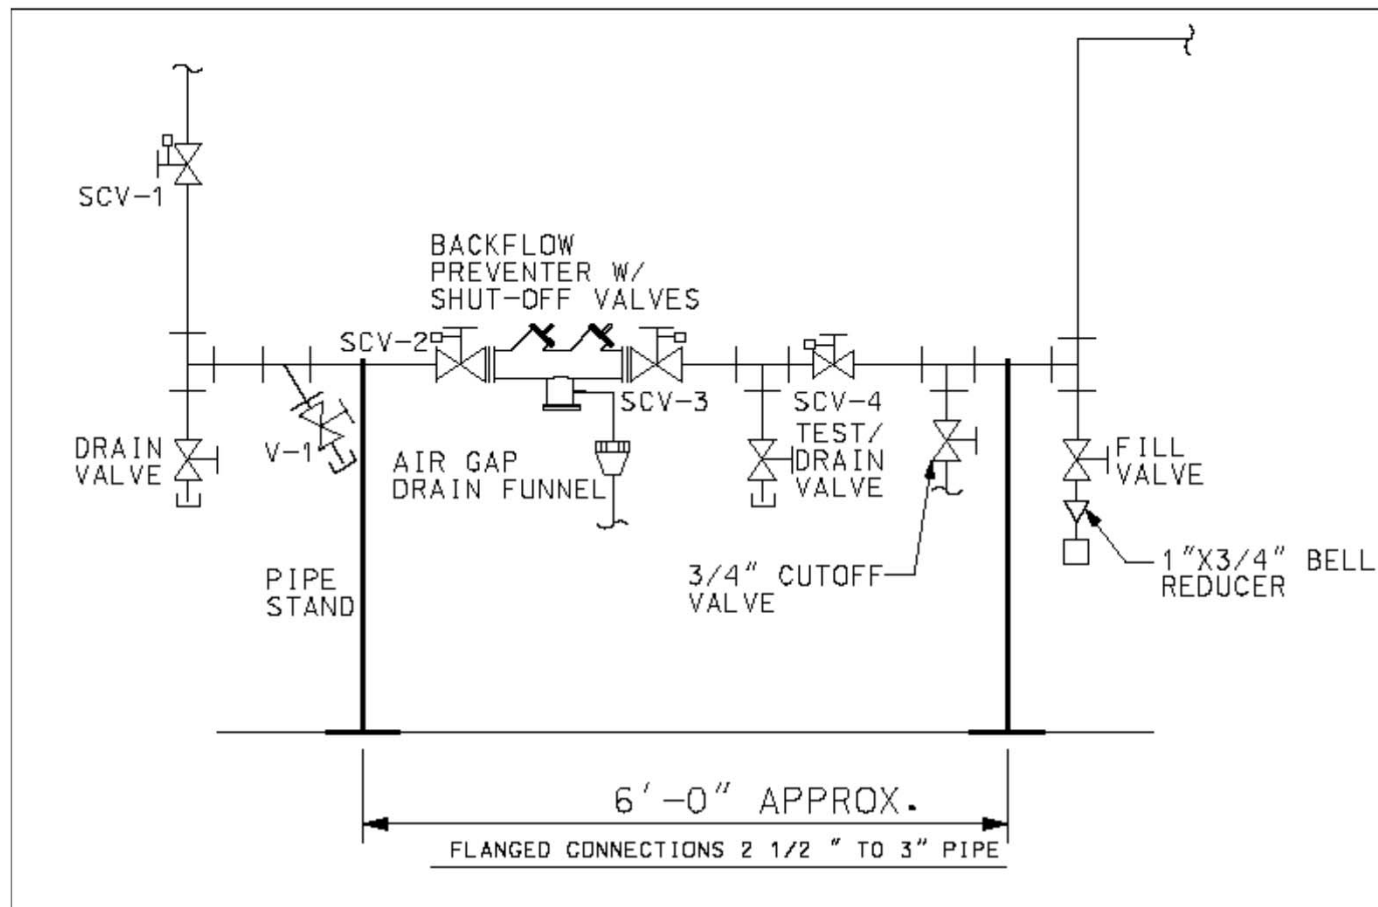
## Typical Backflow Preventer Configuration

- **NFPA 25 requires annual forward-flow testing of the backflow preventer.**
- **Configuration of the system**
  - Majority of our BFP are located between the WPS and AFL
  - Water is introduced to the antifreeze system during testing
- **Timing of the test**
  - Most of the testing took place after the new solution was added to the system
- **Volume of the System**
  - Most of our antifreeze systems are small systems
