B O N N E V I L L E
P O W E R A D M I N I S T R A T I O N

Level I Accident Investigation Report

Wilson Construction Company Employee Fatality on the Bandon-Rogue No. 1 115kV Line

**Report Date:
September 2013**

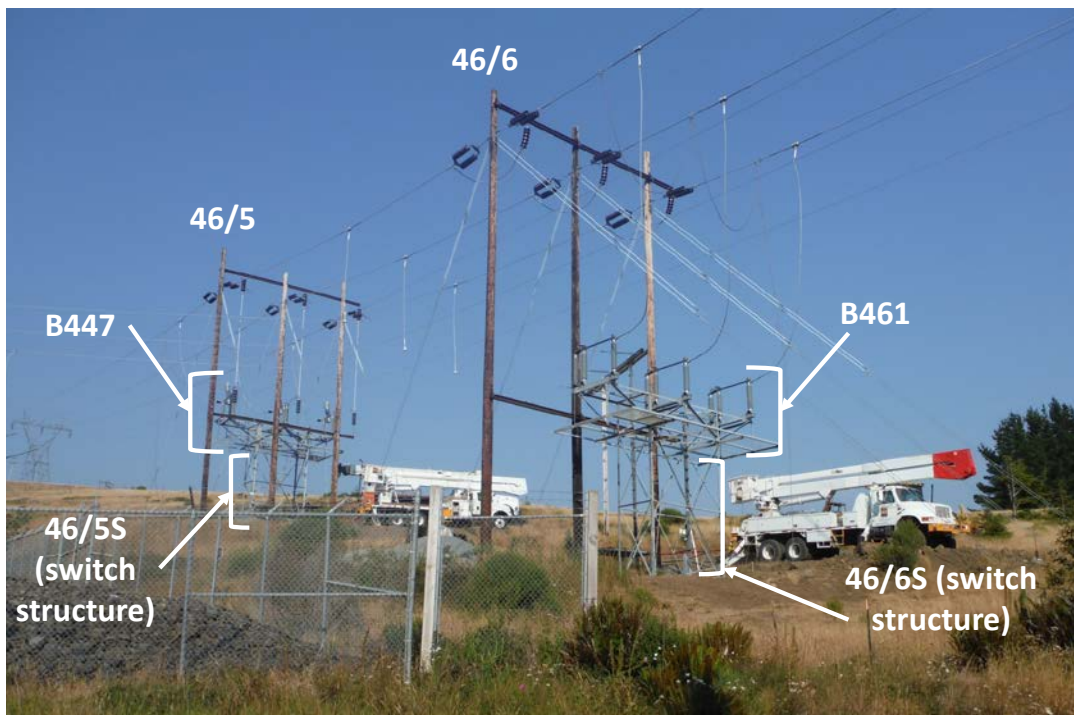
Figure 1: Geisel Monument Worksite

The specific work required at structure 46/5 and 46/6 included relocating switch stands 46/5S and 46/6S (Figure 1), two additional feet away from their respective transmission structures and two additional feet away from the Geisel Monument Substation fence.

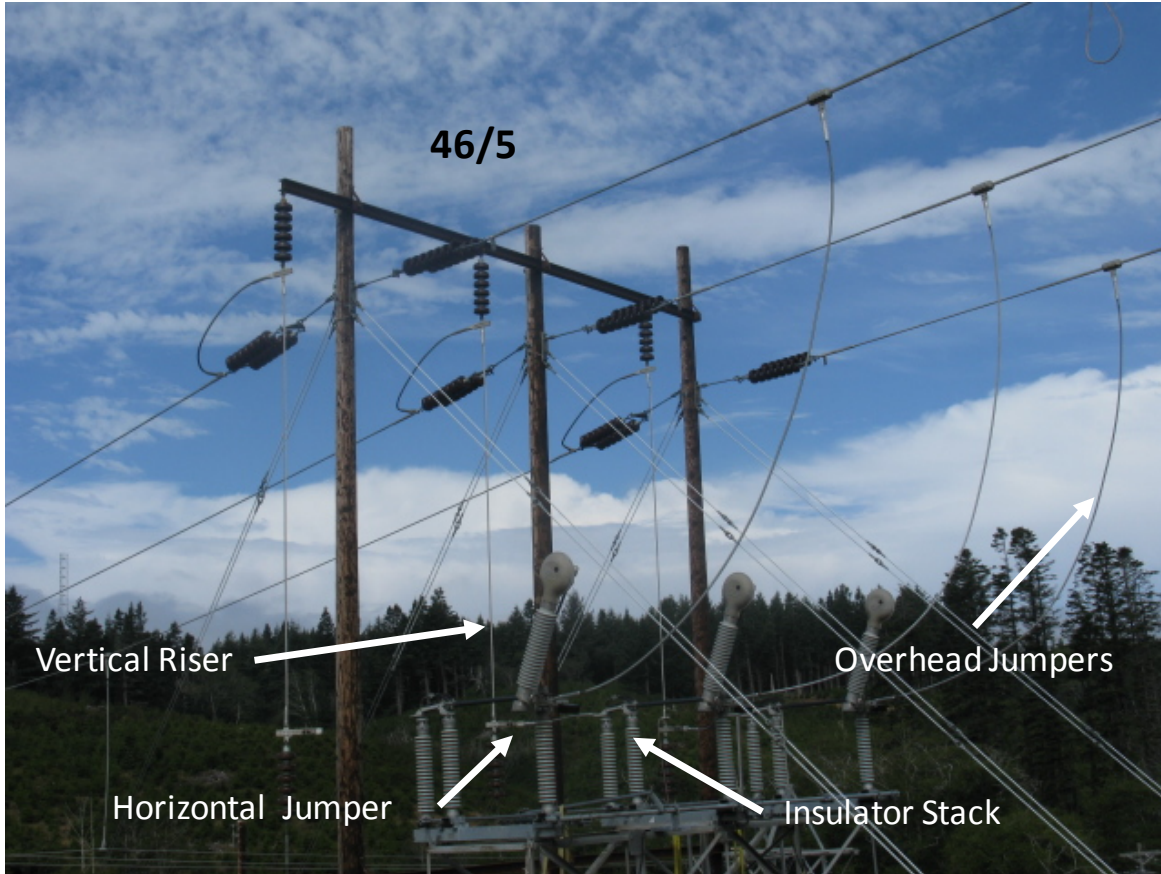
Figure 2: Riser and Jumper Location on Structure 46/5

In addition, new vertical risers were to be installed from the bottom cross arm to the upper cross arm on each structure and the horizontal jumpers from the bottom cross arm to the switch were to be replaced with a higher capacity conductor (Figure 2). Jumpers from the overhead line to the harp end of the switch were to remain in place as constructed in the original release.

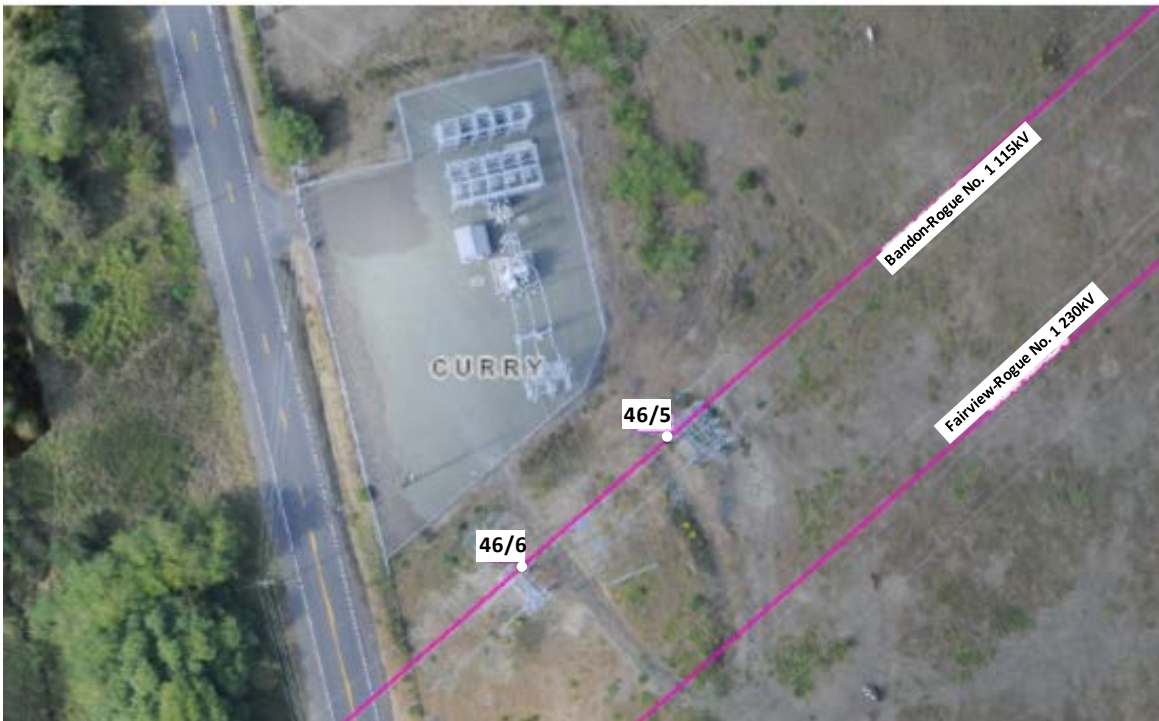
Figure 3: Aerial View of the 46/5 and 46/6 Structures at the Geisel Monument Tap

Upon arrival at the Geisel worksite at approximately 0800, the crews conducted the job briefing of the specific work hazards and how the work was to be performed. The plan of the day was for the six men to break into two crews for work on their respective switch at 46/5 and 46/6. Crew 1 was at structure 46/6 and Crew 2 at structure 46/5. (Figure 3)

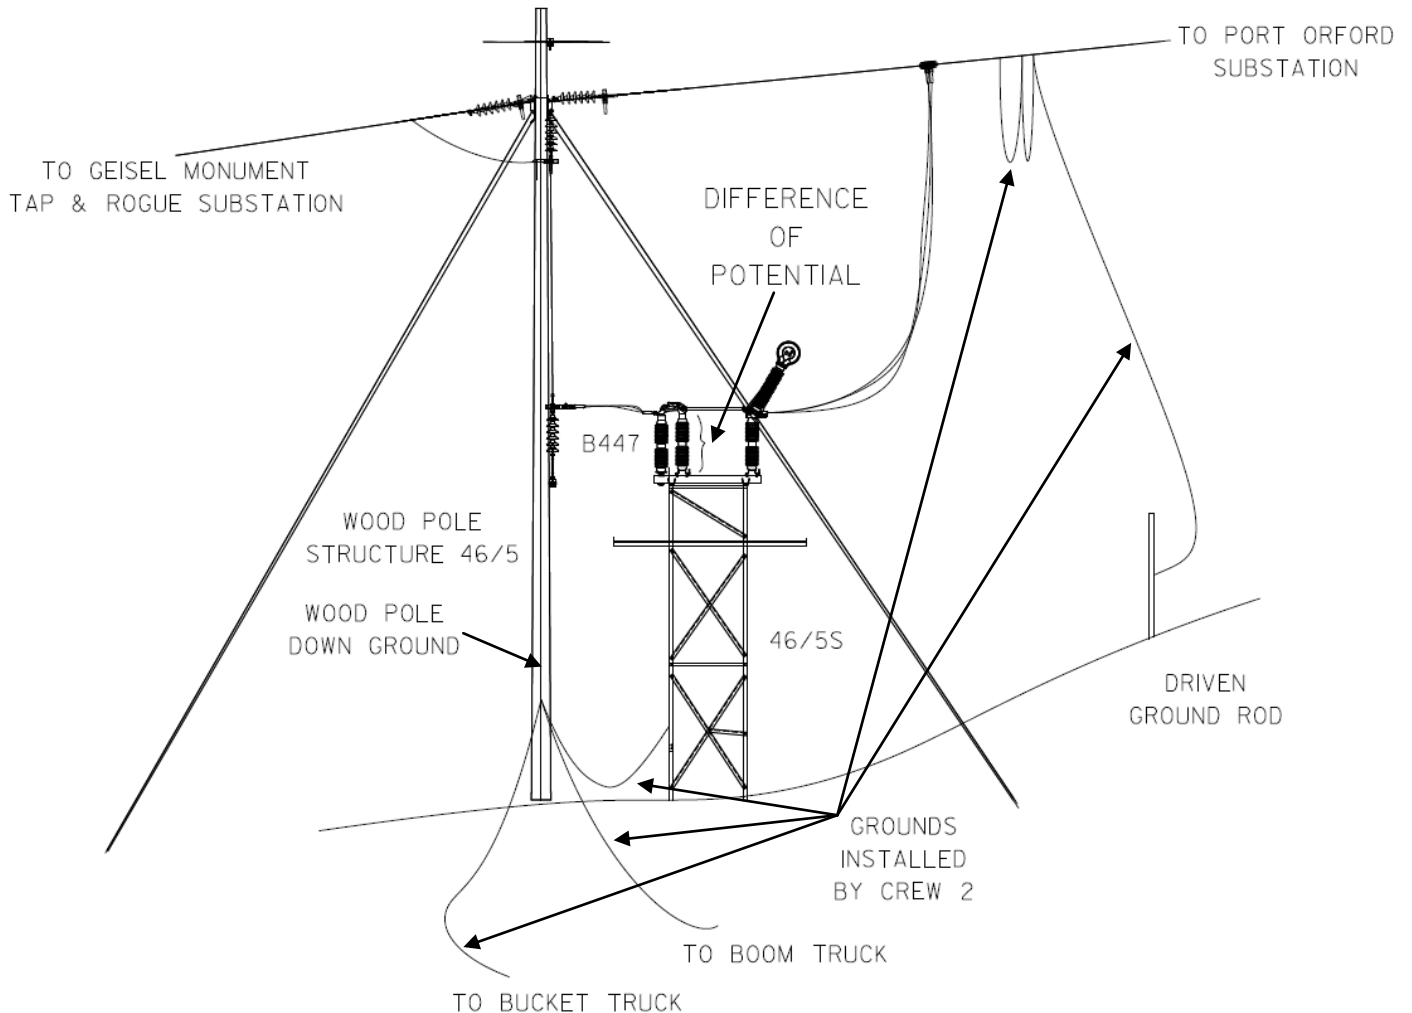
Figure 4: Grounds Installed by Crew 2 at Worksite 46/5

A three phase ground set was installed on the overhead line above the worksite at 46/5 by Crew 2. There was no step and touch voltage measurement taken at the 46/5 ground rod. No EPZ was established by Crew 2 at 46/5 because they did not bond the driven ground rod to 46/5S. (Figures 4 and 5) The tap into Geisel Monument was left ungrounded as neither crew installed a master set of grounds on the tap line.

FINDING 13: The Board found that Crew 2 did not install a ground between 46/5S and the driven ground rod thus failing to establish an EPZ between all the conductive parts at their worksite.

FINDING 14: The Board found that neither Crew 1 nor Crew 2 installed master grounds between either of their work locations (B447 or B461) and the Geisel Monument Tap section.

RECOMMENDATION 10: The Board recommends that WCC management ensure all workers follow the documented grounding procedures outlined in WCC's Safety Manual and the Site Specific Safety Plan (SSSP) posted on-site.

RECOMMENDATION 11: The Board recommends that WCC management establish and implement a formal training program on all grounding processes and procedures.

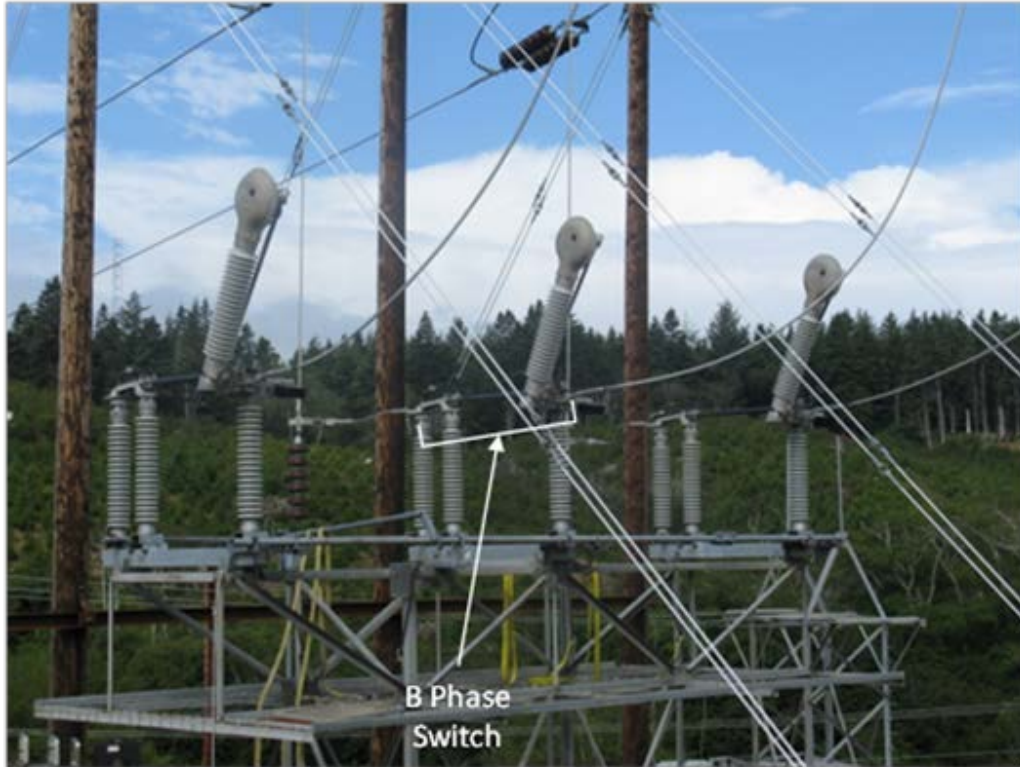
Figure 5: Structure 46/5S Switch B447

The Board concluded the **direct cause** of the accident was that CF2 made contact with a difference of potential across the blade end insulator stack of B447.

The Board concluded the **root cause** of the accident was Crew 2's failure to establish an equipotential zone (EPZ).

By about 0930 at structure 46/5, JL2 was in the bucket truck removing the sectionalizing jumper on A-Phase when CF2 climbed up to the top of the switch stand to attach lift slings suspended from the crane. Once the lift slings were placed and pulled up snug, CF2 positioned himself at the east side of the center switch to assist JL2 in the removal of the blade end sectionalizing jumper on B-Phase.

At approximately 0945, CF2 made contact with a difference of potential across the blade end insulator stack on B447.
