Lessons Learned from Practical Field Experience with High Pressure Gaseous Fuels

DOE – DOT
CNG – H₂ Workshop
December 10, 2009

Douglas Horne, PE – CVEF President

Rob Adams, P.Eng. – Marathon Technical Services

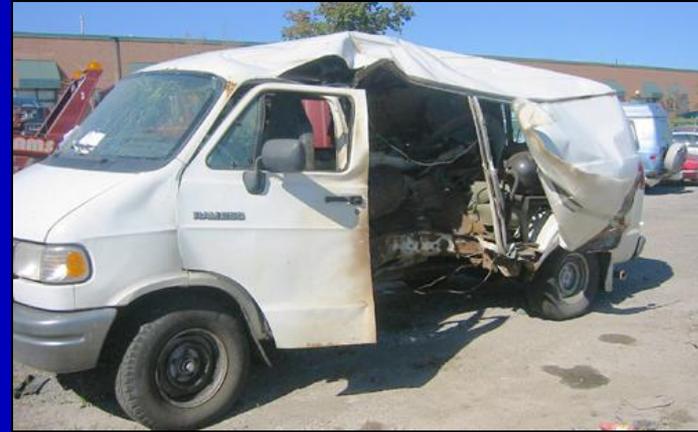
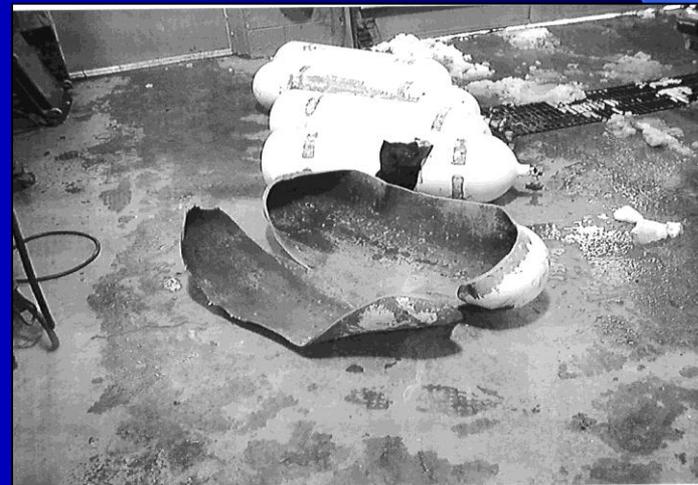
Type 1 Cylinder Incidents

- Type 1 cylinder failed due to extensive external corrosion, the cylinder was not visually inspected for over 10 years
- Type 1 cylinder failed due to over pressure by defective fueling system, the 2400 psi cylinder was subjected to 6000 psi

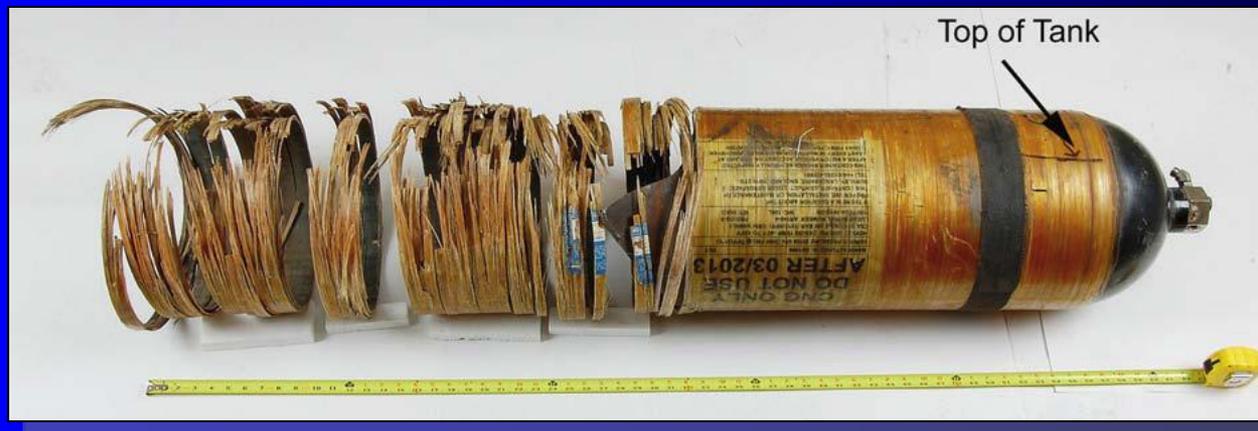
Type 2 Cylinder Incident

- Lucas Type 2 cylinder failed during fueling
- Report by CVEF indicates that there were two probable causes for the failure
 - Stress corrosion cracking of the hoop wrap by chemical attack
 - Chronic over pressure of cylinder during multiple fueling cycles
 - the safety relief valve on the station was improperly set

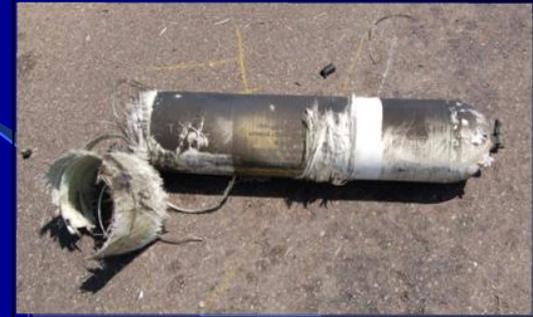
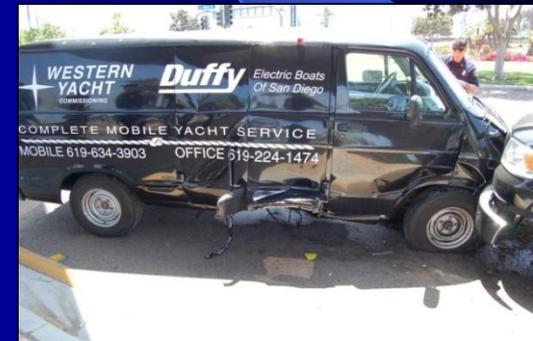
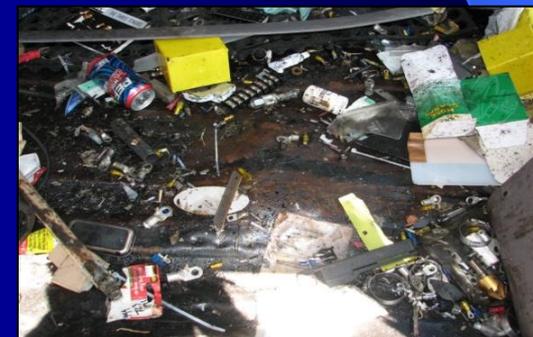
Type 3 Cylinder Incident

- 1996 Dodge B250 Van - four 3000 psi Comdyne Type 3 cylinders one of which ruptured after filling
- Stress corrosion cracking was evident, and led to the failure
- The van was used to haul batteries and chemicals for a yacht maintenance company
- There were no injuries or fire but the vehicle was totaled and scrapped

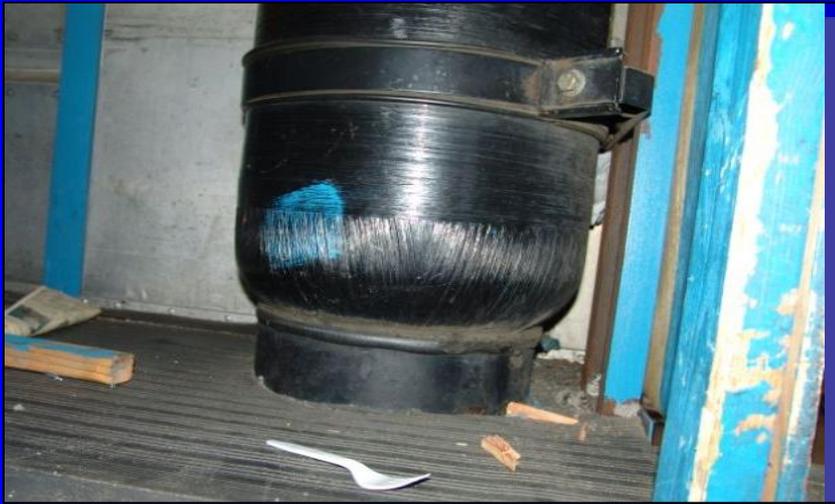
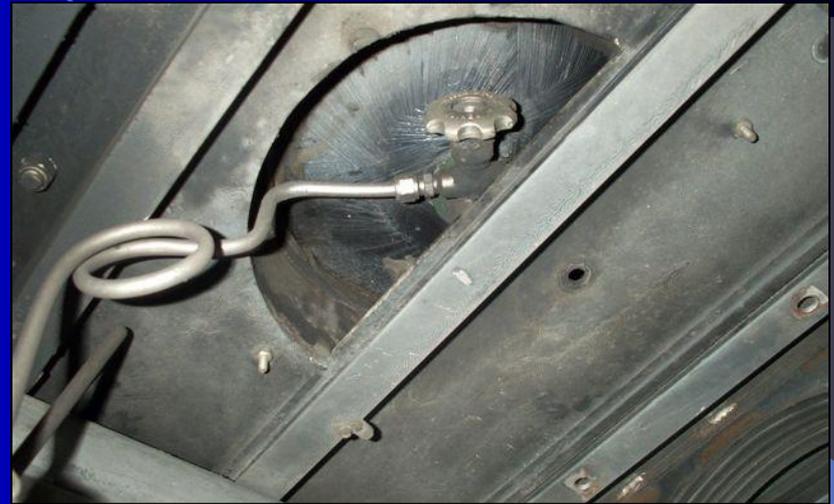
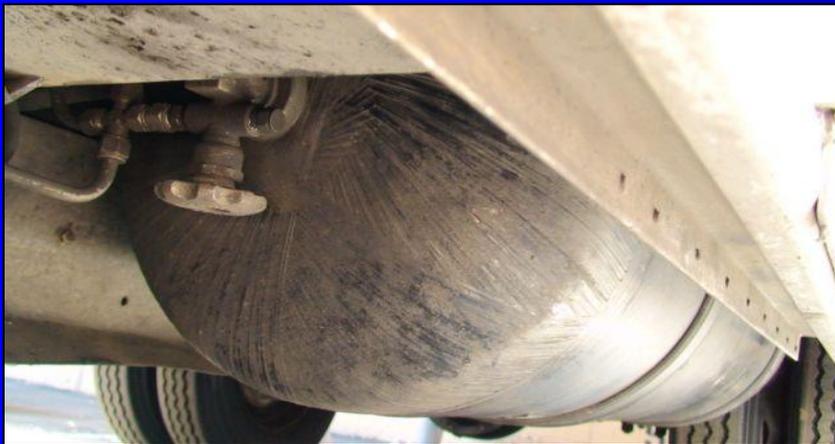
Type 4 Cylinder Incident Physical Damage

- Two Type 4 Brunswick cylinders failed during fueling
 - The cylinders were 14 years old with one mounted horizontally under the truck and the other mounted vertically inside the truck body directly above the horizontal cylinder
 - The vertical cylinder had the valve end dome mounted on a rubber padded steel ring with the valve and piping exposed under the vehicle
 - It is believed that the horizontal cylinder failed first due to unknown road damage and when it failed the floor of the truck was forced upward with the steel ring cutting into the dome of the vertical cylinder which then failed.
 - The initial report has been completed by CVEF and additional evaluation of the cylinders will be made by NASA (White Sands)

Typical installation in multiple vehicles of the same vintage

- No shielding of exposed cylinder under vehicle
- PRD on vertical cylinder isolated from cylinder exposure

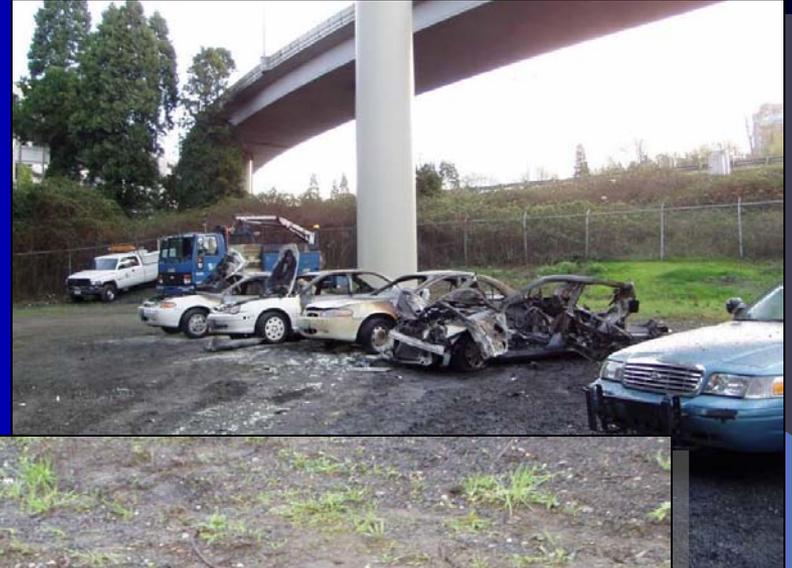
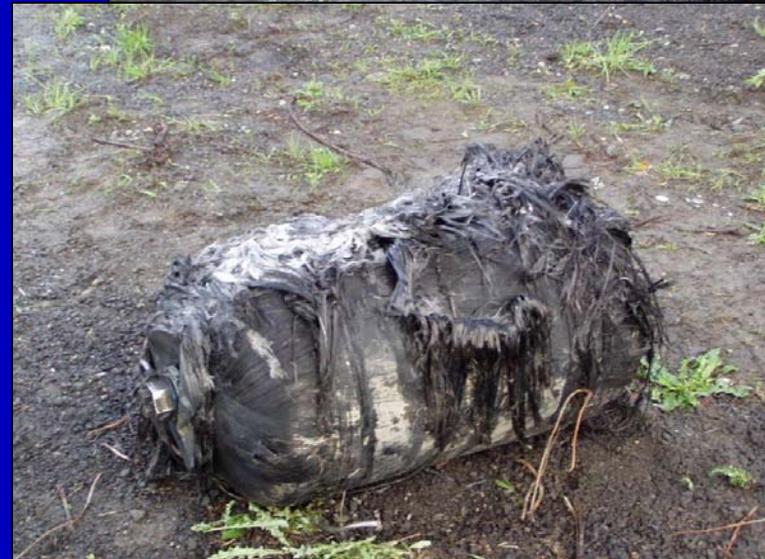
Type 4 Cylinder Incident

- March 2007 an arsonist torched 12 vehicles in a city government holding lot. The tank in a Honda GX failed from a fire moving from the back seat area onto the center of the cylinder, while the PRD was located on one end .
- Honda recalled the GX vehicles and retrofitted the installation to protect the cylinder from a local fire and insure that the PRD would function correctly

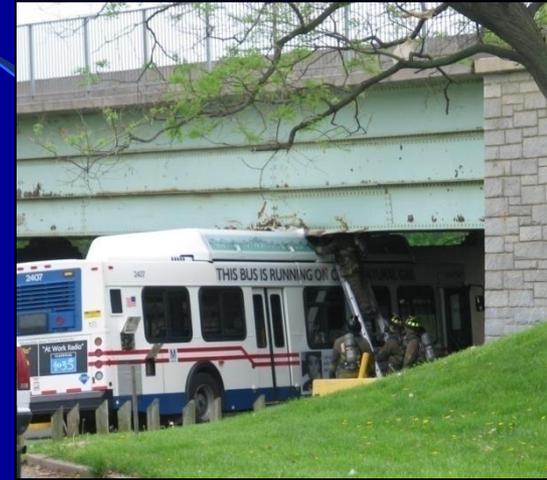
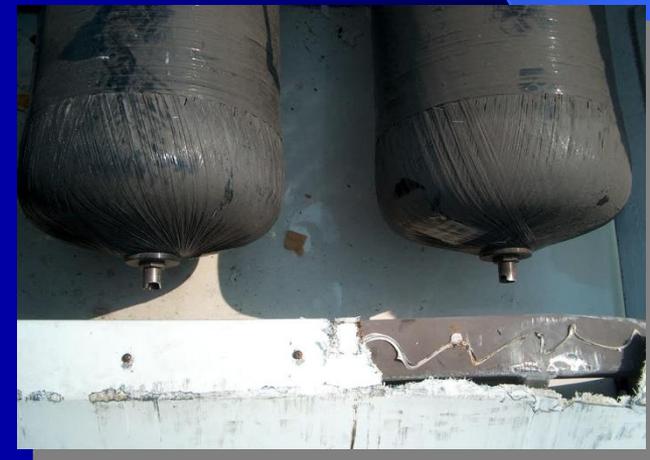
PRD Release Physical Damage

- Bus impacted a steel bridge – with no cylinders failure
- The cylinder support frame bent down and severed the PRDs.
- Gas vented from the two impacted cylinders – no fire or other vehicle damage

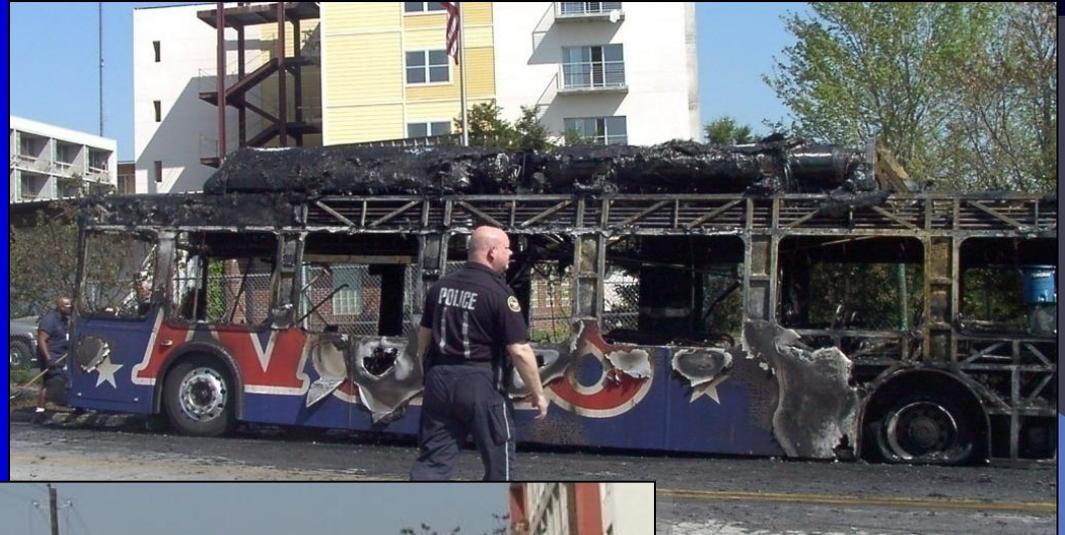
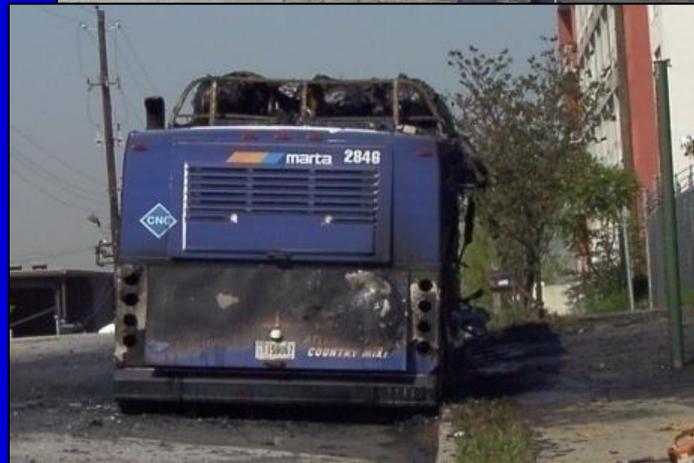
PRD Release

- Fire originated in rear wheel due to over heated brakes
- The CNG cylinders on top of the bus vented properly through the thermally activated PRDs
- For the 24 vehicle fires in our records none were caused by the CNG fuel systems

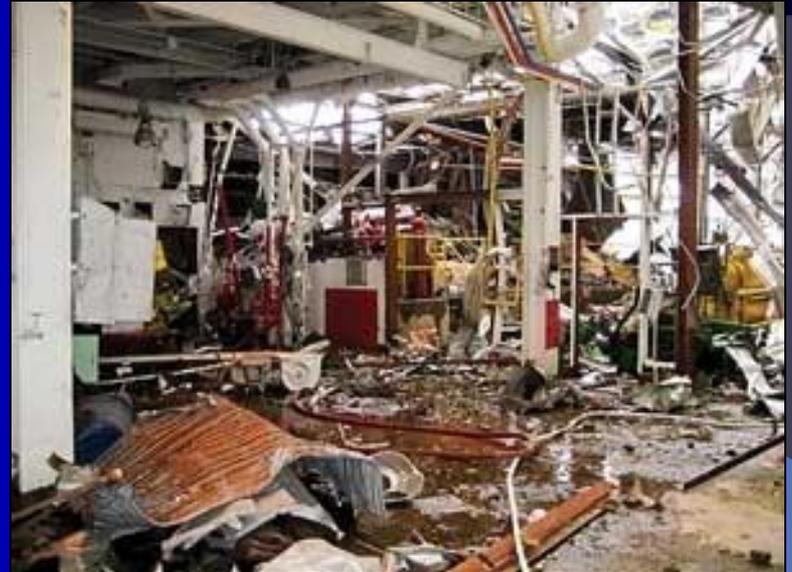
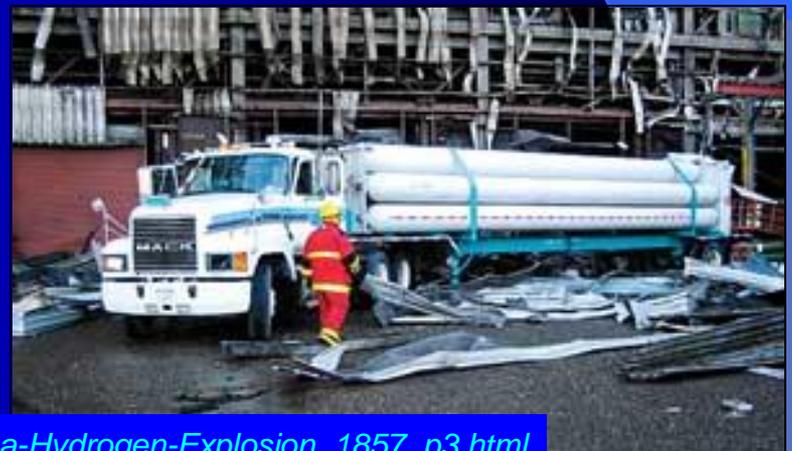
Hydrogen PRD Release Installation Issue

"The investigation into this event showed that the relief device was a rupture disc that normally would have been built to relieve pressure to prevent catastrophic failure of the hydrogen tanks," McCullough said. "Normally, the device has a fusible bismuth plug that holds the coin-shaped disc in place until temperatures exceed 180 degrees. The device had been replaced by the hydrogen vendor several months prior, when the vendor was on-site to make repairs related to an apparent leak. The replacement relief device assembly did not have a fusible plug to support the disc." *

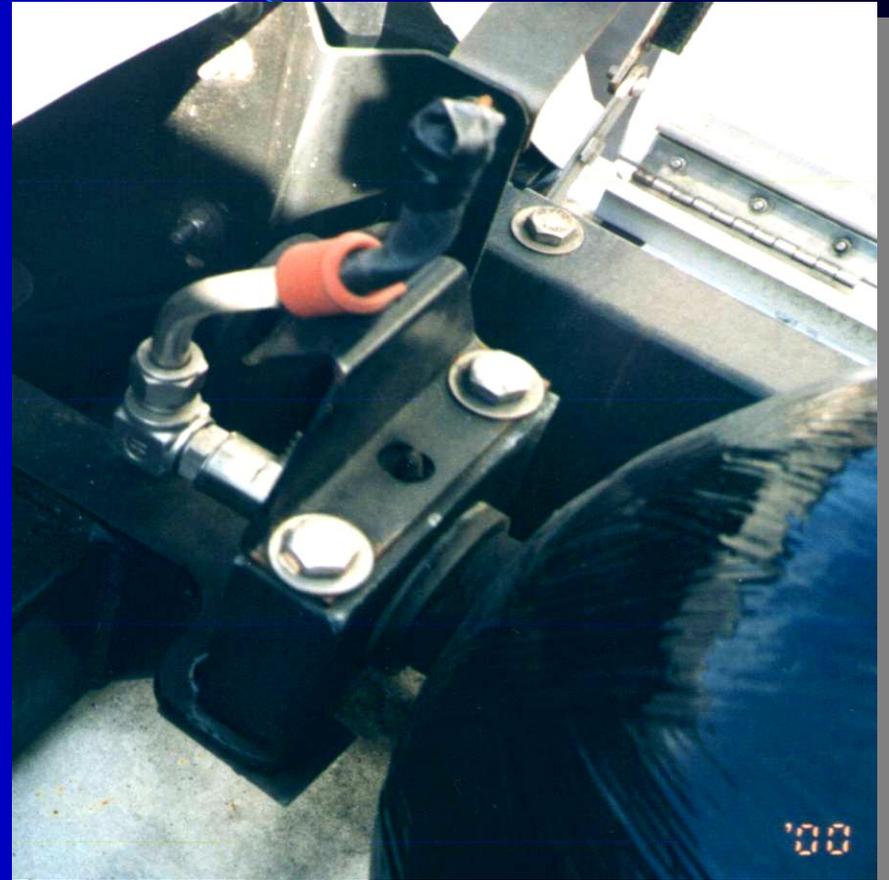
Indoor Fueling Release

- Obsolete PRD design susceptible to water infiltration and freezing

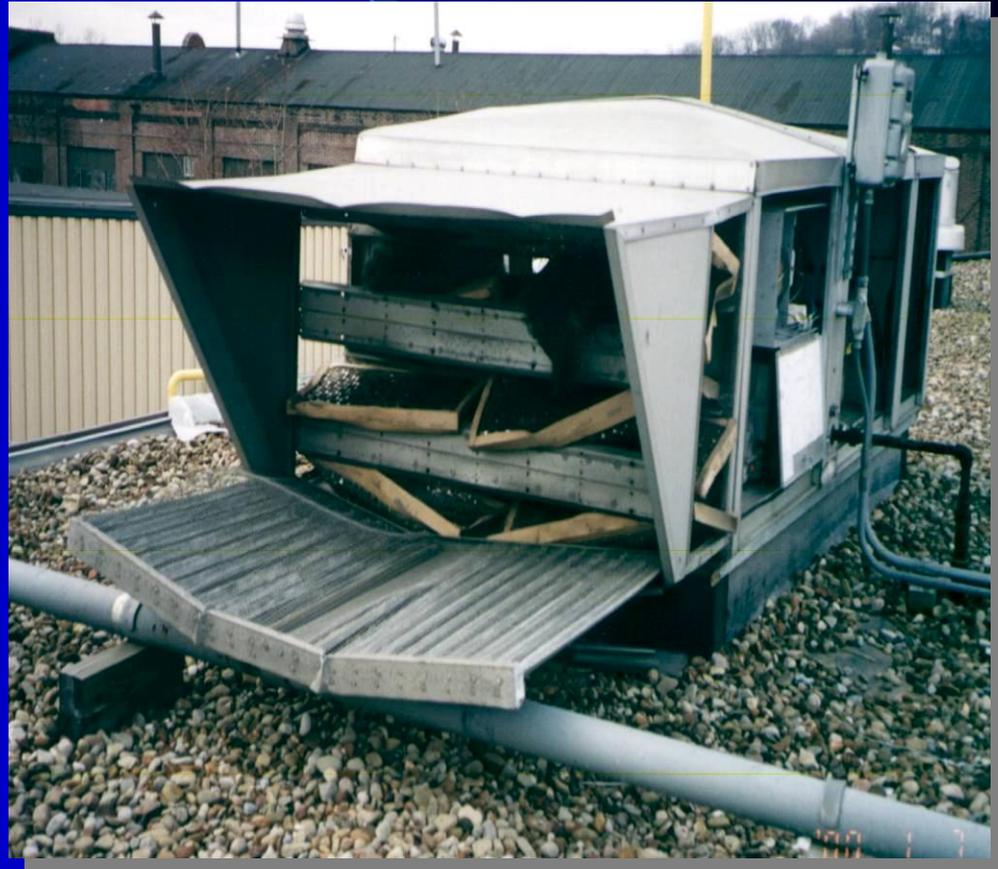
Indoor Release

- Detection system not fail safe.
- Detection system known to be compromised
- Fueler ran past 3 ESD buttons exiting the facility
- Approximately 10 minutes after the gas release started, the gas inside the building ignited.
- The rooftop open flame make up air unit (right) may have been the source of ignition

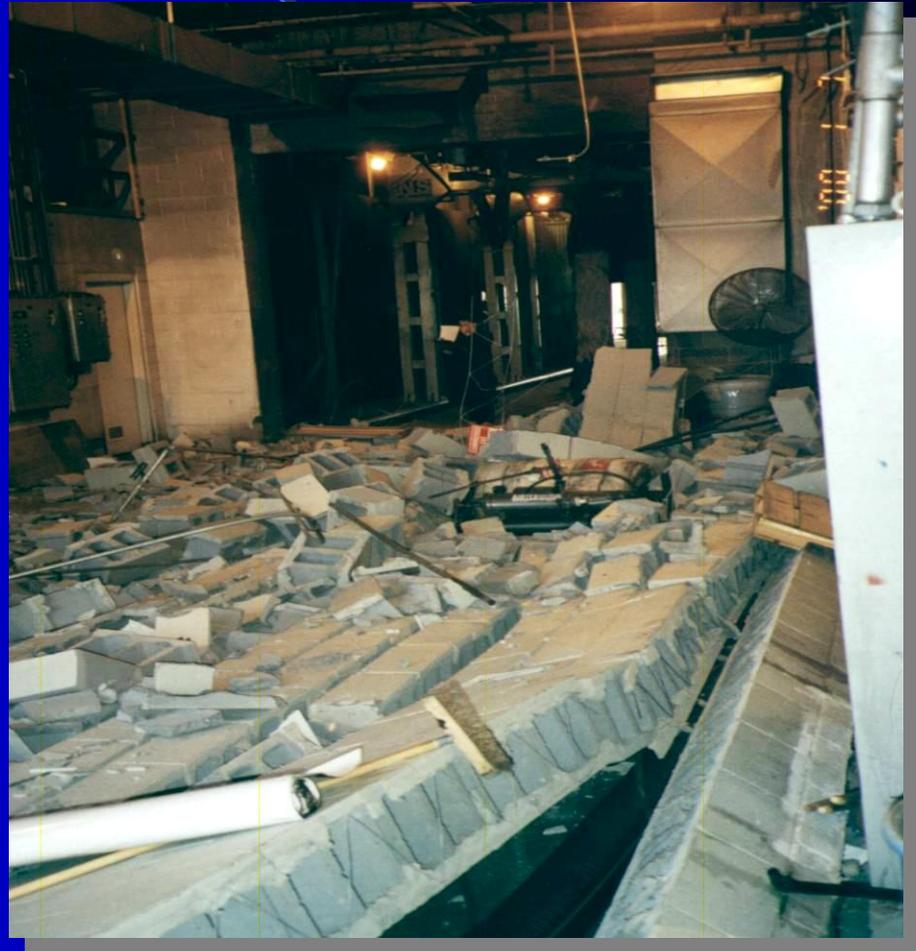
Indoor Fueling Release

- The Service Building was not equipped with deflagration panels (required by NFPA 52)—the pressure of the blast blew over an inside block wall.
- The blast lifted the roof and damaged every wall of the building.

1. Strong codes (NFPA 52, and the NEC) are already in place—facility was not code compliant.
2. DOT FTA recommendations for these facilities were published after installation – but no updated versions have been developed.
3. Better Maintenance and Emergency training by manufacturers and owners might have prevented this incident.

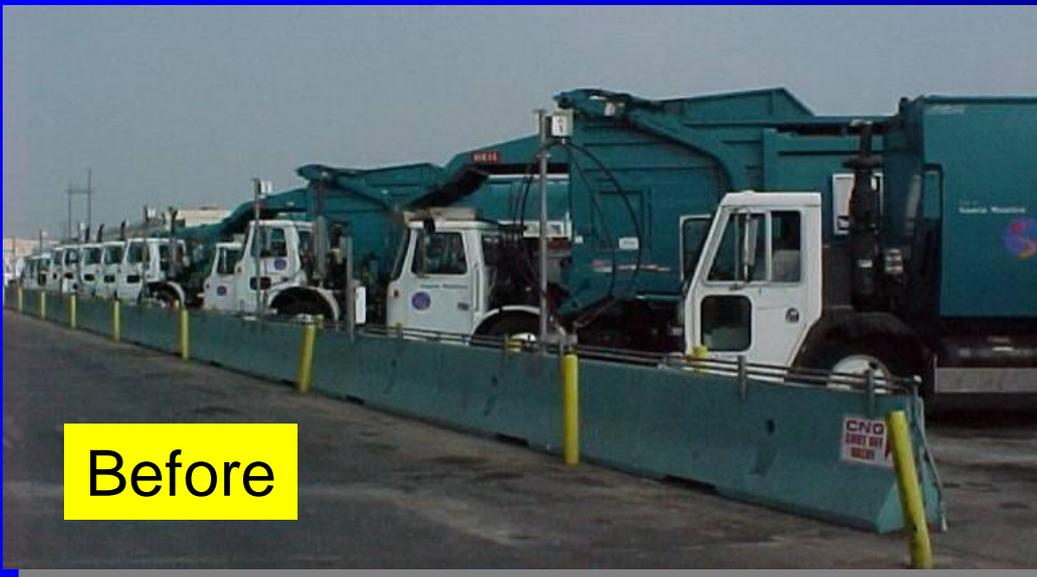
Refuse Hauler Fire

- Vehicles were fueling.
- Staff heard a loud “metallic bang—like a hand grenade.”
- Staff immediately investigated and found the fire.

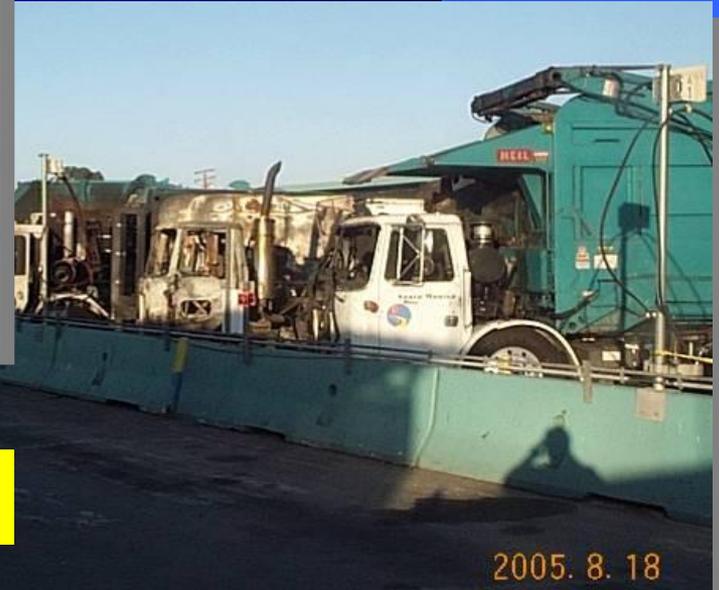
4 of the 5
trucks
involved
were
written off.

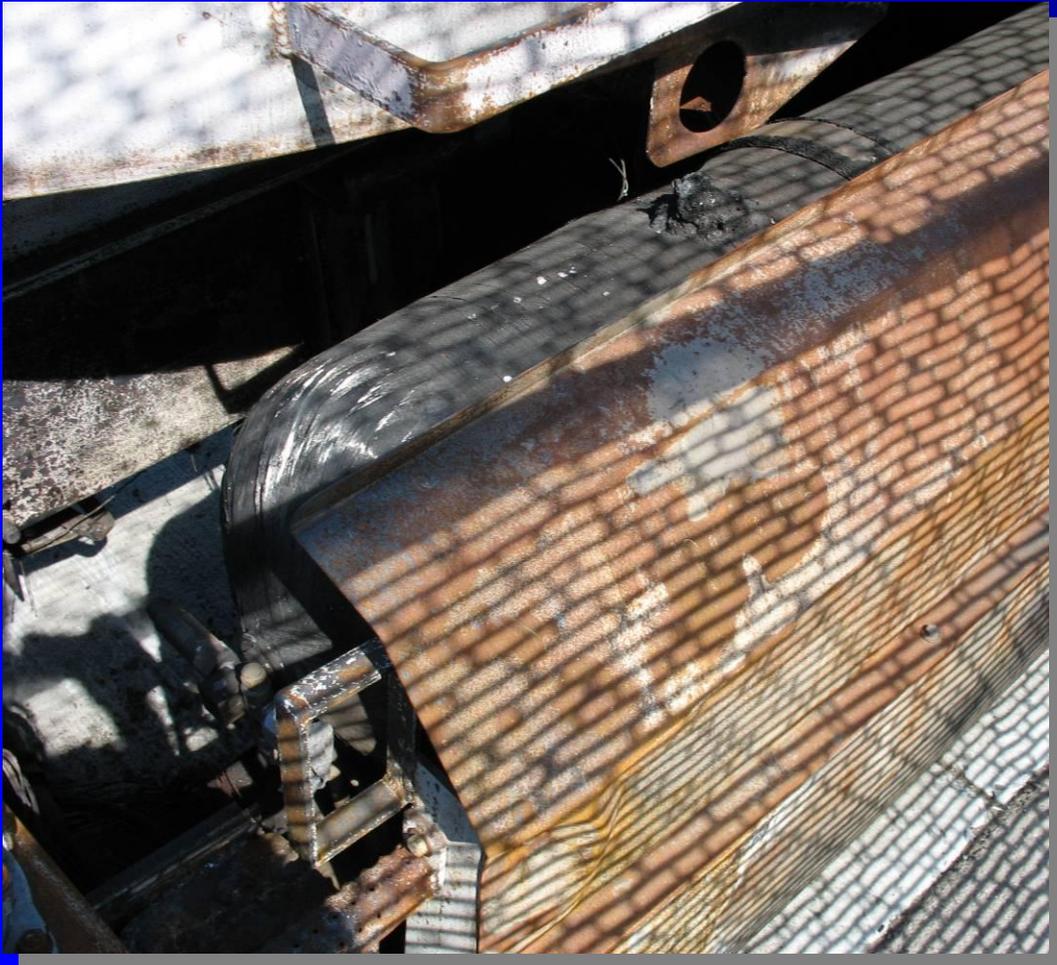
None of the CNG cylinders ruptured and the damage to the cylinders was surprisingly light.

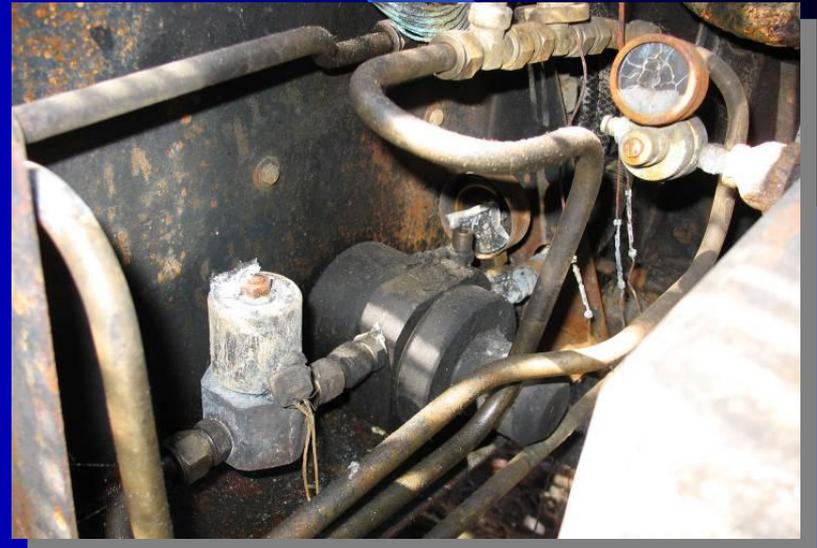
Refuse Hauler Fires—Cause Undetermined

1. HP Regulator on one truck found to have failed at body.
2. PRD release could have initiated fire.
3. Ignition source could have been a static discharge from the rapidly venting gas (except fueling hose should have grounded vehicle).

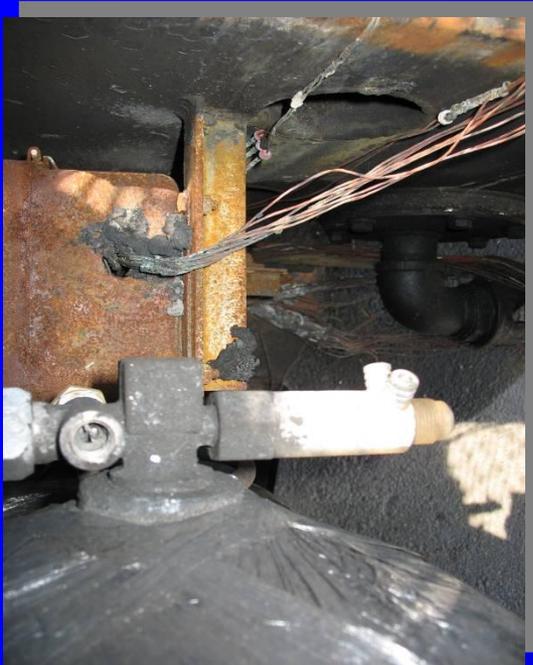
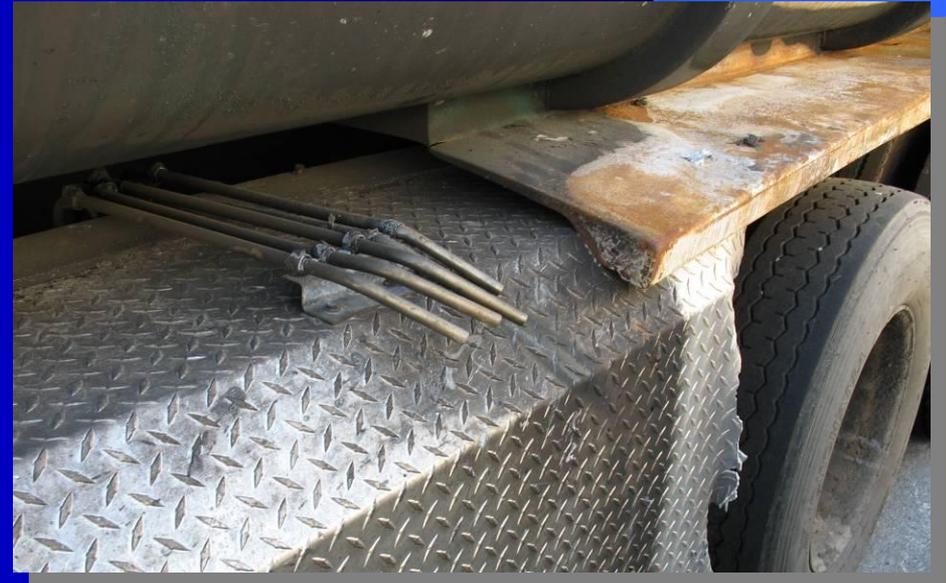
Refuse Hauler Fires—PRD Vent Routing

1. PRDs not vented up, away from vehicle—responsible for the rapid inclusion of other trucks in the fire.
2. The vehicle at the center of the fire still had full CNG tanks and hydraulic reservoir.

1. Strong codes (NFPA 52) are already in place.
2. Inexperienced vehicle builder/converter did not follow current industry practice or common sense (“Reference Guide for Integration of Natural Gas Vehicle Fuel Systems” – Battelle, 2002) as they oriented the PRDs horizontally).
3. Installer personnel training might have prevented or minimized this event.
4. Not an owner maintenance or training issue.

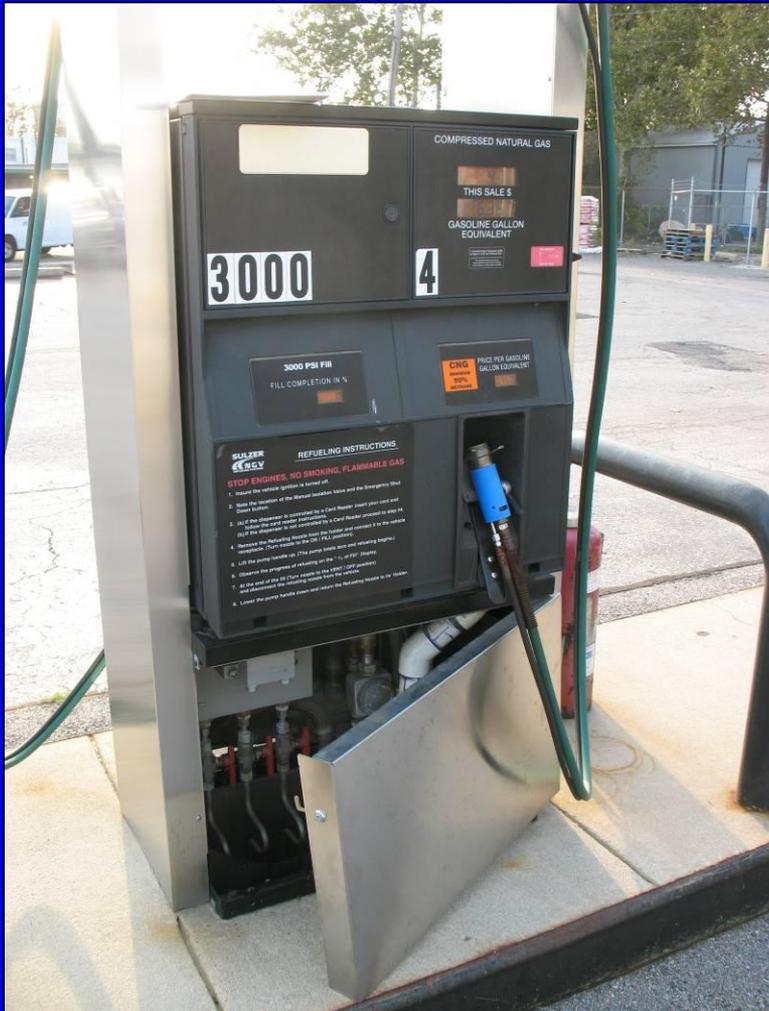
Station Overfilling

1. OEM van 3000 psi cylinder failure.
2. Cylinder had serious degradation.
3. Evidence of overfilling at stations.

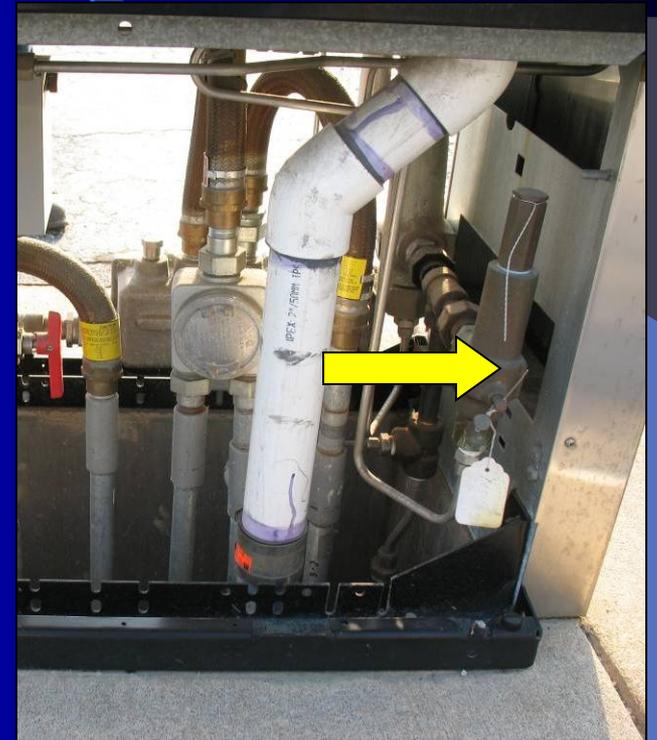
Station Overfilling--Deficiencies

- No overpressure device as required by code and best practice—2 stations.
- Overpressure devices on 3000 psig hoses tampered with at 3rd station (see right)
- High pressure solenoid valves did not provide positive shutoff (ball valves much more effective and reliable).
- Station designed to fuel both 3000 and 3600 psi vehicles—station is particularly susceptible to overfilling 3000 psi vehicles.

1. Strong codes (NFPA 52) are already in place.
2. Experienced equipment suppliers-but significant code deficiencies.
3. Owner took over equipment operation with no training.
4. Maintenance personnel had very little subsequent training and a limited budget.

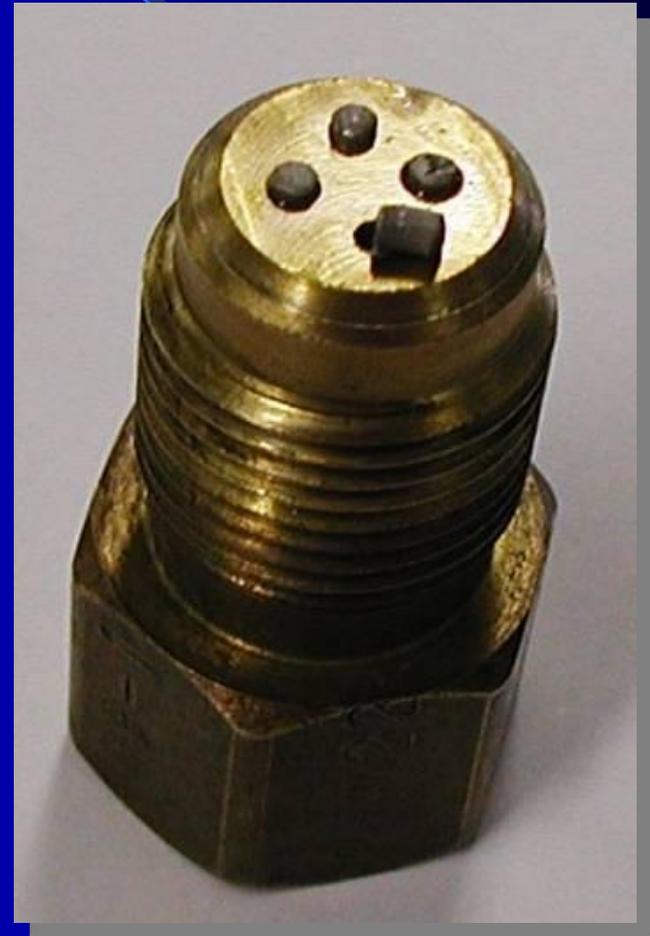
Best Practices and Training Materials must be Living Documents

- C. 2005 PRD Release
- Vehicle began leaking rapidly after fueling—not a full PRD release as per earlier Mirada failures
- Shook model CG-9, 999-1 rated 22 CFM, activation temperature is 217 degrees F, marked for 3600 PSIG
- **Need documented Best Practices to pass on Lessons Learned**
