Accident Investigation Report

Underground Salt Haul Truck Fire at the Waste Isolation Pilot Plant February 5, 2014

March 2014

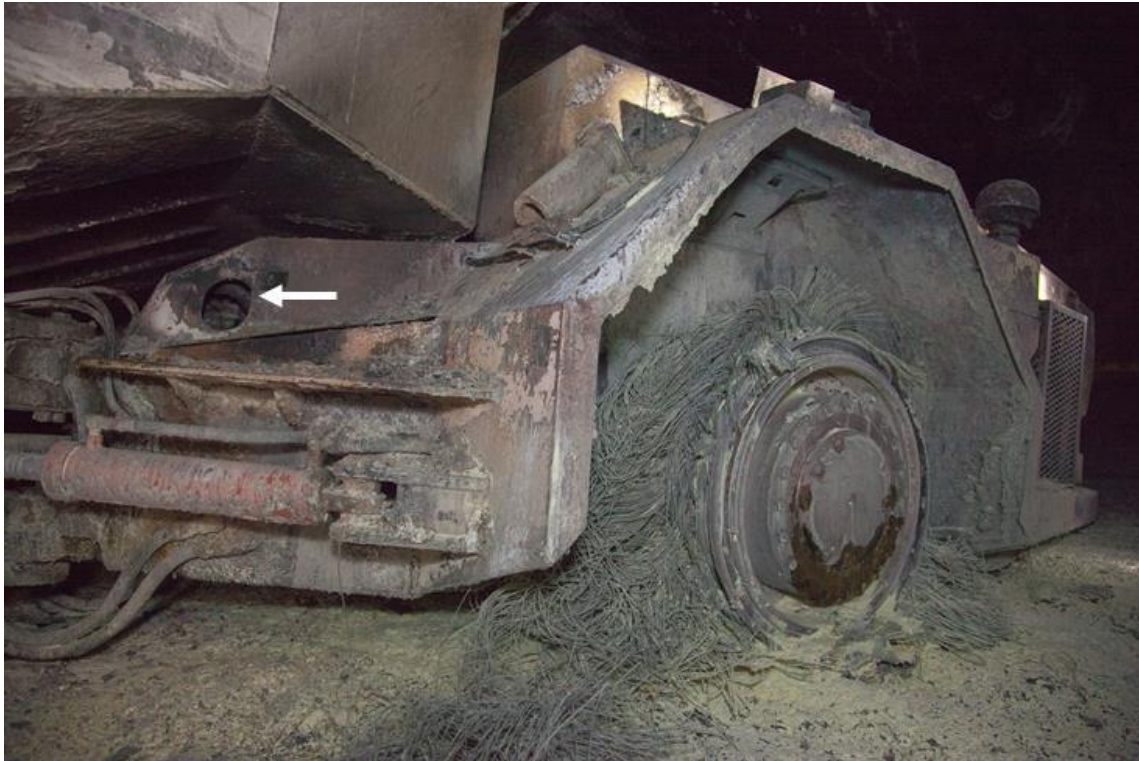
Upon noticing the fire, the Operator stopped the truck, shut off the engine, set the brake, and exited the vehicle, taking a portable fire extinguisher which was mounted on the left front fender. The Operator proceeded to the opposite side of the vehicle, near the articulation joint and attempted to extinguish the fire by discharging the fire extinguisher into the area where the Operator had observed the fire (Figure 9).

Figure 9: Photo Showing the Area on the Salt Haul Truck where the Fire Extinguisher was Discharged

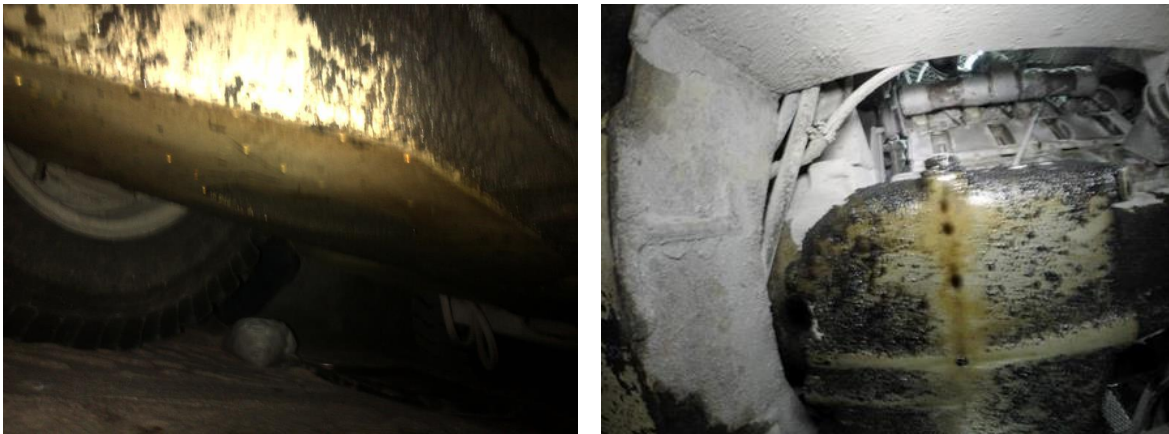
- There was significant buildup of engine and hydraulic oil on other mining equipment including Salt Haul Truck 74U006A. (Figure 13)

Figure 13: Buildup of Engine Fluids on the Underside of Vehicles in the Mine

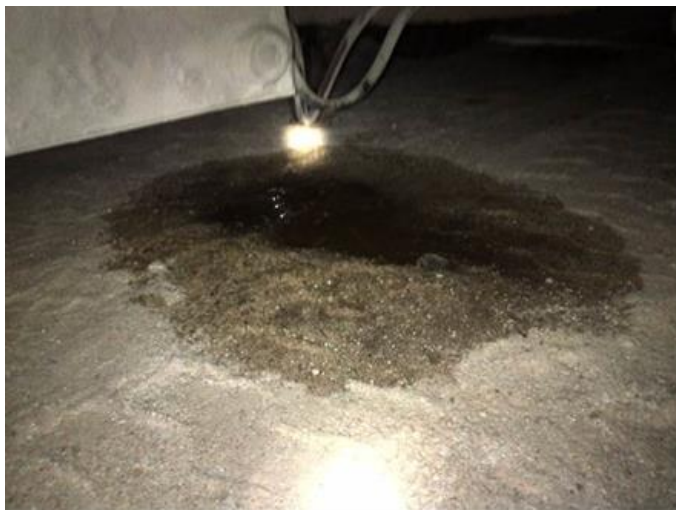
- There was a three-foot diameter puddle of hydraulic fluid underneath Salt Haul Truck 74U006A. (Figure 14)
- The daily Operator's Checklist was completed on February 5, 2014, for Salt Haul Truck 74U006A with no deficiencies indicated.
- There was an Out of Service tag on Salt Haul Truck 74U006A indicating that a lighting deficiency existed.
- Several mine phones were found to be inoperable (run to battery failure). Twelve of 40 phones tested were non-functional.
- Numerous components of the mine ventilation system were out of

Figure 14: Hydraulic Fluid under Truck 74U006A

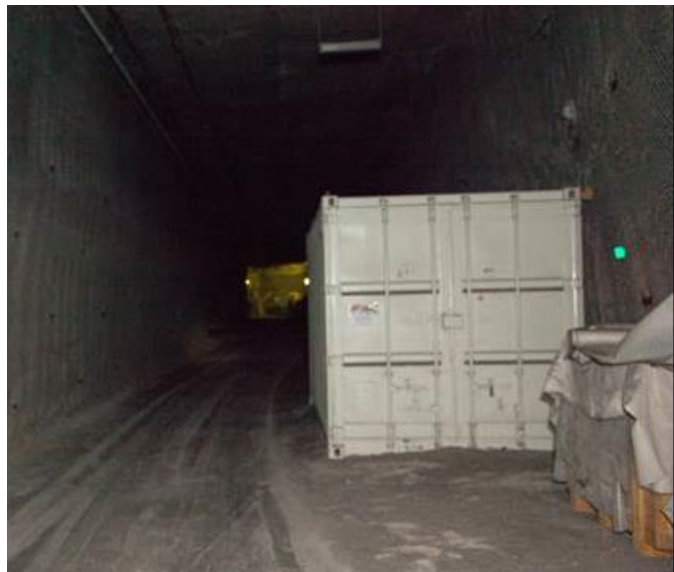
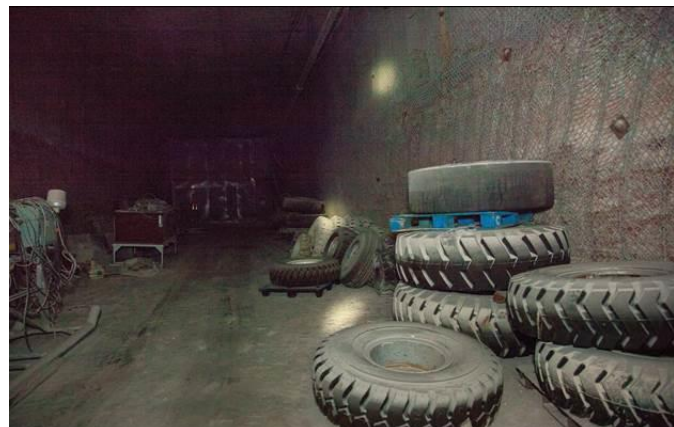
While these fire protection reviews addressed only the control of combustible materials, material storage and staging is really the issue. Salt movement requires periodic touchup to the ribs and back (walls and ceiling) to maintain the non-waste work areas, and the floors throughout the mine, in good repair. As a result, equipment and materials are moved out of an area and staged in the drifts. Although this staging is temporary storage, the condition can last several months. The Board observed materials

Figure 17: Combustible Loading in the Mine

stored on either side of the drifts, materials that obscured reflectors, and stored combustibles exceeding the 5 megawatt (MW) limit. Personnel group interviews indicated storage on only one side of drift could have made navigation in drift easier.

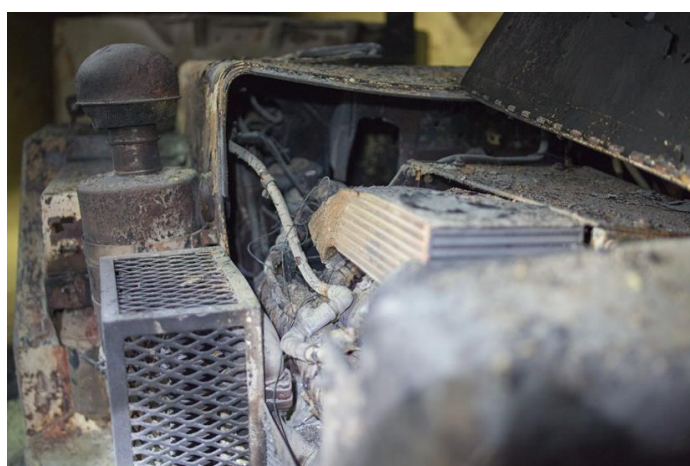
Figure 19: Engine Cooling Coils

The Board observed accumulated grime in the engine compartment of other salt haul vehicles that would have been sufficient to create a sustained fire that would result in additional fluid leaks. The normal hauler ventilation flow pulls air through the front grill and directs it across the cooling coils above the engine block (see Figure 19). This flow exits at the back of the engine compartment and would push the fire towards the transmission (see Figure 18, illustration (c)). In the actual fire, this condition occurred within about 5 to 10 minutes of initial ignition (assumed start time is

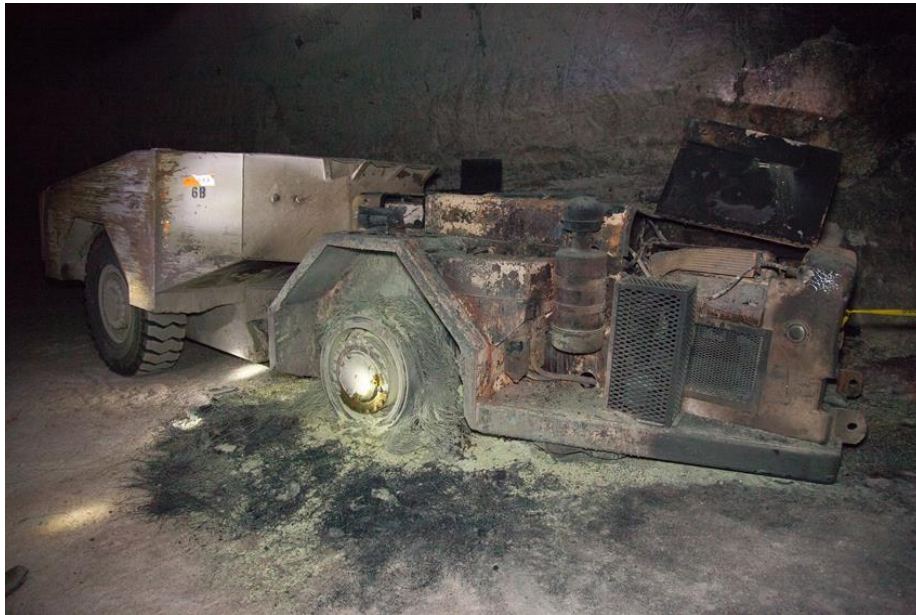
Ignition of the front tires likely occurred within 10 minutes of fire ignition (see Figure 21). Involvement of the tires produced heavy black smoke at the Salt Handling Shaft station before 1053 (1051 plus two minutes for the Salt Handling Shaft Bottom Lander to move to the station).

Figure 21: Salt Haul Truck Damage
(Engine Cowling Was Opened Post-Fire)
