**U.S. Department of Energy
Office of Fossil Energy**

Accident Investigation Report

**Scissor Lift Accident in the West Hackberry Brine
Tank-14 Resulting in Injury on
February 7, 2013**

**Strategic Petroleum Reserve
West Hackberry Storage Site
Cameron Parish, Louisiana**

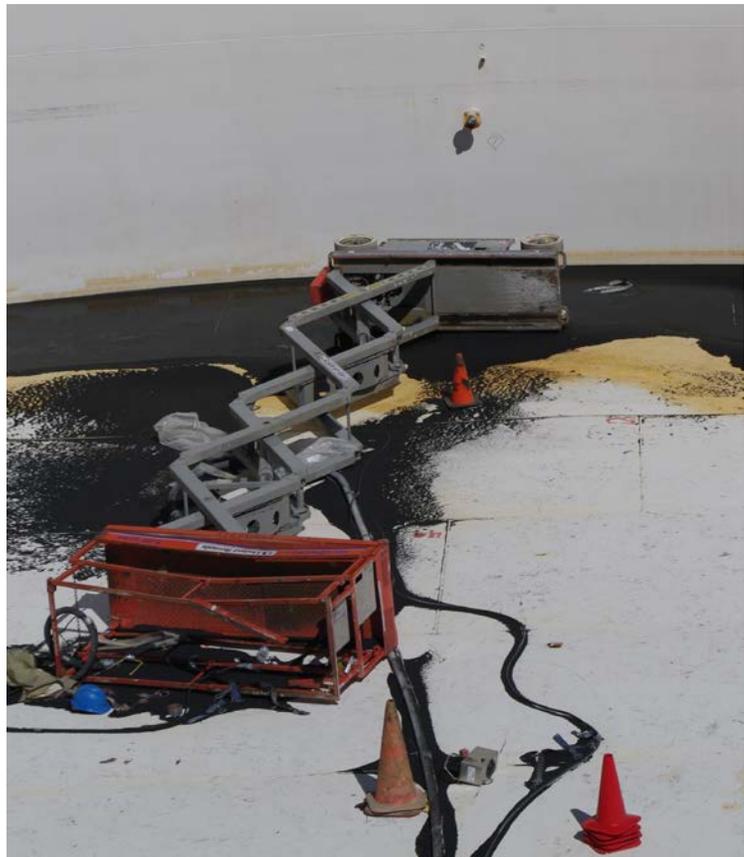
Figure 6: Overturned Scissor Lift in Tank

PBC Blaster 1 and the scissor lift came to rest on the floor of the tank with PBC Blaster 1 lying partially out of the work platform guardrails, still connected to the work platform by a lanyard that was attached to his fall protection harness.

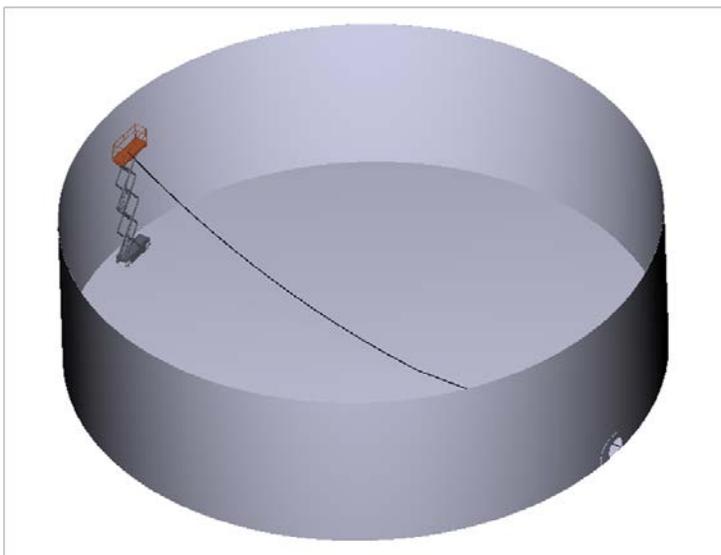
Figure 7: 3-D Rendering of Scissor Lift and Hose Prior to the Accident

Of crucial importance to the analysis was the determination of the length of hose that was suspended above the tank floor. The Board suspected that a significant portion of the hose was in the air and was being supported by the work platform in the upright position just prior to the accident, resulting in significant lateral forces on the work platform guardrails.

blast hose was attached to the lift, was found to be 26 feet from the base of the wheels. Using simple trigonometry the straight line distance from the service entrance to the middle work platform guardrails, when the lift was in the upright position, was calculated to be 108 feet 2 inches (Appendix E). Using a formula for a circle, this distance then represented a chord and, assuming the 111 feet 0 inches of blast hose formed a perfect arc between its ends, the radius was derived. The Board employed an architectural and engineering (A&E) firm to assist in the re-creation of the position of the hose and work platform during blasting. Computer aided design was then utilized to determine that 43 feet 7 inches of that arc lay below the horizontal line (representing the tank floor) leaving 67 feet 5 inches suspended from the lift. The A&E firm was then able to develop a three dimensional mockup of the lift and blast hose configuration prior to the lift toppling (Appendix E, Attachment E.3). These findings support the Board's theory that a significant portion of the blast hose was suspended above the tank floor. See Figure 7.

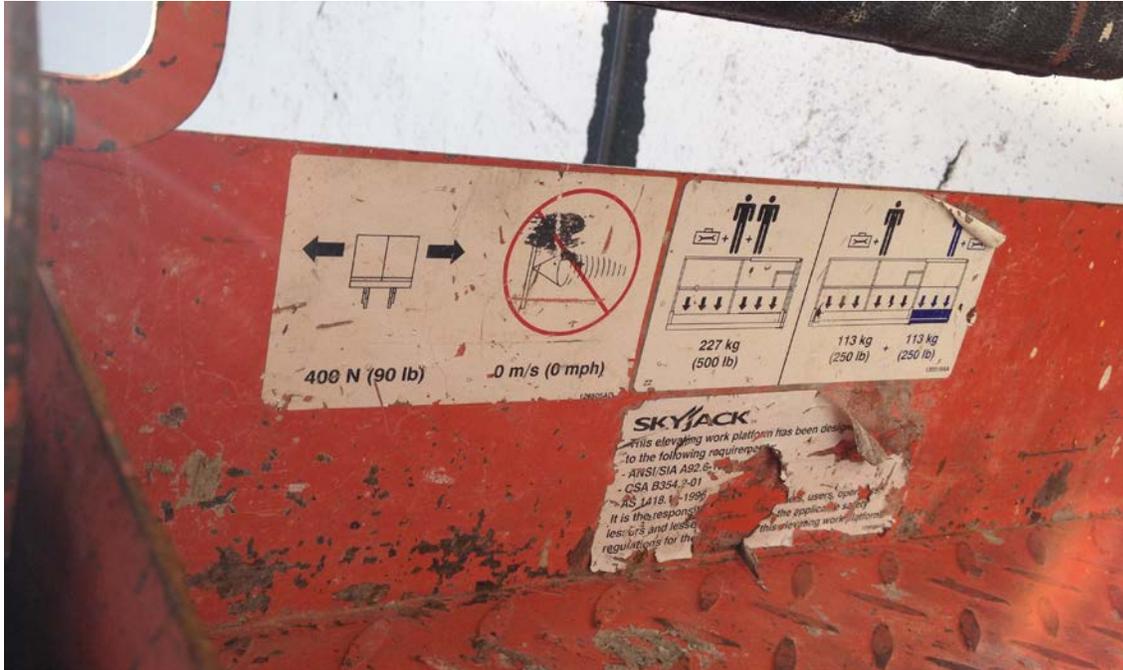
Figure 8: Manufacturer-Applied Label shows 0 wind and 90 lb side force

Ultimately the most significant hazard analysis failure was not recognizing that the work to be performed would place significant lateral forces on the scissor lift. These forces were not identified or estimated and were not considered in selecting the scissor lifts for the job. Also, the hazards of inexperience with scissor lifts while conducting abrasive blasting were not recognized. This inexperience extended from corporate inexperience to crew member inexperience.

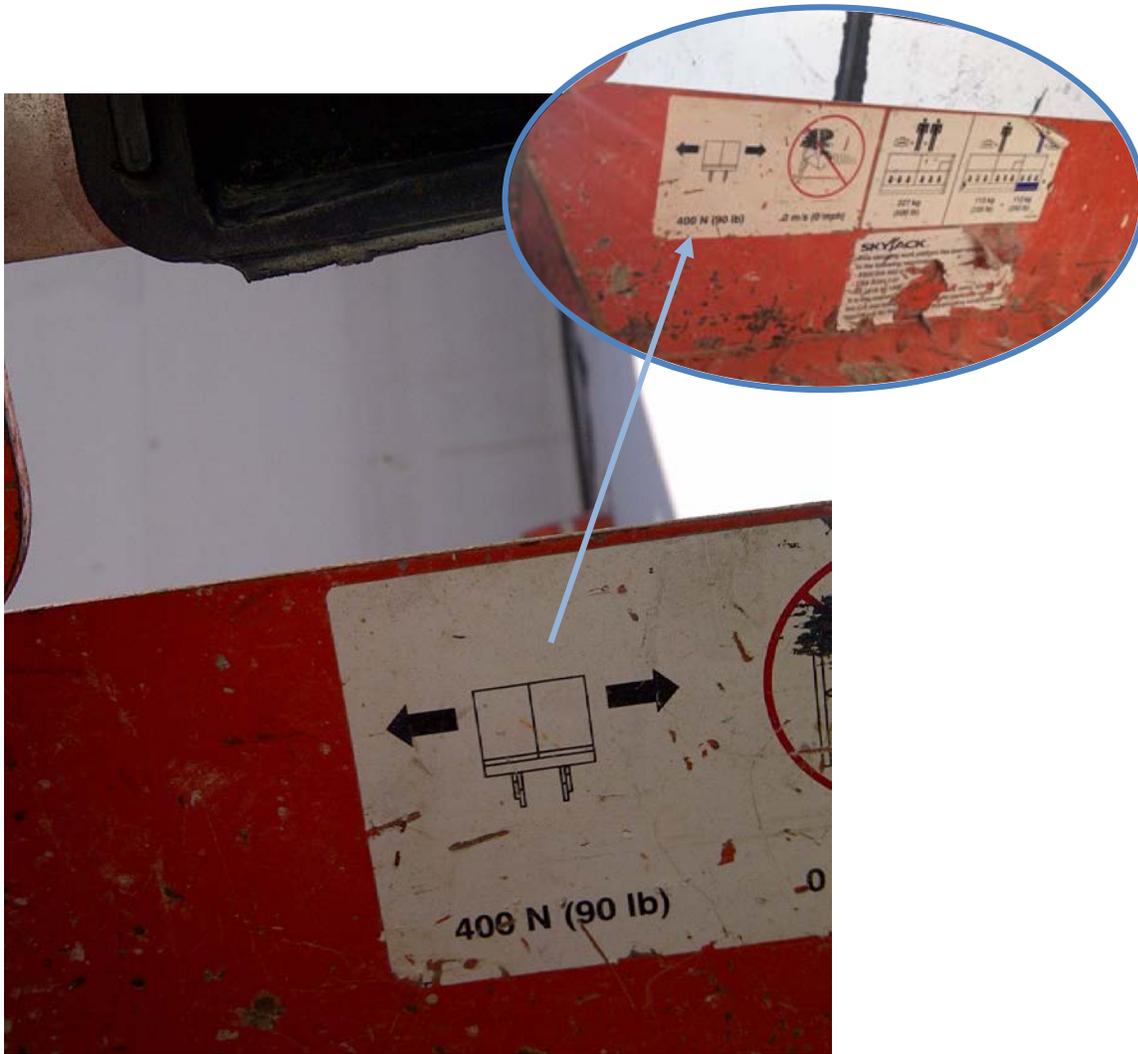
Figure 10: Warning Label inside Scissor Lift Identifying Side Force Limitations

A label near the inner base of the work platform displayed a side load limit of 90 pounds. It was a pictograph label in the scissor lift work platform, located beneath the black box that housed the Operating Manual. See Figure 10. The failure of the PBC hazard analysis to identify and estimate lateral forces that would be made against the lift during blasting resulted in no controls for this hazard and as a result, the PBC SSR had no frame of reference to evaluate this posted limitation. A scaffold competent person is expected to know how to assess loads imposed by persons, materials and winds, but PBC SSR had never been trained to do this. The PBC SSR did not seek guidance regarding the suitability of this model for the planned work, by calling either the PBC safety office or the manufacturer.

Additionally, there was an adjacent label that displayed a warning that wind must not exceed 0 miles per hour. Because WHT-14 was open topped and ambient winds blew through this large enclosed space, the scissor lift would be subject to winds greater than 0 mph during use inside the tank. The PBC SSR failed to observe or failed to recognize this warning during his acceptance inspection of the scissor lift. PBC Blaster 1 inspected and operated this lift despite the warning label. The Operating Manual states: “Do not raise the aerial platform in windy or gusty conditions.”⁷ The Board has no reason to believe that wind conditions were windy or gusty, but the local weather report for the day of the accident showed gusts up to 9 mph. This exceeds the limit established by the manufacturer. It should be noted that these small labels are the only quantitative limits for lateral forces provided by the manufacturer. The manufacturer’s posted control was not heeded. The work control of equipment inspection was performed deficiently.

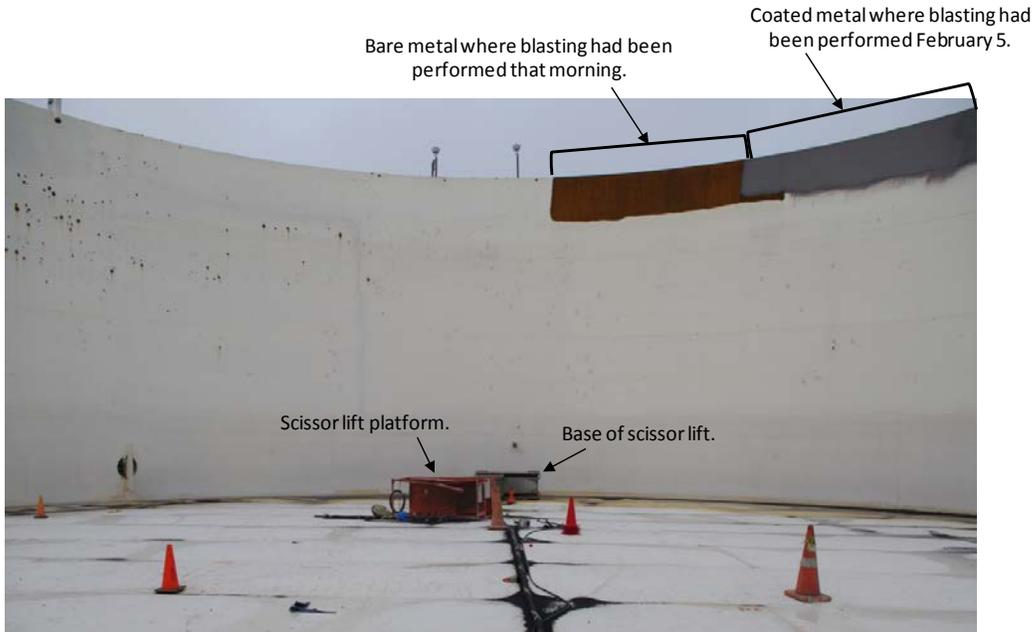
Figure 11: Position of the scissor lift in relation to work completed.

Figure 11 indicates the section immediately to the right of the lift was blasted clean. The Board determined that PBC Blaster 1 had completed that section and had moved the lift to begin work on the next section.

The Board, based on the evidence and interviews, believes that the scissor lift was completely stopped when it toppled over. That is, it was not being driven when it fell. The Skyjack engineer who inspected the tipped over scissor lift confirmed that the wheels were in a locked position and the pothole protection bar was lowered. These conditions are automatically activated when the scissor lift is stopped. Figure 12 shows the toggle switch in the drive position; however, the locked wheels and lowered pothole protection bar indicates that the scissor lift was stopped. The Board was not able to interview PBC Blaster 1, but the PBC SSR told the Board that he asked PBC Blaster 1 what happened when he responded to the tip over. Blaster 1 told him that he had turned his blast hose on and the next thing he knew, he was falling over backwards. Had a supervisor been in position to watch PBC Blaster 1 re-position the scissor lift and to also observe the attached hoses being uplifted along a significant length of the hose, that observer would likely have stopped the action and directed PBC Blaster 1 to pull more hose into the tank.

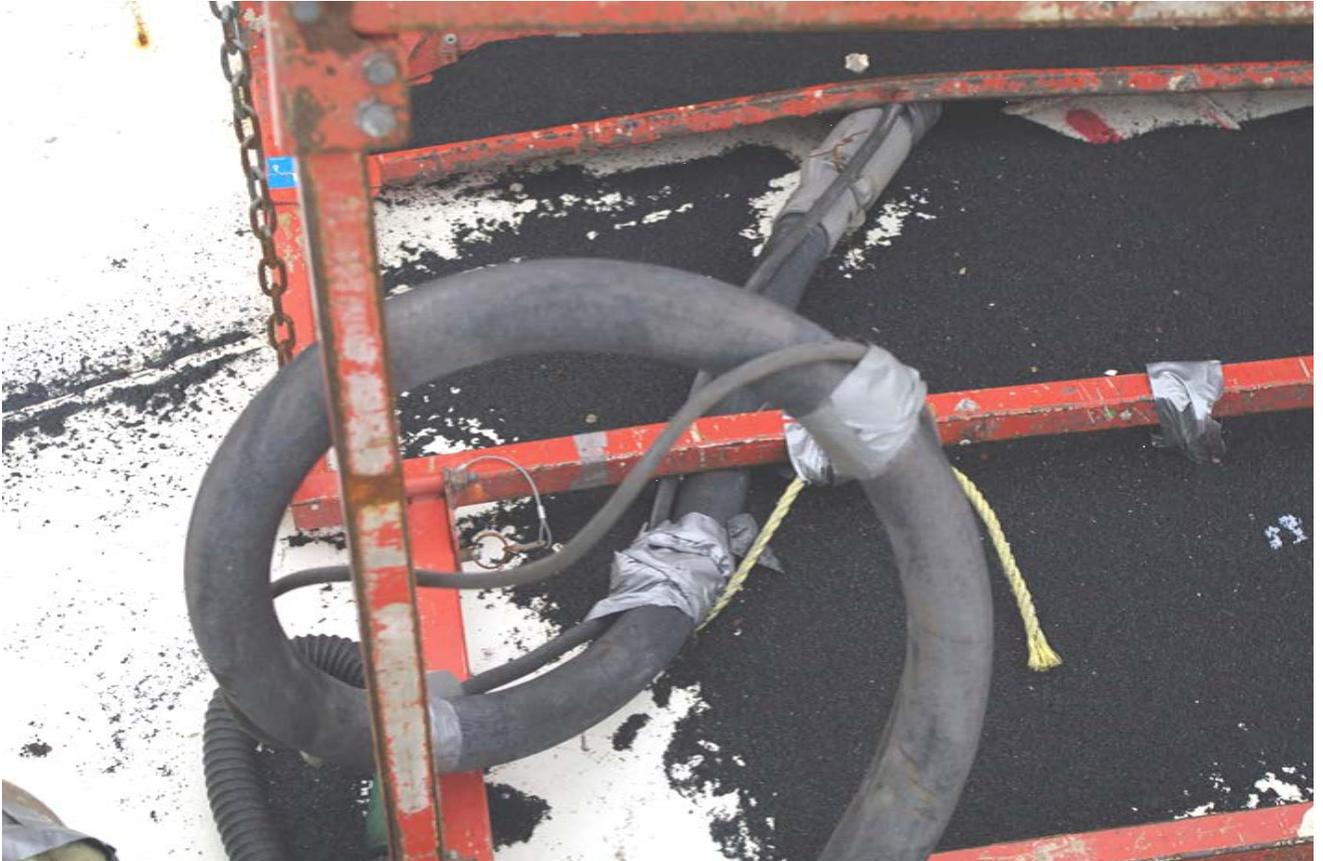
Figure E-9: Close-up of Blasting and Electrical Control Cable Attached to Work Platform Guardrails

The lateral force on the work platform guardrails resulting from securing the blast and air supply hoses to the work platform guardrails and the blasting operation ranges from 184.55 pounds (no media present) to 470.32 pounds (hose 100% full of media).

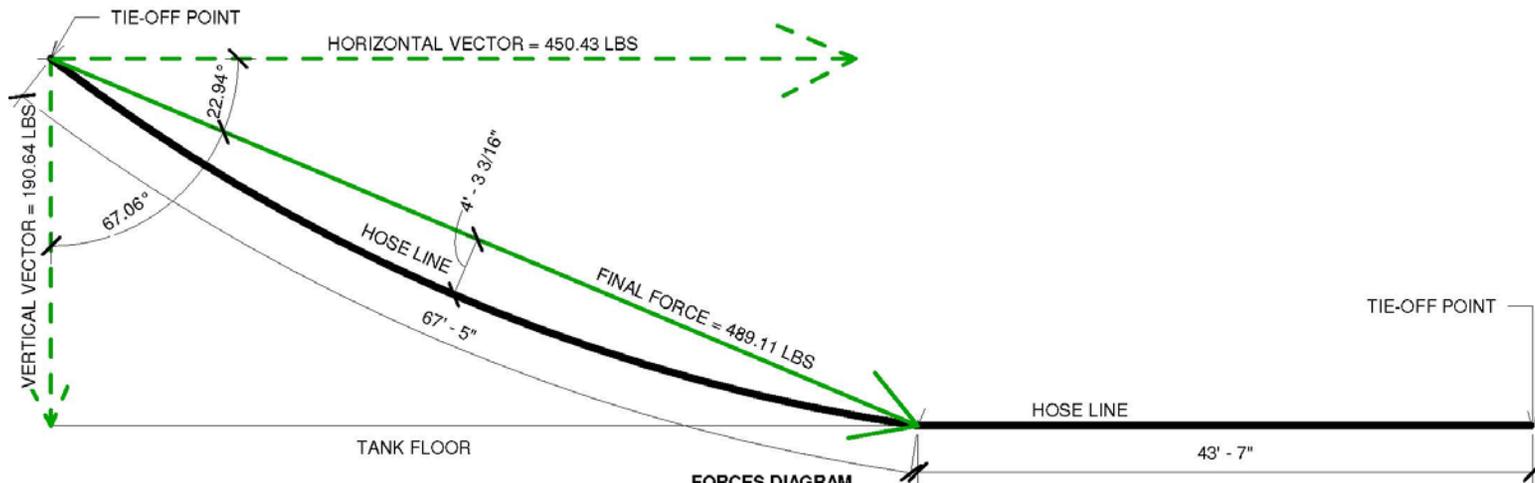
Attachment E.4. Force Analysis Example

Forces Acting on Lift by Weight of Blast Hose

Total weight of suspended hose
 = 67.4167' x 3.89 lb/ft = 262.25 lbs.
