**U.S. Department of Energy
Office of Health, Safety and Security**

Accident Investigation Report

**Accident Investigation of the June 1, 2013
Stairway Fall Resulting in a Federal Employee
Fatality at DOE Headquarters
Germantown, Maryland**

August 6, 2013

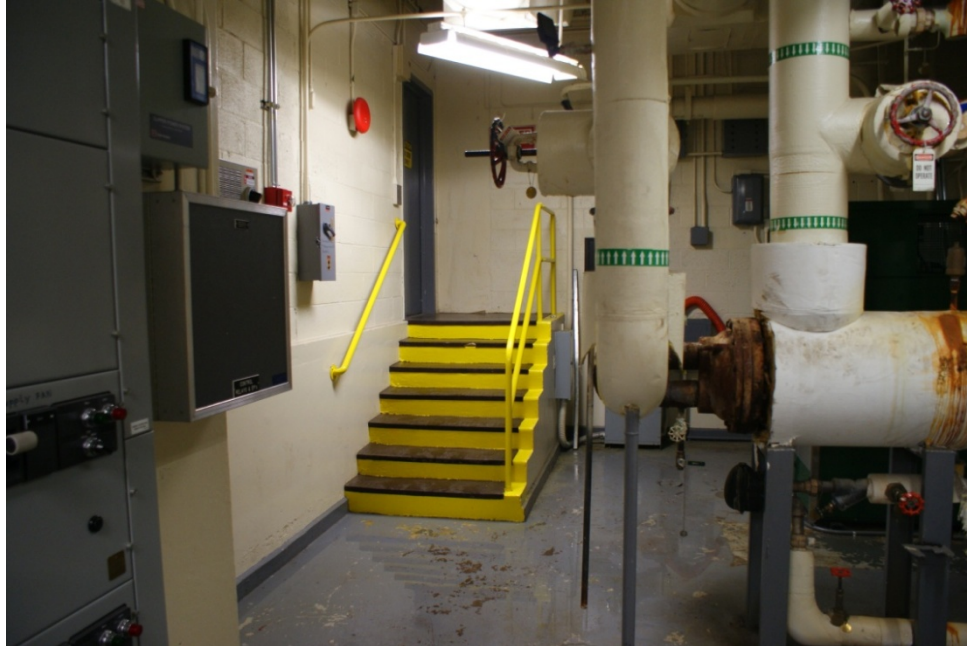
Figure 3: Mechanical Equipment Room 7 Entrance Stairs

The stairs are poured-in-place concrete. The stairs have six steps, handrails on both sides, and a large landing area; the door opens into the hallway, not into the landing space. The steps in MER 7 are covered with rubber stair treads made by Flexco Floors.

The photographs in Figures 3 and 4 were taken two days after the accident by the initial investigator. Figure 3 shows the scene of the accident and the stairs leading into MER 7. Figure 4 shows the side view of the stairs.
