ACCIDENT INVESTIGATION

JULY 15, 2004

HANFORD 200 EAST AREA

FALL FATALITY

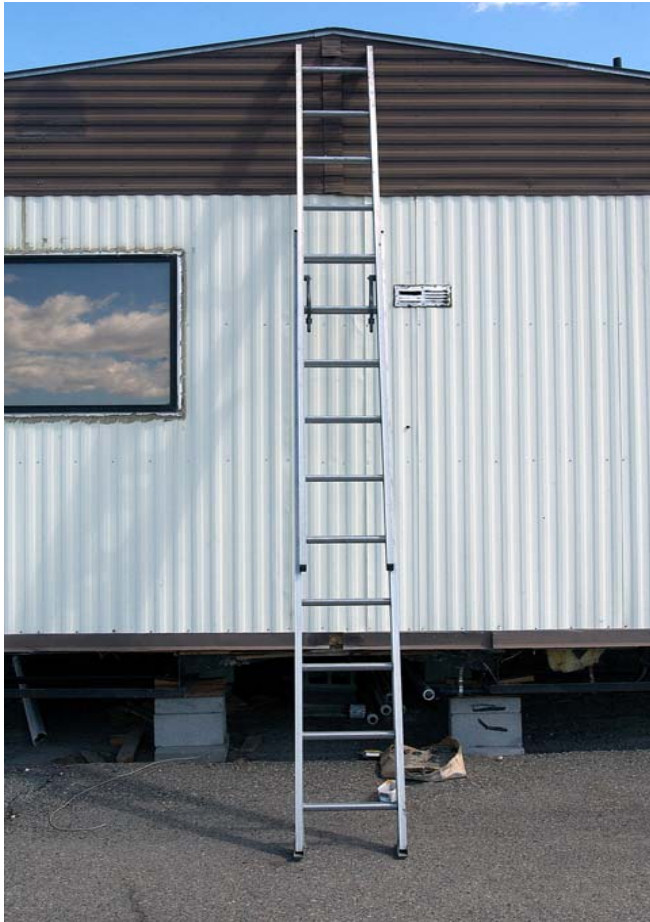
The Board conducted an evaluation of the ladder used in the accident and its use. No eyewitnesses observed the AMTR employee deploy or use the ladder, and the movement of the ladder by fireman No. 1 introduces a measure of error on ladder placement. (Exhibits 2-1, 2-2, and 2-3)

Exhibit 2-1, Ladder base at 3 ½ feet from MO-392, south wall.

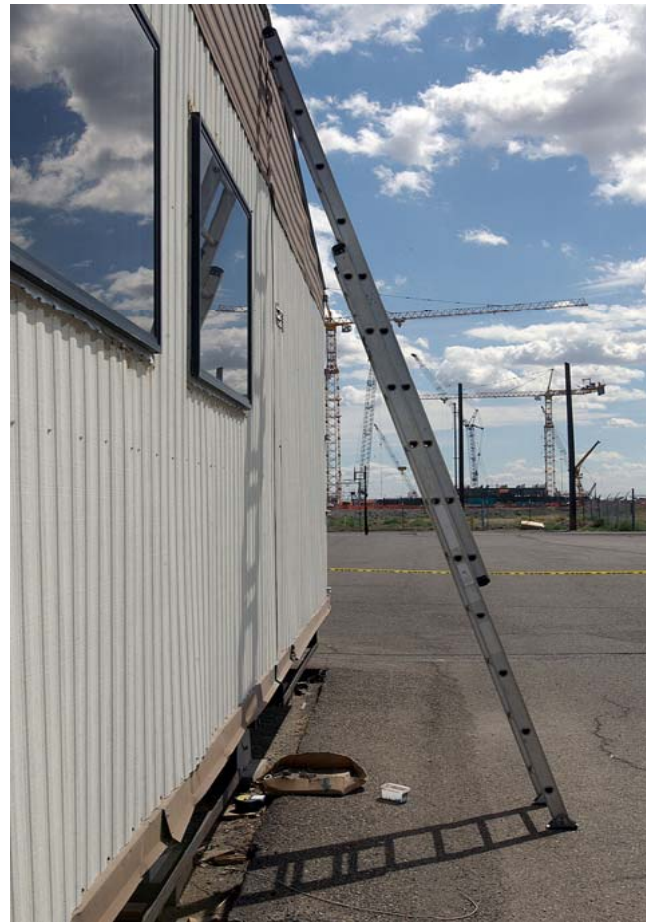
Exhibit 2-2, Ladder base at 3 ½ feet from MO-392, south wall

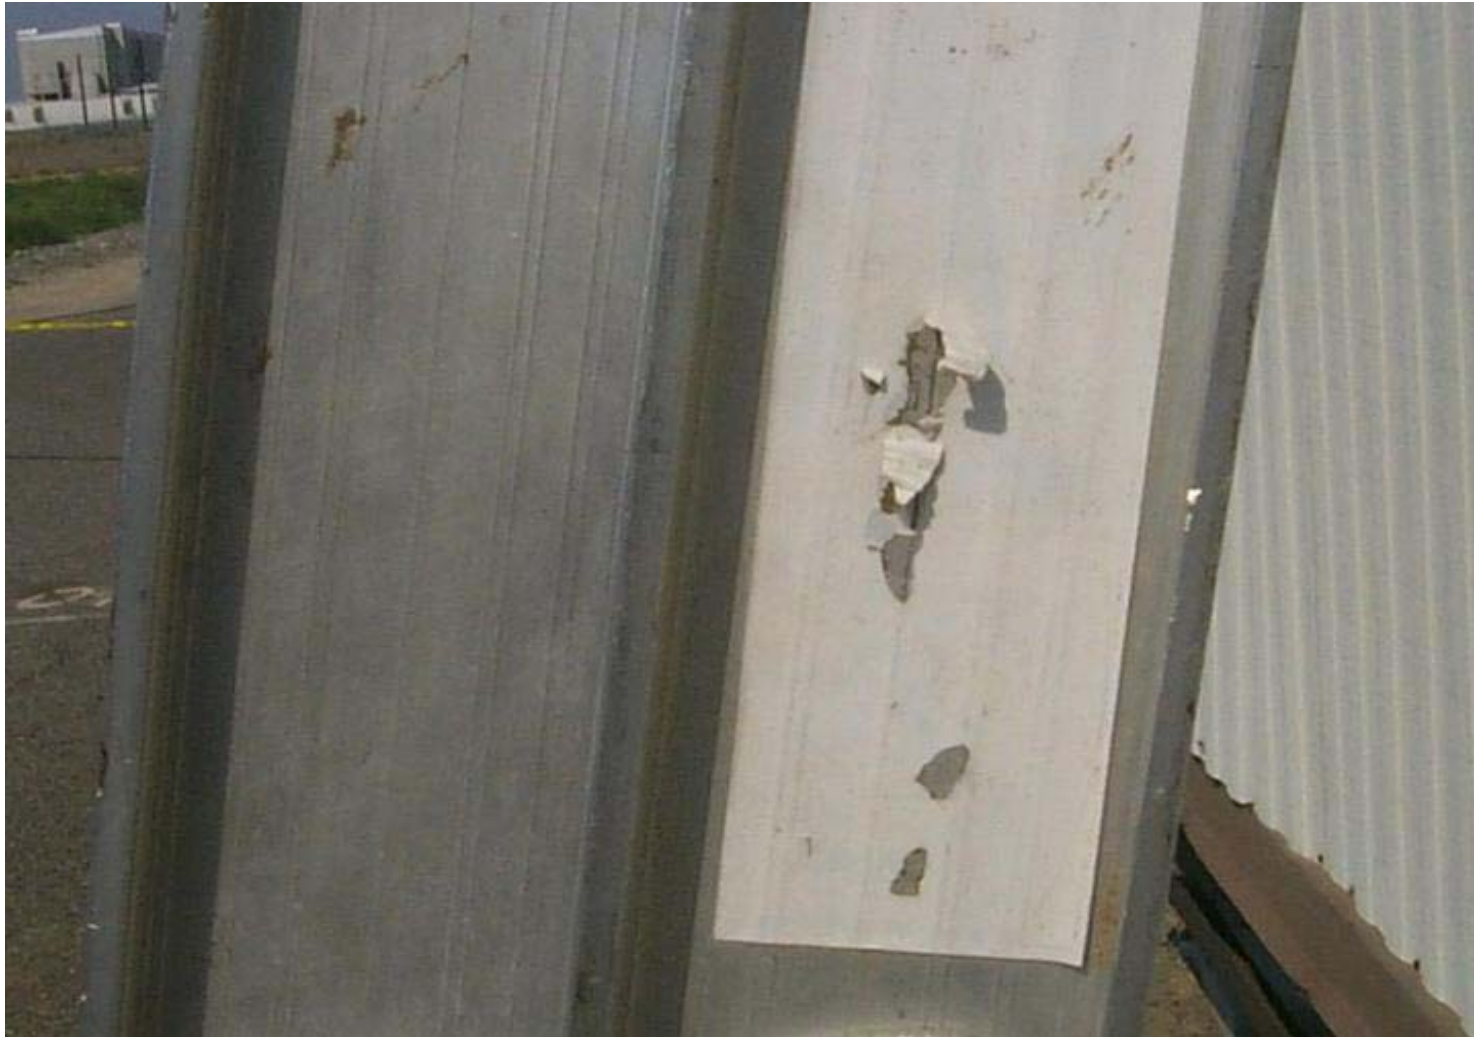
Ladder was found in a stable configuration against the wall, but no one witnessed AMTR employee's actions while on the ladder.	(b)(11) Ladders shall not be moved, shifted, or extended while occupied.	(2) (k) Ladders shall not be moved, shifted, or extended while occupied.		A1 Do not shift, reposition, or extend portable ladders when the ladder is occupied.	Unknown
No energized lines were located in the vicinity. All electrical connections to MO-392 had been disconnected. Labels on ladder were	(b)(12) Ladders shall have nonconductive siderails if they are used where the employee or the ladder could contact exposed energized electrical equipment, except as provided in 1926.951(c)(1) of this part.	(2) (l) Ladders shall have nonconductive side rails if they are used where the employee or the ladder could contact exposed energized electrical equipment, except as provided in the following: (i) Portable metal or other portable		A1 Do not use metal or metal-reinforced portable ladders when the ladder is occupied.	Non-compliant on WAC (2)(ii) "conductive" warning was illegible, however, no lines were energized in the vicinity

Exhibit 2-3, Faded label on ladder used at MO-392, south wall.
