**TYPE A ACCIDENT INVESTIGATION
OF THE MARCH 16, 2000
PLUTONIUM-238 MULTIPLE INTAKE
EVENT AT THE PLUTONIUM
FACILITY LOS ALAMOS NATIONAL
LABORATORY
NEW MEXICO**

July 2000
Prepared by
Office of Oversight
Office of Environment, Safety and Health
U.S. Department of Energy

Executive Summary

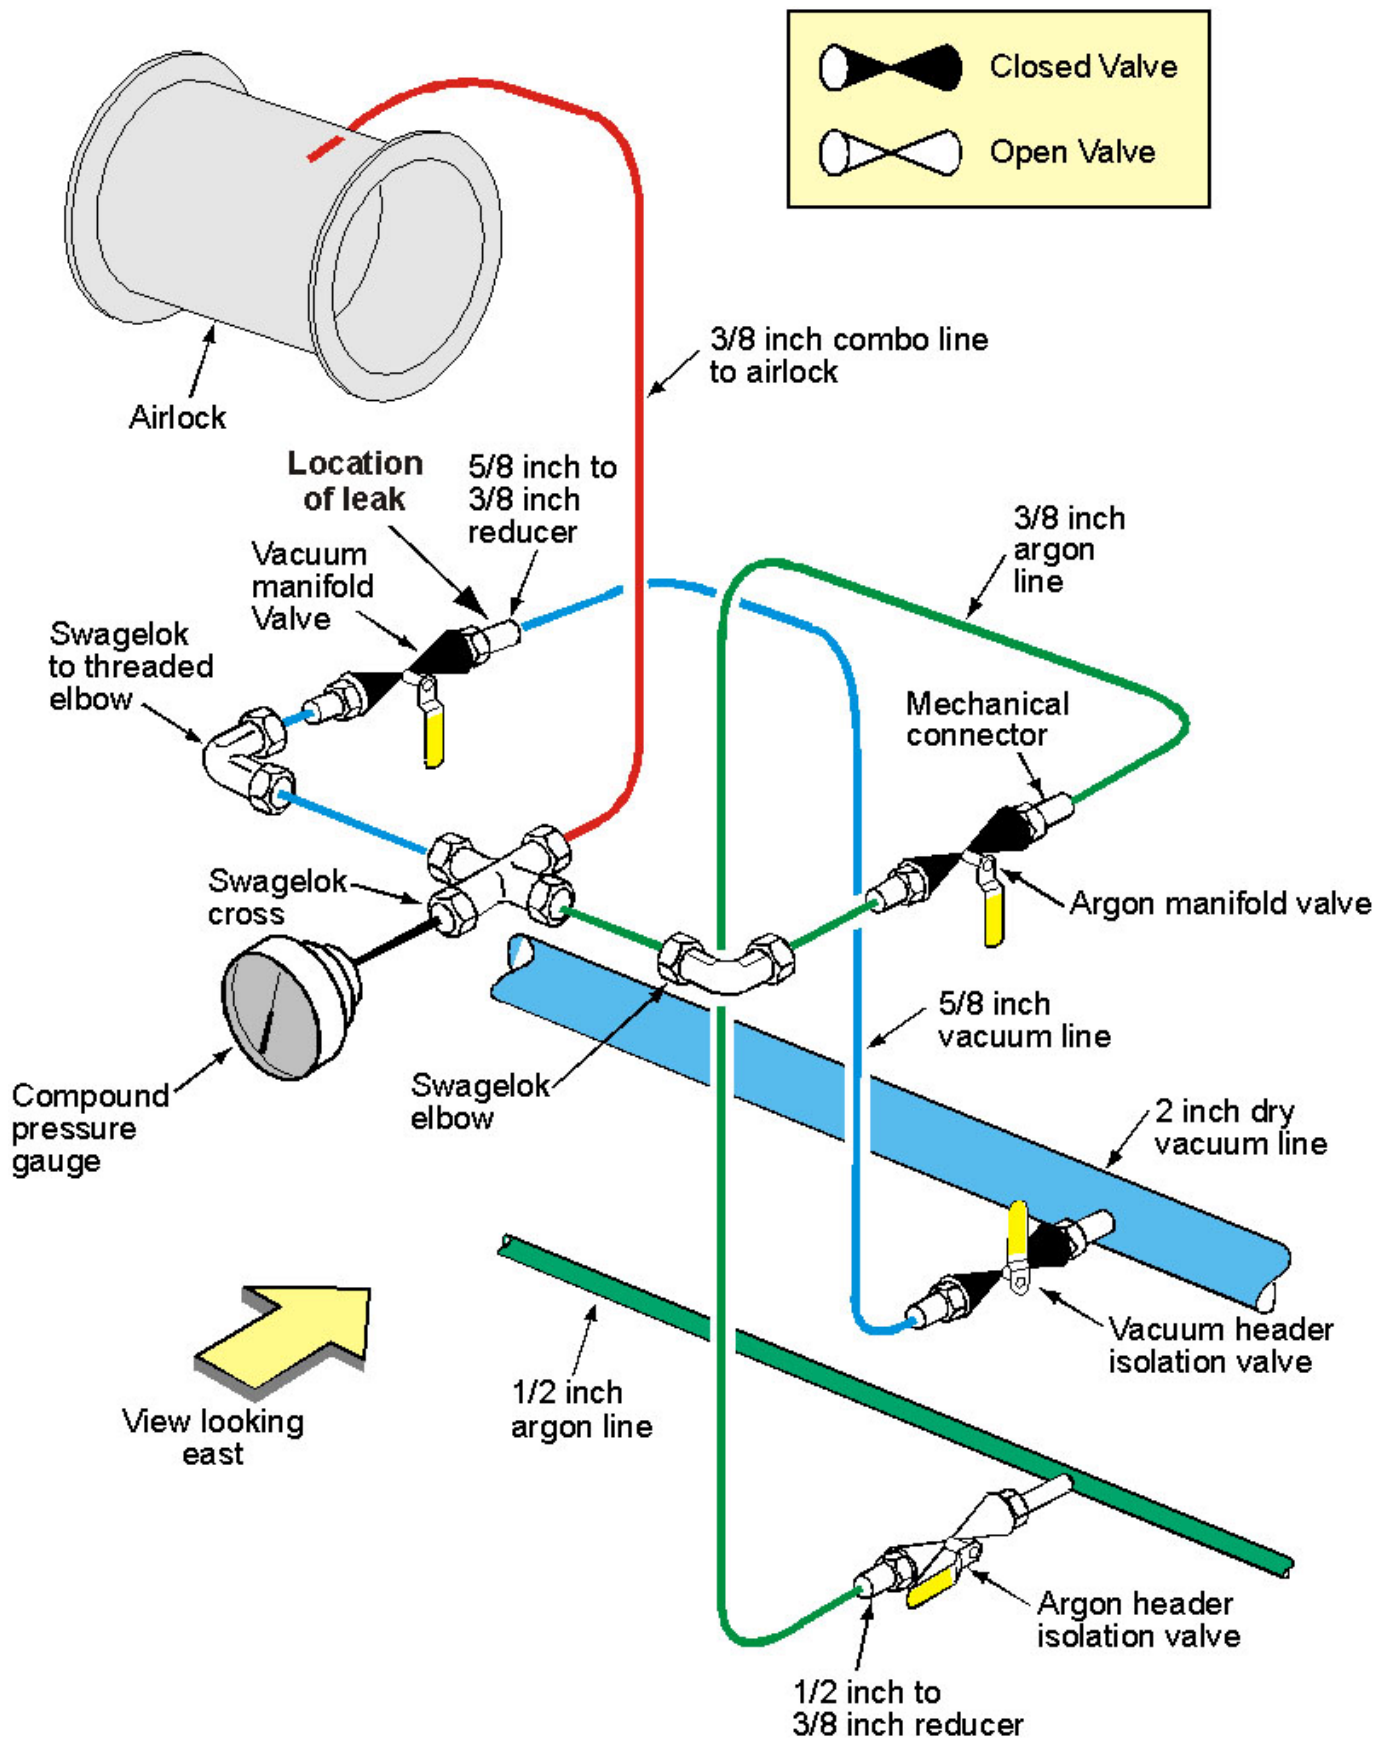
Figure 2-2. Airlock Manifold Piping Diagram

The accident investigation board determined that the direct cause of the accident was a release of airborne contamination from a leaking compression fitting in an inadvertently pressurized dry vacuum line. The vacuum line serves an airlock between the glovebox and an adjacent dropbox.

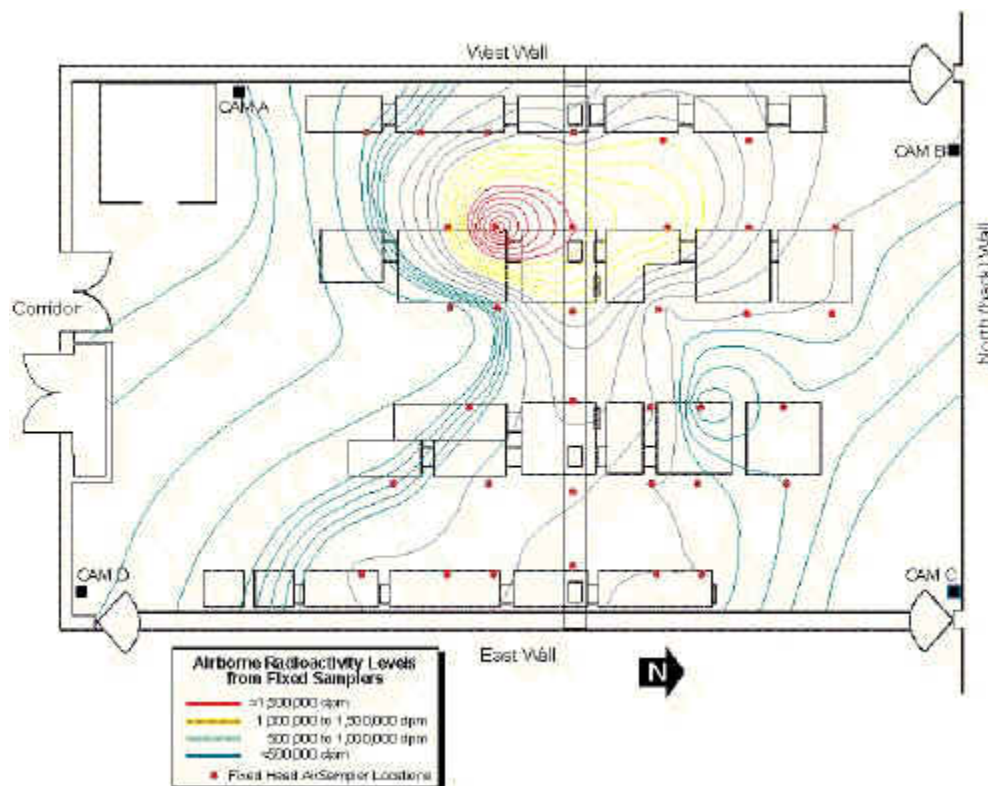
Figure 2-3. Fixed-head Air Sampler Results in Room

LANL and Lovelace Respiratory Research Institute (LRRI) estimate the particle size distribution of the release to be in the range of 1 to 5 micrometers activity medium aerodynamic diameter. The contamination evidence suggested that there was a significant amount of locally deposited material that may have caused the hand monitors to alarm. To assess this possibility, the Board had the probes of the hand monitors in the area surrounding the glovebox surveyed. It was found that the probe directly above the apparent release location was reading 17,000 dpm, and the probe on the dropbox north of the glovebox was reading 6000 dpm. The probe on the glovebox across the aisle and directly behind ET's task location was reading 11,000 dpm. All other probes were less than 1000 dpm (the hand monitors are set to alarm at 1000 dpm). The order in which the monitors alarmed can be inferred from the distances between the monitors and the location of the release. This inference suggests that the monitor directly above the release point alarmed first, followed by the monitor on the dropbox to the north, and finally by the monitor on the glovebox across the aisle to the west of the release point.

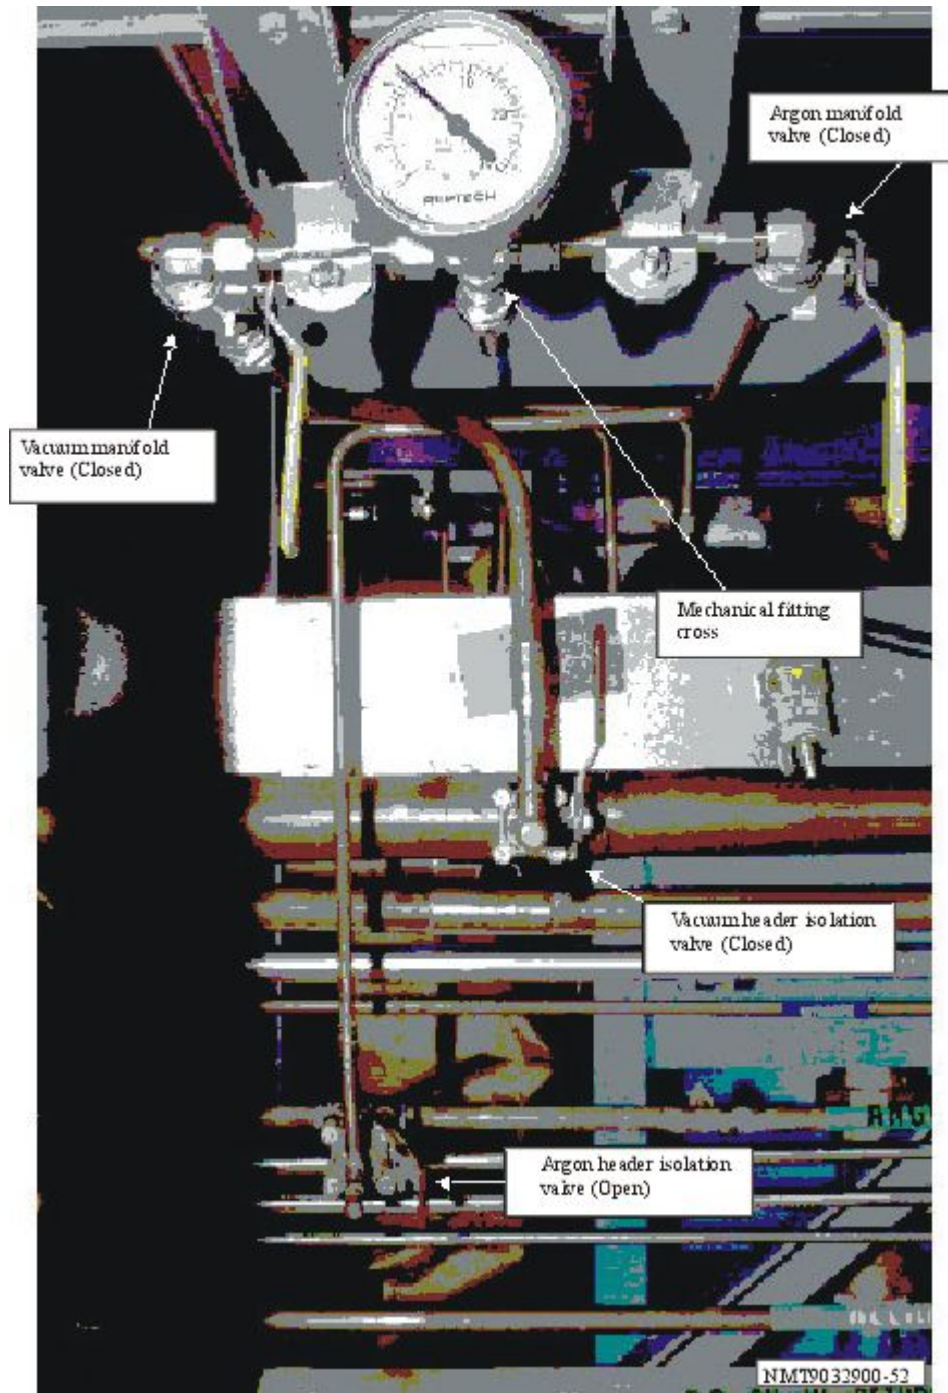
Exhibit 2-3. Alignment of Valves in the Manifold Line after the Accident

At the time of the first hand monitor alarm, ET was tracing the piping and valve alignment underneath the northwest corner of this glovebox, and stated that he had "shaken" the pipes to test joint integrity. Therefore, the Board directed significant attention toward measuring the contamination levels at this location. The floor under the glovebox was found to be measuring about 1,000,000 dpm. The service pipelines were found to be reading levels ranging from 20,000 dpm to 200,000 dpm, with several locations as high as 1,000,000 dpm. The manifold for the airlock argon purge system is also at this location (see [Exhibit 2-3](#) and [Figure 2-4](#)). On the line from the dry vacuum supply line to the manifold, near the vacuum manifold valve, there was also a reducer coupling for changing the size of the pipe. The argon manifold valve was not contaminated, and the piping to the airlock read about 10,000 dpm. The vacuum manifold valve read 100,000 dpm, but the reducer was contaminated to a level exceeding the range of the instrument at 2,000,000 dpm. This last measurement was taken at a distance of about two inches from the coupling, indicating that the contamination level was actually much higher than the recorded reading.

The Board focused primary attention on the manifold under the northwest corner of the glovebox where the maximum contamination was found. This manifold is used for purging the airlock between the glovebox and the dropbox to its north. For the general layout of this location refer to [Exhibit 2-3](#).

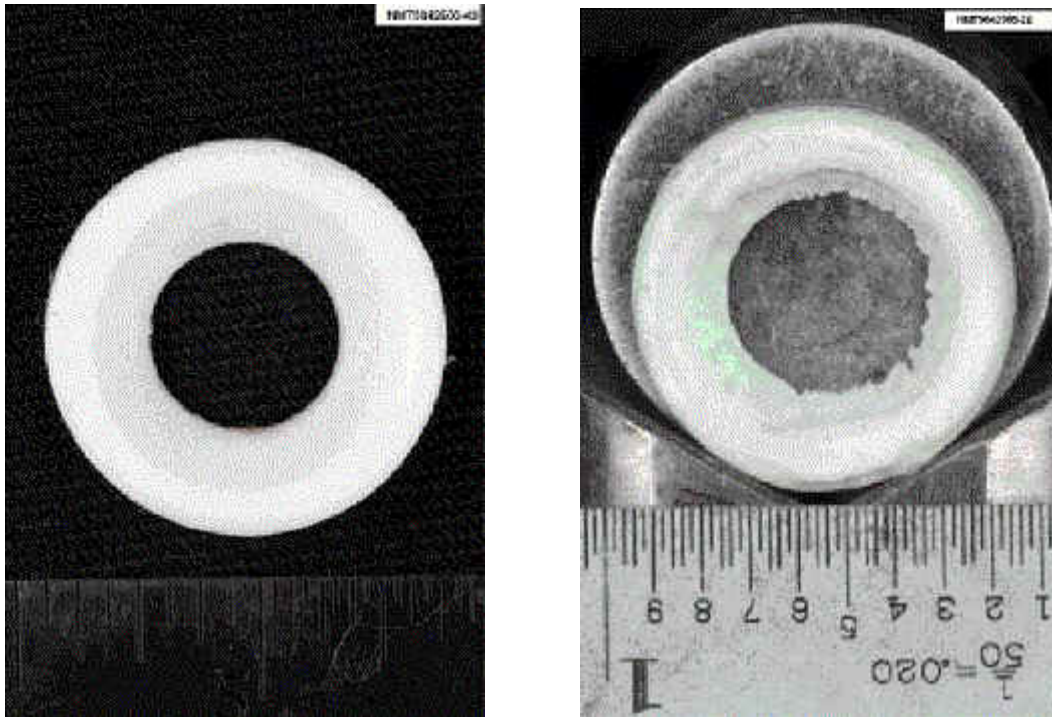
Exhibit 3-1. Teflon^(r) Seat Degradation

Furthermore, the vacuum manifold valve was found to have a significant seat leakage and could not maintain a static pressure in the line. The cause of this leakage was found to be significant degradation of the Teflon(r) seats in the ball valve. The cause of this degradation will require

further analysis, but it probably results from a combination of thermal, abrasion, and radiation damage from prolonged exposure to Pu-238. The Board concluded that further analysis of this Teflon(r) degradation mechanism is warranted, and that DOE should evaluate the impact of this degradation at all similar plutonium facilities within the complex.

In addition to the use of Teflon^(r) as the seat material in this valve, Teflon^(r) tape is used to connect mechanical joints with pipe threads in this manifold. The Board concluded that Teflon^(r) was an inappropriate design choice as a sealing material in an environment containing Pu-238.
