## **Type A Accident Investigation**

**Subcontractor Fatality at the  
Pond B Dam Upgrade Project  
on July 26, 2004  
at the  
Savannah River Site  
Aiken, South Carolina**

**September 2004**

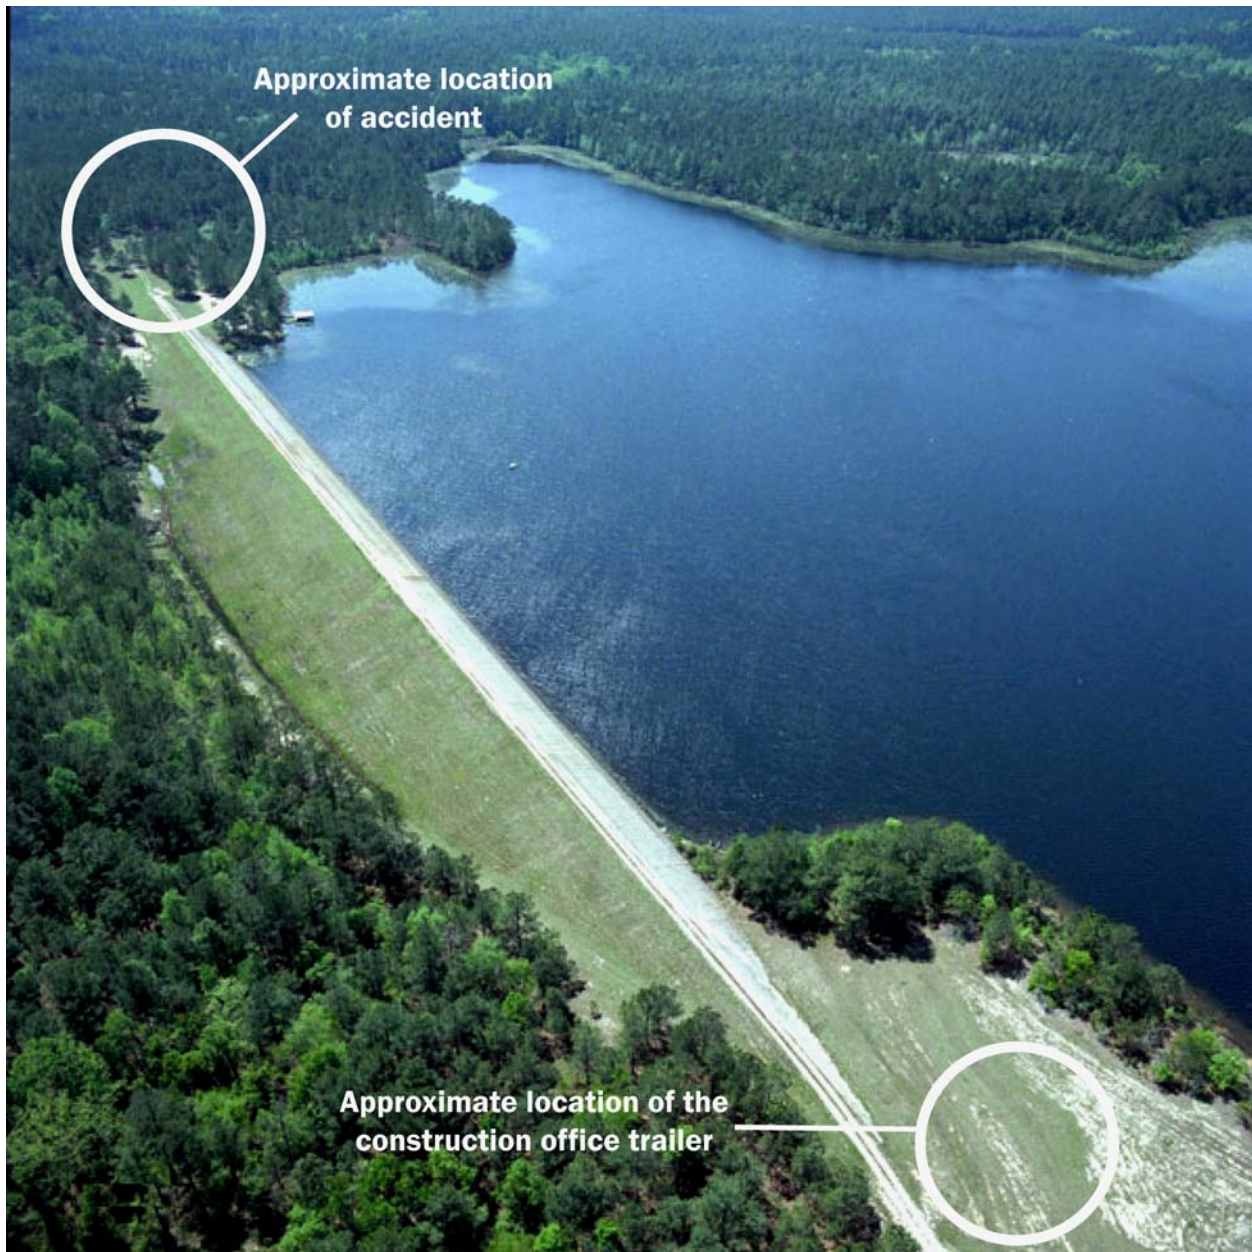
*Figure 1-1. South end of Pond B Dam*

Figure 1-1 shows an aerial view of Pond B. The Pond B Dam, the scene of this accident, was constructed in 1960 as a simple earthen dam with a sandy-toe drain system that was typical of that period. The dam is operated and maintained using the Federal Energy Regulatory Commission (FERC) guidelines as set forth under Title 18 Code of Federal Regulations (CFR) Part 12, *Safety of Water Power Projects and Project Works*. WSRC and FERC inspections confirmed that the pre-repair state of the Pond B structure did not comply with FERC guidelines and required repair. A fixed-price construction contract was awarded to and executed by GradeSouth, Inc., a sister company to Beam's Contracting. The scope of the Pond B Upgrade Project included the installation of a filter and drainage system consisting of coarse gradation sand, fine gradation sand, and a compacted-earth fill berm; installation of a rock riprap collection ditch; installation and removal of a temporary sediment basin; and installation of four piezometers. At the time of the accident, GradeSouth was completing punchlist activities

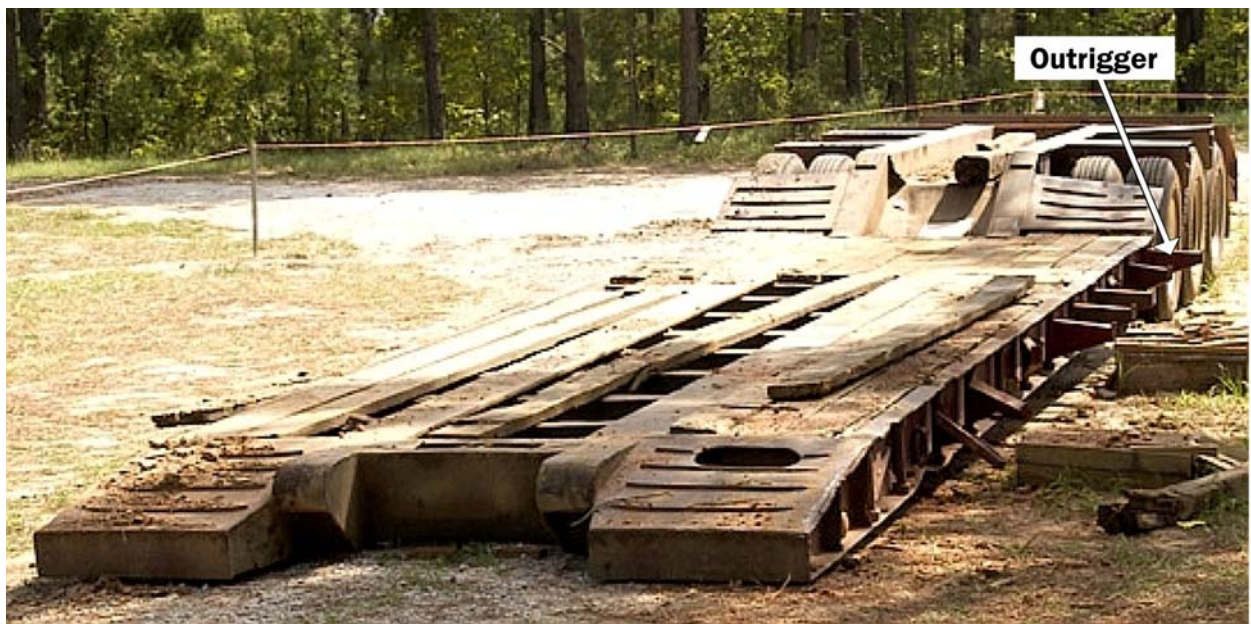
**Figure 2-2. Lowboy after removing excavator**

The driver positioned the outrigger and plank on the driver's side of the lowboy, and the teamster assisted the driver in positioning the outrigger and plank on the passenger side (post-accident visual examination indicated that outriggers were missing on the lowboy – three on the passenger side and two on the driver's side). The outrigger plank on the driver's side spanned six outrigger positions, including one of the missing positions. The teamster drove the excavator onto the lowboy trailer from the front end of the trailer. He stated that he loaded the excavator as a courtesy to the driver. The GradeSouth employee is a teamster, not an operating engineer.

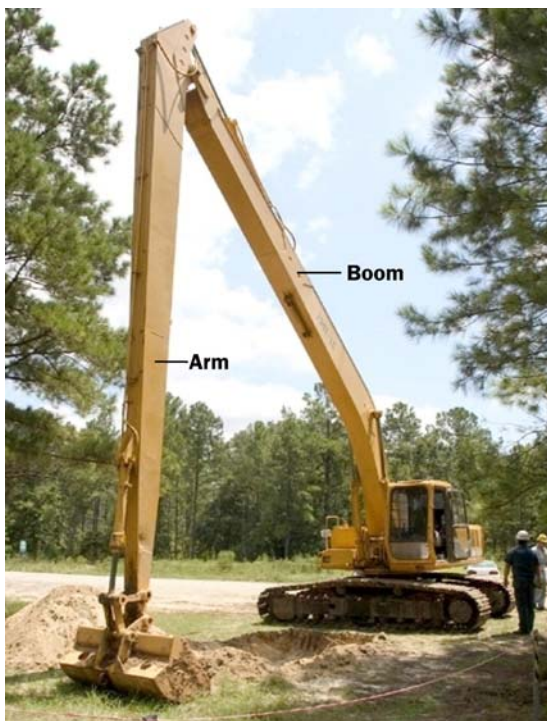
**Figure 2-3. (left) The recommended arm configuration for lifting tracks**

The teamster raised the excavator boom and swung it about 90 degrees to the right so that it was nearly perpendicular to the excavator tracks. He positioned the boom and the arm to place the bucket on the ground about 10 to 12 feet from the trailer. In this position, the arm is at an approximate 45-degree angle to the ground. John Deere recommends that the arm should be at a 90- to 110-degree angle to the boom, allowing the track to be elevated by applying downward force on the boom only, rather than operating in "two-stick" control

(illustrated in Figures 2-3 and 2-4). The teamster then used the excavator controls to push down on the boom and out on the arm to raise the track (i.e. “two-stick” control). He stated that the truck driver verbally directed him at least twice to raise the track higher. During this activity, the driver was in the teamster’s line of sight. The driver then squatted down near the excavator and trailer, and he then disappeared from the teamster’s line of sight.

at 90 to 110 degrees (as recommended by John Deere) because of the long boom. He noted that a regular excavator could be raised in that manner but with a long-stick excavator, there is a chance of bending the piece of equipment or not picking it up at all. The Board believes the teamster's assumption was incorrect.

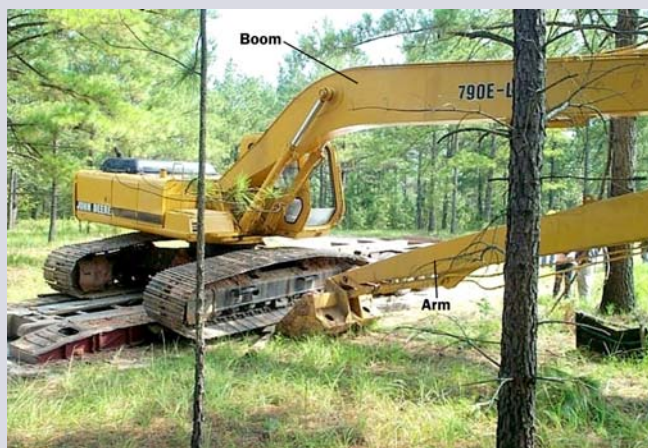
**Figure 2-4. (below) Approximate arm configuration the teamster used.**

The Board conducted engineering analysis and calculations, and simulated the accident conditions in the field to assist in analyzing the accident. Engineering analysis indicate that initially, the excavator configuration was stable with about 16,000 pounds of force on the bucket and 35,000 pounds of force on the stationary track. The Board determined that, while the track was elevated, a leak on the hydraulic line to the arm cylinder (caused by a loose fitting) relieved hydraulic pressure from the arm cylinder. The gradual loss of pressure in the cylinder resulted in a redistribution of loads within the excavator structure, which caused a buildup of lateral loads at the excavator support points (the stationary track and the bucket). After the lateral loads built up to a level that exceeded the frictional holding capability at the excavator supports (between either the stationary track and trailer or the bucket and ground), slippage occurred, until sufficient pressure was built up in the cylinder to re-support the load. This action occurred repeatedly, causing either the bucket or the track to slip, until the suspended track was again resting on the trailer bed.

The simulation of the accident conditions using the excavator involved in the accident, with the existing hydraulic leak present, confirmed the Board's engineering analysis. Both bucket slippage and track slippage were noted with a similar pre-accident excavator configuration. The simulation was re-performed after repair of the hydraulic leak by tightening the loose fitting. No bucket slippage or track slippage was noted. However, the raised track did lower slowly over the next 20 minutes, probably from slow internal leakage around the cylinder piston

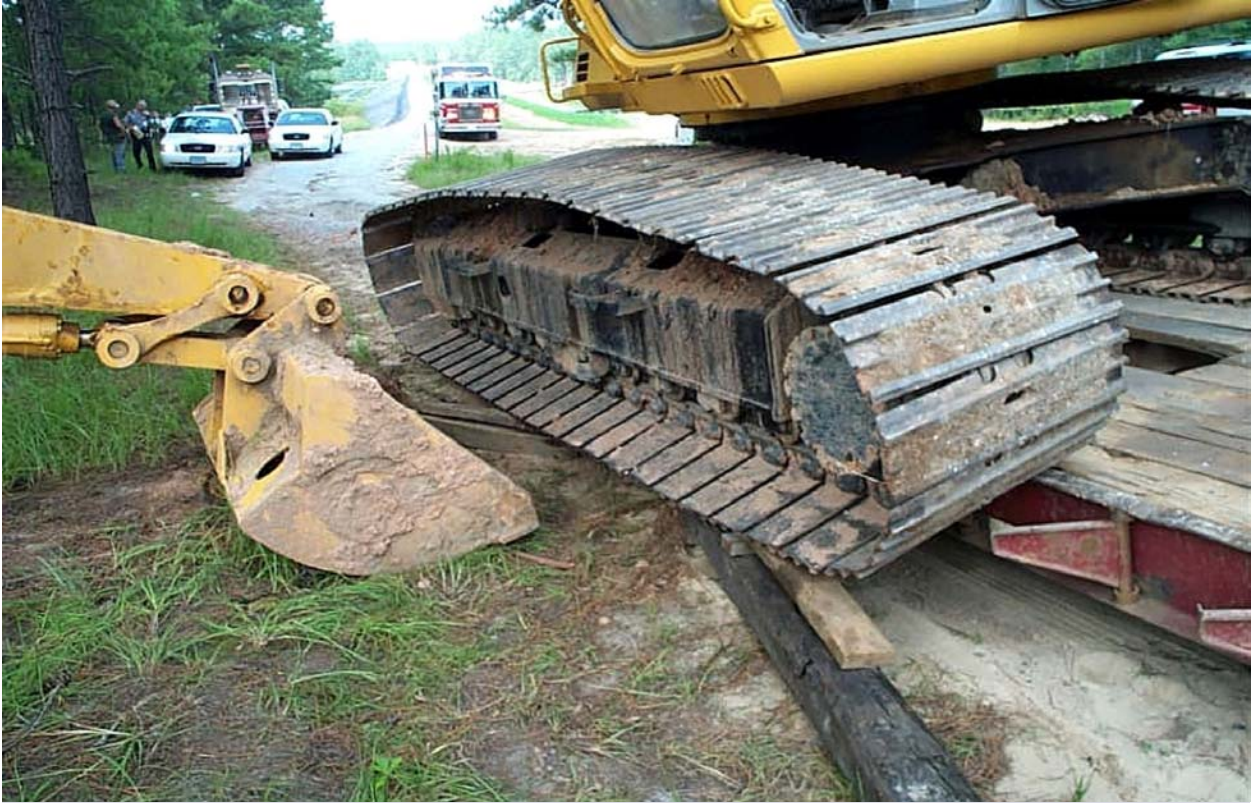
**Figure 2-5. The scene immediately following the accident**

The first responders noted that the driver's feet were near the track and that his body was positioned at approximately the same angle as the lumber (Figure 2-5) that was placed under the track by GradeSouth personnel to prevent the tracks from falling onto the driver. They also noted that the driver's pants were torn and that his right leg and pelvis were injured. The driver could not provide the first responders with an accurate description of the accident. During the first responders' initial assessment, the driver's blood pressure decreased and heart and respiratory rates increased. The driver was given oxygen by non-rebreather mask and placed on a Reeves Sleeve for transport.
