TYPE B ACCIDENT INVESTIGATION BOARD REPORT

**GROUT INJECTION OPERATOR INJURY AT
THE COLD TEST PIT SOUTH,
IDAHO NATIONAL ENGINEERING AND
ENVIRONMENTAL LABORATORY,
OCTOBER 15, 2001**

IDAHO OPERATIONS OFFICE

November 2001

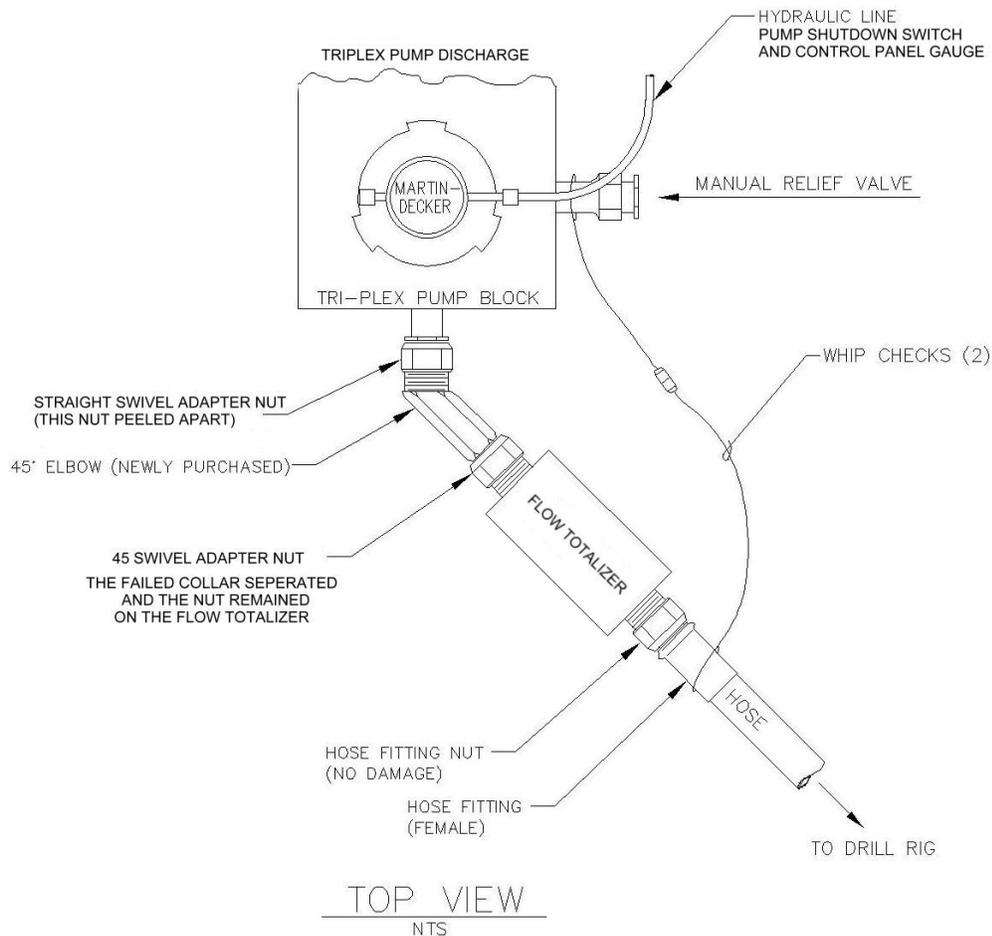
Triplex Pump Discharge With Fittings, Flow Totalizer and Hose

The accident occurred when a 45° swivel elbow with a rated working pressure of 3,000 psi (normal working pressure during high pressure grout injection was 6,000 psi) broke under pressure and set into course a chain of events that led to the injury of a subcontractor operator. The equipment involved in the accident, shown in the equipment drawing, included the straight swivel adapter on the triplex pump high pressure outlet, a 45° swivel elbow, a flow totalizer and two whip check restraining devices. (See Triplex Pump Discharge With Fittings, Flow Totalizer and Hose.)

The Board determined that the most likely chain of events for the accident started with the failure of the collar on the 45° swivel elbow nut by ductile rupture. This allowed the remainder of the 45° swivel elbow nut and flow totalizer to separate from the grout flow path. The flow totalizer was restrained to the block of the triplex pump by the use of two whip checks on its outlet connecting hose. The whip checks restrained the flow totalizer until the applied forces and momentum broke the whip checks.

While the flow totalizer was being thrown from the system, the applied force from the 45° swivel elbow was transmitted onto the straight swivel adapter nut on the high pressure outlet of the triplex pump. The straight swivel adapter nut then ruptured in a brittle cleavage fracture causing the 45° swivel elbow and the straight swivel adapter nut to be thrown from the grouting system. The straight swivel adapter nut struck the operator on his safety glasses on the right side of the head in the vicinity of the right eye socket causing the safety glasses to break and striking the operator.

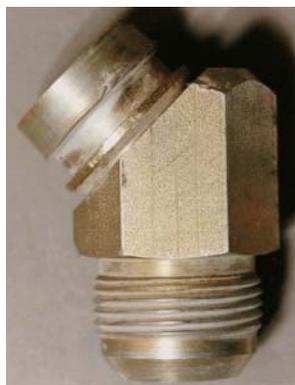
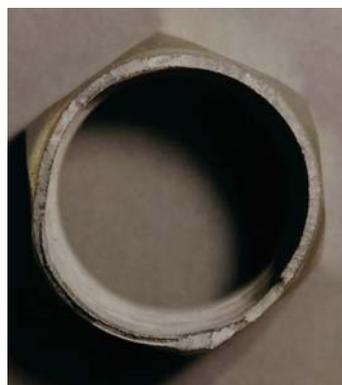
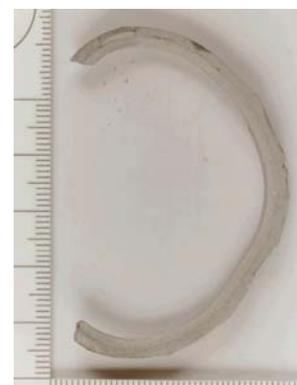
45° Swivel Adapter

The fitting nut collar was entirely separated from the main body of the nut by a circumferential fracture. The fracture surface was very uniform, with no sign of an initiation site. It was concluded that the nut failed by ductile rupture corresponding to a tensile overload (i.e. high pressure).

The damage patterns exhibited by the fittings and their post-accident resting places, suggest a failure sequence. The 45° swivel elbow nut failed by tensile over-load in a plane perpendicular to its centerline as noted by the uniform fracture surface. By comparison, the straight swivel adapter fitting exhibited a failure pattern that was dominated by a loading unsymmetrical to the fitting centerline. Such a failure pattern is consistent with a loading resulting from a blow down through the downstream end of the 45° swivel elbow fitting, since the exiting flow would be in a direction well off of the centerline of the straight swivel adapter. Failure of the whip checks that spanned the failed fittings indicates a dynamic unloading of the system fluid through the failure locations, confirming that a system blow down did occur.

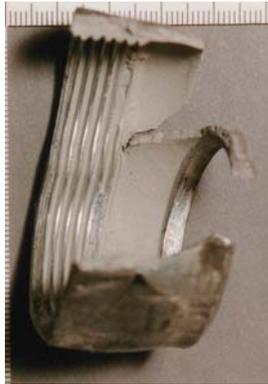
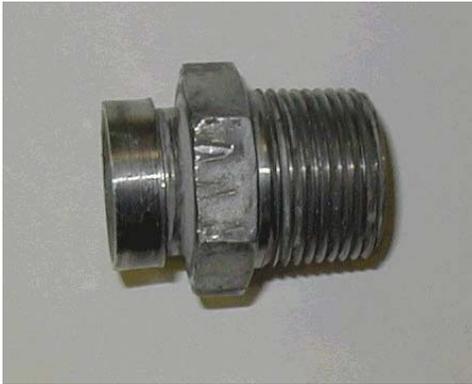
Straight Swivel Adapter

The fitting nut failed by a brittle cleavage fracture process, not uncommon for low-carbon steels. Fracture by cleavage is promoted by low temperature, high loading rates, or a combination of both.

The straight swivel adapter had been in service for some time and was not replaced just prior to the accident on the morning of October 15, 2001. There were no manufacturing trademarks on the fitting and no information about the fitting was available. However, the 45° swivel elbow had been recently purchased from a local vendor and installed by the subcontractor on the morning of the accident. The manufacturer's catalog rated working pressure for this fitting was 3,000 psi. It should be noted that the vendor
