# OPERATING EXPERIENCE SUMMARY

U.S. Department of Energy  
Office of Health, Safety and Security  
OE Summary 2012-02  
May 11, 2012

## Improper Use of Dewar Carts Results in Serious Hand Injuries

### Strategic Petroleum Reserve Investigation Results — Fatality at the Bryan Mound Site

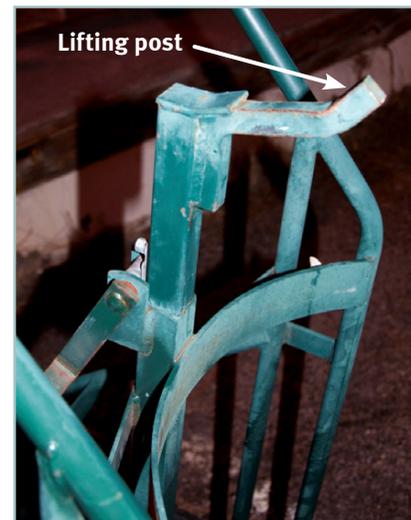
Figure 1-1. Lifting post that fits into Dewar

On August 23, 2011, a worker's fingertip was amputated when he attempted to move a 160 L liquid nitrogen Dewar using a Harper Series 600 Universal Liquid Gas Cylinder Truck (Dewar transport cart). The worker had inserted the cart's lifting hook into the Dewar's lifting slot (shown in Figures 1-1 and 1-2), placed his left hand on the Dewar handling (halo) ring, and placed his right hand on the cart handle. He then began tilting the cart down onto its wheels. As he pulled back on the cart and Dewar, the cart lifting hook disengaged from the lifting slot of the Dewar and the Dewar rapidly slid down the cart. His left middle finger was caught between the handling ring and a horizontal steel support on the cart, resulting in an avulsion of the fingertip. Emergency response personnel transported the worker to the local emergency room, where the

A preliminary investigation identified the direct cause of the incident as the improper adjustment of the cart lifting hook. In addition, the placement of the worker's hand on the handling ring while tilting the cart back placed the hand in a vulnerable position when the Dewar disengaged from the lifting hook. Management of the divisions utilizing Dewar carts was made aware of the incident, and management curtailed Dewar movements until supervisory personnel could inform affected personnel about the incident and the identified causes. In addition, the Laboratory Cryogenic and Mechanical Safety Subcommittees were contacted and a panel of members from those committees, along with Environment, Safety & Health personnel from affected divisions, was convened to assist in further investigation of the incident and in the development of corrective actions.

The panel inventoried the carts and evaluated them for hazard potential. One style of cart (not the same style as the one involved in the incident) was judged to have an unacceptably high risk associated with its use and was removed from service. All of the other carts of different styles were determined to be fit for use, including the style of cart used during the specific incident. However, the evaluation made it clear that personnel needed training on the proper means to adjust each style of tilt-back cart, since each style has the potential to be inadvertently misadjusted, potentially resulting in loss of control of the Dewar. Dewar and cart vendor materials were reviewed to ascertain the proper procedures for use of the carts.

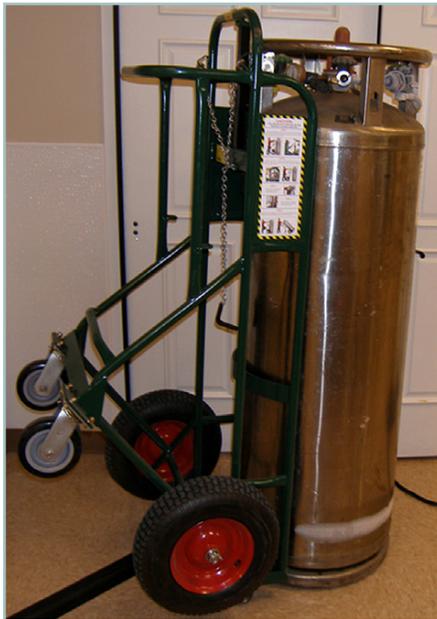
**Figure 1-3. Non-DOE Dewar and cart in pre-tipped configuration**

According to the operating procedure posted on the commercial transport cart, the hook height must be adjusted so that the hook is fully engaged through the lifting eye of the cylinder and is in contact with the top of the eye before tipping the cylinder. Figure 1-3 shows a cylinder loaded onto a cart before being tipped. Immediate post-event actions included pausing Dewar movements, instructing gas plant personnel to bring their own carts with them on deliveries to minimize movements by programmatic personnel, outfitting stationary carts

with a wheeled base where appropriate, procuring new carts to replace inferior units, reviewing and revising work control documents as appropriate, adopting a two-person rule for cart movement, and reviewing and revising cryogenic safety training course content.

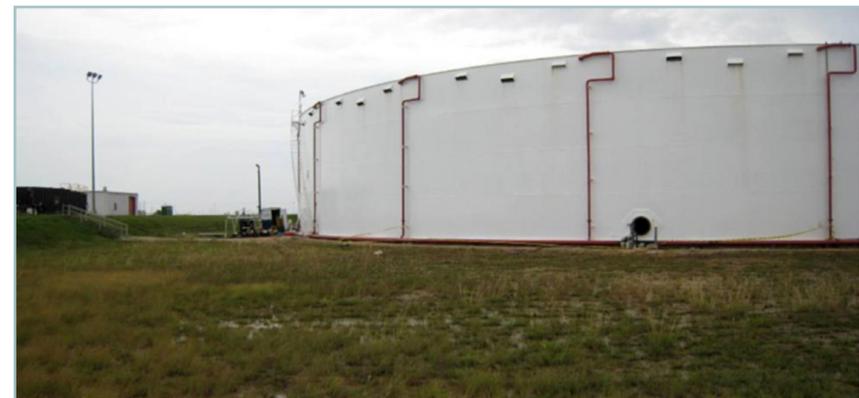
**Figure 2-2. Crude oil tank that was being cleaned**

On July 8, 2010, at the Department of Energy's (DOE) Strategic Petroleum Reserve (SPR) Bryan Mound Site, a subcontractor tank technician (Technician 1) suddenly collapsed while cleaning the floor of a 32-foot-high, 222-foot-diameter crude oil storage tank. The SPR Bryan Mound Site and the tank that was being cleaned are shown in Figures 2-1 and 2-2. The worker was using supplied air to protect against the possibility of inhaling hazardous materials (e.g., benzene in oil vapors) that could be stirred up by cleaning operations. Another tank

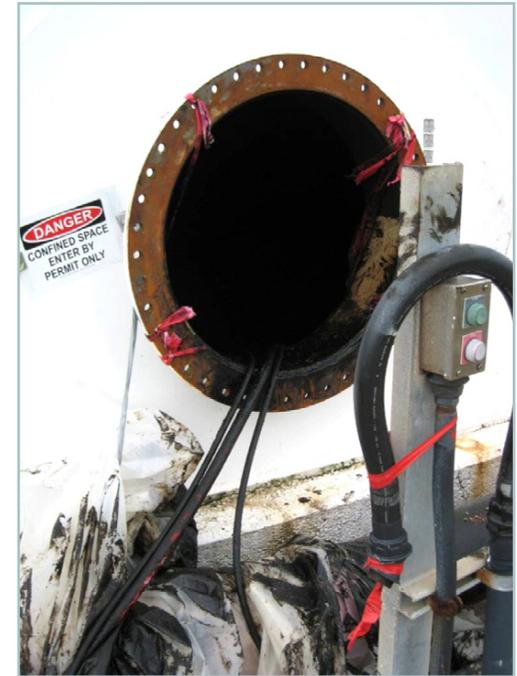
**Figure 2-3. Tank opening for workers' ingress/egress (posted as Confined Space)**

**Confined Space Safety Controls** – Although the tank was appropriately designated and controlled as a confined space, the IRB identified deficient practices and conditions. The method for communicating between tank entrants and the confined space attendant was not sufficiently reliable for the working conditions present in the tank. Communications between tank entrants and the attendant were limited to hand signals and a bull horn, and the relatively dim artificial lighting inside the tank reduced visibility. (Figure 2-3 shows the Confined Space posting at one of the openings used for workers' ingress/egress.)

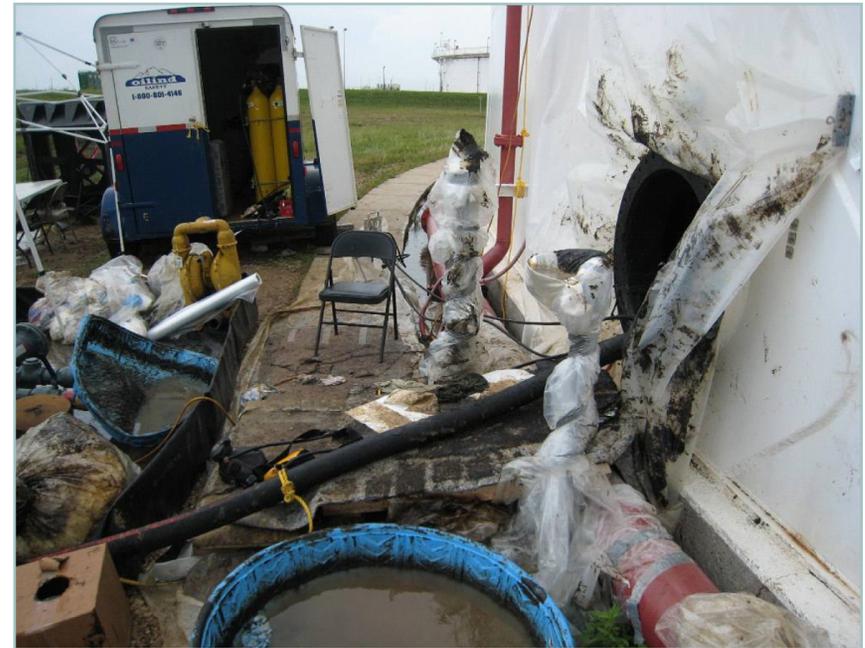
**Figure 2-4. Tank opening used by the subcontractor to feed air hoses to workers inside tank**

The IRB determined that most aspects of the emergency response process appropriately reflected applicable regulations and DOE requirements and that the emergency response was rapid and effective. However, the sequence of events following the incident indicated that there were a number of deficiencies in implementing site requirements and that onsite personnel were not fully prepared to respond to an incident of this nature. Among the IRB's findings were that workers inside the tank were not wearing retrieval harnesses as required and that the tank cleaning team had not trained and practiced a physical rescue from a confined space in accordance with site and regulatory requirements. (Figure 2-4 shows the outside of the tank.)

The IRB also determined that site ES&H, LLC (a subcontractor to AGSC) personnel were not sufficiently prepared for an emergency entry. For example, a self-contained breathing apparatus was available at the work site, but it was not pre-positioned or ready for use at the tank; nor was the protective equipment (e.g., latex gloves, eye protection) needed for the protection of rescuers pre-positioned and readily available. In addition, because responders were understandably focused on assisting Technician 1 as rapidly as possible and believed that the air quality was safe, one responder entered the tank for a very short time without the required respiratory protection equipment.
