OPERATING EXPERIENCE SUMMARY

U.S. Department of Energy
Office of Health, Safety and Security
OE Summary 2013-02
August 14, 2013

Fall Fatality While Installing Work Platform at Remote Bonneville Power Administration Project

Accident Investigation into Serious Injuries from Fall from Fixed Ladder at Brookhaven National Laboratory

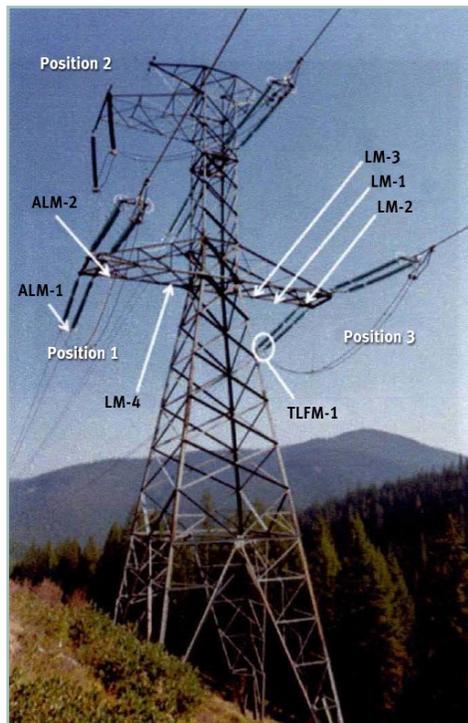
Figure 1-2. Positions of crew on tower 83/4

As the platform was being lowered, it was parallel to the power line but then rotated 90 degrees as it approached the tower. (Figure 1-3 shows relation of a platform to a similar tower.) The pilot was hovering and maneuvering to get the platform to turn parallel to the insulators when LM-1 decided to change work locations to help guide the platform. He unbelted and moved left behind LM-3 toward the center of the tower; LM-3 stated that he saw LM-1's hands grasping the structure on both sides of him when LM-1 was directly behind him, indicating LM-1 was still in control. However, as LM-1 moved farther left, he lost his footing and fell. The time was approximately 1102.

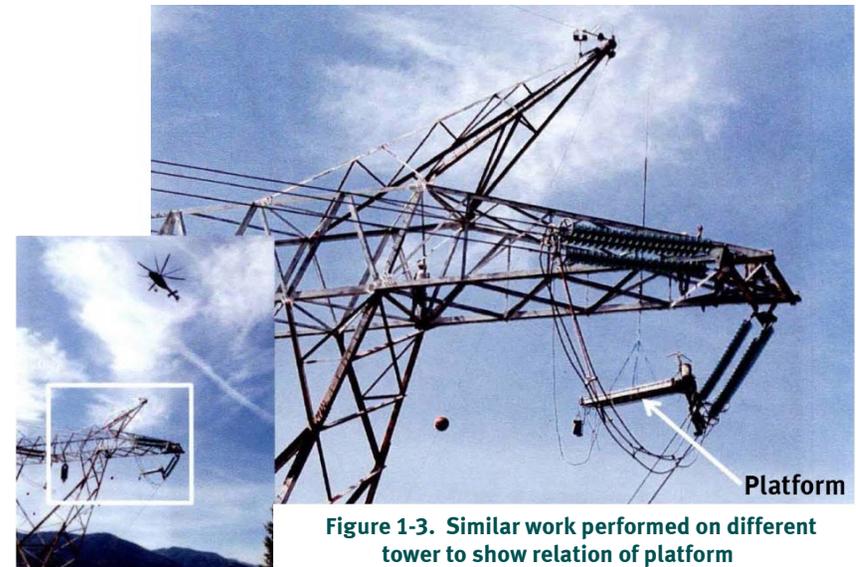
Figure 1-3. Similar work performed on different tower to show relation of platform

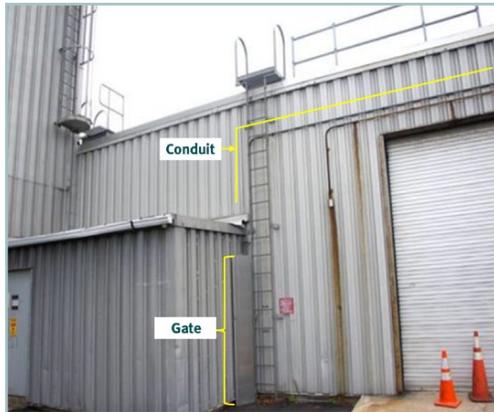
Figure 2-1. Current location of the fixed ladder showing gate and conduit

Two or more decades ago, a lockable side-hinged gate was installed to cover the bottom eight rungs of the ladder. The gate was intended to prevent access to the Lab 17 roof because of radiological exposure concerns during sample loading or removal in the building below. That exposure concern no longer exists, but the gate remains. In

addition, in 1992, a 1-inch rigid metal conduit was installed on the exterior of Lab 17 to carry power to a nearby storage area. That conduit starts next to the ladder, halfway up its 18-foot length, then turns to run horizontally and away.

In 1968 when the ladder was reinstalled, it was not inspected and did not comply with then-current ANSI A14.3-1956 codes. The Board determined that the ladder is noncompliant with OSHA requirements and/or ANSI standards in the following five areas.

- There is a non-uniform distance between the first rung and the pavement (i.e., not 12 inches).
- The ladder guard preventing access is mounted onto the left ladder rail and violates both ANSI A14.3-1956 and 29 CFR 1910.27, which requires a 15-inch clearance on either side of the vertical center line on a fixed ladder.
- The conduit installed behind the ladder in 1992 violates a 7-inch clearance requirement described in both ANSI A14.3-1956 and 29 CFR 1910.27.

- The top rung of the ladder is not flush with the platform.
- The height of the upper extension rails meets requirements, but the 36-inch width between them is not compliant.

- BSA needs to implement a comprehensive fixed-ladder inspection program that identifies deficiencies and ensures implementation of effective corrective actions. (JON 4)
