OPERATING EXPERIENCE SUMMARY

U.S. Department of Energy
Office of Health, Safety and Security
OE Summary 2013-03
November 19, 2013

Fall from Scissor Lift at Brookhaven National Laboratory Results in Serious Injuries

Accident Investigation: Contamination at Los Alamos Neutron Science Center Due to Deficiencies in Conduct of Operations

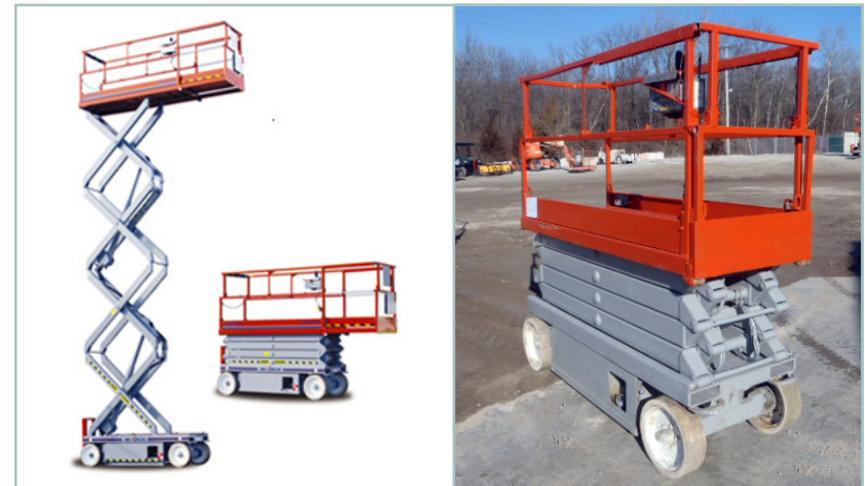
Neither worker inspected the scissor lift (similar to the ones shown in Figure 1-1 below) before use because each worker assumed that the other had done so. If one of the workers had performed the inspection, he would have discovered that pins designed to secure the guardrail from accidentally opening were missing. Both workers were qualified to use the lift and, therefore, knew of the requirement to perform a pre-use inspection; however, the responsibility for the inspection was not specifically assigned during the PJB.

Figure 1-1. Examples of extended and unextended Skyjacks

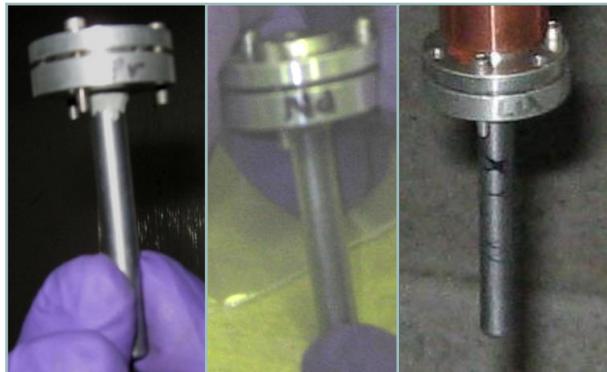
three screws was inconsistent with the safety review expectations and posed an increased risk of the canister seal failing (Figures 2-1 and 2-2).

Figure 2-1. Top of Neodymium Technetate sample canister showing three used screw heads and three unused screw holes

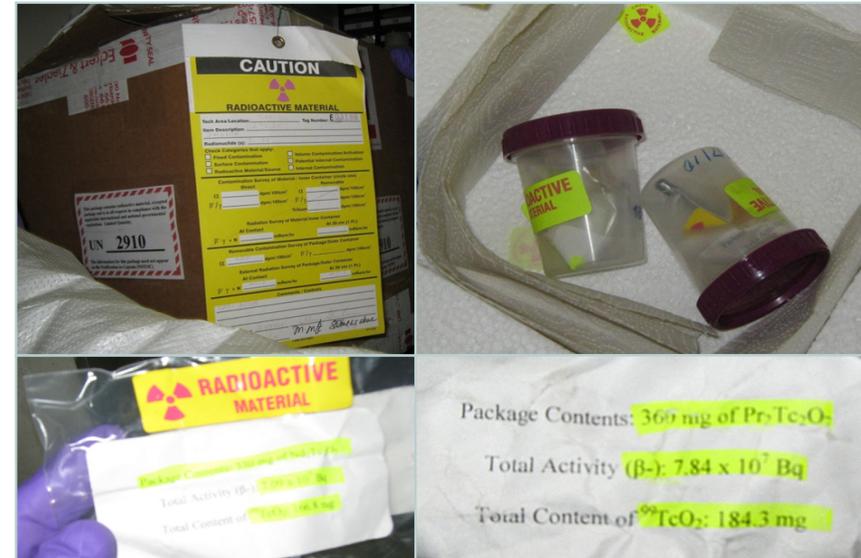
Figure 2-3. Sample canisters were shipped inside plastic bags, held inside plastic cups. The cups, bags, and box were all well marked to indicate their contents and that the contents were radioactive.

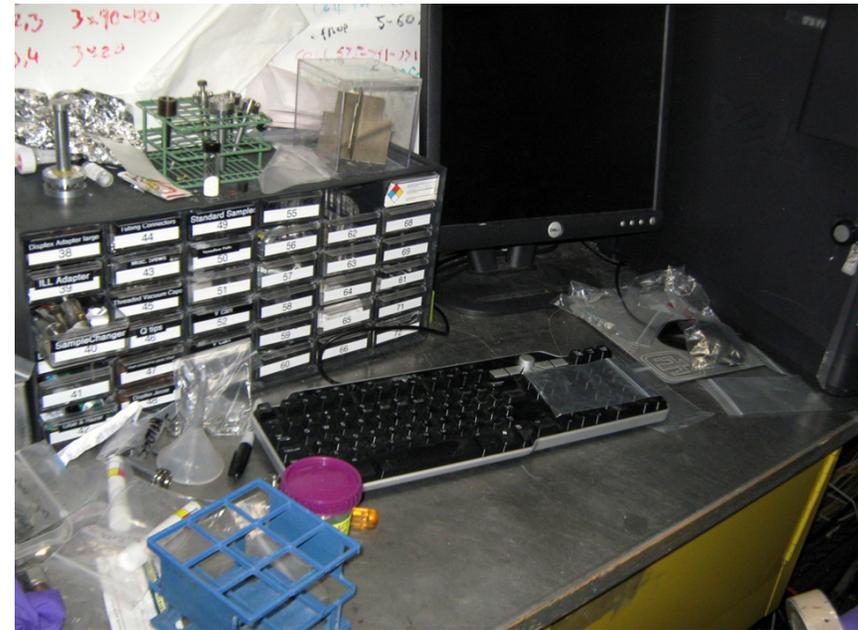
Figure 2-6. Work area/accident scene — Sample canisters are seen on top of supply cabinet and new sample canister/sample staged for preparation on desk.
