OPERATING EXPERIENCE SUMMARY

U.S. Department of Energy

OE Summary 2014-03

Wilson Construction Company Crew Foreman Receives Fatal Shock During Transmission Line Rebuild Project

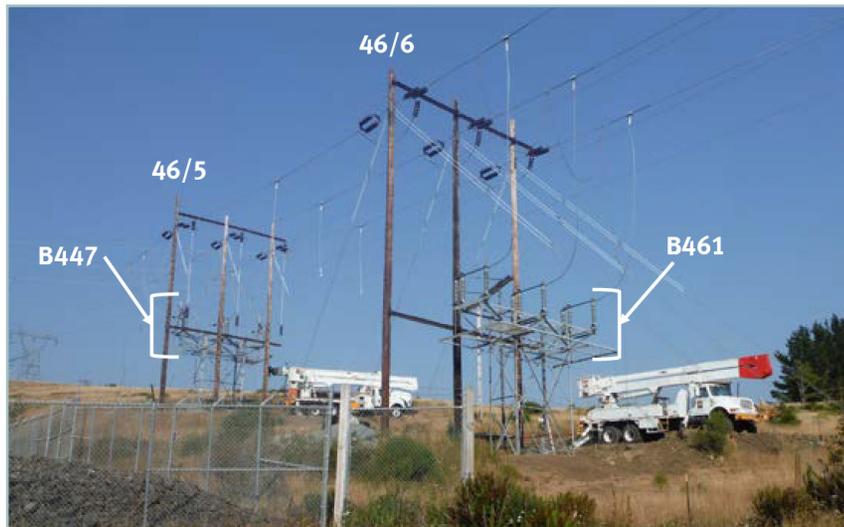
Figure 1-1. Geisel Monument Tap worksite

work: Crew 1 (CF-1, JL-1, and EO-1) at switch 46/6 and Crew 2 (CF-2, JL-2, and EO-2) at switch 46/5.¹ Figure 1-1 shows the Geisel Monument Tap worksite.

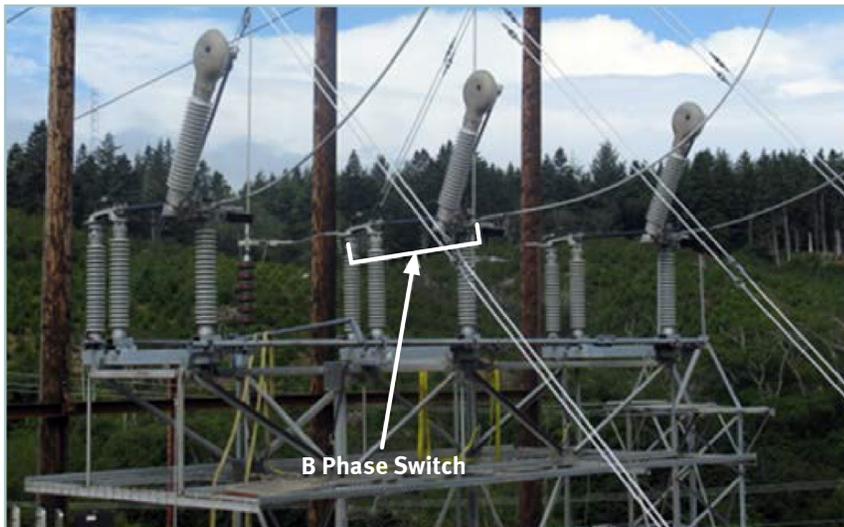
Figure 1-2. Structure 46-5

At approximately 0945, CF-2 made contact with a difference of potential across the blade end insulator stack and received an electrical shock. (Structure 46/5 Switch B447 is shown below in Figure 1-2).

The *direct cause* of an accident is the immediate event or condition that caused the accident. The Board determined that the accident's *direct cause* was that CF-2 made contact with a difference of potential across the blade end insulator stack.

order, fundamental causes that address classes of deficiencies rather than single problems or faults. The Board determined that the *root cause* of this accident was Crew 2's failure to establish an EPZ.

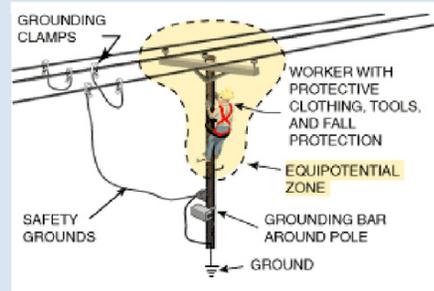
Figure 1-3. Establishing an equipotential zone or EPZ

An **equipotential zone** is a work zone in which the worker is protected from electric shock from differences in electric potential between objects in the work area. These differences in potential can be caused by induced voltage, line re-energization, or lightning.

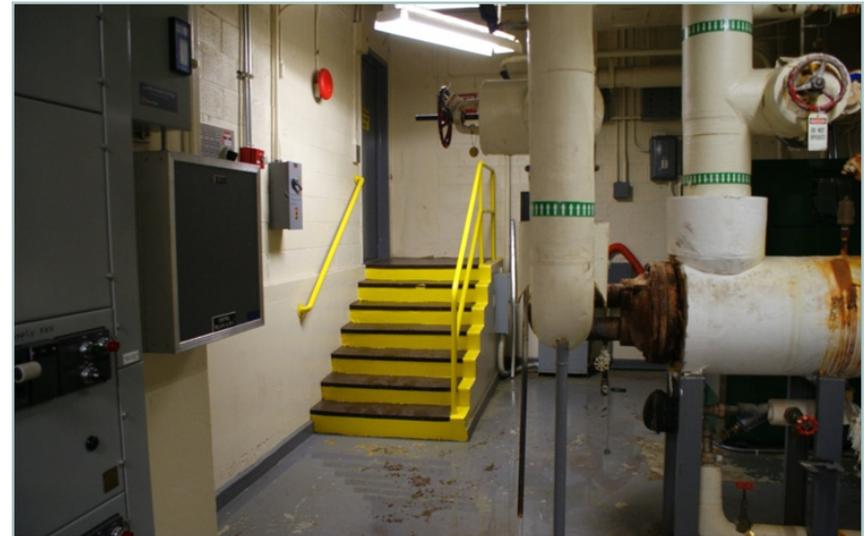
Figure 2-2. MER 7 entrance stairs

MER 7 using his cane. The floor and stairs were dry, the room was well lit, and most equipment was off, allowing normal conversation. (Figure 2-2 shows MER 7 stairs.) As the engineer and electrician proceeded into and across MER 7, FMS1 remained on the landing and gave them instructions.

- FMS1 may have fallen due only to his physical limitations.
- FMS1 may have caught his foot on the rail post at the top of the stairs because the toe board was missing. However, the position in which he landed at the bottom of the stairs suggests he did not fall from a higher level (i.e., the landing).
- FMS1 may have tripped on a torn stair tread cover.
- FMS1, leading with his cane, may have lost his balance on the bottom step because the rise of the last step was not consistent with the others and presented an unexpected condition.

4. Clear responsibilities and guidance did not exist for conducting oversight of the fitness-for-duty and return-to-work processes.
5. Management systems weaknesses existed because oversight of the fitness-for-duty and return-to-work processes and the Federal Employee Occupation Safety and Health program had not been conducted.
6. The MER 7 stairs were not in compliance with codes and standards, and were not in optimum condition for traversing.

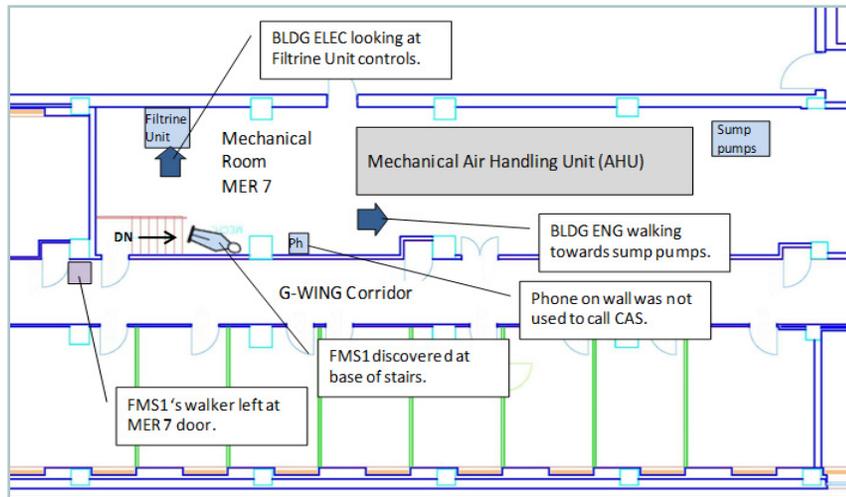
Figure 2-3. MER 7 floor plan showing location of accident victim

The electrician turned toward FMS1 when he heard a thud, saw he had fallen, and went to his aid; the engineer also turned toward FMS1 when he heard the electrician calling out FMS1's name. Both of them stated that FMS1 did not cry out or make any other noise as he fell. FMS1 was unresponsive, lying fully extended face down on the cement floor, his head away from the stairs, his left arm and hand up to his head, and his cane and right arm beneath him, all of which strongly suggested that he was at or near the bottom of the stairs when he fell. (Figure 2-3 depicts the MER 7 floor plan post-accident.)

The Board determined that the *direct cause* of the accident was that FMS1 fell while descending the stairs or transitioning from the stairs to the floor, striking his head on the floor and sustaining a fatal head injury. The location of his feet and body indicated that he had fallen at or near the bottom of the stairs and not at the top.
