OPERATING EXPERIENCE SUMMARY

OE Summary 2014-04

August 5, 2014

Scissor Lift Falls Over Inside Tank at Strategic Petroleum Reserve's West Hackberry Storage Site Resulting in Serious Injuries

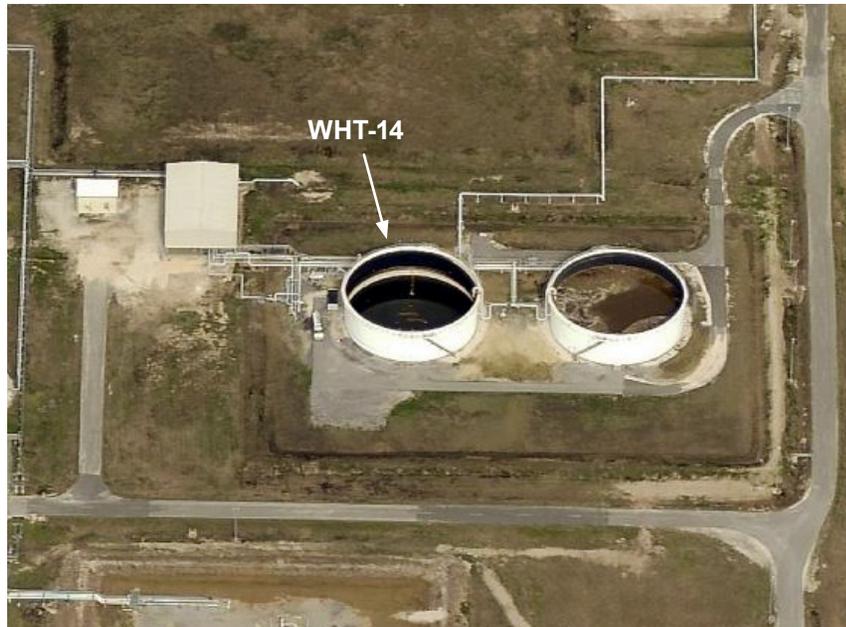
Figure 1-2. Brine tank where accident occurred

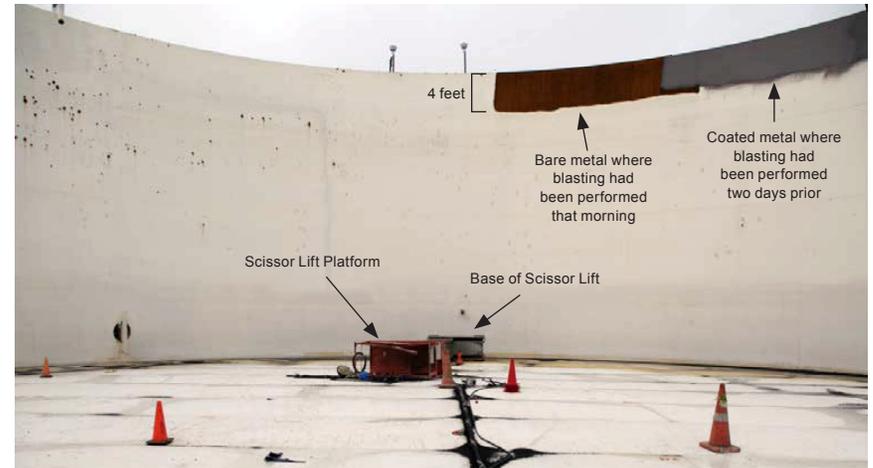
After less than an hour into work, the HW felt the blast hose supplying air and abrasive to Blaster 1 “pulse,” indicating that the nozzle had opened to begin blasting another section. He looked up to see Blaster 1 and the scissor lift falling to the floor and immediately sounded the air horn, the designated emergency signal, according to PBC procedures. The scissor lift came to rest extended toward the middle of the tank floor with Blaster 1 lying partially out of the platform guardrails, still attached to the platform by his fall protection harness (Figures 1-4 and 1-5).

Figure 1-4. Position of scissor lift in relation to completed paint blasting and coating at top 4 feet of tank

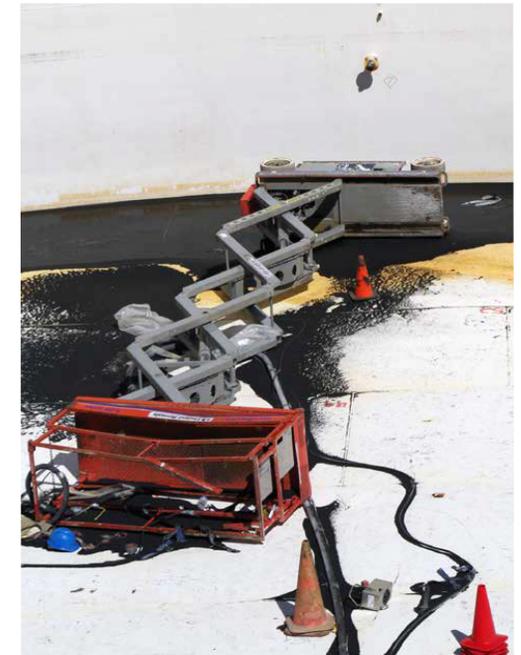
Figure 1-5. Scissor lift after the event

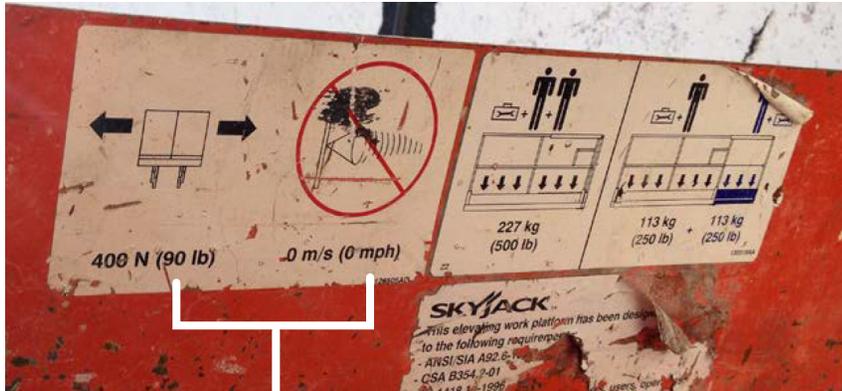
Figure 1-6. Manufacturer-applied label shows 0 mph wind and 90 lb side force limitations

Two other things added to the weight: the copper slag blasting material inside the hose and the Blaster's .75 inch outer diameter supplied breathing air hose. Force analysis calculations (provided in the architectural and engineering firm's report) demonstrated that the force exerted on the worker—and ultimately on the work platform—by the multiple forces when the “deadman” switch was depressed ranged from 184.55 pounds with no blasting media present to 470.32 pounds if the hose was full of blasting media. The Side Force Limitation labels clearly posted and visible on the scissor lift warned that winds must not exceed 0 miles per hour and **side force must not exceed 90 pounds.**

- The JSA did not identify hazards associated with abrasive blasting work from a scissor lift, specifically the lateral force restriction.
- Information regarding the lateral force restriction specific to the scissor lift was available in both the operating manual located in a holder on the scissor lift and on a warning label attached to the scissor lift, but that restriction was not incorporated into work controls.

- Contractors must ensure that subcontractors review, understand, and incorporate equipment-specific operator manual and label requirements into work control documents and practices.

- Subcontractors must ensure that equipment-specific operator manuals and label requirements are appropriately reviewed, understood, and incorporated into work control documents and practices.

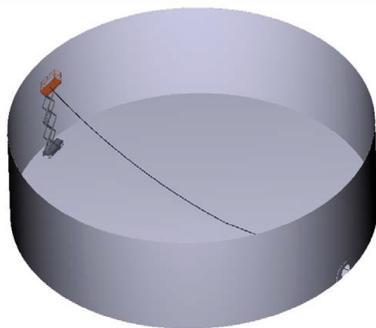
Of crucial importance to the Board's analysis was the determination of the length of hose that was suspended above the tank floor. The Board suspected that a significant portion of the blasting hose was in the air and was being supported by the work platform just before the accident, putting significant force on the platform's guardrails. The Board employed an architectural and engineering (A&E) firm to assist in the re-creation of the position of the hose and work platform during blasting. Computer-aided design was then used to determine that 43 feet, 7 inches of hose length lay on the tank floor, leaving 67 feet, 5 inches supported by the scissor lift platform guardrail. The A&E firm was then able to develop a three-dimensional mockup of the lift and blast hose configuration prior to the lift toppling (Appendix E, Attachment E.3 of the Accident Investigation Final Report). These findings support the Board's theory that a significant portion of the blast hose was suspended above the tank floor and thus contributed to the accident (Figure 1-7).

Figure 1-7. 3-D rendering of scissor lift and hose prior to the accident, depicting the length of hose and resulting pull

Lifts are top-heavy particularly when extended and as a result, weight must be at the bottom. Wind of any velocity or a lateral force exceeding 90 pounds can topple the lift. The base of the scissor lift (right wheel) was 105 feet from the service entrance. The middle work platform guardrails (where the hose attached to the lift) were 26 feet from the base of the wheels. Trigonometry was used to calculate the distance and arc, enabling an engineering firm to develop a three dimensional mockup of the lift and blast hose configuration. Based on the calculations and mockup, it was determined that a significant portion (67 feet 5 inches) of the heavy hose was suspended, putting weight on the lift that exceeded safe limits.

to the work platform guardrails, and the blasting operation, ranged from 184.55 pounds (no media present) to 470.32 pounds (hose 100 percent full of media). *All calculations resulted in amounts far exceeding the maximum posted load of 90 pounds.*
