OPERATING EXPERIENCE SUMMARY

OE Summary 2014-06

December 16, 2014

Truck Fire Underground at the Waste Isolation Pilot Plant

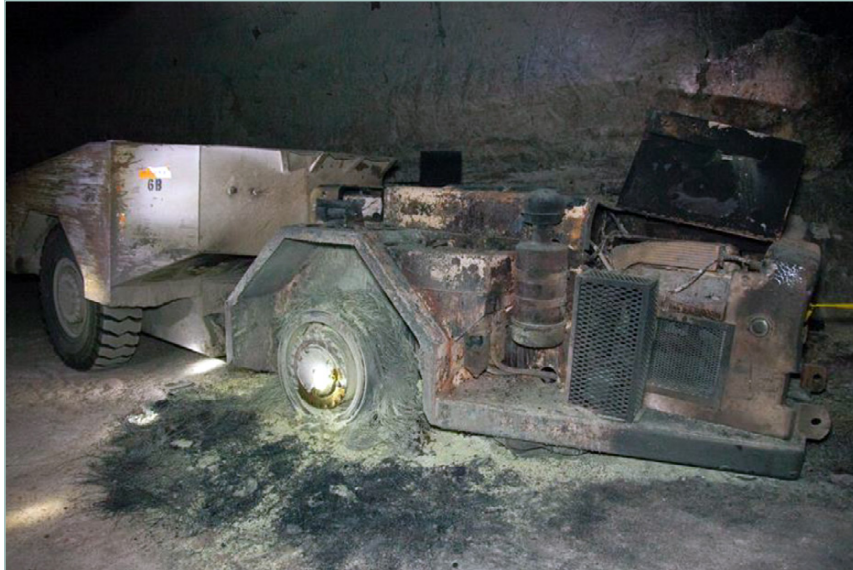
Figure 1-3. Truck after the fire

The fire, which burned the engine compartment and consumed the front tires, created a significant amount of smoke and soot. The Facility Shift Manager (FSM) on duty instructed the CMRO to change the ventilation to filtration mode, believing it would reduce both fire and smoke, but it had the opposite effect. Air flow changes as well as the smoke contributed to the confusion.

Direct cause is the immediate event or condition(s) that caused the accident. The Board identified the direct cause of this accident to be contact between flammable fluids (either hydraulic fluid or diesel fuel) and hot surfaces (most likely the catalytic converter) on the salt haul truck.

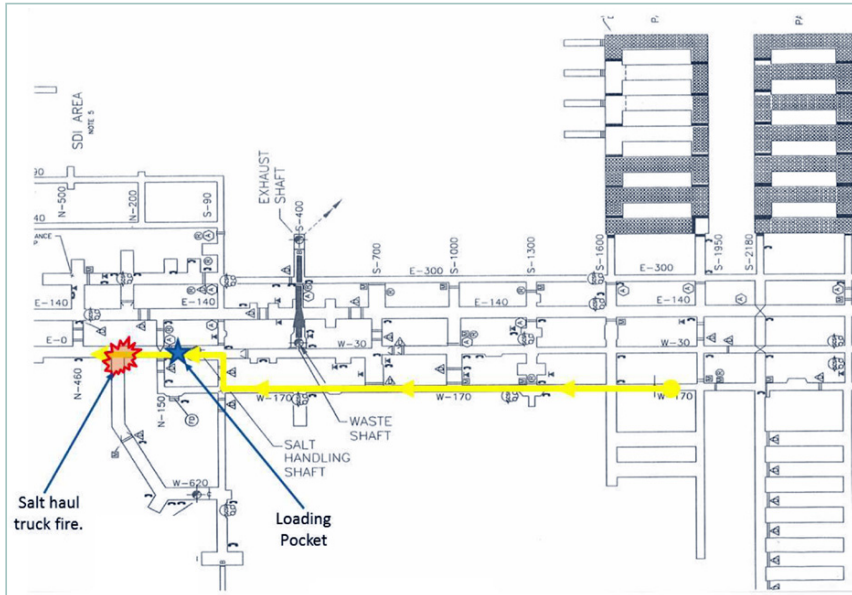
Figure 1-4. Map of the underground showing location of the truck fire

The first evacuation of workers via the waste hoist was made at about 1100 hours. At that time, the CMRO notified the MSHA of the event and the State Mine Inspector and activated the Mine Rescue Team (MRT). Within the next half hour, all 86 underground workers were successfully evacuated via the waste hoist. Six workers were examined and taken to the Carlsbad Medical Center with possible smoke inhalation; seven additional workers were examined onsite, but required no medical attention. In accordance with its Memorandum of Understanding with DOE, MSHA arrived to provide support. By evening, the MRT had entered the underground to perform air monitoring and noted that the fire was out. The layout of the underground is depicted in Figure 1-4.

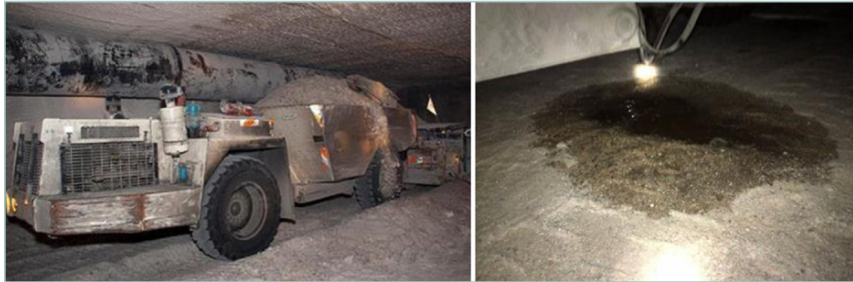
Figure 1-5. EIMCO Haul Truck 74-U-006A (similar to burned truck) and hydraulic fluid leak

Routine maintenance for the salt haul truck is not included in the facility procedures. Poor maintenance can affect engine performance, resulting in higher than normal operating temperatures. The Board determined that there is a significant difference between the preventive maintenance prescribed in the service manuals and what is actually performed. In addition, a decision was made to discontinue the truck wash station without sound engineering judgment because of difficulty in disposing of wash water. The contractor opted instead to use compressed air to clean vehicles, which inhibited maintenance personnel's ability to find and fix leaks and other problems. This resulted in a buildup of combustibles. The Board also discovered that, although the salt haul truck was built to use a fire-resistant fluid in the hydraulic oil system, standard hydraulic fluid was used. Poor maintenance was visible elsewhere; for example, there was a 3-foot puddle of hydraulic fluid under the truck shown in Figure 1-5 (the same model and year as the truck that caught fire).

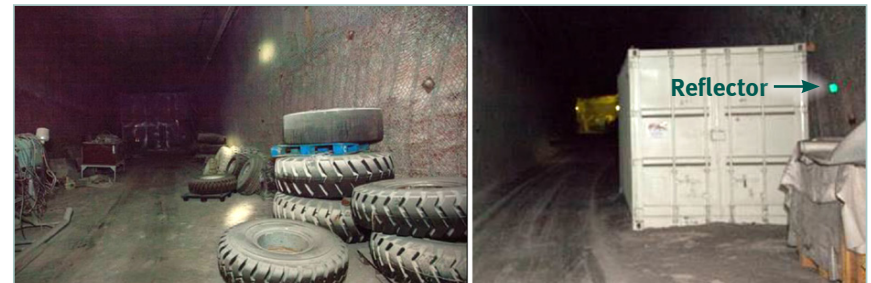
Figure 1-6. Combustible loading in the drifts and an obscured reflector

ing in the underground not only contributed to combustible loading concerns, but also added to the confusion and impeded evacuation paths. Red and green reflectors that indicated where to proceed were not effective because they were not consistently located; some were obscured under mesh fencing, and others were hidden behind stored materials.

Underground combustible material storage and good house-keeping are components of any good fire protection program, but external reviews have identified long-standing deficiencies in this area at WIPP. Not only large equipment, but also materials exceeding the 5-megawatt combustible limit are stored on both sides of the drifts. In addition to exceeding combustible loading limits, this condition impedes rapid egress and obscures reflectors. Figure 1-6 shows combustible loading in the drifts and an obscured reflector.

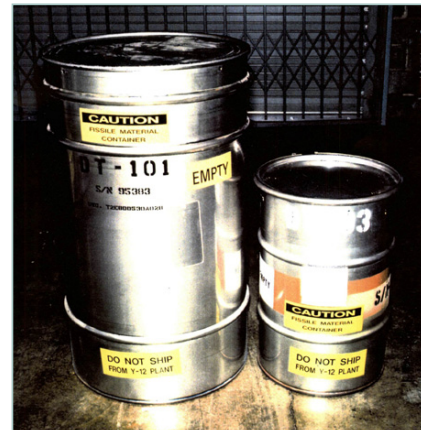
Figure 2-1. DT-101 container (left) and DT-103 container (right)

Specifically, pallets were found with DT-103 30-gallon containers stacked on top of DT-101 80-gallon containers (Figure 2-1). The Criticality Safety Approval (CSA) for this storage operation had recently been revised to allow other 30-gallon containers for stacking, but not the DT-103 container. A second infraction was for intermingling DT-100 and DT-100A 55-gallon containers (Figure 2-2). These containers were identical (with the exception that the DT-100 containers were painted black), but intermingling was not authorized in the approved CSA.

All production fissile operations were curtailed to facilitate walkdown of all CSAs to look for similar conditions. Over the next 5 days, 1,344 other CSA noncompliances were identified; 74 percent were administrative, involving no loss of criticality safety controls. Twenty-six percent involved loss of a control, but double contingency was not violated. The bulk of the non-

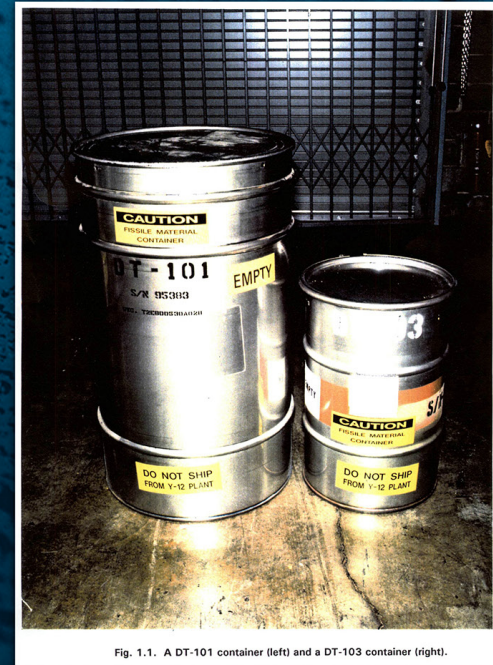
Fig. 1.1. A DT-101 container (left) and a DT-103 container (right).

September 1994: The Defense Nuclear Facilities Safety Board identified a criticality safety approval (CSA) infraction
