U.S. DEPARTMENT OF  
**ENERGY**

Legacy  
Management

# 2014 Annual Site Inspection and Monitoring Report for Uranium Mill Tailings Radiation Control Act Title II Disposal Sites

November 2014

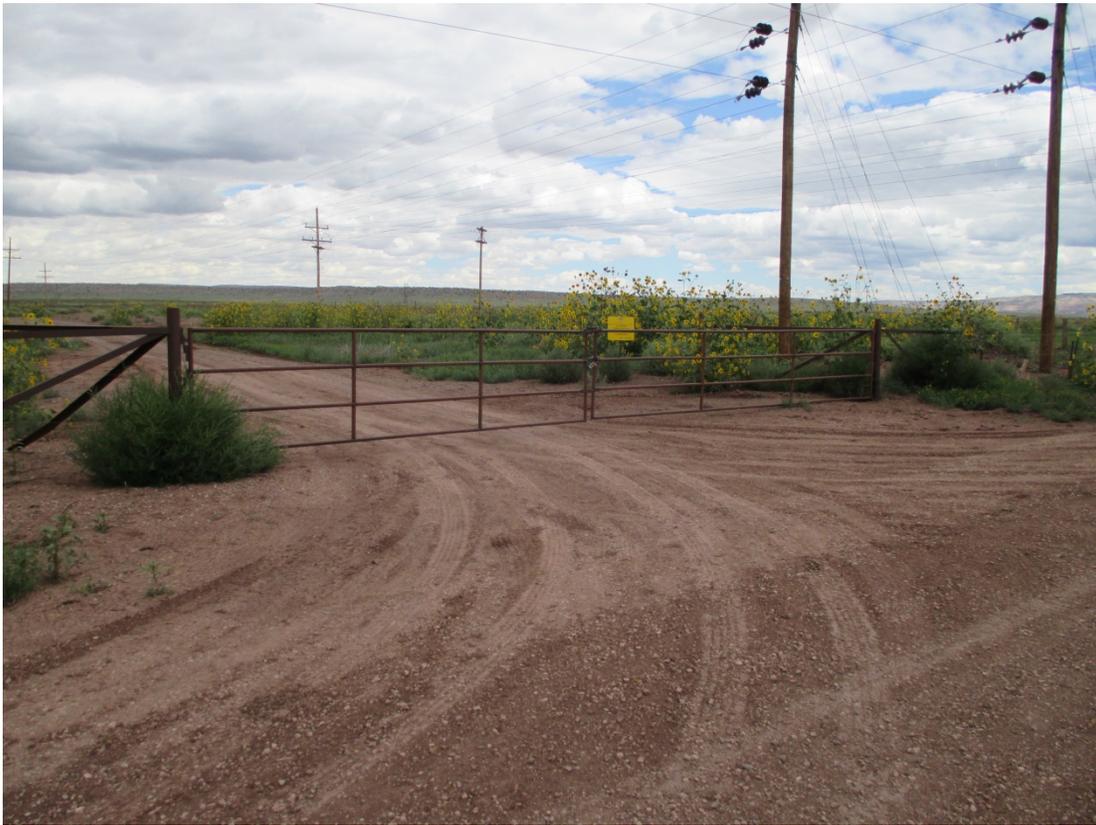
Access to the site is directly off gravel-surfaced Cibola County Road 63; no private property is crossed to gain site access. The entrance gate is a tubular steel, double-swing gate. The gate is secured by a chain and locks belonging to DOE and the various utility companies that have rights-of-way across the site. The gate was locked and in good condition (PL-1).

*BLU 8/2014. PL-1. Site entrance gate.*

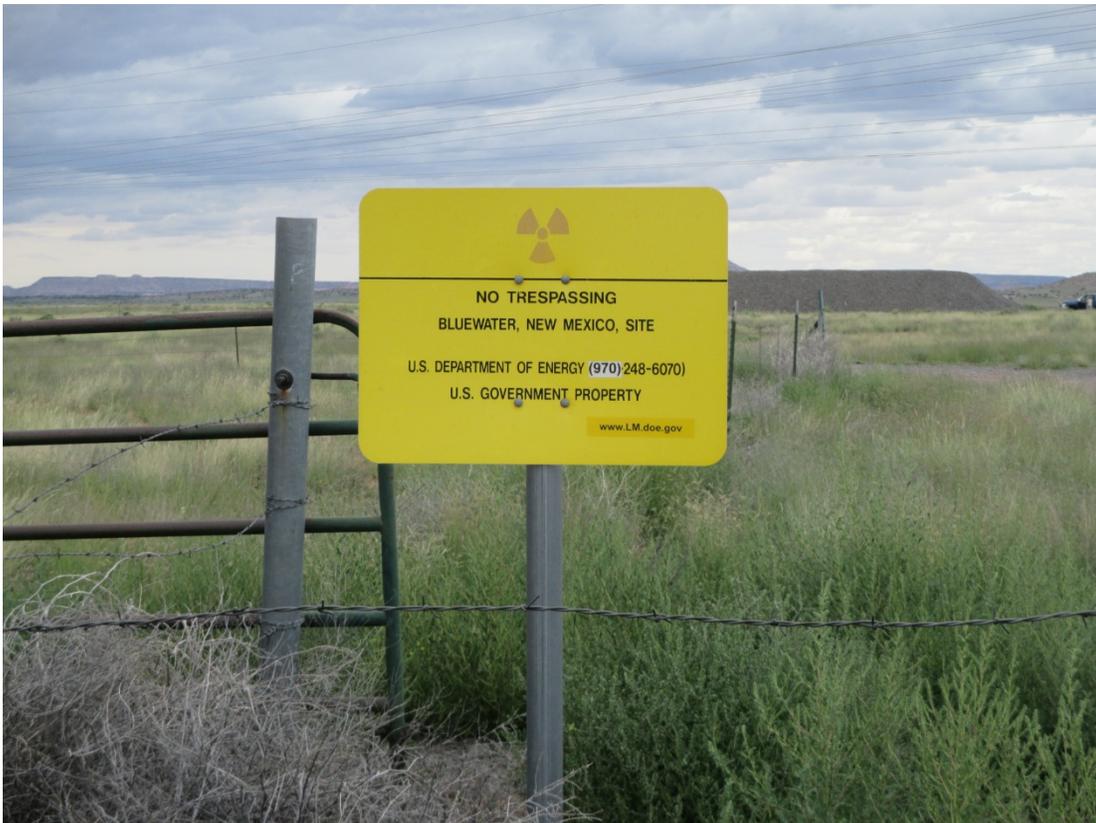
Fifty-five warning signs, referred to as perimeter signs, are mounted on steel posts along the site boundary and around the main and carbonate tailings disposal cells. Perimeter signs P3 and P10 have gunshot damage but are still legible. All other observed signs were in good condition (PL-2).

*BLU 8/2014. PL-2. Perimeter sign P2.*

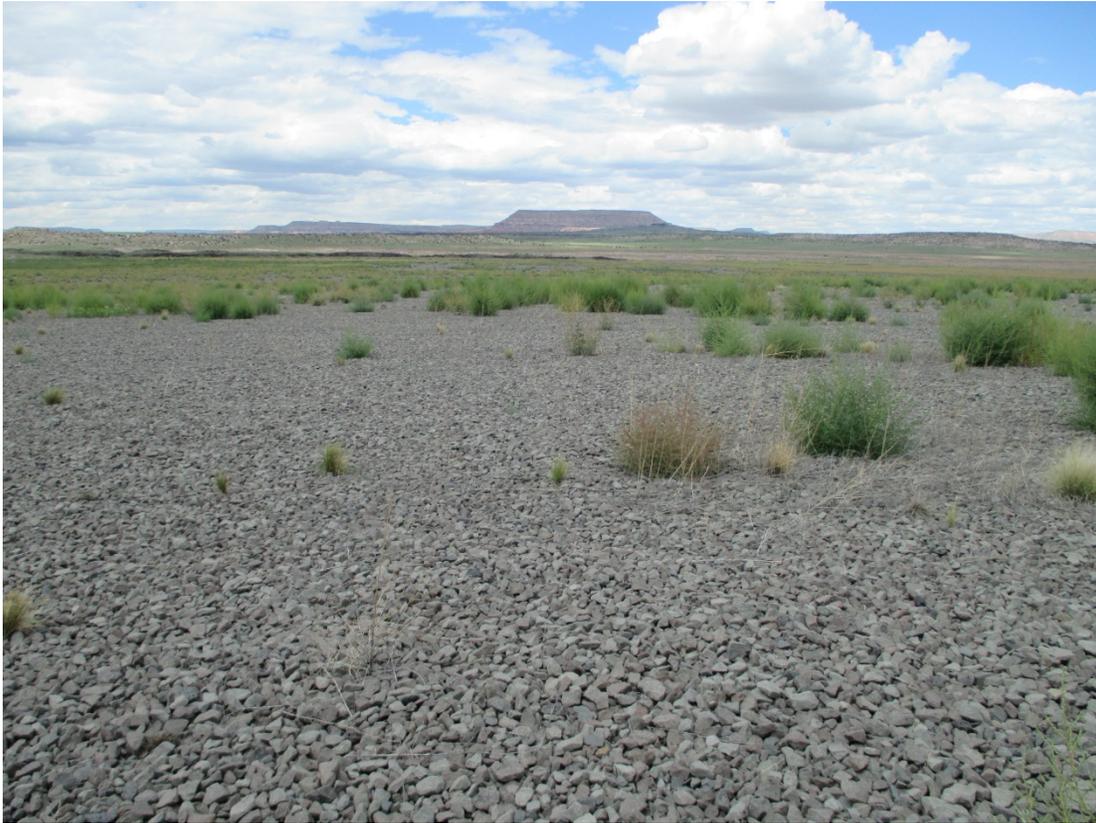
Plant encroachment (annual weeds, perennial grasses and forbs, and scattered perennial shrubs) continues on the cell cover and side slopes (PL-7). Saplings of Siberian elm have been present on the cell cover and are periodically cut and their stumps are treated with herbicide; several saplings were observed during the inspection and were treated with herbicide.

*BLU 8/2014. PL-7. Vegetation on main tailings disposal cell top slope.*

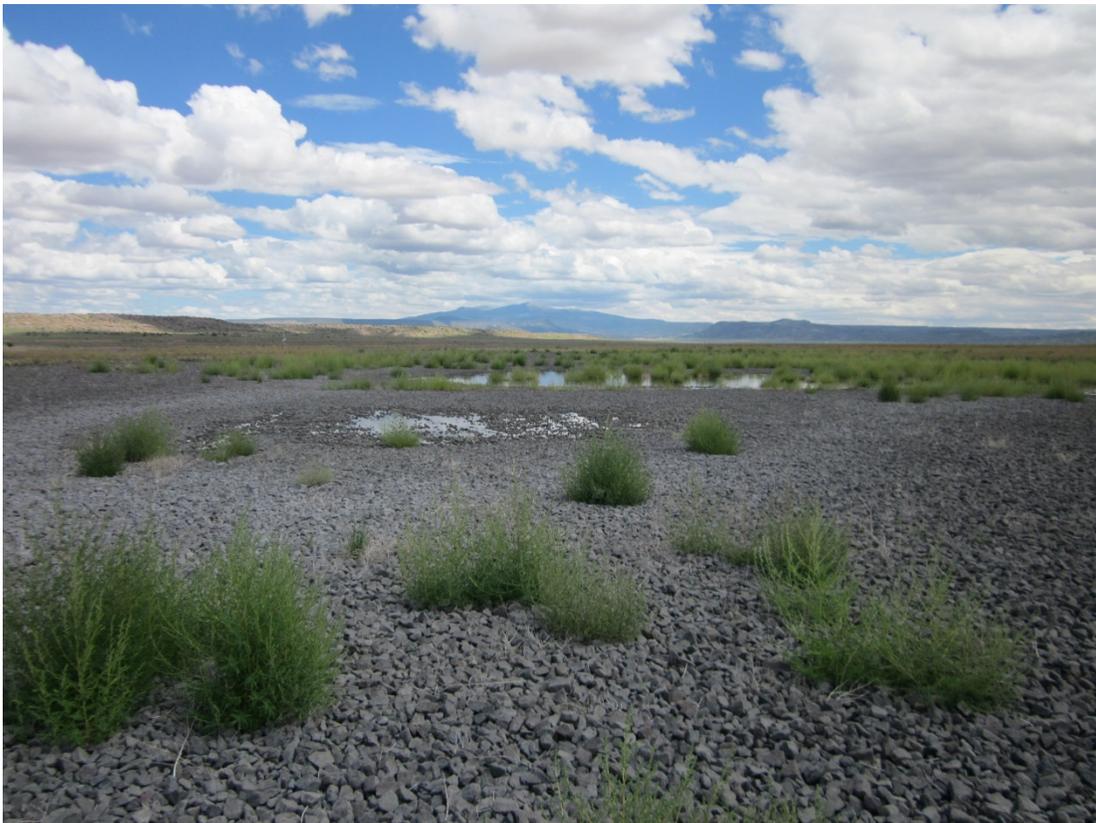
Several shallow depressions exist on the relatively flat north end of the top slope of the main tailings disposal cell and along the east and northwest edges of the cover. Ponds often develop in the depressions after rainfall events, and some of the depressions had standing water at the time of the inspection (PL-8). Because of a concern that the ponds were degrading disposal cell performance, NRC requested DOE to evaluate the performance of the radon barrier. Radon flux measurements on top of the radon barrier in the area of depressions were collected in July 2013. All radon measurements were below the detection limit, indicating that the radon barrier in that portion of the disposal cell is performing as designed. Results of the investigation will be used to determine, in consultation with NRC, if additional monitoring or cover enhancements are necessary.

*BLU 8/2014. PL-8. Ponded water in shallow depressions on main tailings disposal cell top slope.*

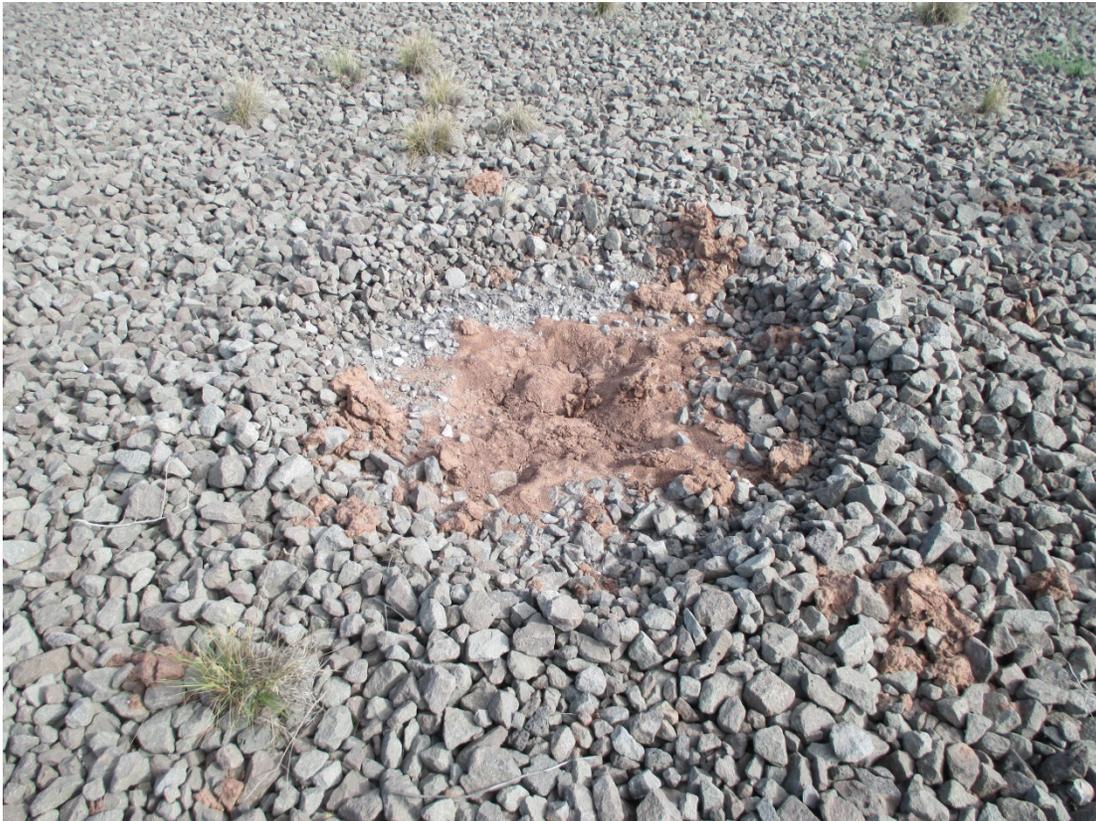
The top surface of the radon barrier was exposed in a very small area of the cell cover (PL-10). Apparently an animal scraped away the thin rock cover to expose vegetation. The rock cover was repaired in September 2014.

*BLU 8/2014. PL-10. Exposed radon barrier surface on carbonate tailings disposal cell top slope.*

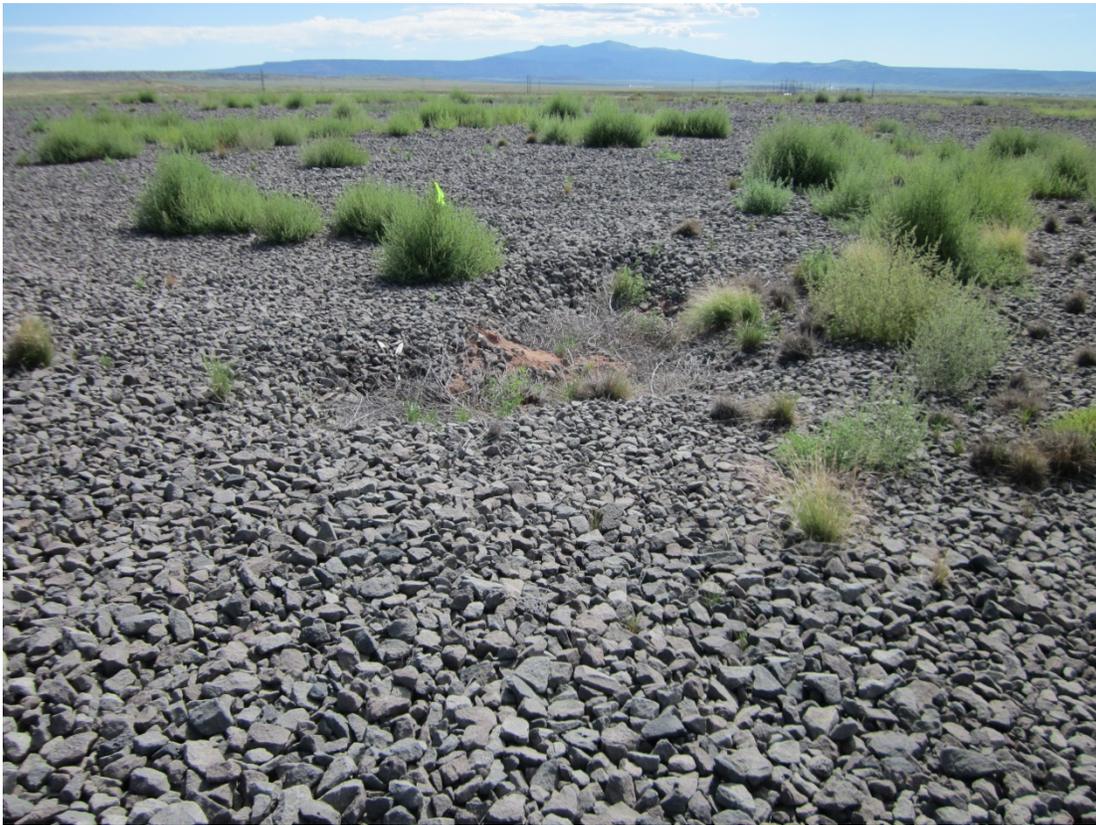
**1B** A small depression a couple of feet deep in the south portion of the top slope was noted for the first time during the inspection (PL-11). The depression was repaired in September 2014. It was apparent that radon barrier material had been placed over basalt boulders at that location. The material eventually filtered into spaces between the boulders causing a small collapse in the surface. No tailings materials were exposed in the depression. During repair activities, the cover rock was removed from the depression and radon barrier material was added to the depression in compacted lifts. The cover rock was replaced after the radon barrier surface matched the surrounding surface.

*BLU 8/2014. PL-11. Depression on top slope of carbonate disposal cell.*

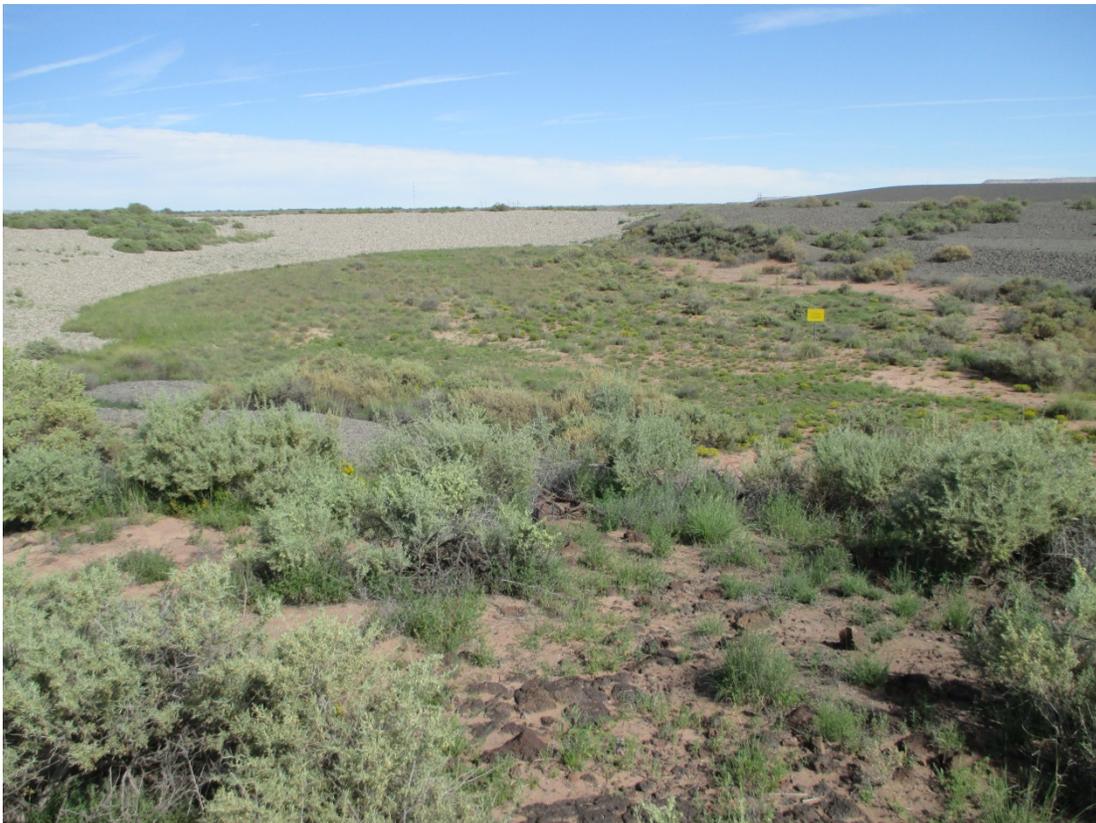
**1C** The 2-acre asbestos disposal area is a bowl-like feature just south of the carbonate tailings disposal cell (PL-12). The north, west, and south side slopes of this feature are covered by limestone riprap; the bottom of the bowl (the asbestos cell cover) is grass-covered. Four small depressions were noted around the perimeter of the disposal area and were subsequently repaired in September 2014 by filling them with small-diameter rock. The depressions formed when

*BLU 8/2014. PL-12. Asbestos disposal area.*

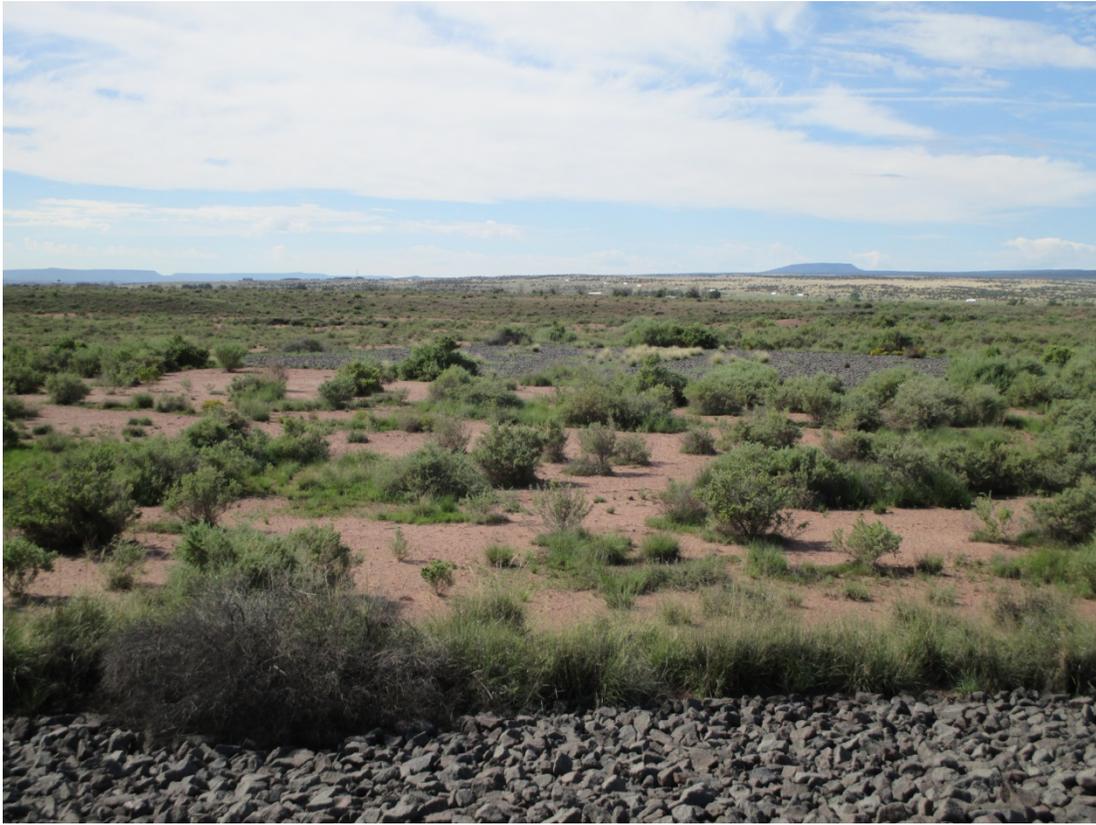
The 11-acre grass-covered disposal area south of the asbestos disposal area was in excellent condition, as was the small riprap-covered PCB cell located within the disposal area (PL-13). The two grass-covered landfills east of the carbonate tailings disposal cell, totaling about 2 acres, were in excellent condition (PL-14).

*BLU 8/2014. PL-13. Cover of PCB disposal area.*

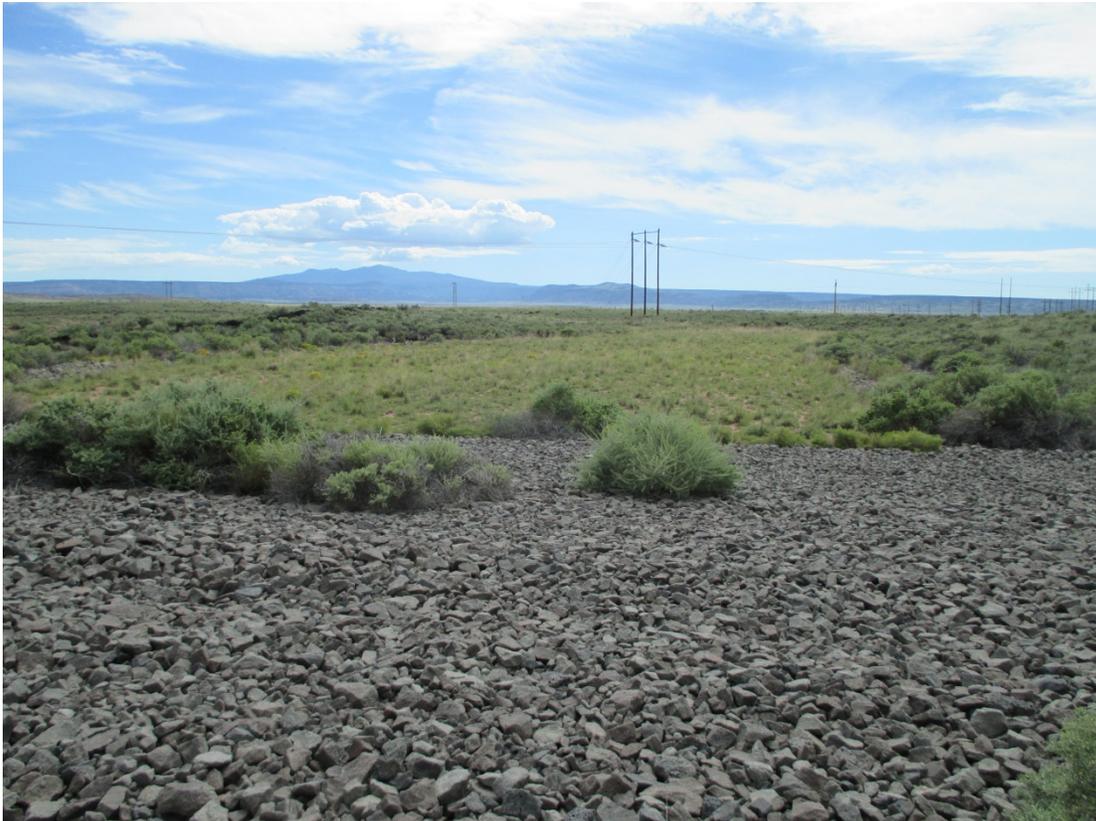
*BLU 8/2014. PL-14. East landfill.*

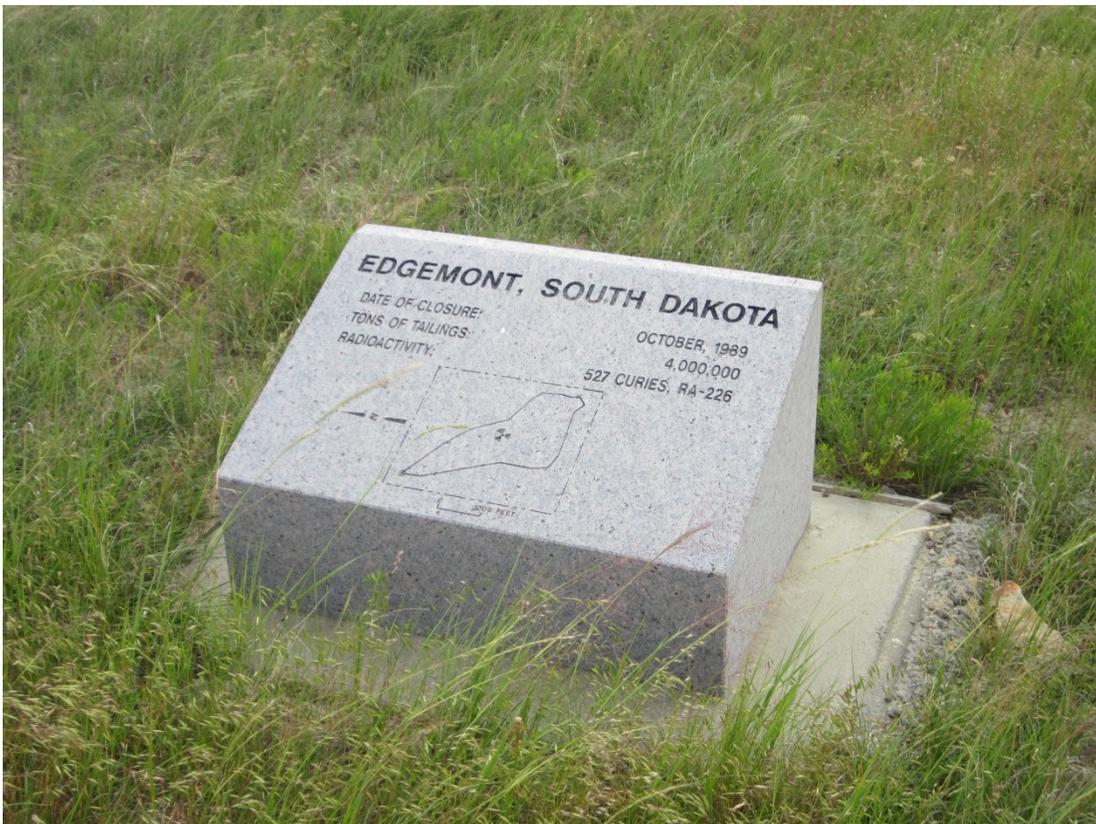
One granite site marker identifying the site is just inside the entrance gate and was in excellent condition (PL-2).

EDG 7/2014. PL-2. Site marker.

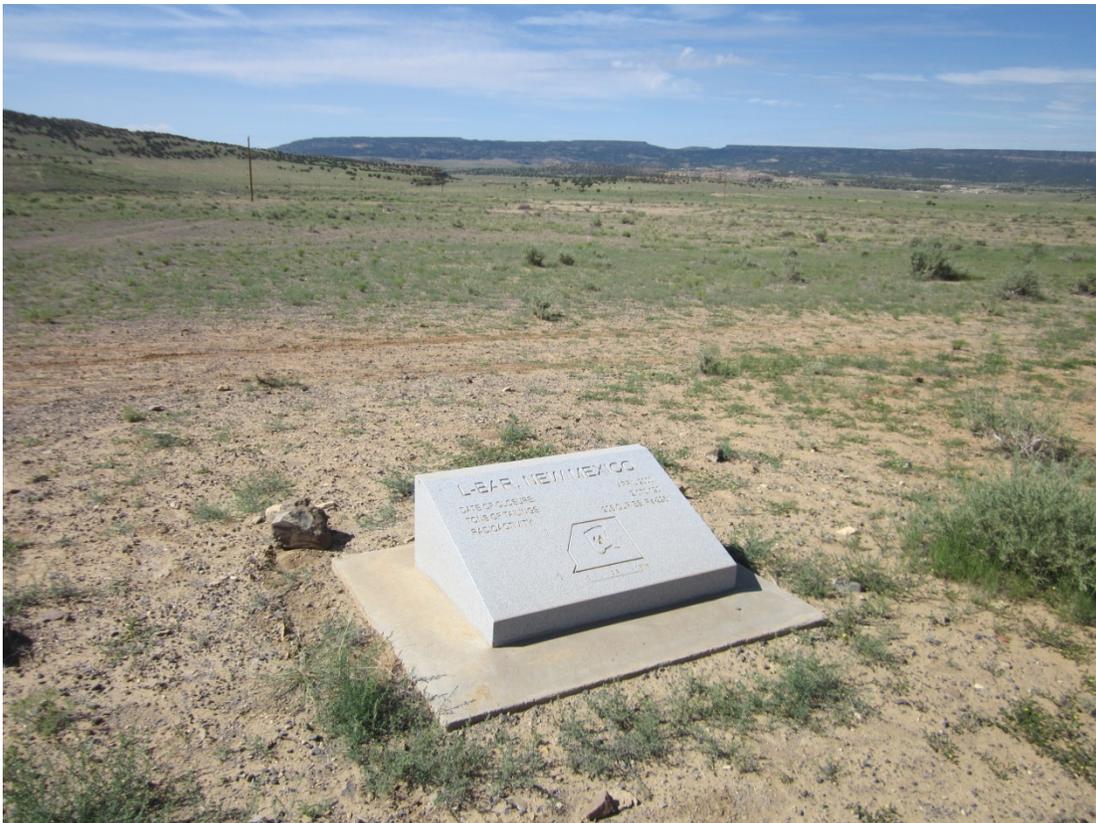
A granite site marker is located north of the disposal cell adjacent to the site access road. The marker was in excellent condition (PL-4).

*BAR 8/2014. PL-4. Site marker.*

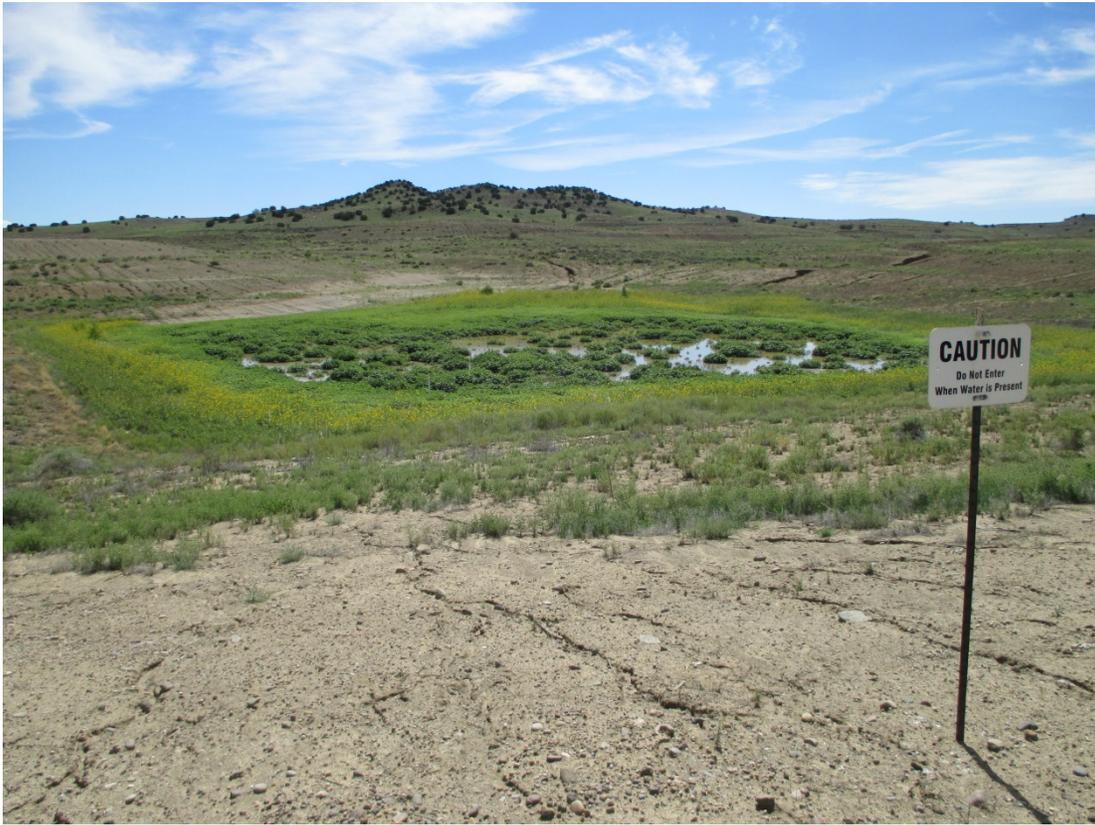
*BAR 8/2014. PL-9. Vegetation and standing water in sediment trap.*

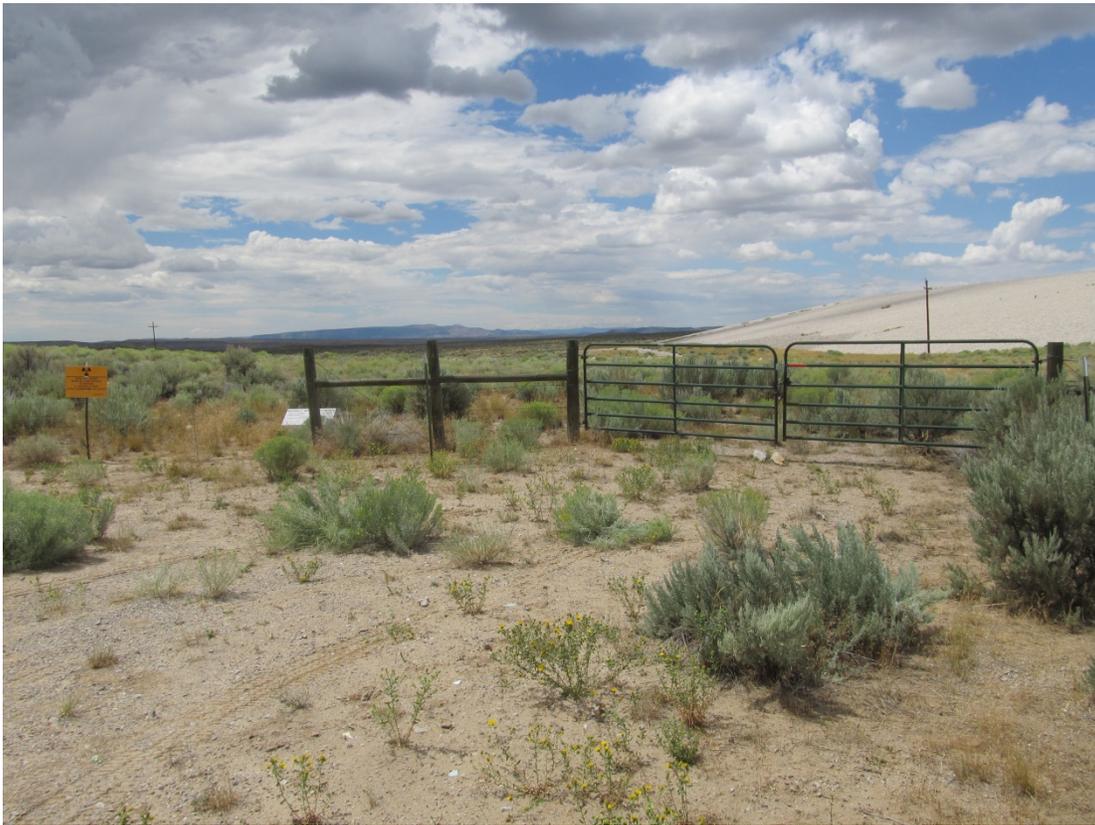
The entrance sign is mounted on a perimeter fence metal t-post directly south of the entrance gate (PL-1). The entrance sign was in good condition.

MAW 8/2014. PL-1. Entrance gate, entrance sign, and site marker (disposal cell in background).

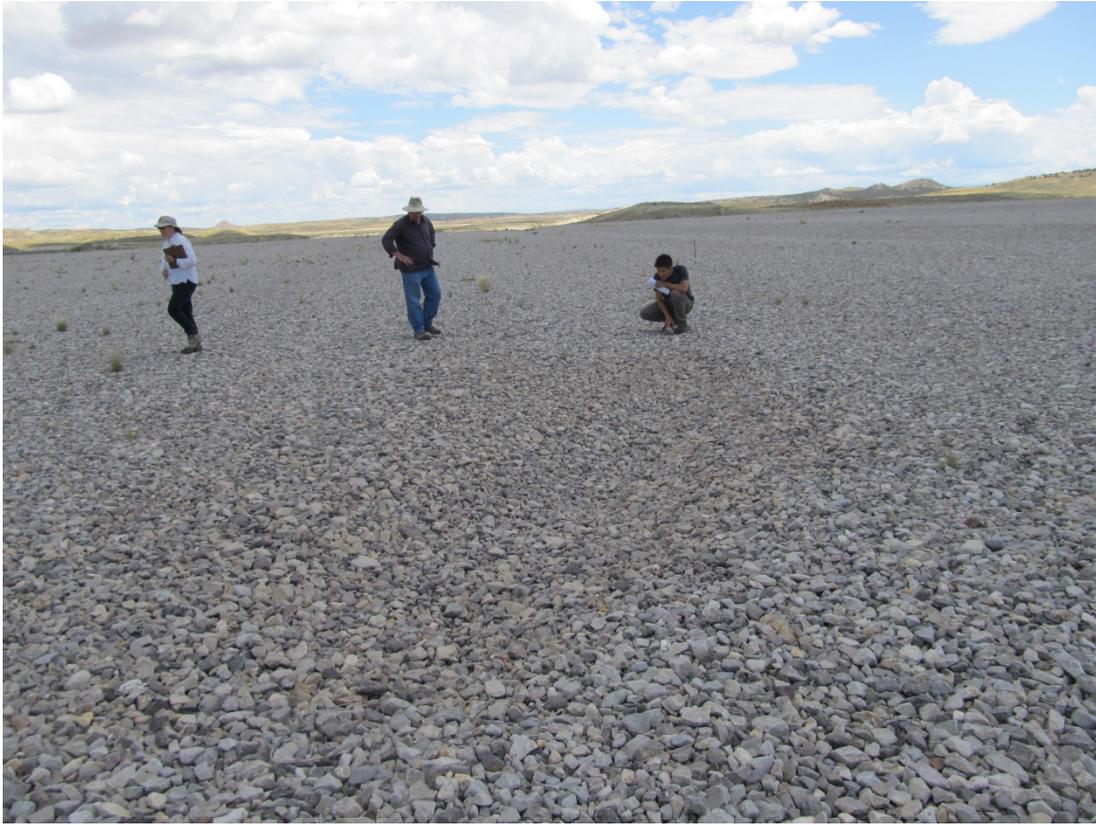
*MAW 8/2014. PL-7. Shallow depression on top of disposal cell.*

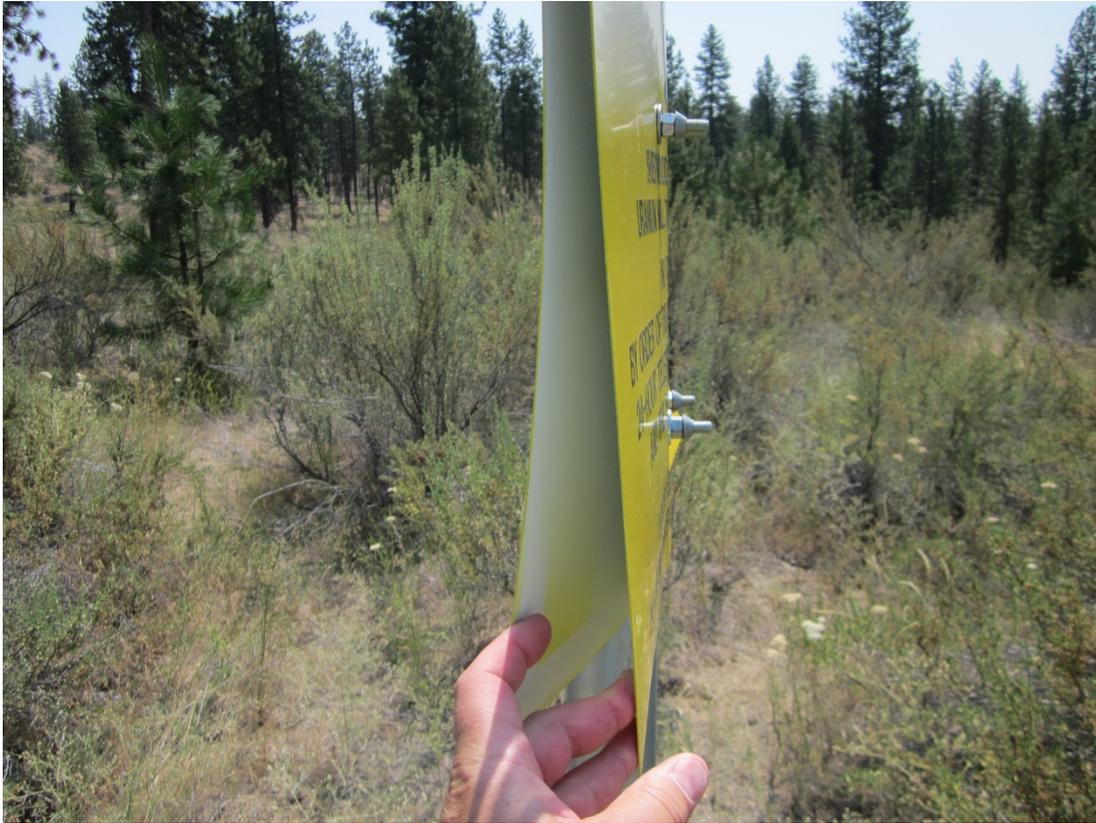
*SHE 7/2014. PL-1. Damaged perimeter sign P2.*

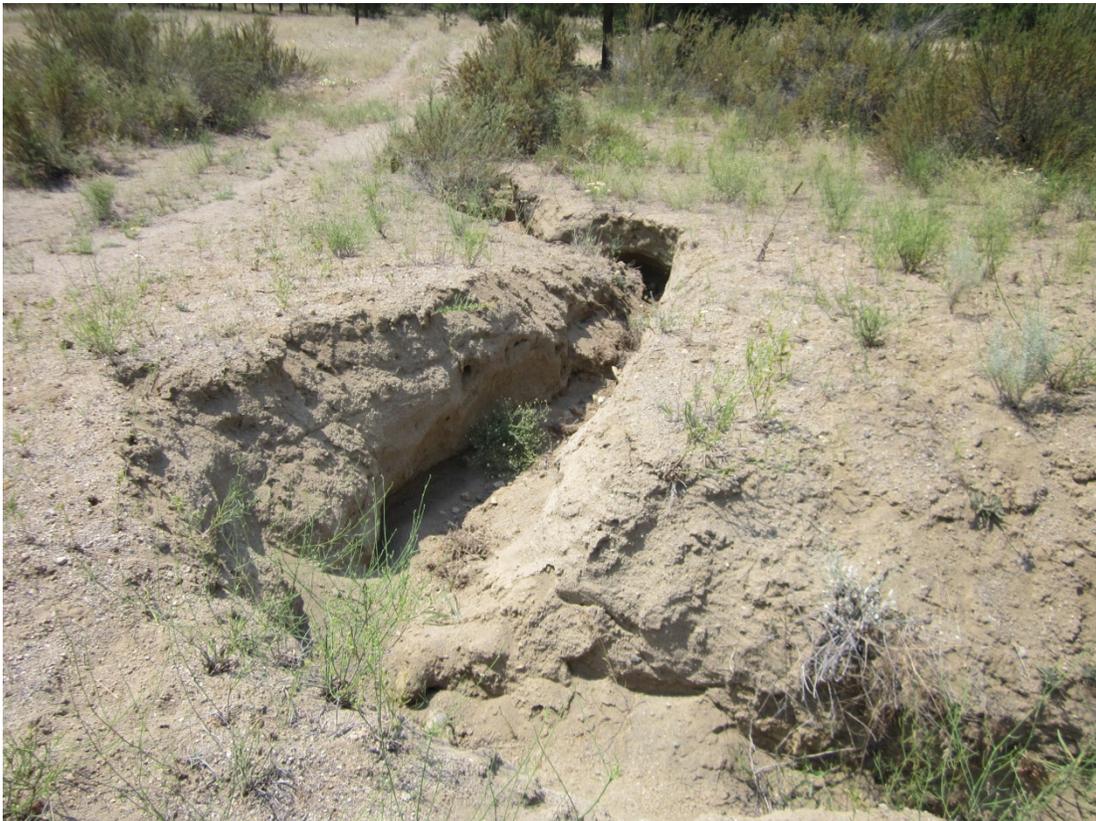
*SHE 7/2014. PL-4. Erosion near perimeter sign P2.*

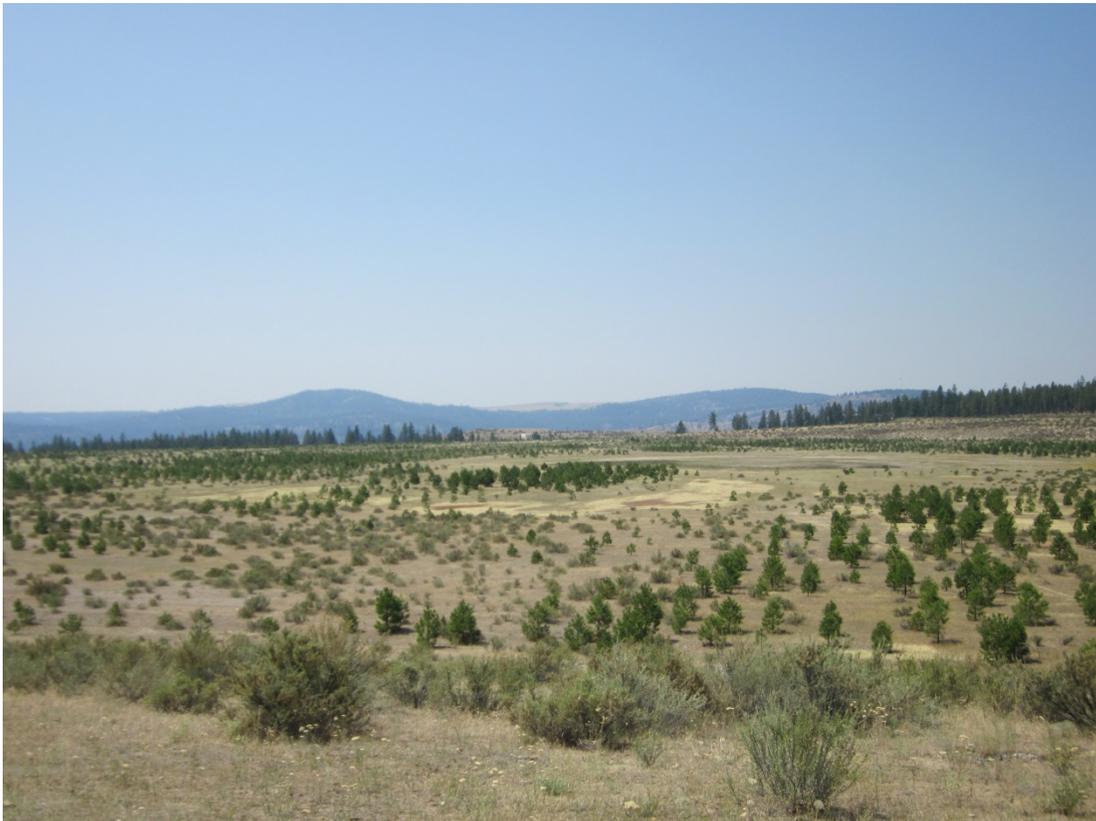
*SHE 7/2014. PL-6. Dry depressions and cell cover.*

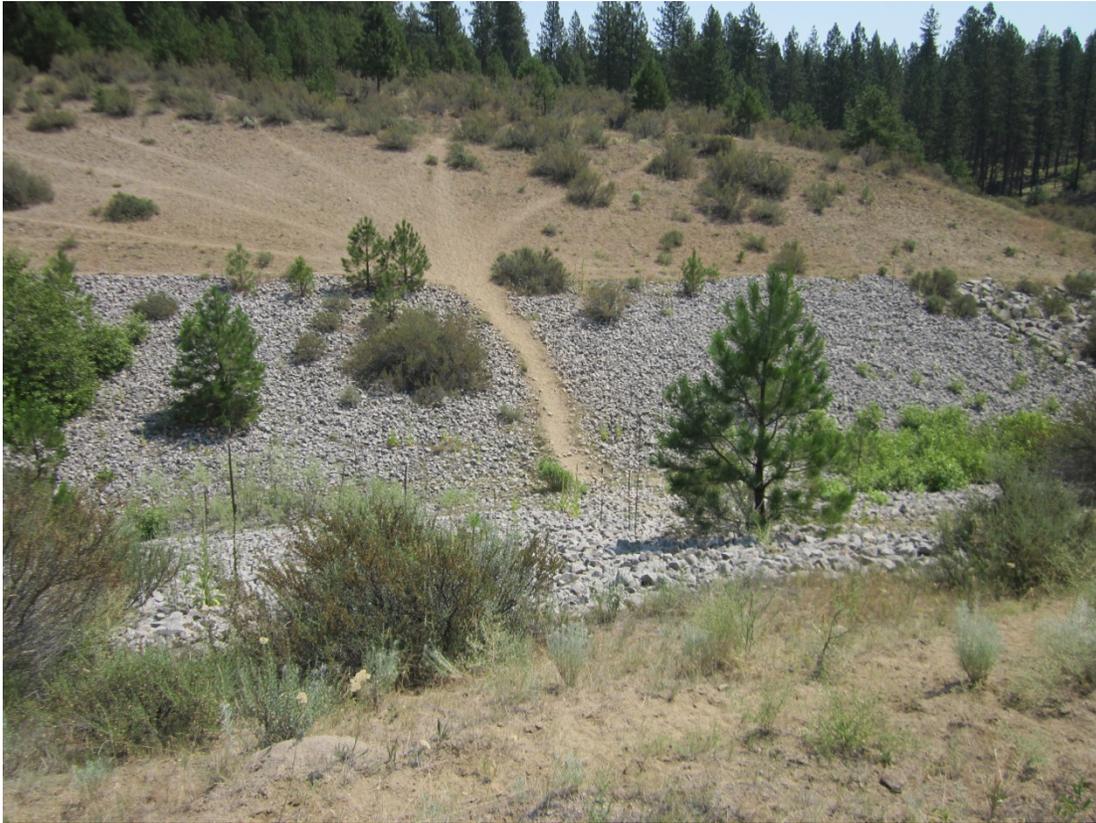
*SHE 7/2014. PL-7. Displaced riprap along animal trails in diversion channel.*

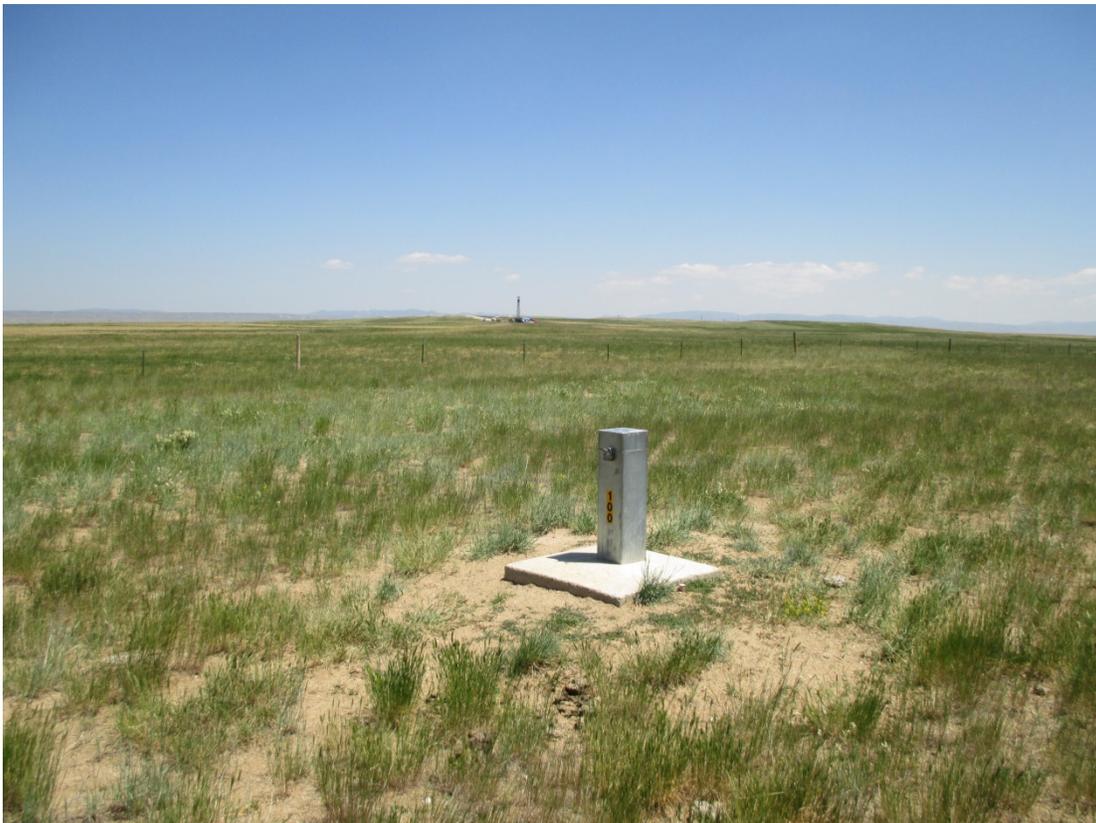
The site groundwater monitoring network consists of 14 wells; six of these wells were installed downgradient of the disposal cell during fall 2008. The wells were in excellent condition (PL-4).

*SBS 7/2014. PL-4. Monitoring well 100-SC.*
