U.S. Department of Energy Office of Environmental Management

Accident Investigation Report

Phase 1 Radiological Release Event at the Waste Isolation Pilot Plant on February 14, 2014

April 2014

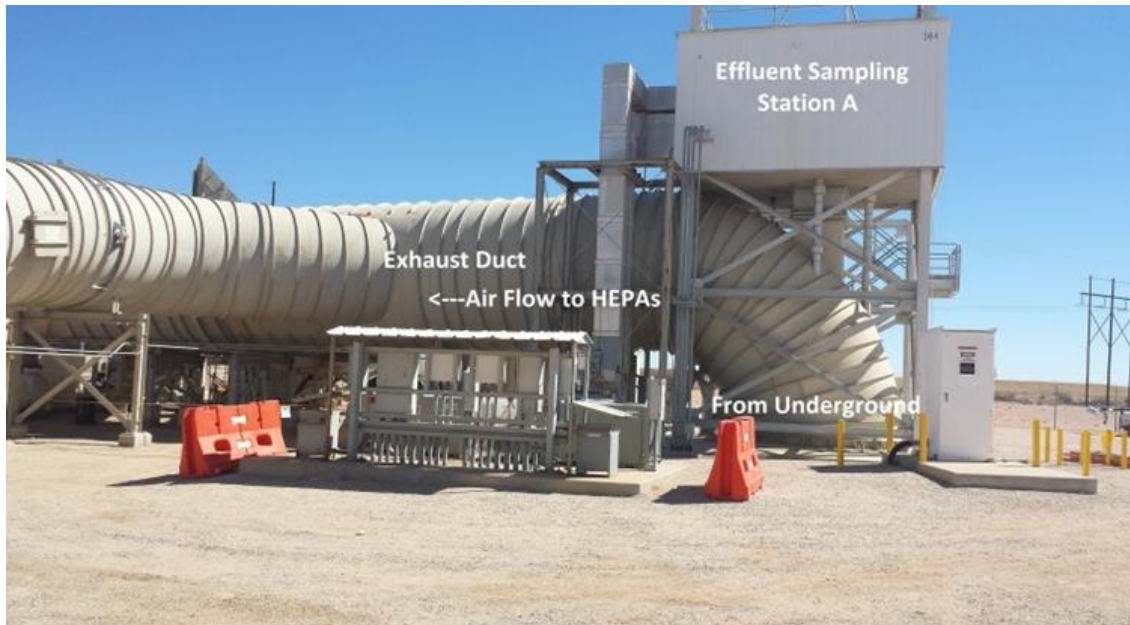
Figure ES-2: Exhaust Air Shaft and Effluent Sample Station A

On Saturday, February 15, 2014, the filters were counted at 0715; the RCM reported 4.4 million disintegrations per minute (dpm) alpha contamination on the filters from the effluent sample station upstream from the HEPA filters (Station A) (Figure ES-2). Preliminary data indicated the presence of TRU materials.

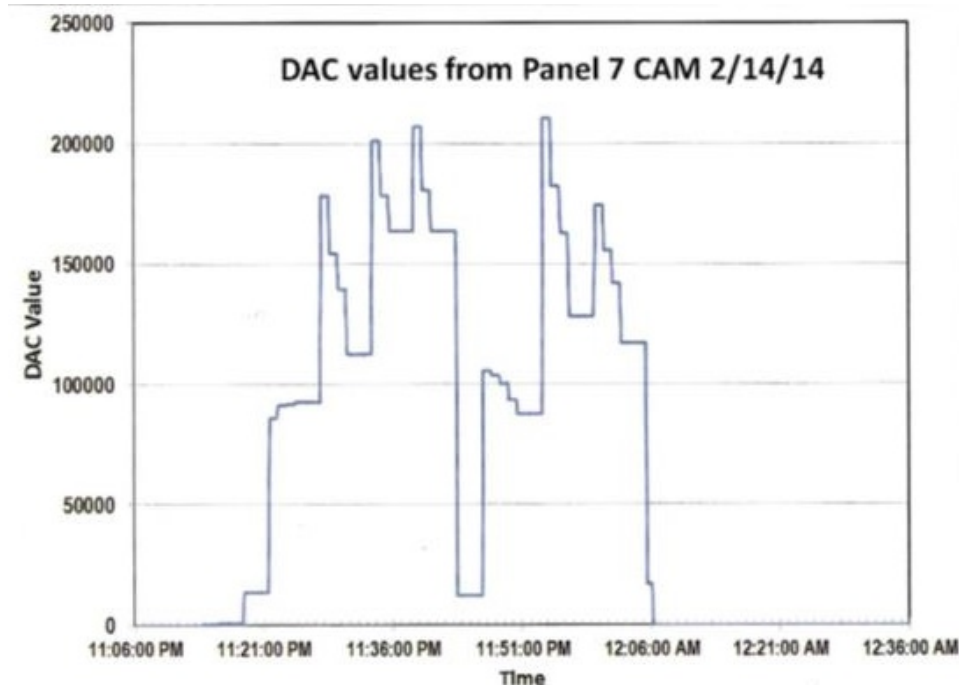
Figure 7: CAM-151 CMS

On February 14, 2014, at 2313, a “HI RAD” alarm from CAM-151 (U/G, monitoring the Panel 7 exhaust drift) was received on the CMS. The “HI RAD” setpoint for this CAM is 30 Derived Air Concentration (DAC) for alpha and beta contamination. Approximately one minute later, a “HI-HI RAD” alarm from CAM-151 was received on the CMS. The “HI-HI RAD” setpoint is 50 DAC. The CMS indicated that the CAM reading was 332 DAC. Figure 7 provides a graphical representation of CAM readings during the event.
