U.S. Department of Energy Office of Environmental Management

Accident Investigation Report

Phase 2 Radiological Release Event at the Waste Isolation Pilot Plant, February 14, 2014

April 2015

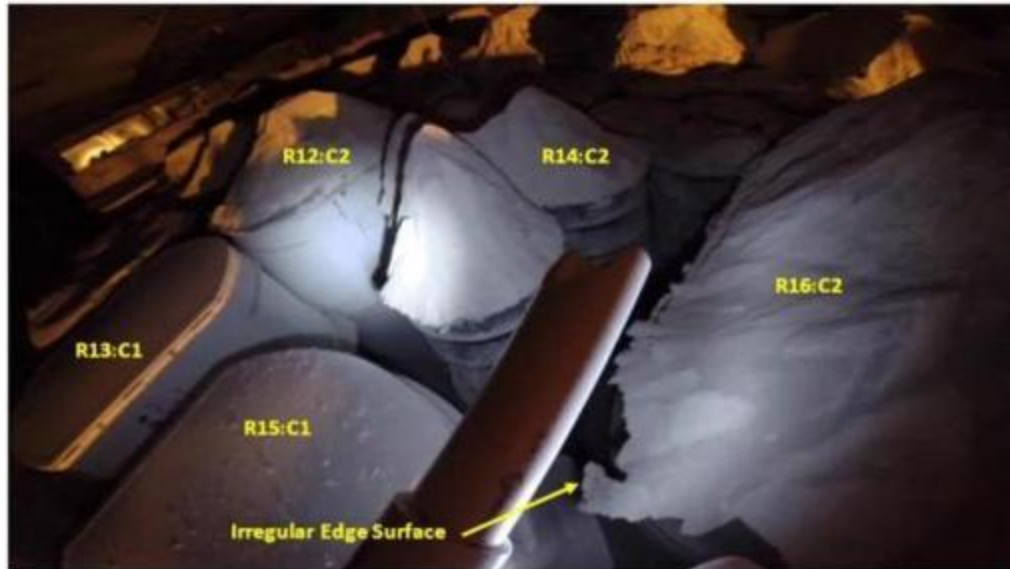
The cardboard stiffeners collapsed into multiple final orientations: hanging from a stack edge, cantilevered over the edge of a waste package, bridging between two stacks, or resting on the floor. Some of the locations where the stiffeners were cantilevered or bridging exhibited irregular edge surfaces (Figure 6-5). At R15:C5 there was a concave burn pattern in the portion of the cardboard that was cantilevered over the edge of the lid of a standard waste box (SWB) (Figure 6-6). The burn-pattern is typical of horizontal material exposed to a flame from below. Similar materials may burn as long as exposed to an external flame, but will likely self-extinguish once the flame is removed. There were also smaller cardboard remnants lying on the lid. These remnants display striations of the corrugated layer within the original cardboard matrix.

Figure 6-5: Evidence of Irregular Edge Surfaces at R16:C2

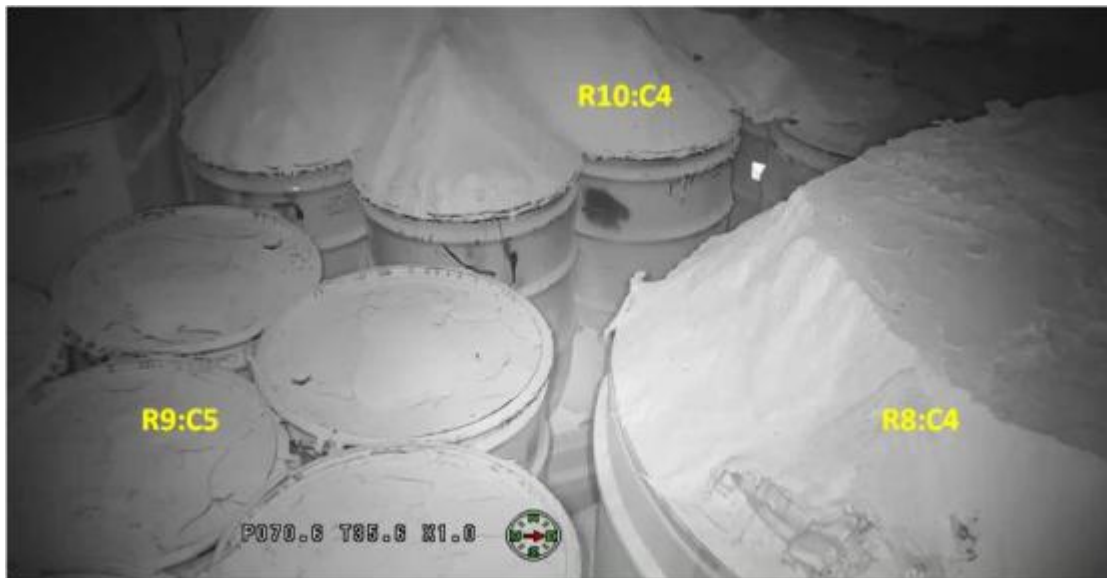
Figure 6-22: Damage at R9:C5 and R10:C4
