Corrosion within the Z-Bed Recovery Systems at the Savannah River Site's Tritium Facilities

Jared Clark, PE

Tritium Engineering Department
Savannah River Nuclear Solutions, LLC
April 23th-25th, 2013

Tritium Focus Group

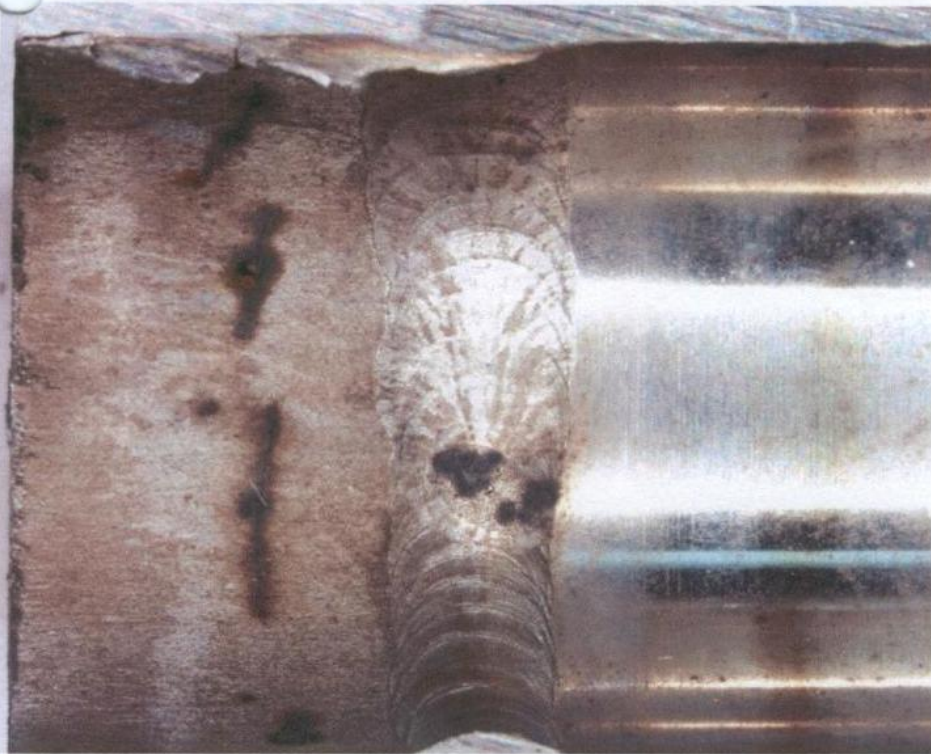
Figure 37
Piece I

STRESS CORROSION CRACKING

Photo #: 0501A00450
Magnification: 6X

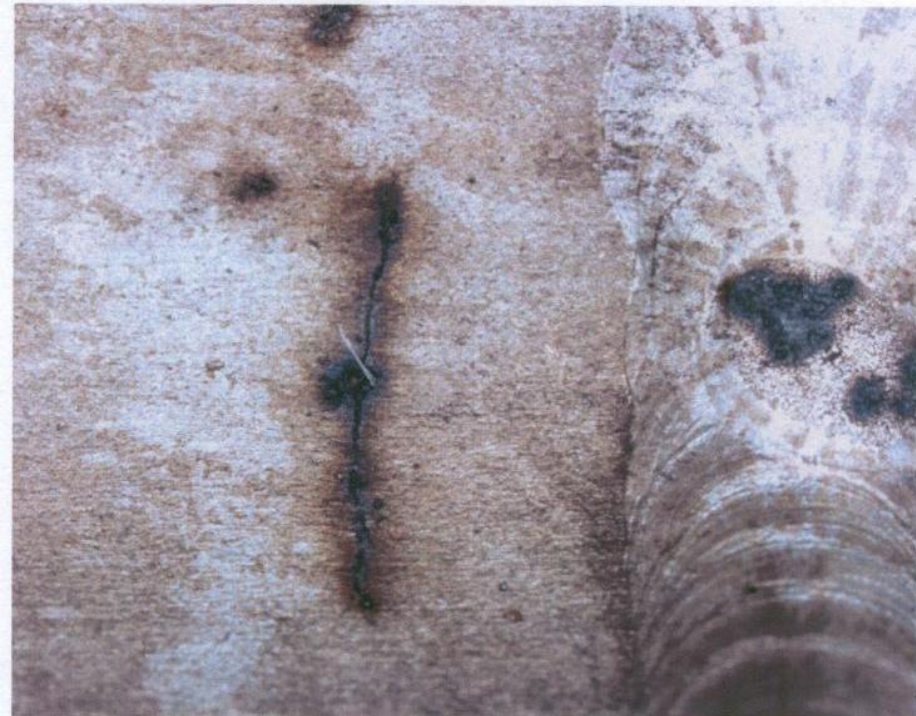
Figure 38
Piece I

Photo #: 0501A00452
Magnification: 15X

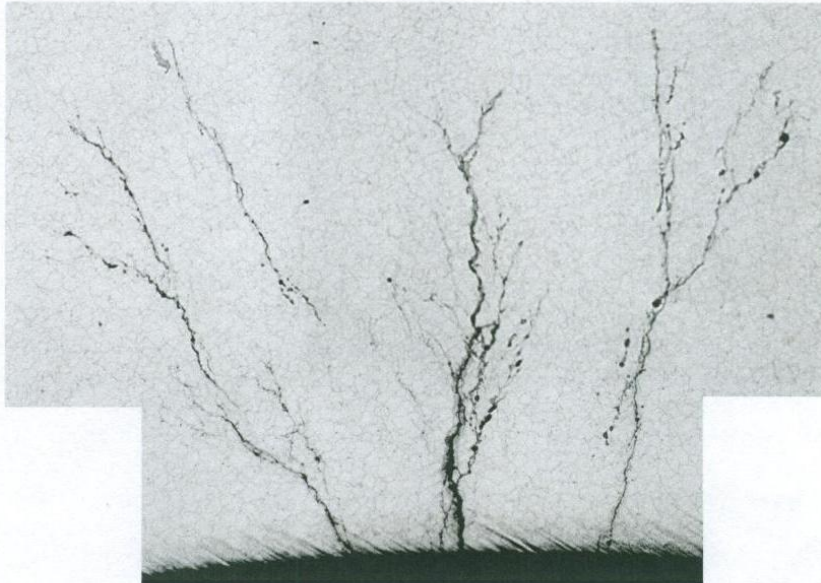
Figure 43
Etch: 60% Nitric Acid

STRESS CORROSION CRACKING (CONT.)

Photo #: 0502A00326
Magnification: 50X

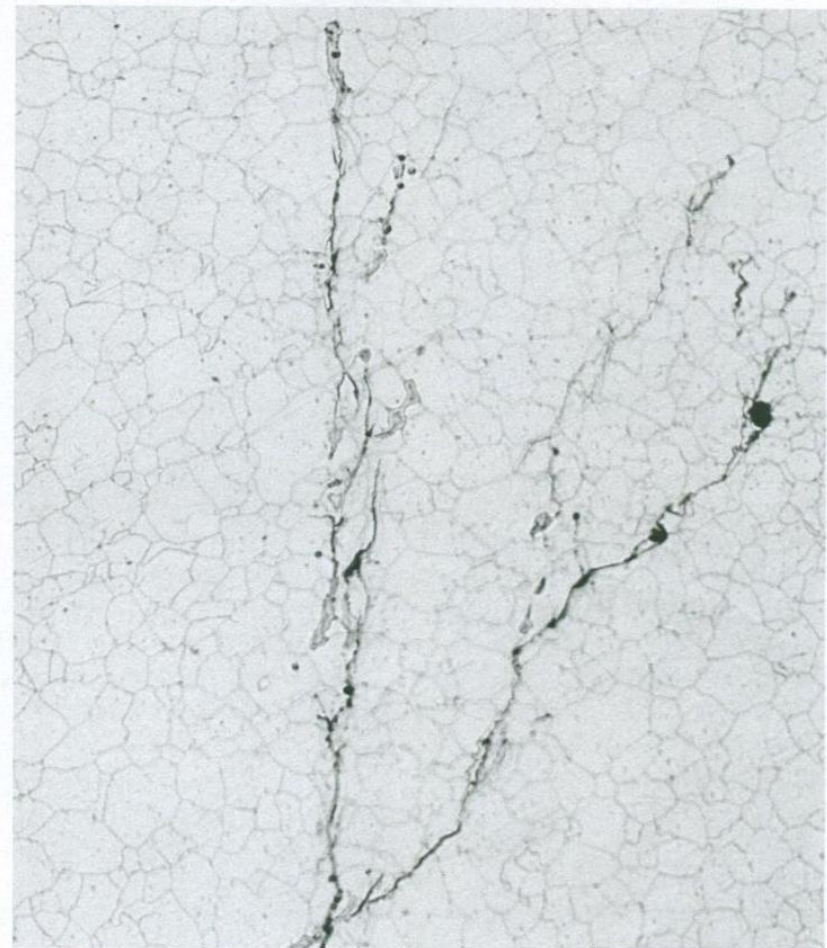
Figure 42
Etch: 60% Nitric Acid

Photo #: 0502A00349
Magnification: 160X

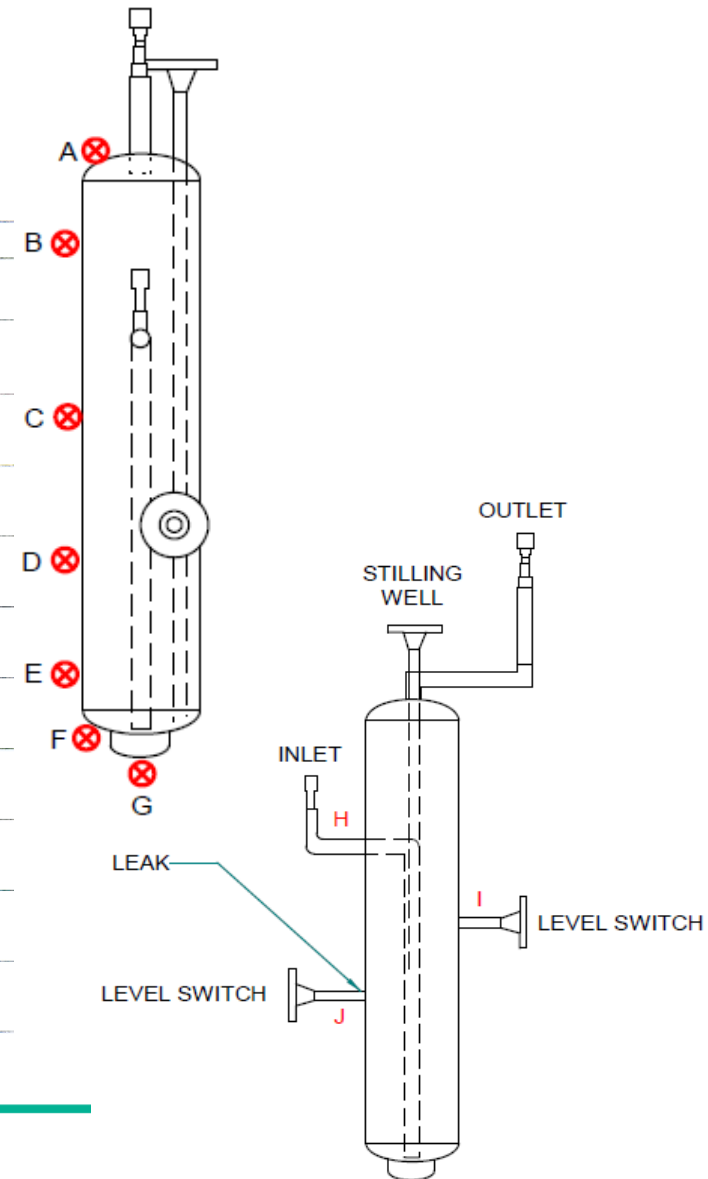
- **Water Trap #1, Ultrasonic Testing (UT)**
 - December 12, 2011

Location	0°	90°	180°	270°
A	N/A	N/A	N/A	N/A
B	0.332"	N/A	N/A	N/A
C	0.304"	0.322"	0.314"	0.302"
D	0.302"	0.331"	0.307"	0.302"
E	0.302"	0.326"	0.307"	0.309"
F	N/A	N/A	N/A	N/A
G	N/A	N/A	N/A	N/A
N/A	N/A	N/A	N/A	N/A
H	N/A	0.121"	N/A	N/A
I	0.121"	0.126"	0.129"	0.124"
J	0.126"	0.129"	0.122"	0.120"

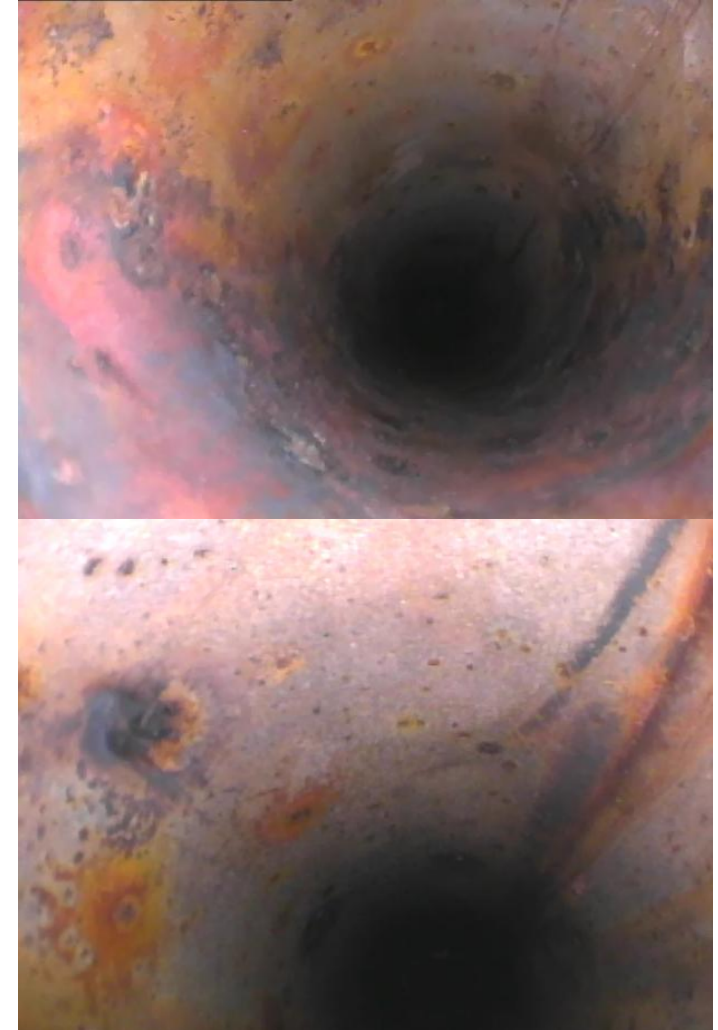
- Evidence of Corrosion and Pitting
- Stilling Well
- Level Switch Wells
