Accident Investigation Report

Underground Salt Haul Truck Fire at the Waste Isolation Pilot Plant February 5, 2014

March 2014

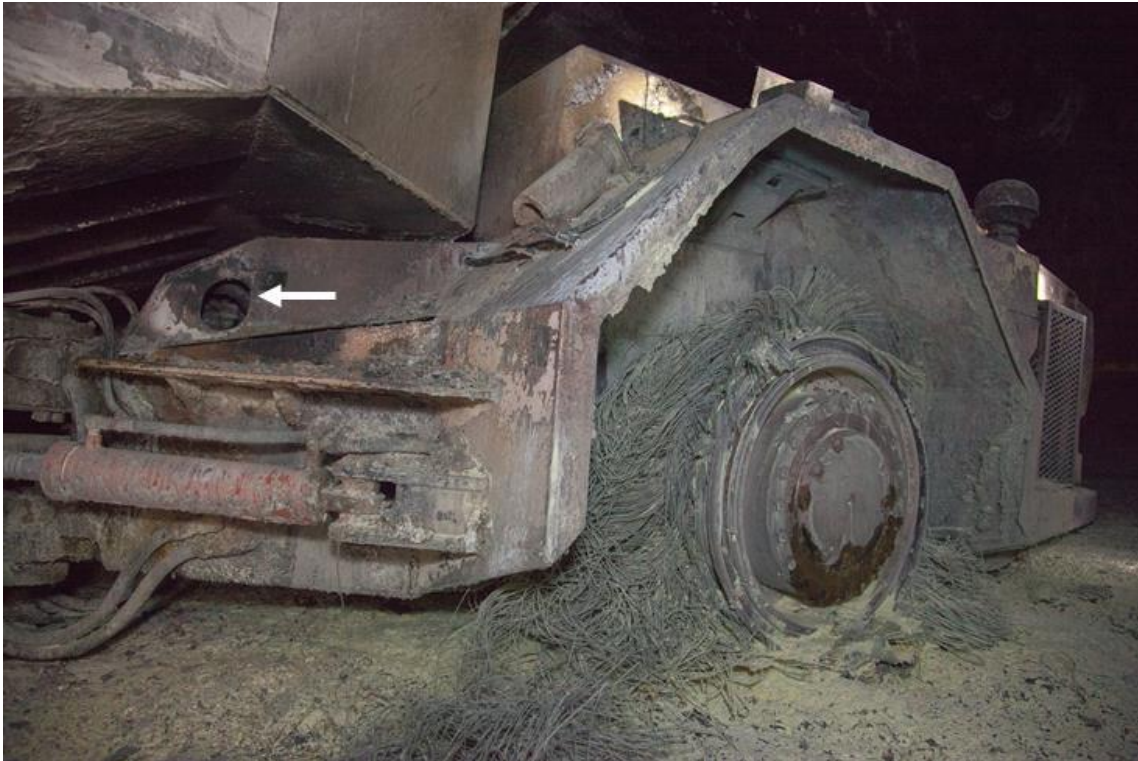
Upon noticing the fire, the Operator stopped the truck, shut off the engine, set the brake, and exited the vehicle, taking a portable fire extinguisher which was mounted on the left front fender. The Operator proceeded to the opposite side of the vehicle, near the articulation joint and attempted to extinguish the fire by discharging the fire extinguisher into the area where the Operator had observed the fire (Figure 9).

Figure 9: Photo Showing the Area on the Salt Haul Truck where the Fire Extinguisher was Discharged

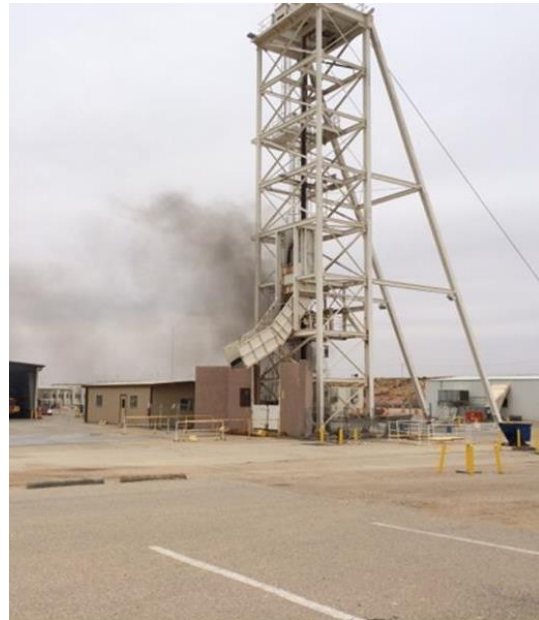
Figure 10: Smoke Visible Exiting through the Salt Shaft

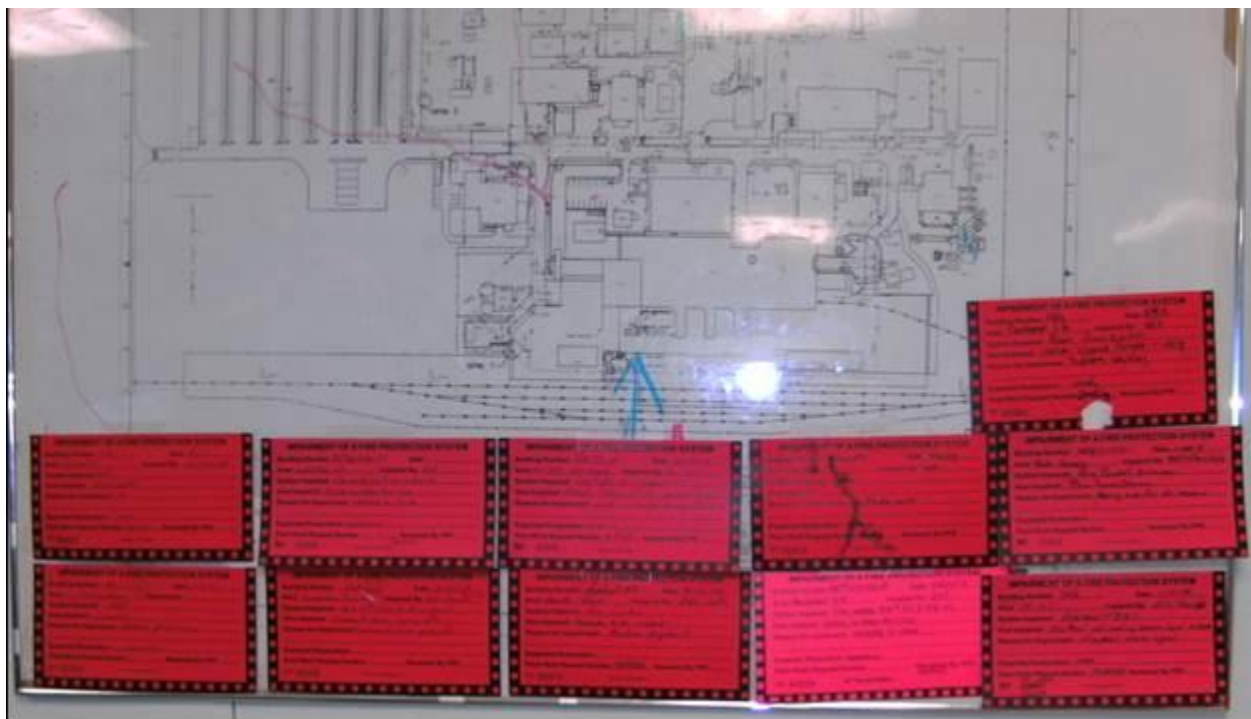
The Board reviewed the equipment status and condition in the CMR and the U/G. The condition of critical pieces of equipment, such as the 700 exhaust fans, indicates that management has not taken prompt action to resolve longstanding deficiencies. Many items have been out of service or in a reduced status for more than six months. It was not clear that NWP had a clear approach to prioritizing maintenance activities in regard to critical equipment or that there is an effective formal process to identify compensatory measures other than a fire watch for impaired safety-related equipment. Additionally, the equipment and components that affect normal operation of the mine ventilation system did not appear to have been effectively evaluated and dispositioned regarding their impact on system operation. (Figure 16)

Figure 16: Fire Protection System Impairment (Out-of-Service Tags) in the CMR

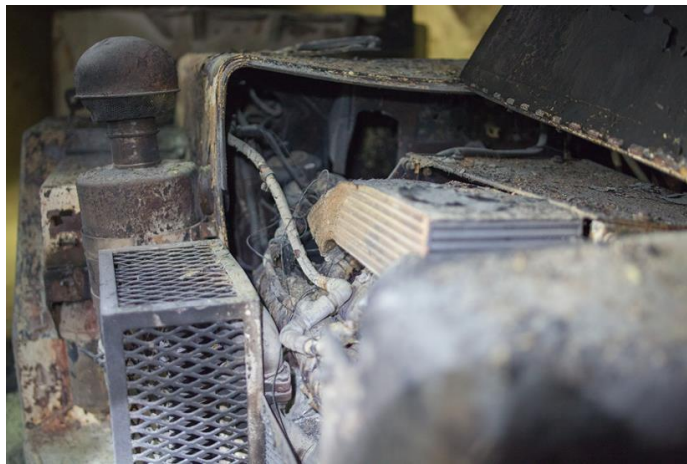
Figure 19: Engine Cooling Coils

The Board observed accumulated grime in the engine compartment of other salt haul vehicles that would have been sufficient to create a sustained fire that would result in additional fluid leaks. The normal hauler ventilation flow pulls air through the front grill and directs it across the cooling coils above the engine block (see Figure 19). This flow exits at the back of the engine compartment and would push the fire towards the transmission (see Figure 18, illustration (c)). In the actual fire, this condition occurred within about 5 to 10 minutes of initial ignition (assumed start time is

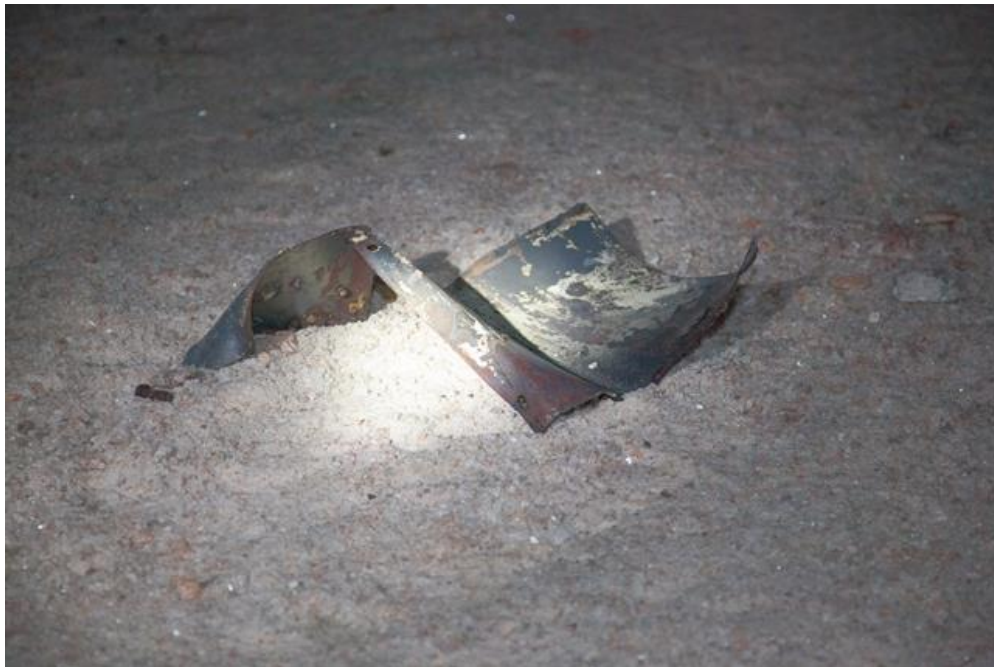
Sometime during the intense burning period an accumulator within the engine compartment burst. This ejected an end-cap which ruptured an access plate and went through the hauler operator compartment. The end-cap traveled approximately 10 feet beyond the back of the haul truck (see Figure 25). The access plate was severely deformed and traveled approximately 20 feet beyond the end of the haul truck (see Figure 26).

Figure 26: Damaged Access Plate
