# U.S. Department of Energy Office of Environmental Management

## Accident Investigation Report

## Phase 2 Radiological Release Event at the Waste Isolation Pilot Plant, February 14, 2014

April 2015

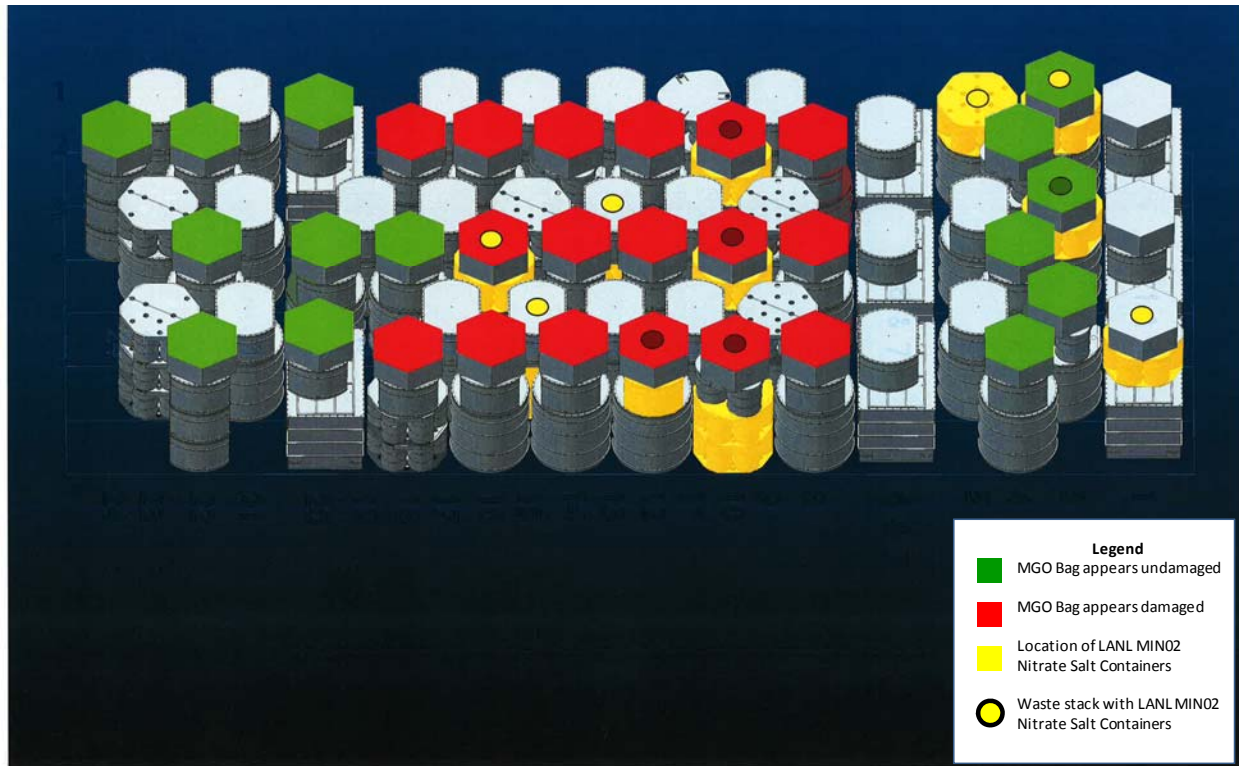
**Figure 2-4: Panel 7, Room 7 Location of Damage from Event**

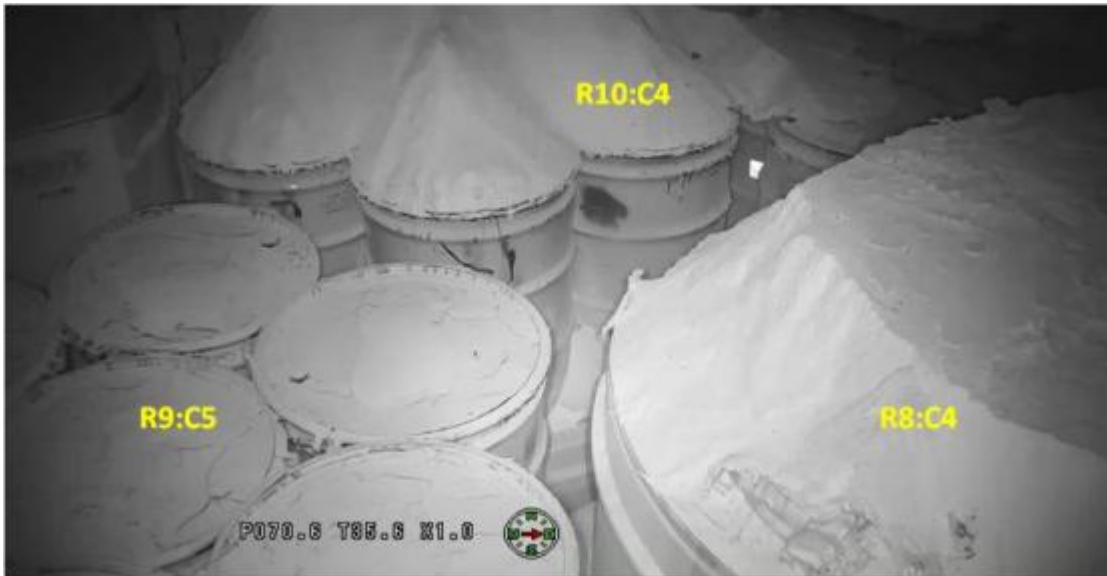
**Figure 6-22: Damage at R9:C5 and R10:C4**

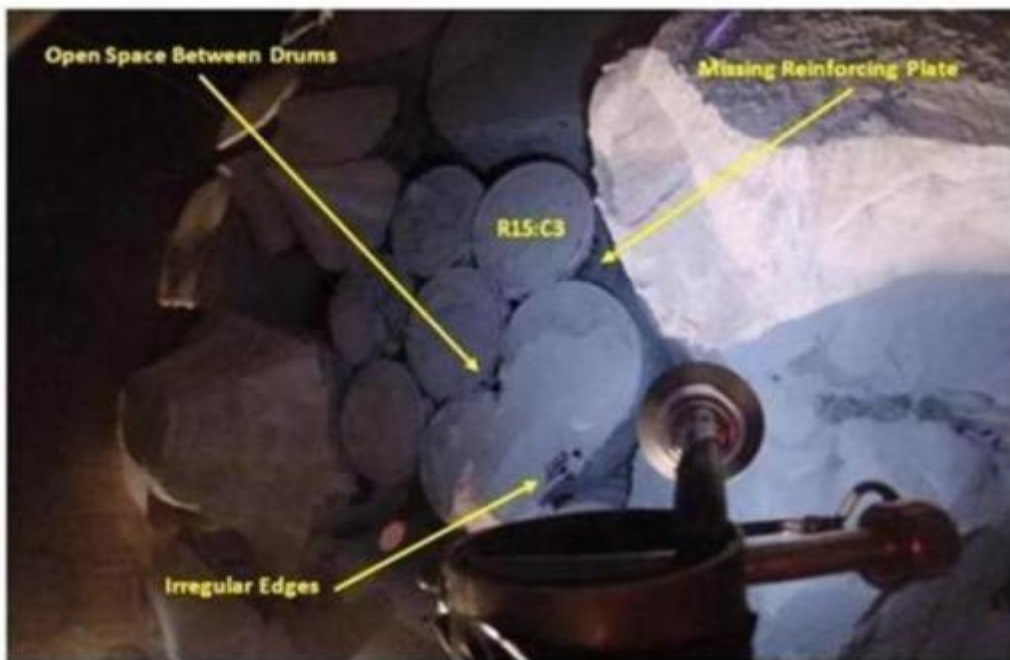
The reinforcement plate at R15:C3 was damaged. The missing plate material conformed to the outline of the seven drums, including the spaces between the drums (Figure 6-33). There was residual stretch wrap visible on some portions of the assembly and some of the drum labels were undamaged (Figure 6-34). The TDOP below the 55GD assembly was undamaged.

Figure 6-33: Missing Reinforcement Plate at R15:C3

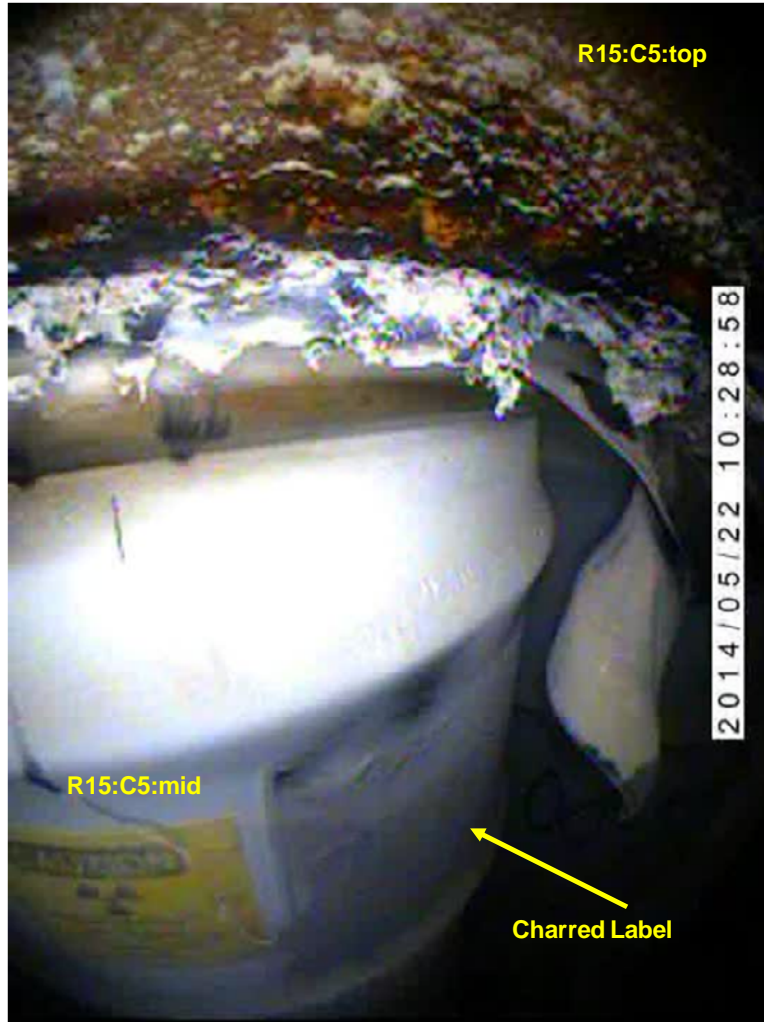
One 55GD on the middle tier of R15:C5 exhibited evidence of localized heat or flame exposure. Between the middle and upper rolling hoop there was one label that had charred, while a second label that showed no damage (Figure 6-39). In addition, there was a dark inverted-cone shaped pattern starting at the base of the drum that extended up the side of the drum about 12 inches. Around this region there was clumped MgO resting on the middle-tier slip sheet. While there was severe flame damage evidence on the west side of the SWB and the middle tier 55GD assembly, the lower tier stretch wrap appeared undamaged on the outer surface as viewed from the west side of the stack.

**Figure 6-39: Charred Label at R15:C5**
