Allatoona Update

Southeastern Federal Power Alliance

15 Sep 2016

Christopher Ludwig
U.S. Army Corps of Engineers
Mobile District

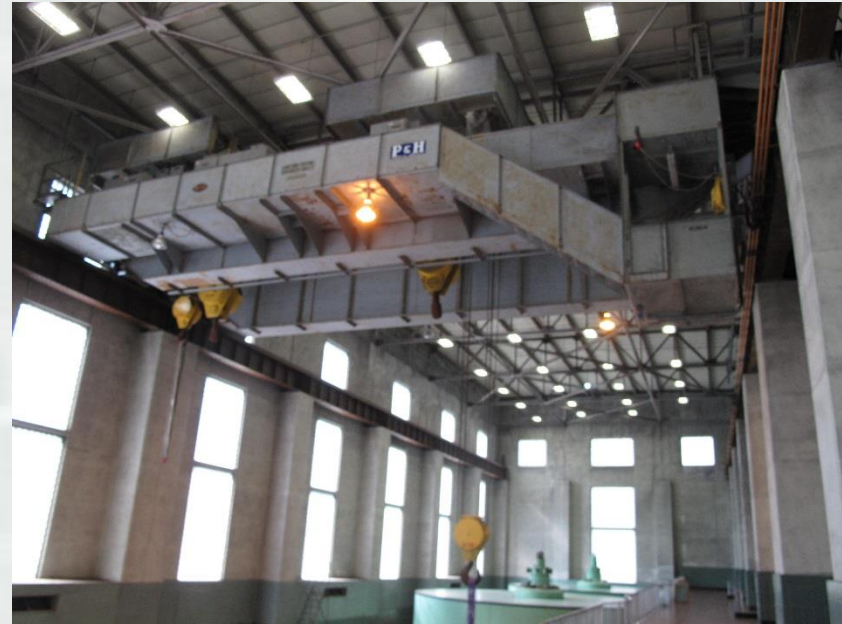
Crane

Issue: Soot from the fire caused corrosion of electrical and mechanical components as well as the main hooks. This is preventing operation of one of the trolleys and warrants certified personnel inspect and recommend repairs followed by complete load testing prior to use of the main hooks.

Status: Operation has been limited to only auxiliary hooks until all repairs and load testing is complete. A contract to inspect and repair the crane has been awarded and the contractor is expected to be on sight in November. Completion is dependent on the results of the inspection but is estimated at June 2017.

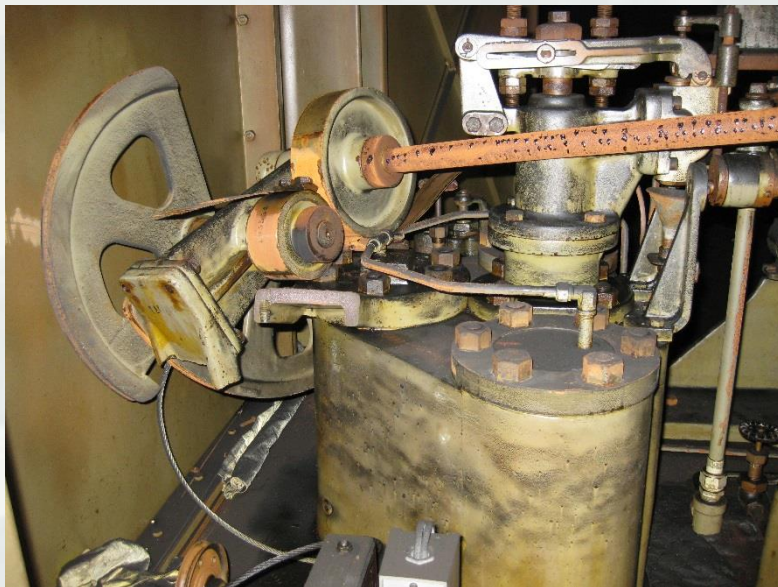
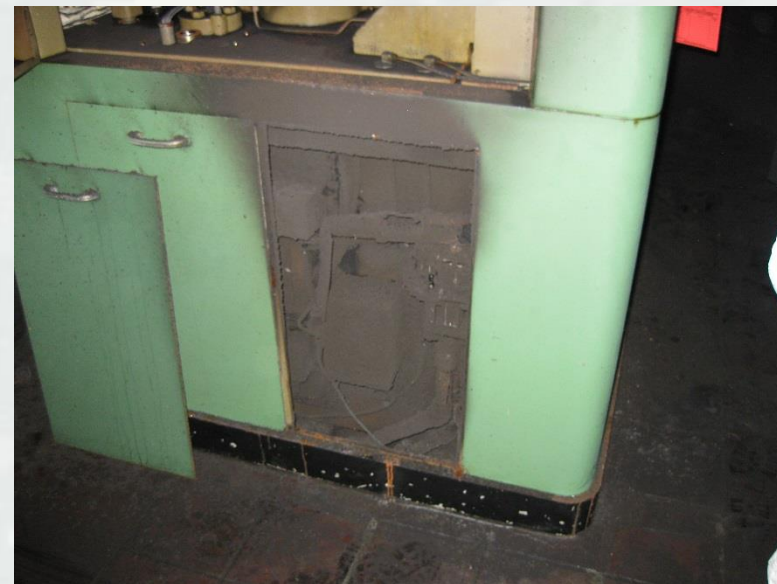
Governor

Issue: The Governors experienced heat and corrosion damage as a result of the fire. They are currently inoperable and must be replaced.

Status: Plans and specifications have been completed and a solicitation is expected to be advertised in November. Expected completion for the installation is October 2017.

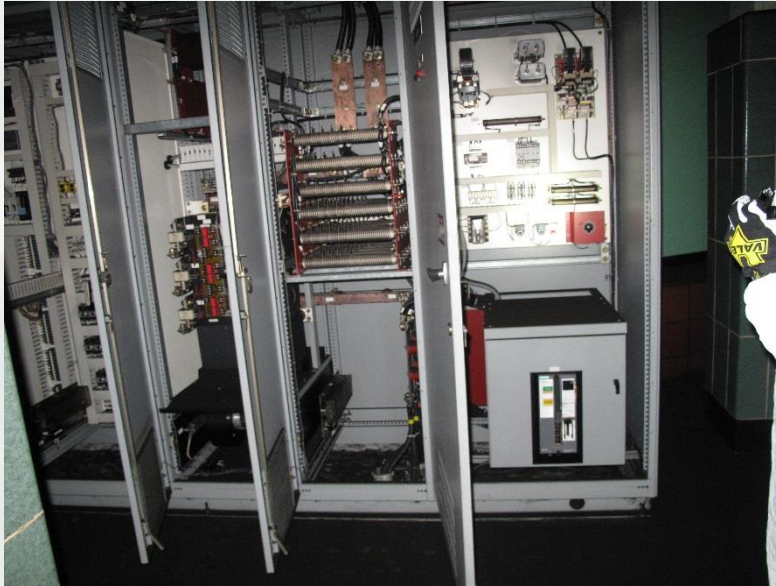
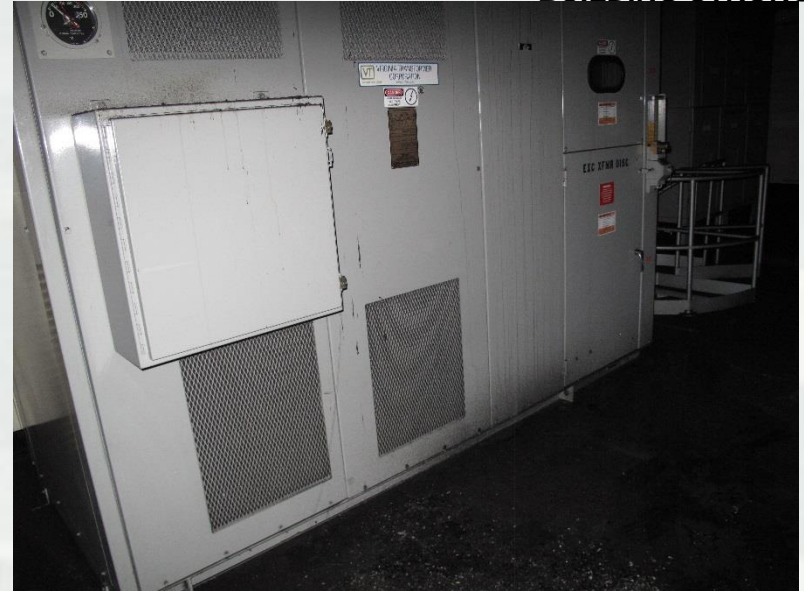
Exciter

Issue: The Exciters were in close proximity of the fire and experienced heat and corrosion damage as a result. They are currently inoperable and must be replaced. The excitation transformers also require replacement due to corrosion damage.

Status: Plans and specifications have been completed and replacement is included in the final directive list currently being negotiated with the contractor. Expected completion for the installation is October 2017.

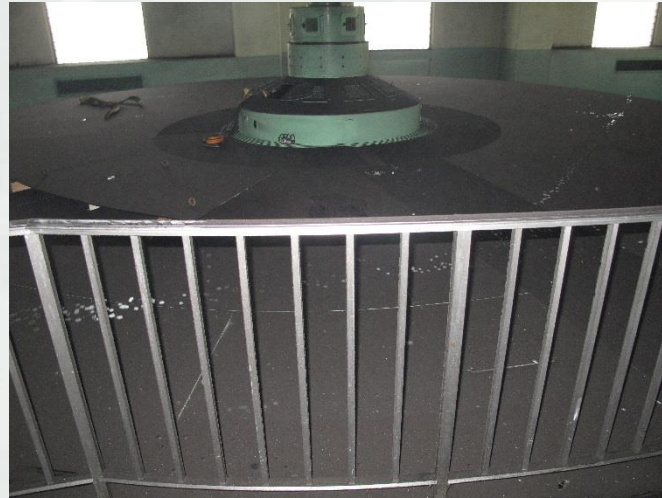
Generator Cleaning and Testing

Issue: Significant amounts of soot entered the generator air housing but little corrosion has been observed as most surfaces are painted. The extent of exposure of the winding and core cannot be determined without disassembly however these surfaces are protected with varnishes so corrosion damage is not expected.

Status: A plan for plant personnel to disassemble and clean the rotor and stator has been developed but cannot be executed until the crane is repaired. Inspections have begun on other areas not requiring the crane's use such as the shafts and bearings.
