Building America Efficient Solutions for Existing Homes

Case Study: Deep Energy Retrofit of 1910 House

Portland, Oregon

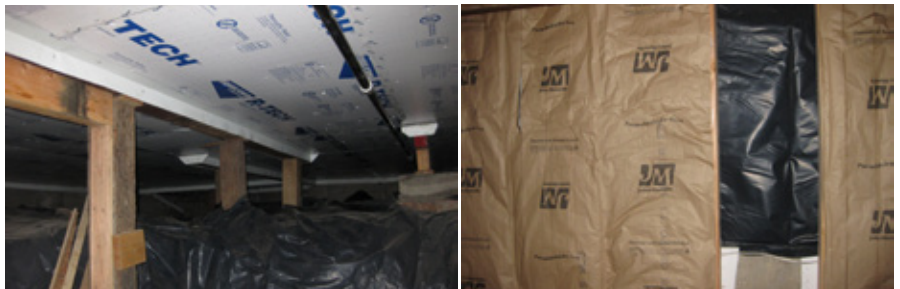
(left) In the crawlspace, R-30 fiberglass batts were installed between the 2x10 floor joists. The joists were then covered with 1 inch of expanded polystyrene (EPS) rigid foam board that was taped at the seams to provide a continuous air barrier and flashed at the edges to protect against rodents. The crawlspace floor was covered with a 6-mil visquene vapor barrier.

(right) On the lower 4 feet of the concrete basement walls 1 inch of EPS was installed. Then a new 2-foot-high concrete stem wall was added in front of the rigid foam to support the aging existing foundation wall. The upper portion of the wall was covered with a plastic vapor barrier and framed with 2x4 studs; R-15 faced fiberglass batts were installed between the studs. Taped and mudded sheetrock provided a fire barrier, air barrier, and finished look to the basement wall assembly.

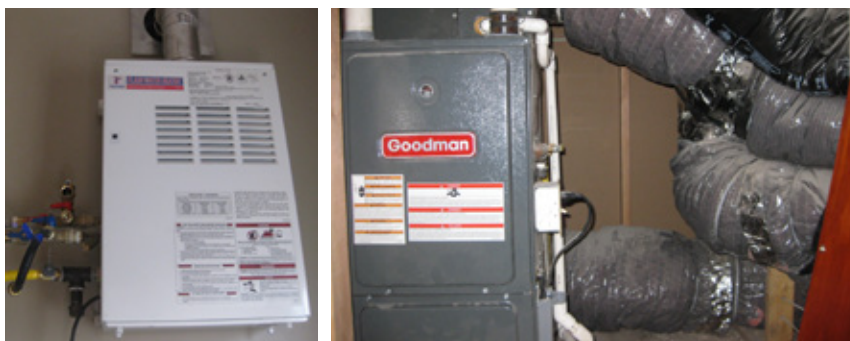
New high-efficiency heating and cooling equipment, water heater, and appliances lower energy consumption and improve indoor air quality.

(left) A 0.85 EF tankless hot water heater eliminates standby energy consumption.

(right) The 95% AFUE, sealed-combustion gas furnace and well-insulated and sealed ducts are located in an insulated but air and vapor permeable side attic.
