U.S. DEPARTMENT OF
ENERGY

Legacy
Management

2013 Annual Site Inspection and Monitoring Report for Uranium Mill Tailings Radiation Control Act Title II Disposal Sites

November 2013

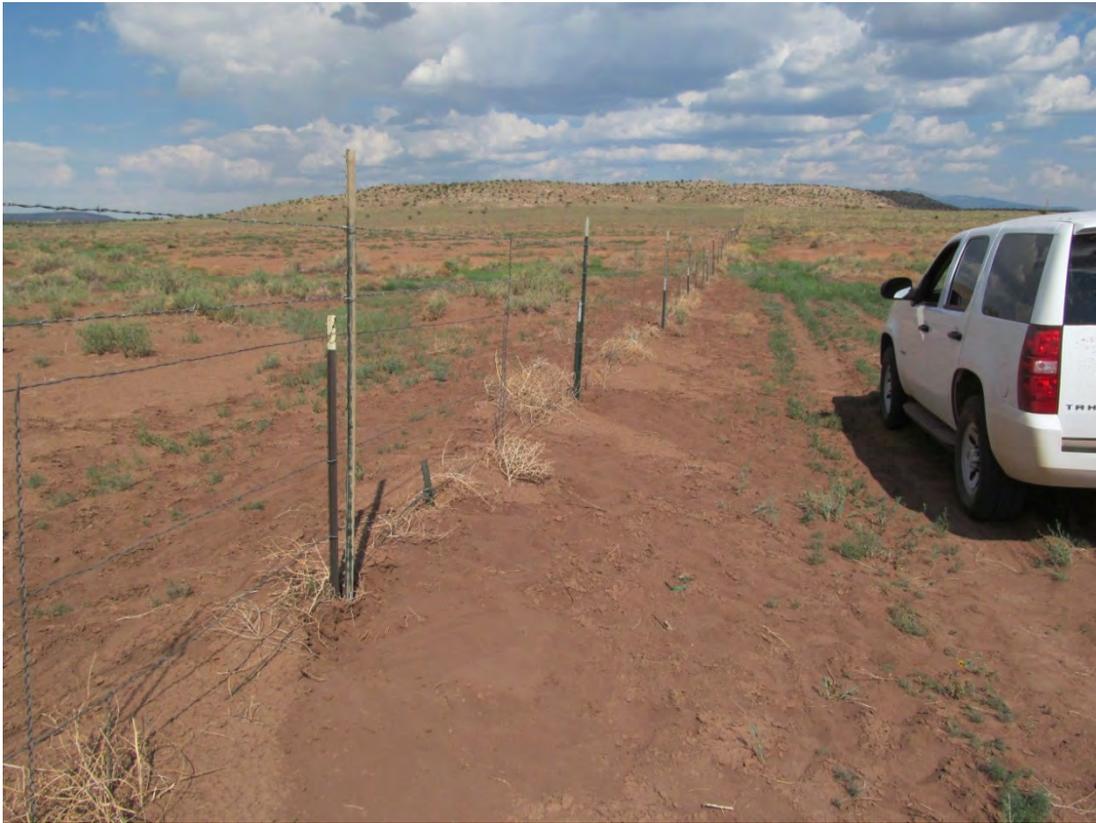
1A A four-strand barbed-wire fence encompasses the site to facilitate land management by DOE. The fence was in good condition. Sand had drifted to near the top of a portion of the north perimeter fence allowing site intrusion by cattle. The fence in this drift-prone area was modified by installing taller fence posts and additional strands of wire (PL-1).

BLU 8/2013. PL-1. Modified fence along north property boundary.

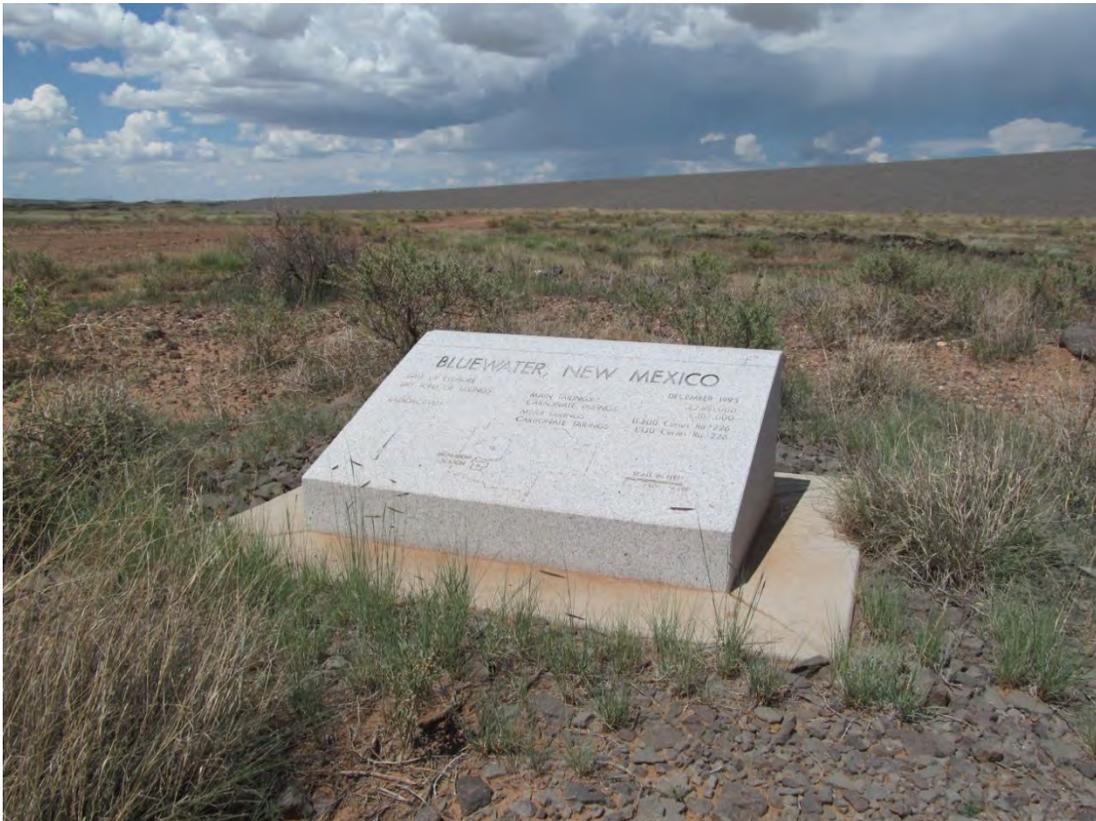
A granite site marker is between the southwest corner of the main tailings disposal cell and the northwest corner of the carbonate tailings disposal cell. The marker was in excellent condition (PL-2).

BLU 8/2013. PL-2. Site marker.

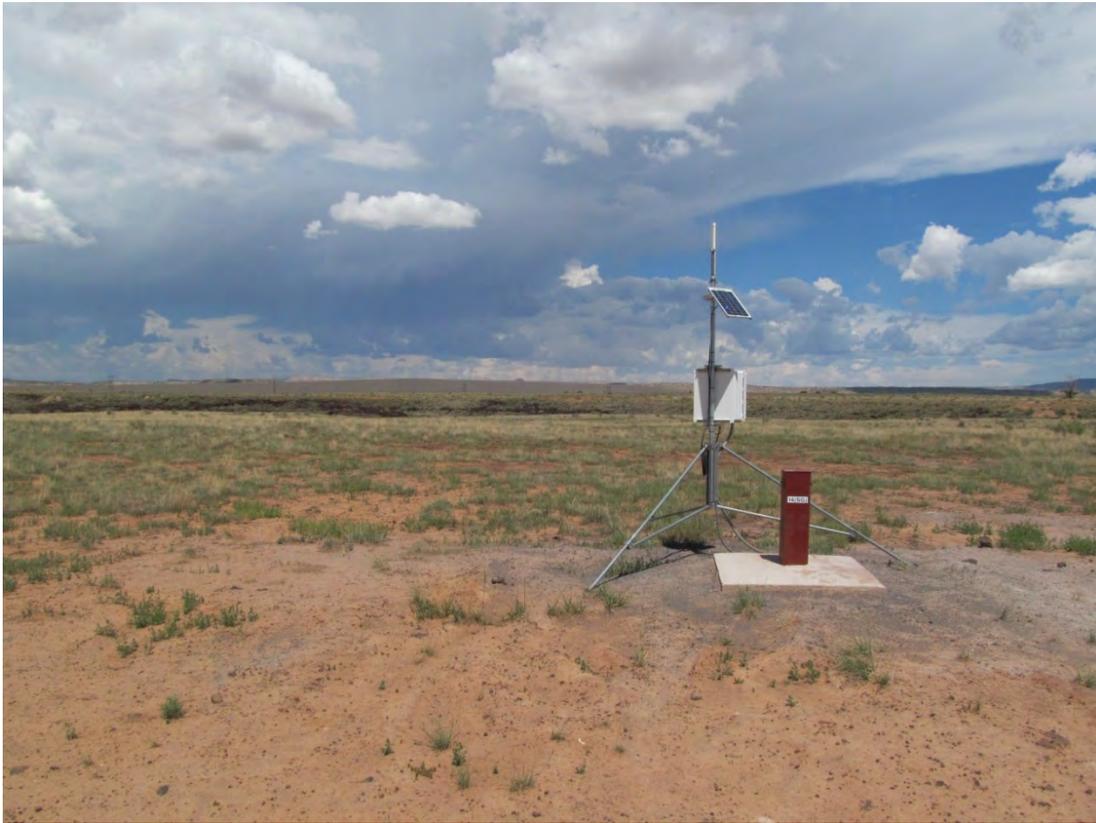
BLU 8/2013. PL-3. Monitoring well 14(SG).

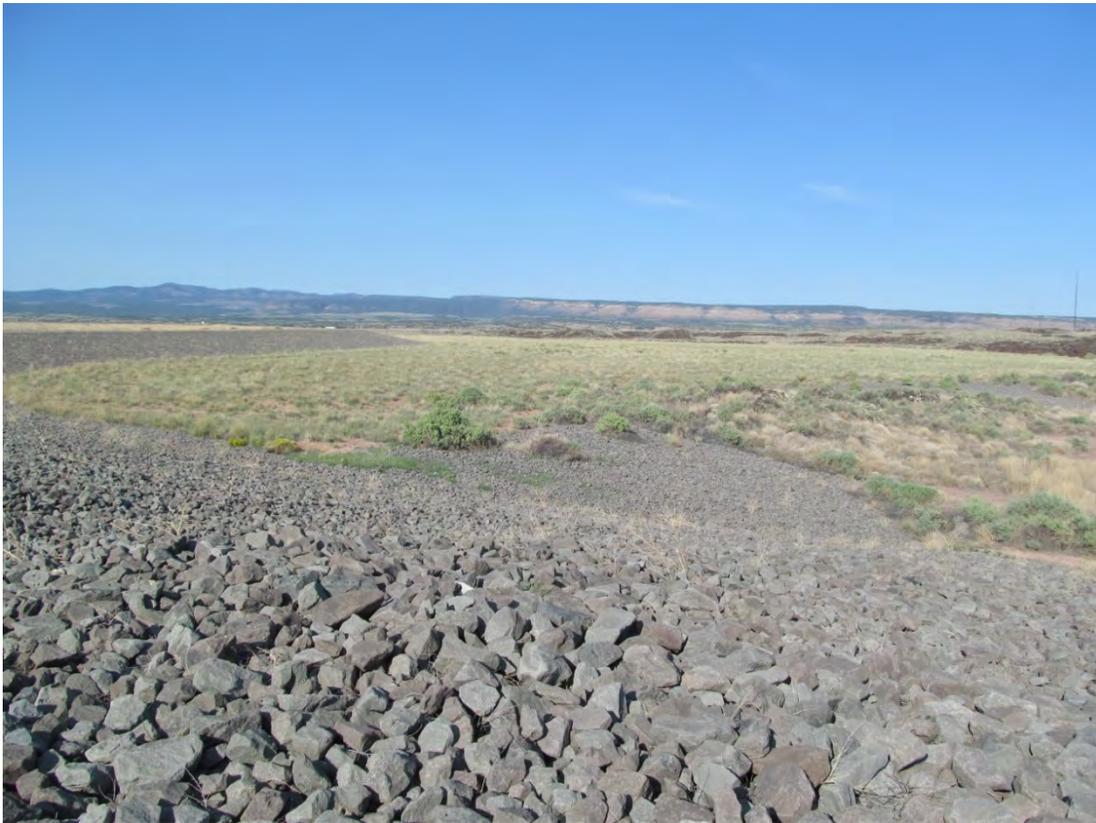
BLU 8/2013. PL-4. Acid tailings portion of main tailings disposal cell.

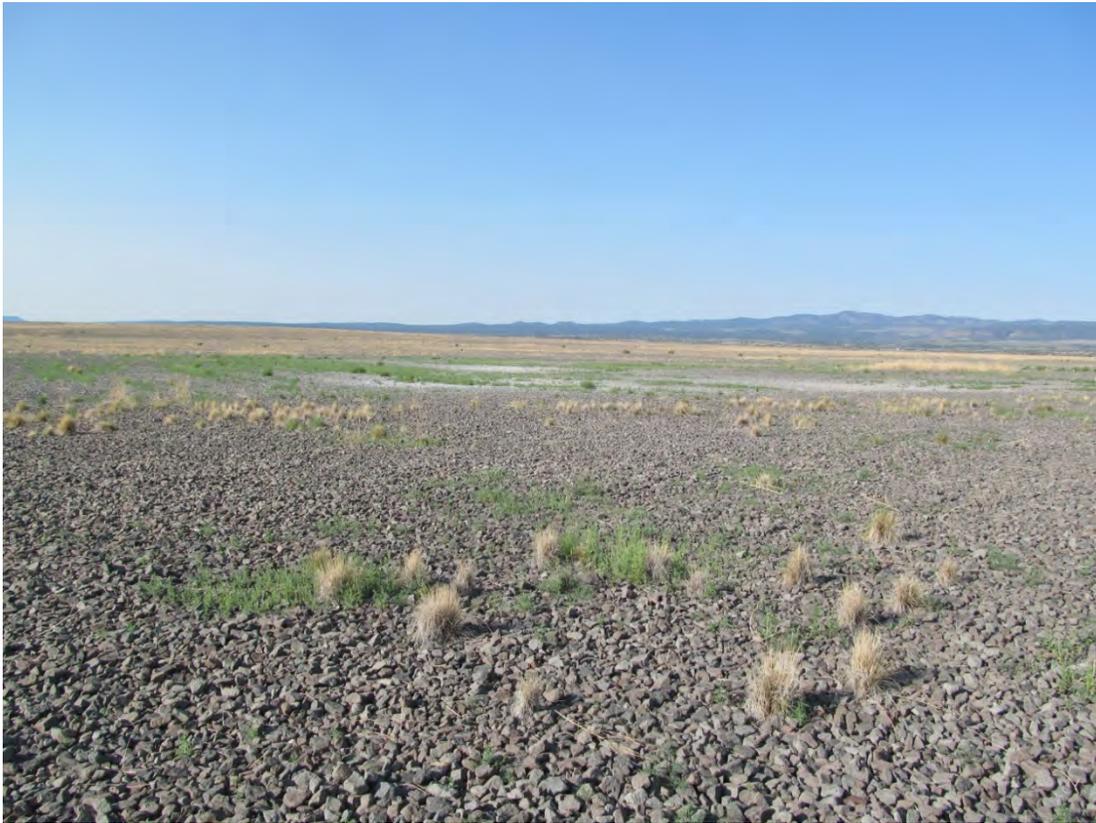
BLU 8/2013. PL-5. Dry depressions on north end of main tailings disposal cell top slope.

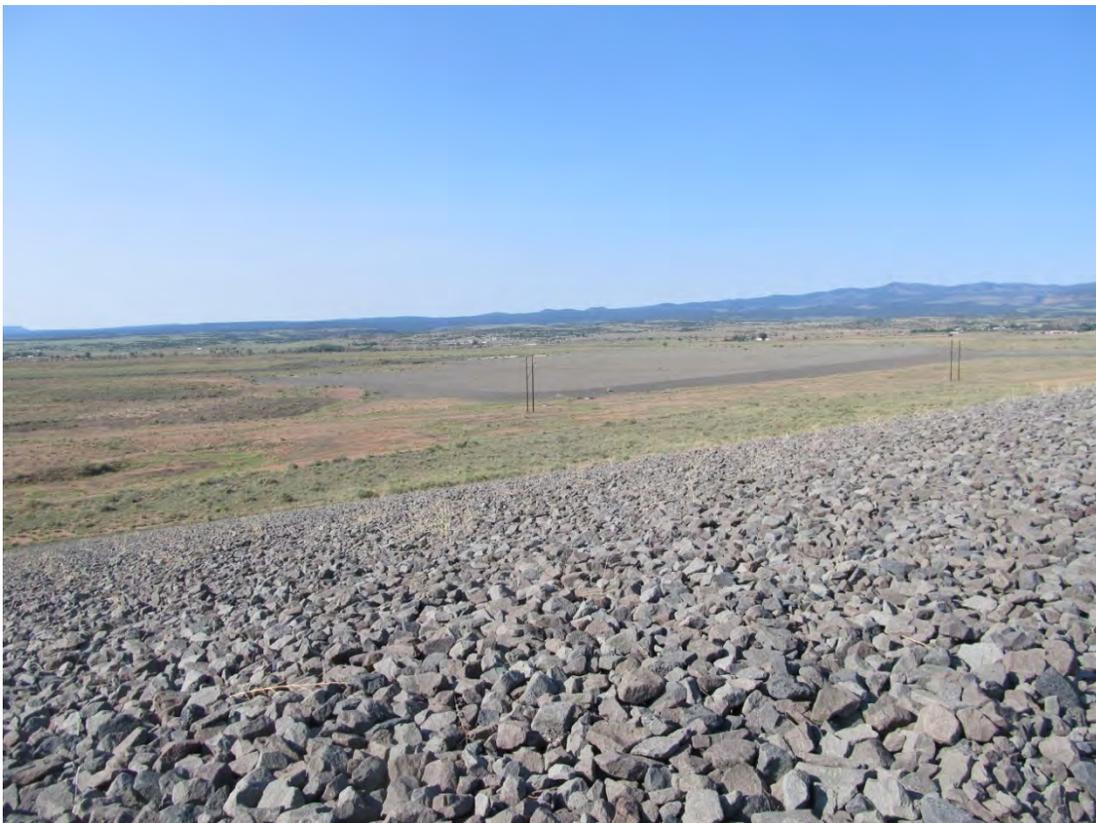
The 54-acre carbonate tailings disposal cell is south of the main tailings disposal cell (PL-6). The cell was in excellent condition except for a shallow depression on the northwest extension of the cell that was dry at the time of the inspection. Basalt riprap covers the top and side slopes of the disposal cell. The top, for the most part, slopes gently eastward. The small northwest and southeast extensions slope in their respective directions. Annual weeds, perennial grasses, and scattered woody shrubs were present on the cell and its extensions. Saplings of Siberian elm have been present on the cell cover and are periodically cut, and their stumps are treated with herbicide; no saplings were observed during the inspection.

BLU 8/2013. PL-6. Carbonate tailings disposal cell.

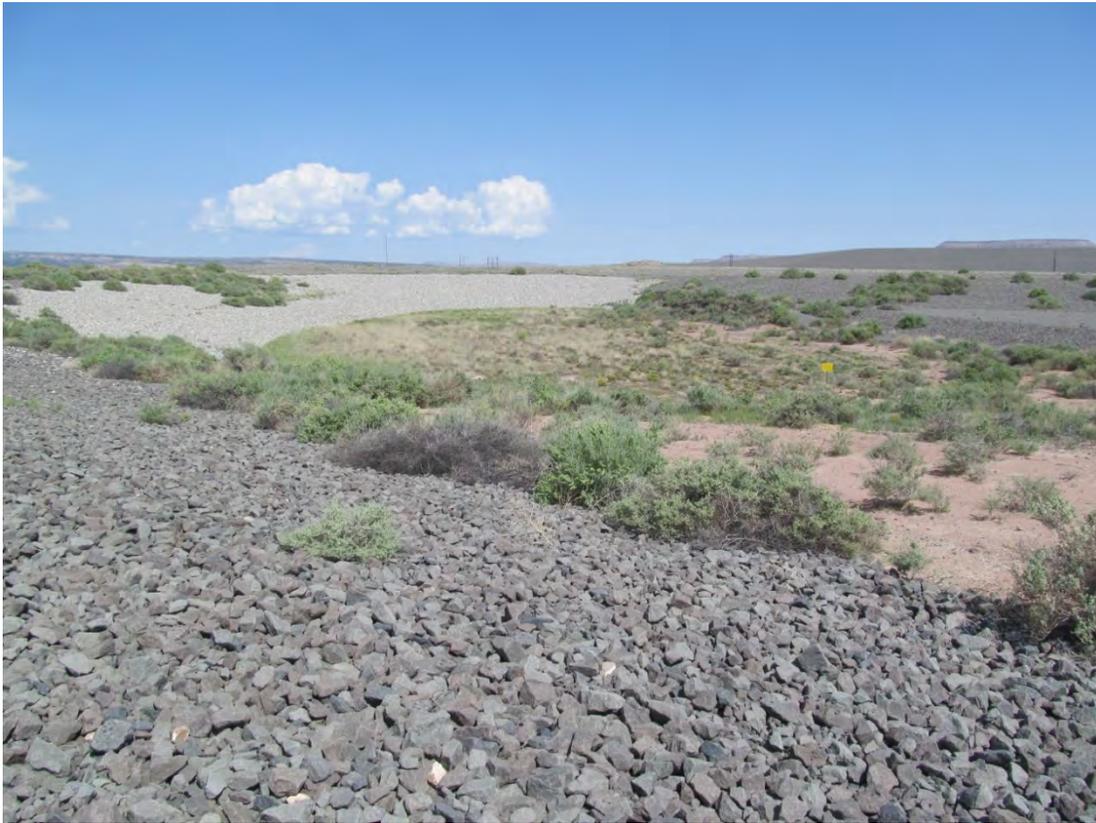
The 2-acre asbestos disposal area is a bowl-like feature just south of the carbonate tailings disposal cell (PL-7). The north, west, and south side slopes of this feature are covered by limestone riprap; the bottom of the bowl (the asbestos cell cover) is grass-covered. The asbestos disposal area was in excellent condition.

BLU 8/2013. PL-7. Asbestos disposal area.

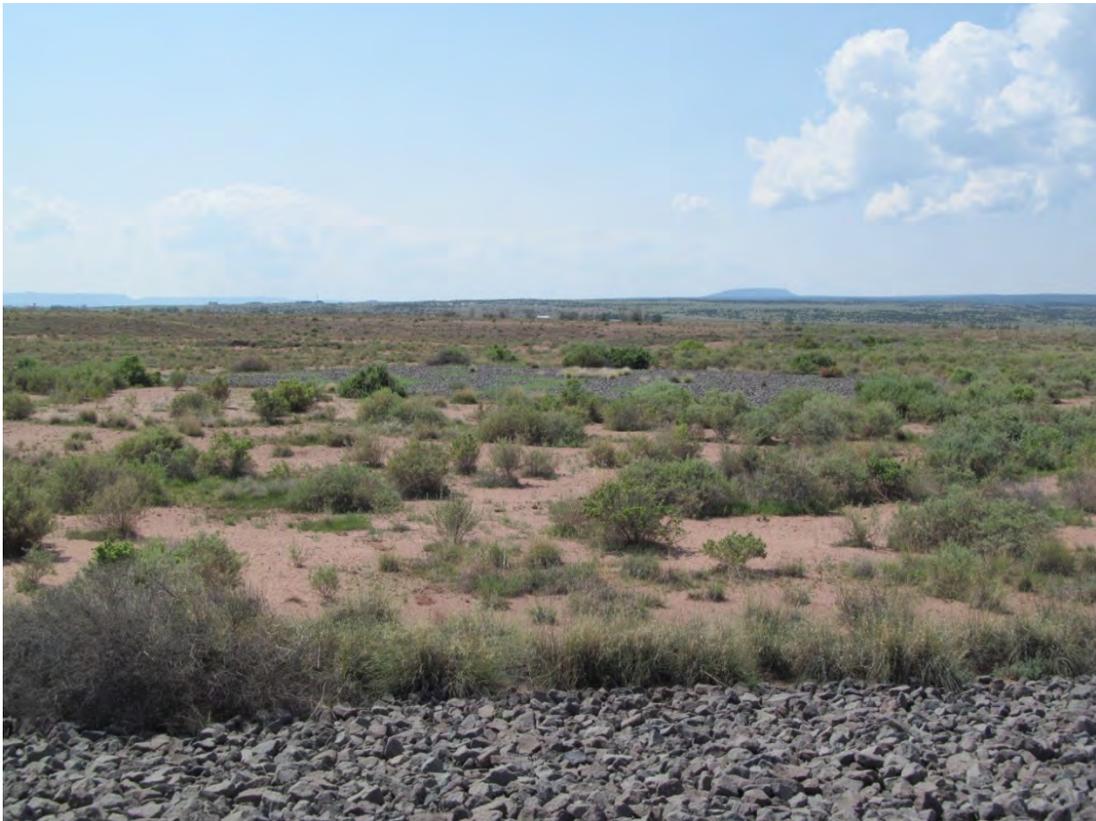
The 11-acre grass-covered disposal area south of the asbestos disposal area was in excellent condition, as was the small riprap-covered PCB cell located within the disposal area (PL-8). The two grass-covered landfills east of the carbonate tailings disposal cell, totaling about 2 acres, were in excellent condition.

BLU 8/2013. PL-8. PCB disposal area (rock-covered area in center of photo).

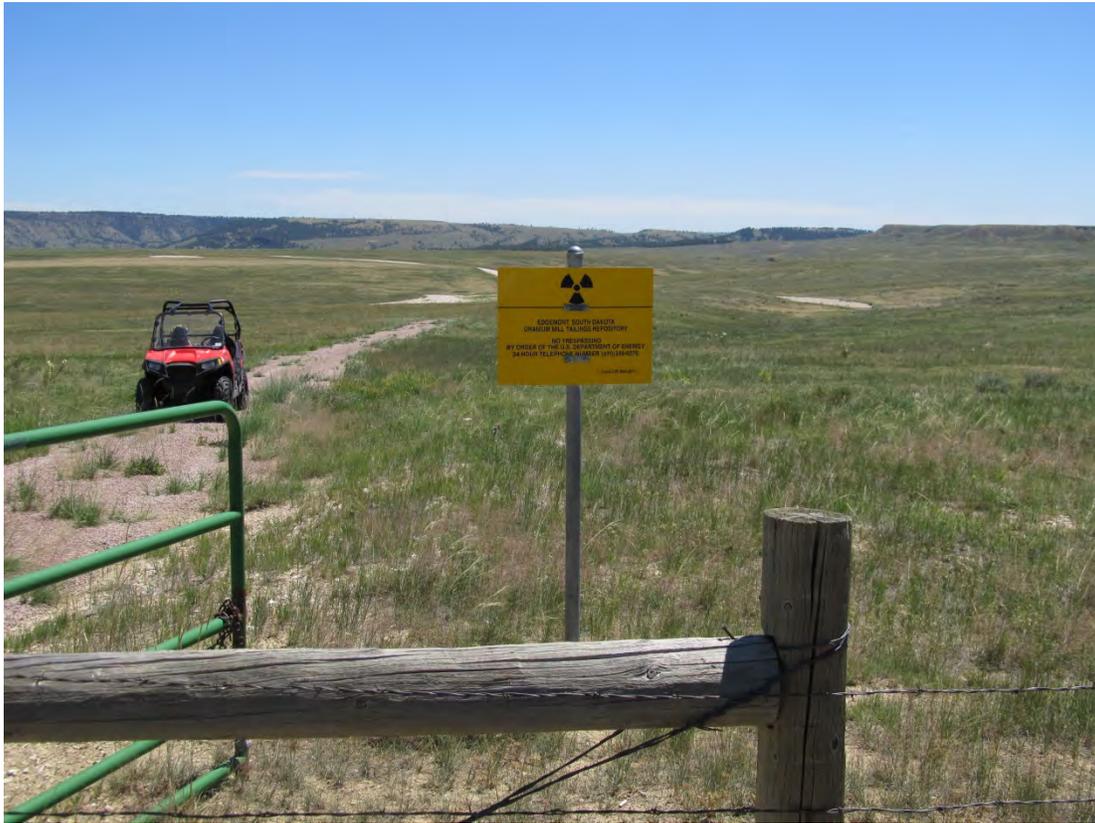
Access to the Edgemont site is immediately off County Road 6N. No private property is crossed to gain access. The entrance sign was in excellent condition (PL-1).

EDG 6/2013. PL-1. Site entrance sign.

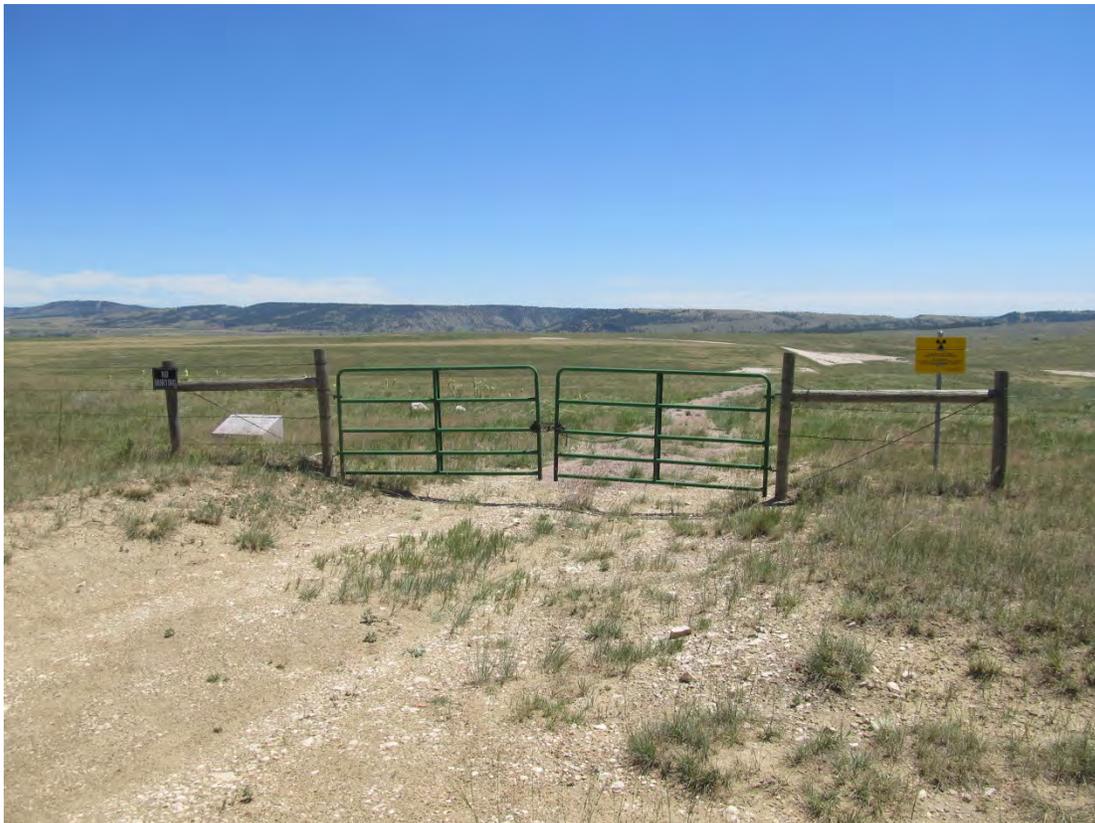
A tubular metal entrance gate is secured by a locked chain and was in excellent condition (PL-2). Three wire gates are along the perimeter fence: at the northwest corner of the property; approximately 700 feet north of the southeast corner; and at the southeast corner of the site. All gates were closed and in good condition.

EDG 6/2013. PL-2. Site entrance gate.

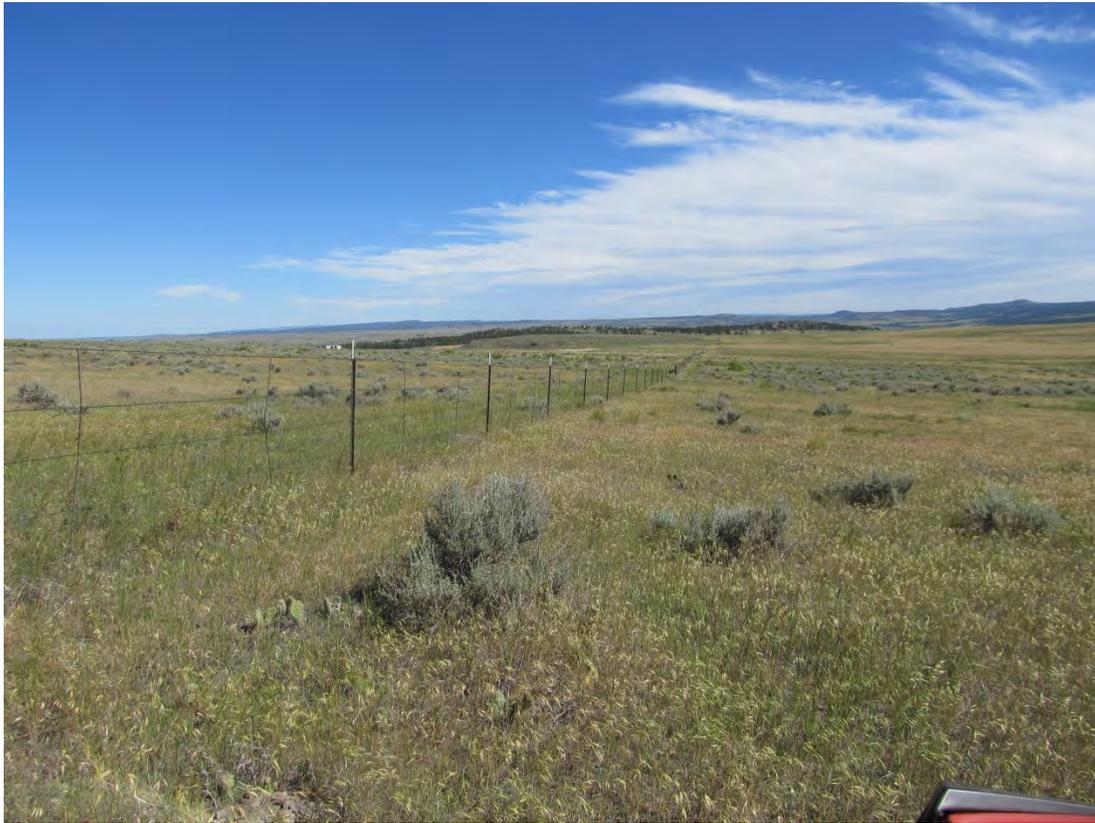
EDG 6/2013. PL-3. West perimeter fence.

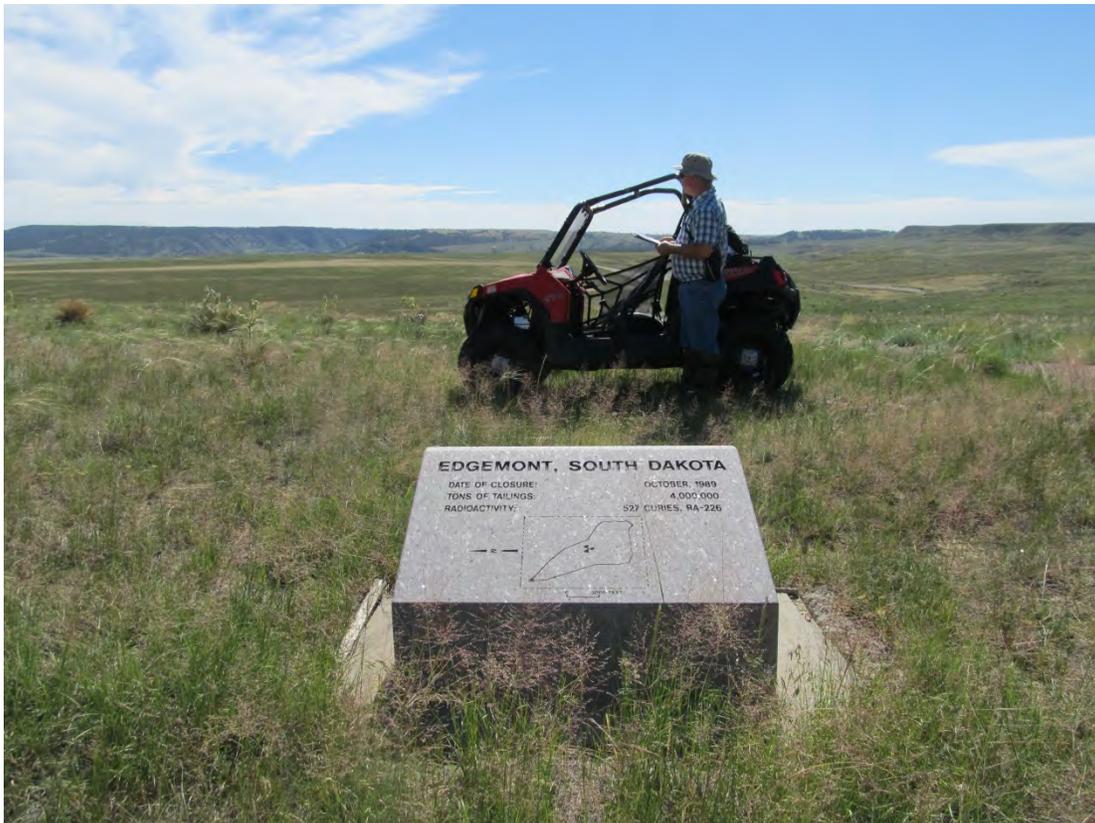
One granite site marker identifying the site is just inside the entrance gate and was in excellent condition (PL-4).

EDG 6/2013. PL-4. Site marker.

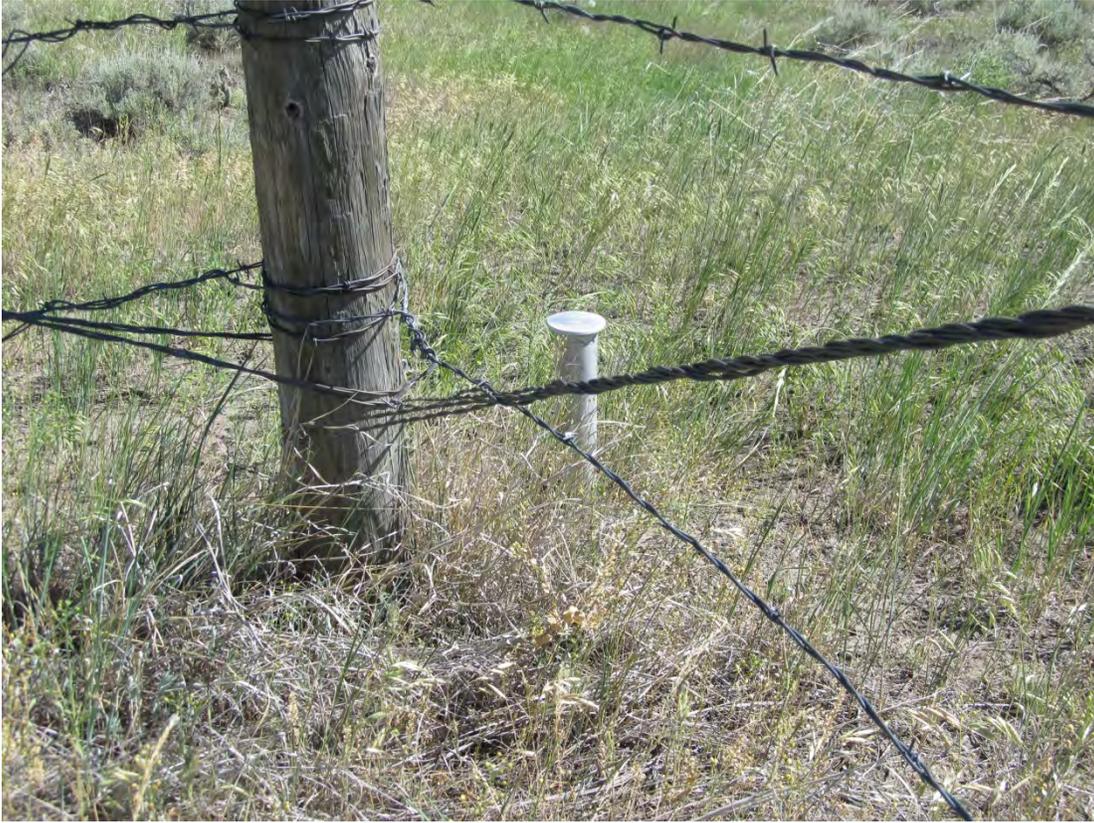
Four boundary monuments—one at each corner of the property—were in excellent condition (PL-5).

EDG 6/2013. PL-5. Boundary monument BM-2.

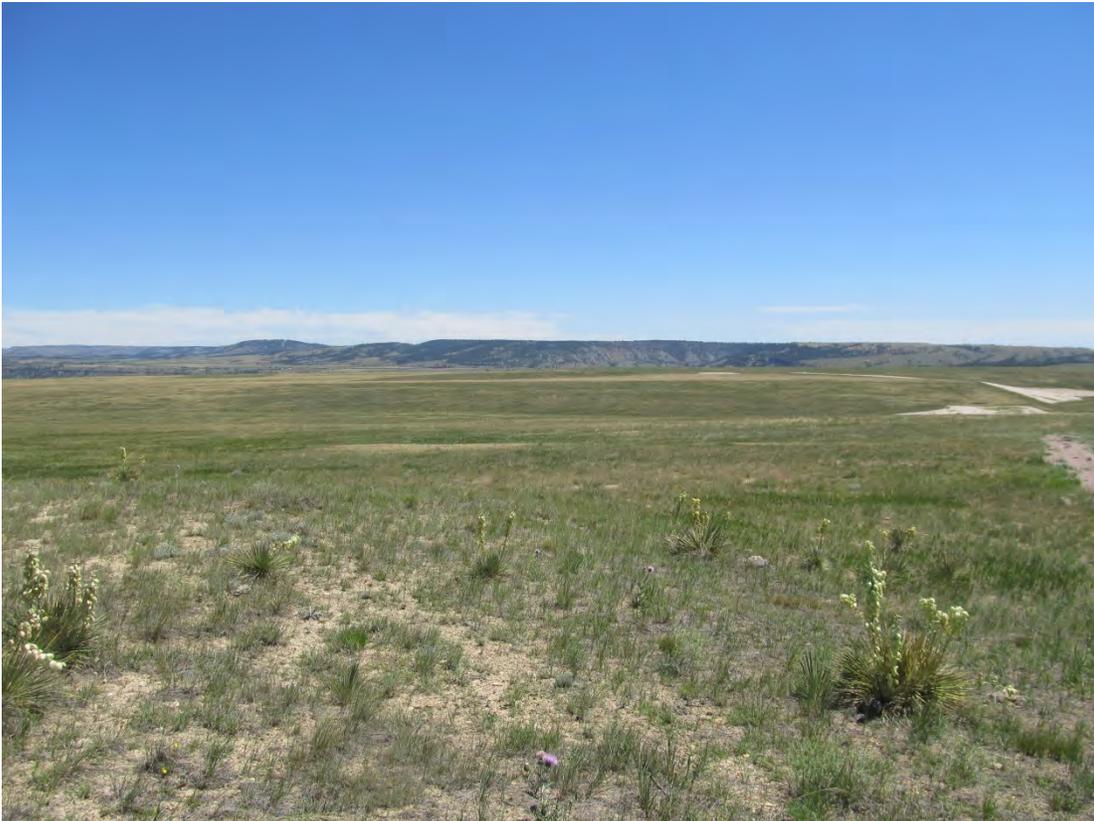
The 100-acre top of the disposal cell, completed in 1989, is grass-covered and was in good condition (PL-6). Although numerous cattle trails are present on the cell, no signs of erosion, settling, or other modifying processes that might affect the integrity of the cell were noted.

EDG 6/2013. PL-6. Southeast portion of disposal cell cover.

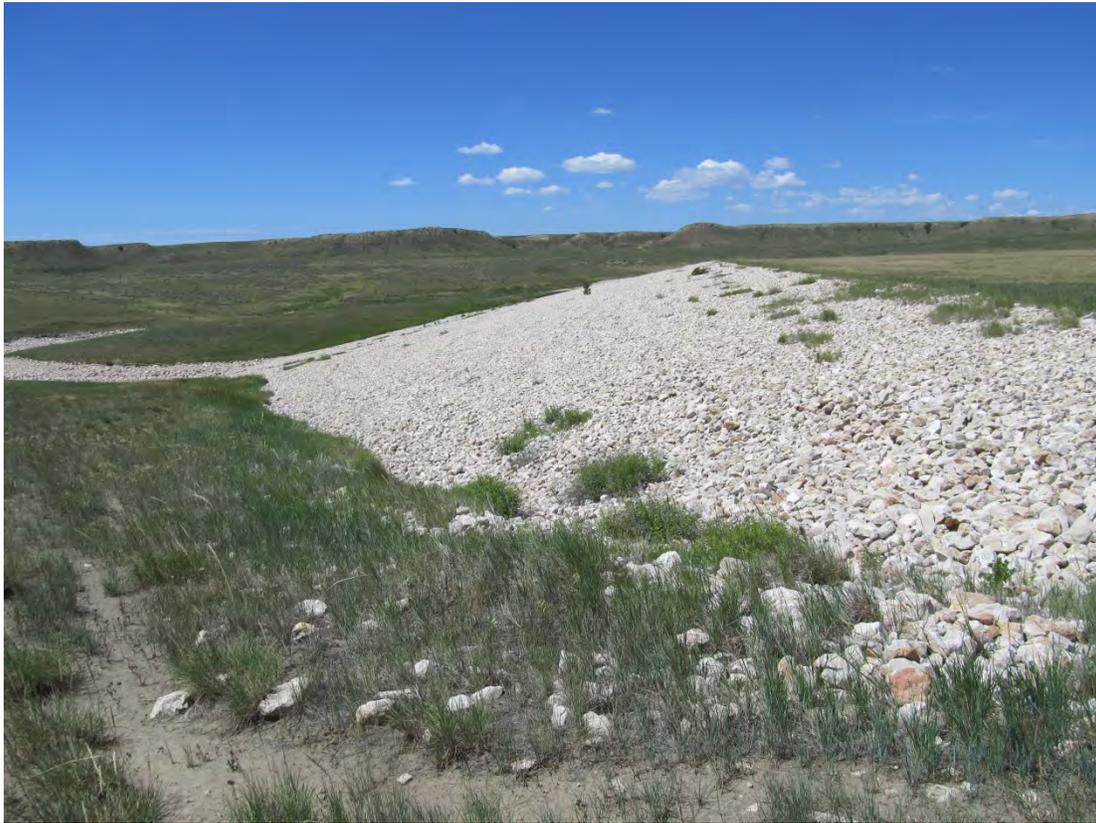
The tailings embankment face, the steepest manmade slope onsite, is covered with riprap, and was in excellent condition (PL-7). The slope is stable, and the riprap showed no signs of degradation. Scattered plants, mostly grass and annual weeds, grow in the riprap. These plants do not threaten the stability or function of the embankment face.

EDG 6/2013. PL-7. Northeast portion of tailings embankment.

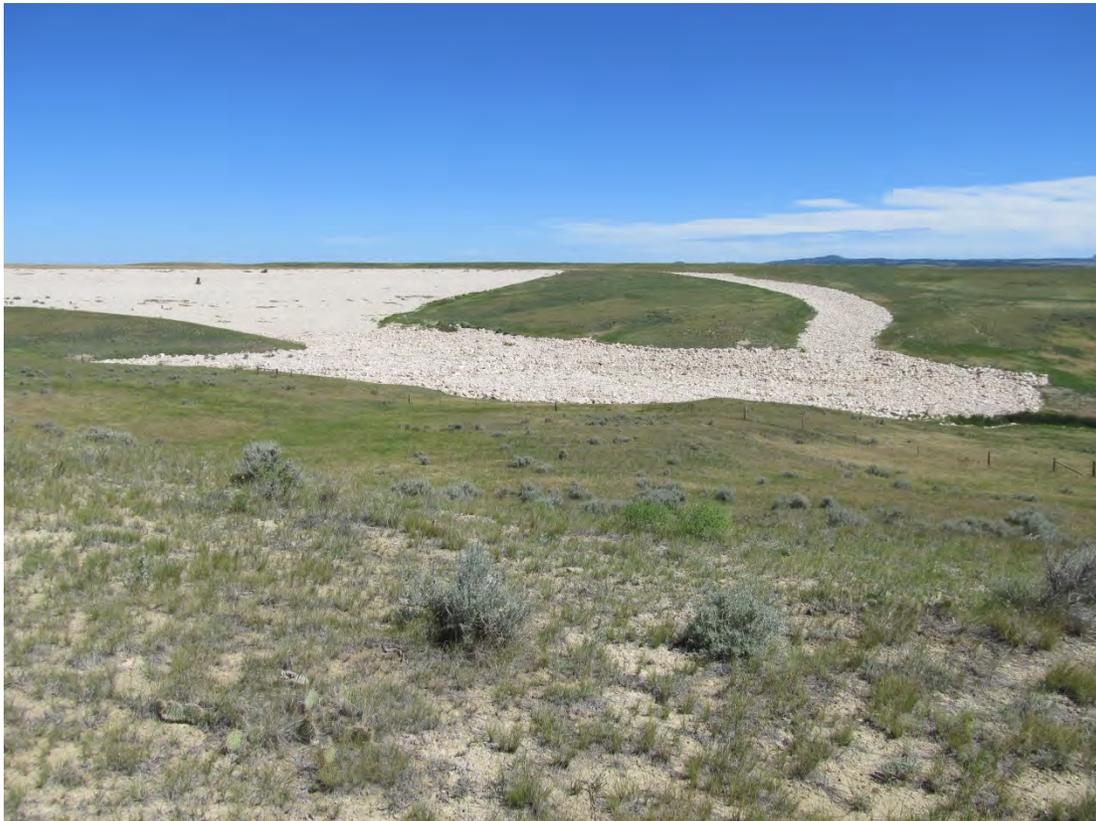
Diversion and drainage channels are grass-covered on their upslope portions (these are gentle swales on each side of the disposal cell) and riprap-armored on their downslope portions and on steeper slopes. These structures were in excellent condition (PL-8). Grass in the vegetated portions of the channels upgradient of the tailings embankment was in good condition, and there was no evidence of erosion. Minor amounts of vegetation are present in the riprap. The vegetation helps to stabilize these areas and does not impair the function of the channels. Precipitation runoff pooling and wetland vegetation are present at the base of the diversion channels.

EDG 6/2013. PL-8. Tailings embankment, drainage channel, and east diversion channel.

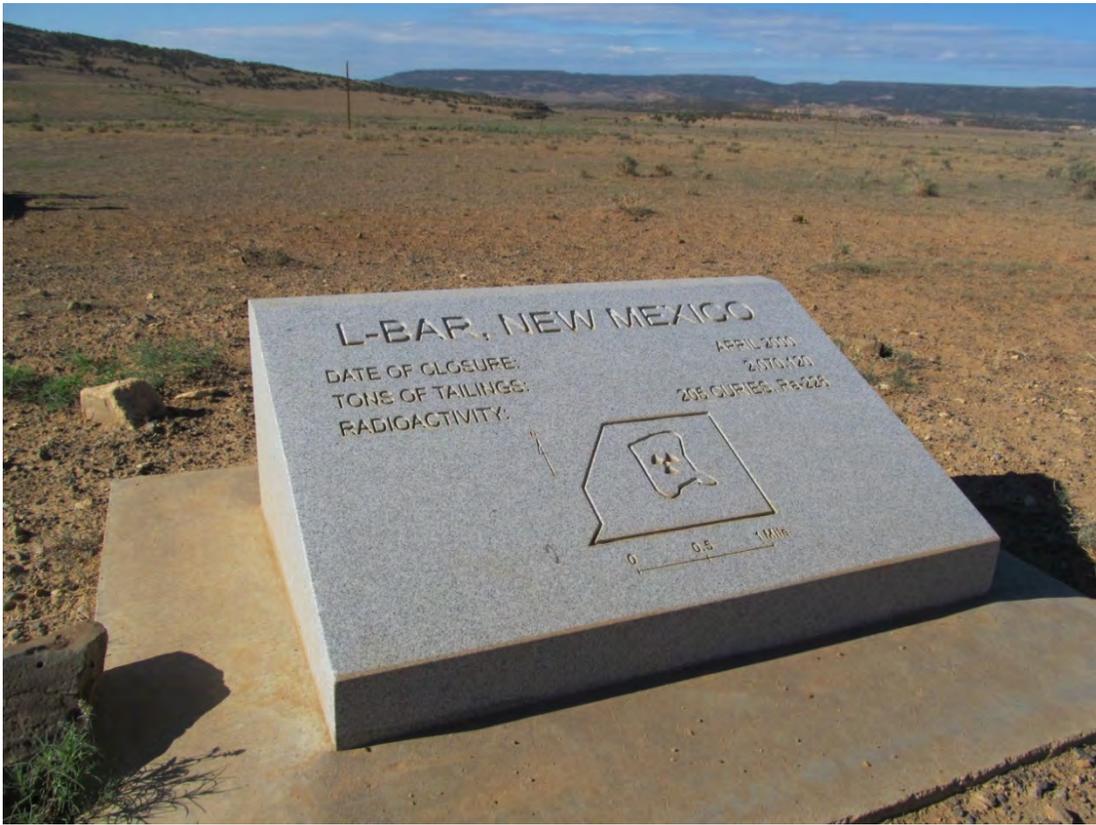
A granite site marker is located north of the disposal cell adjacent to the site access road. The marker was in excellent condition (PL-3).

BAR 8/2013. PL-3. Site marker at site entrance.

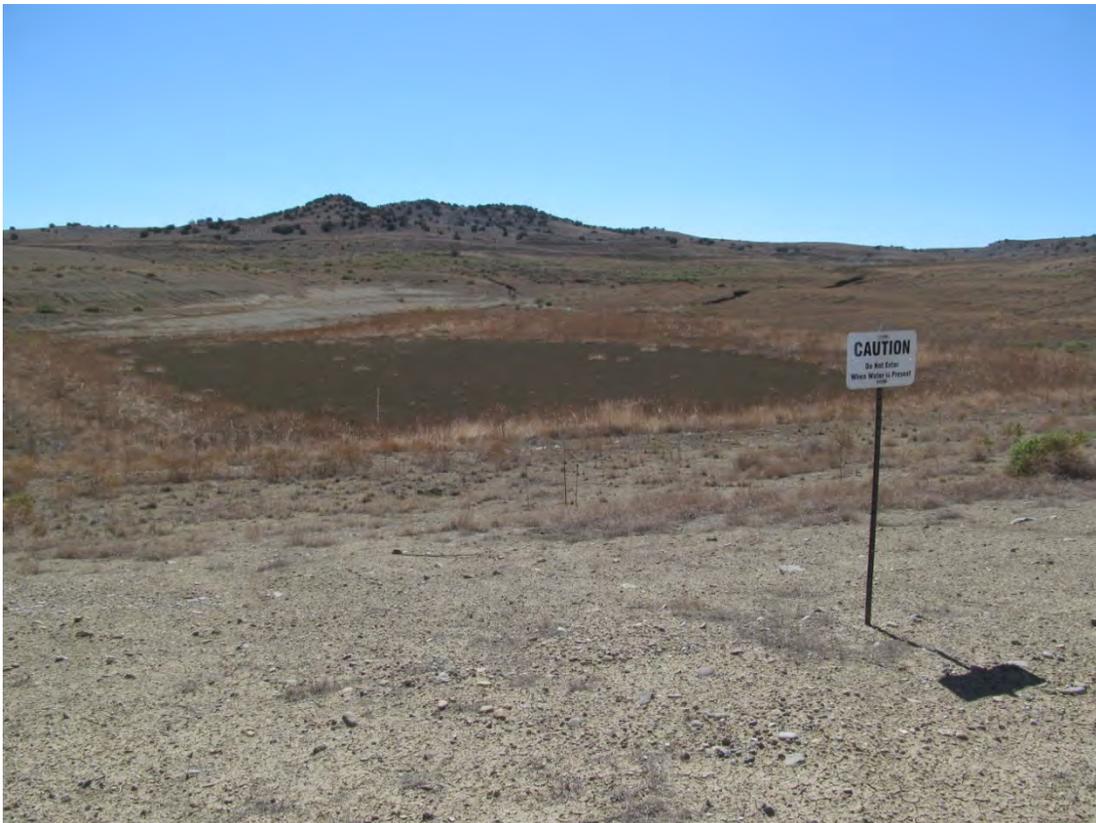
BAR 8/2013. PL-6. Sediment trap (dry).

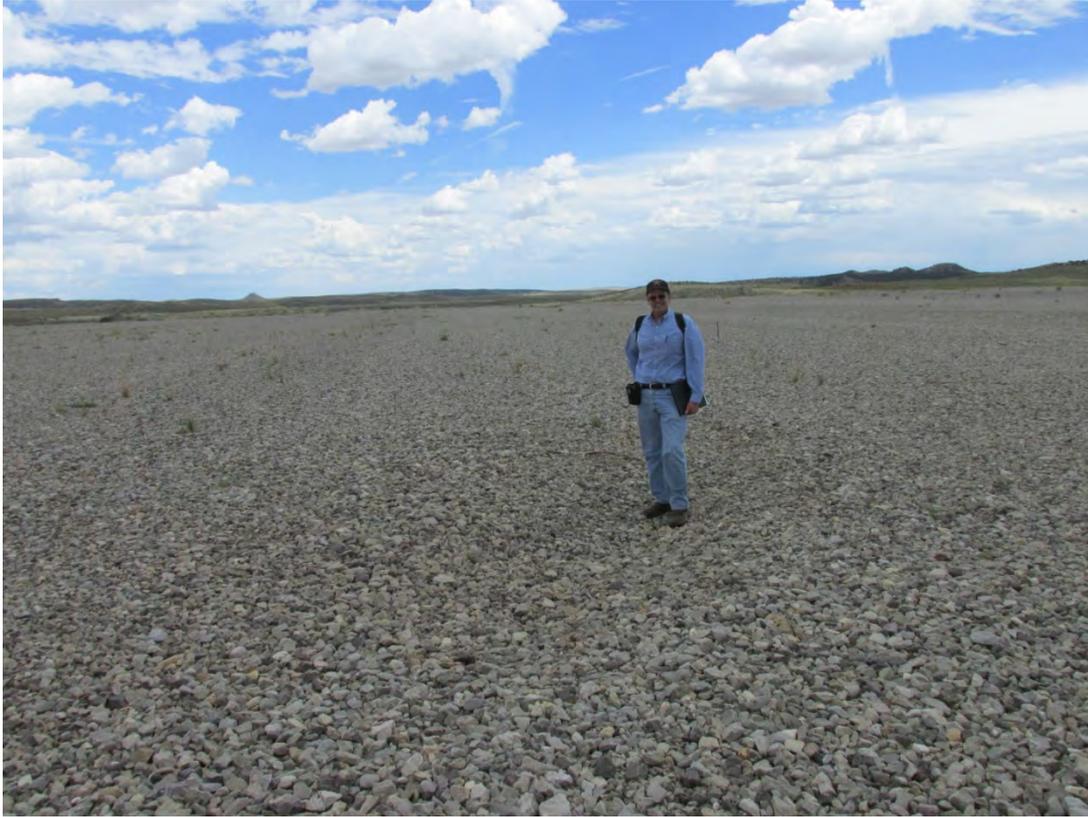
MAW 8/2013. PL-6. Small shallow depression on disposal cell top slope.

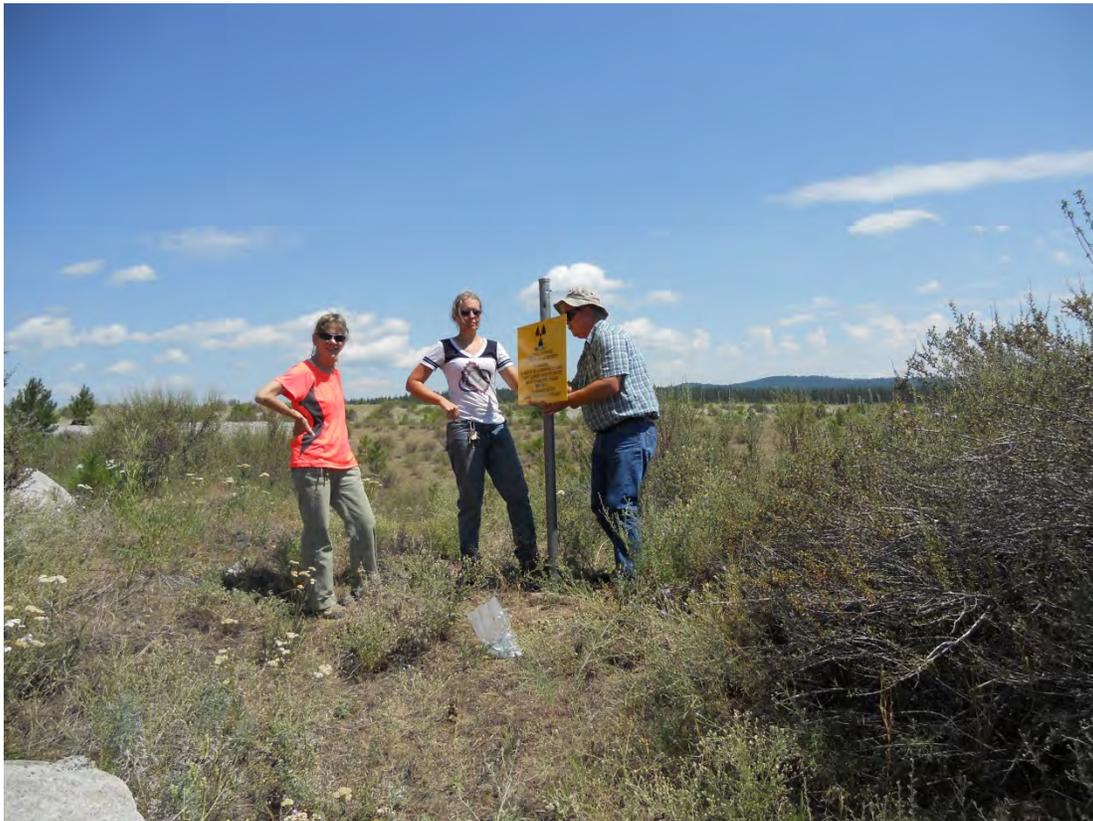
SHE 7/2013. PL-1. Replacement of perimeter sign P6.

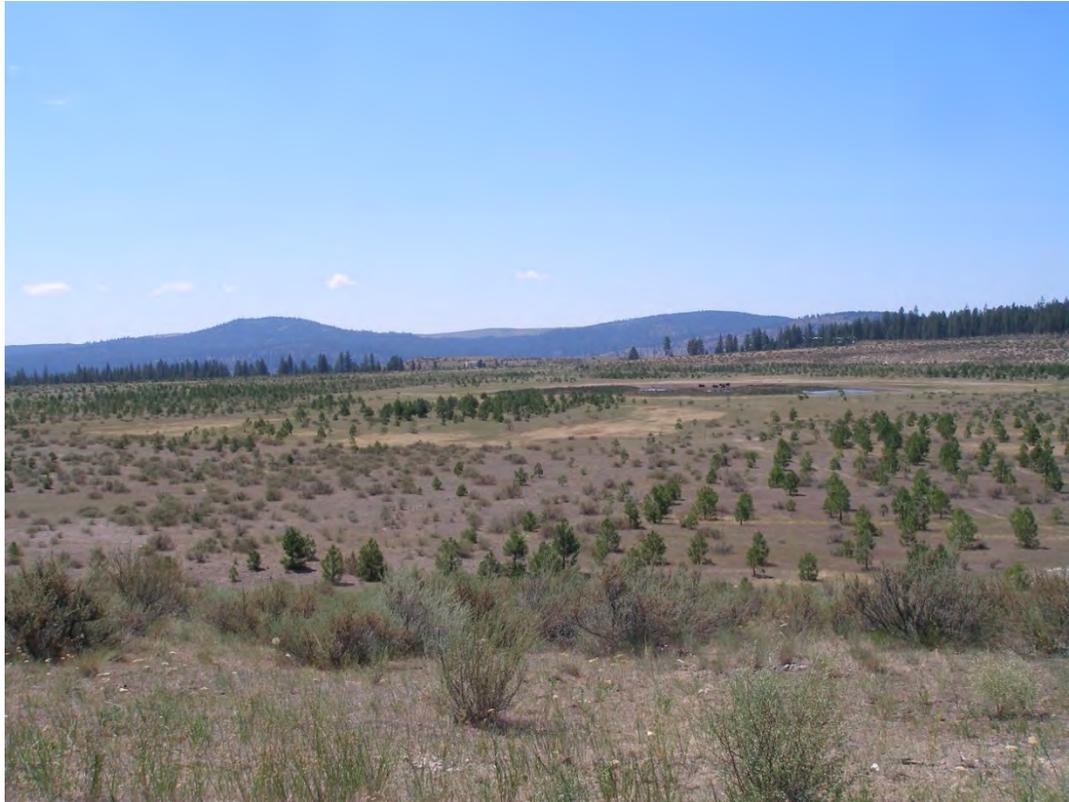
SHE 7/2013. PL-5. Pond 1 on tailings impoundment cover.

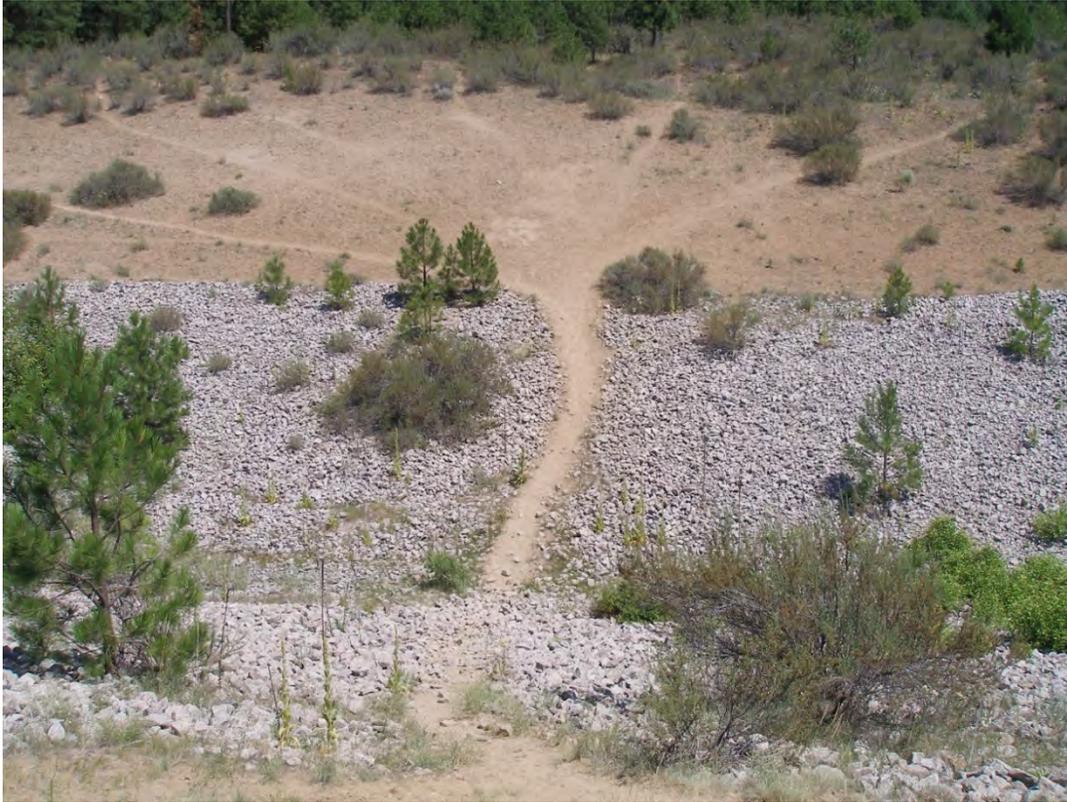
SHE 7/2013. PL-6. Animal trail across diversion channel.

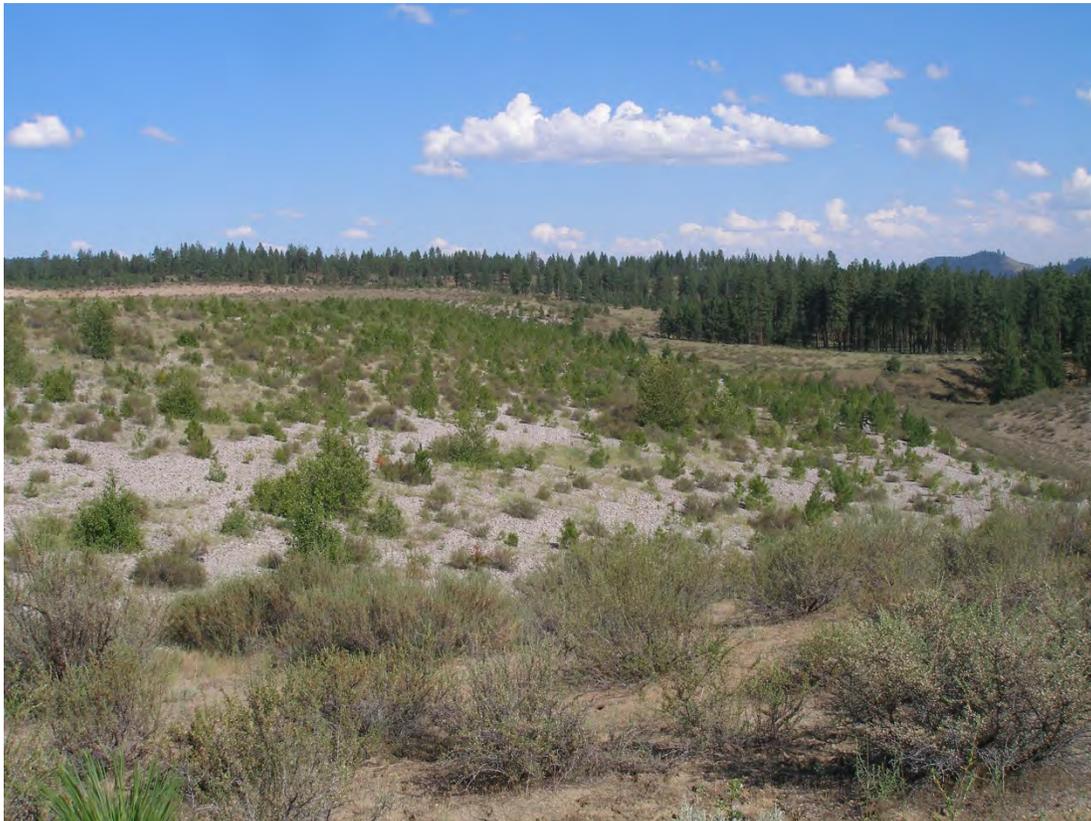
SHE 7/2013. PL-7. Tailings dam face.

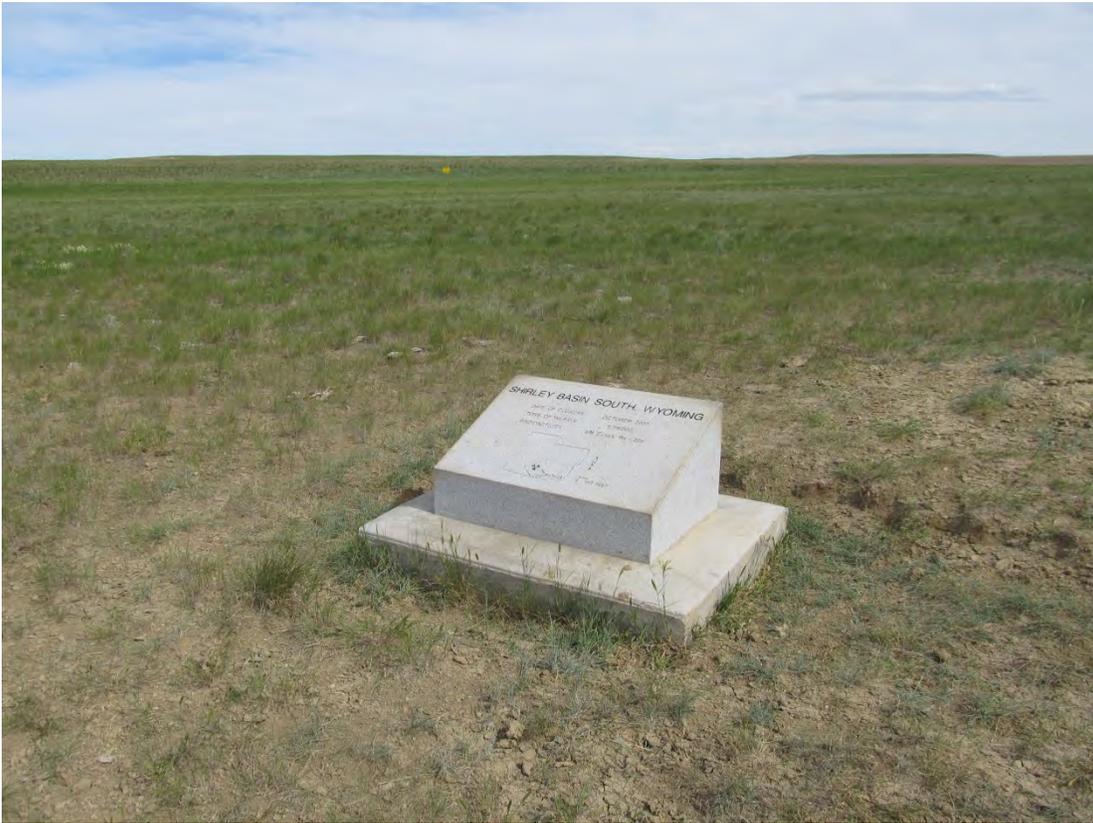
The granite site marker, which is located at the site entrance, was in excellent condition (PL-3). All 26 boundary monuments delineating DOE property were located and were in excellent condition (PL-4).

SBS 6/2013. PL-3. Site marker.
