U.S. DEPARTMENT OF
ENERGY

Legacy
Management

2013 Annual Site Inspection and Monitoring Report for Uranium Mill Tailings Radiation Control Act Title II Disposal Sites

November 2013

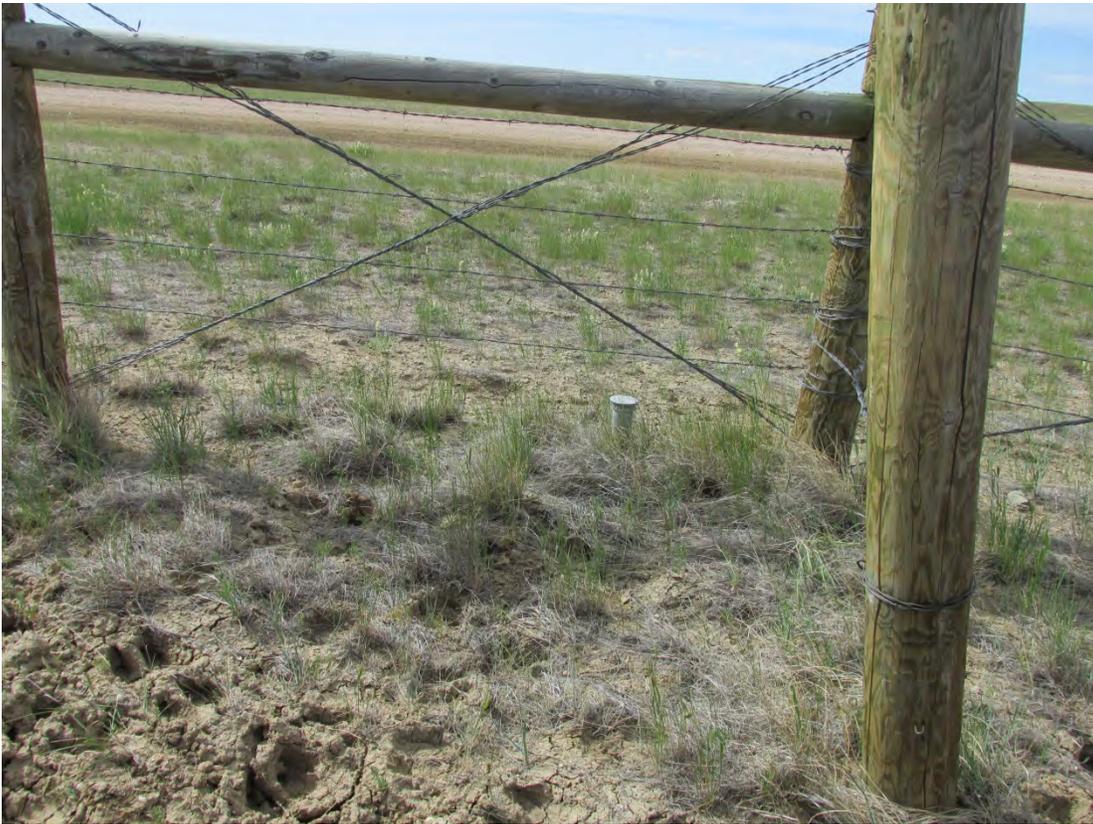
The granite site marker, which is located at the site entrance, was in excellent condition (PL-3). All 26 boundary monuments delineating DOE property were located and were in excellent condition (PL-4).

SBS 6/2013. PL-4. Boundary monument BM-16.

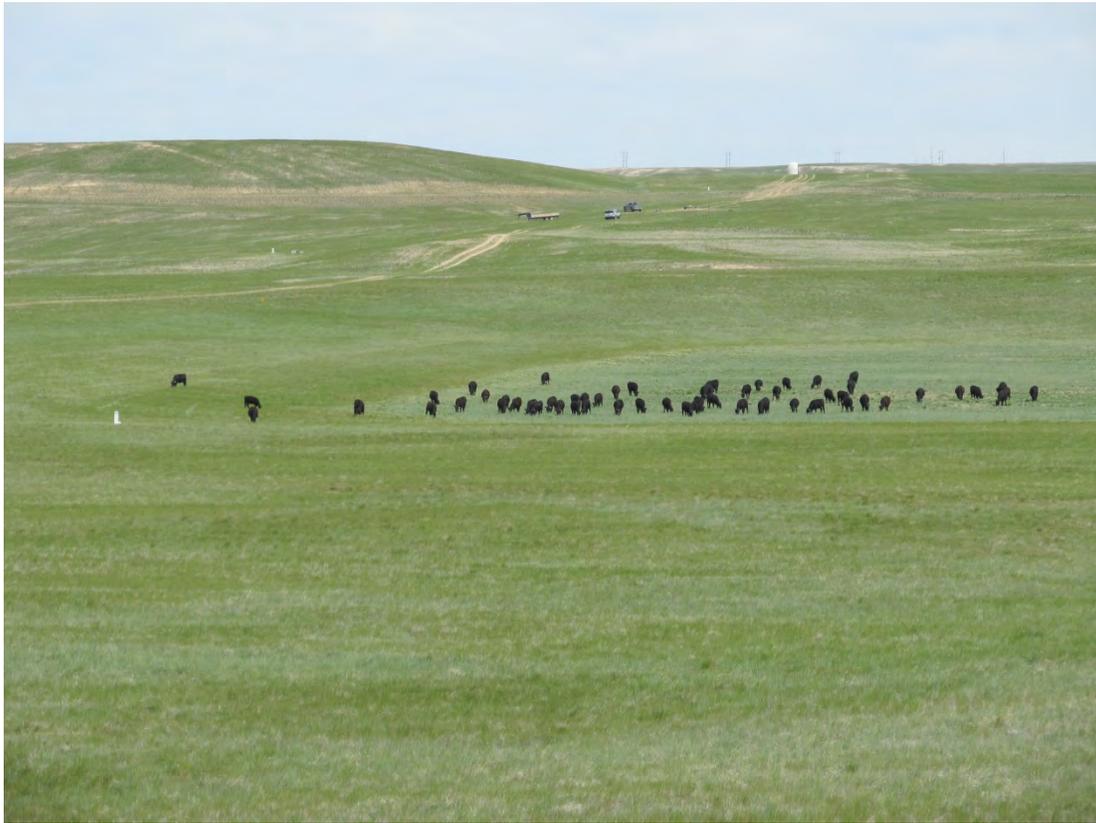
SBS 6/2013. PL-9. Cattle in east drainage basin.
