# Non-uniform Aging on Super Duty Diesel Truck Aged Urea Cu/Zeolite SCR Catalysts

Ford Motor Company

Pacific Northwest National Laboratory

September 28, 2010  
2010 DEER Conference

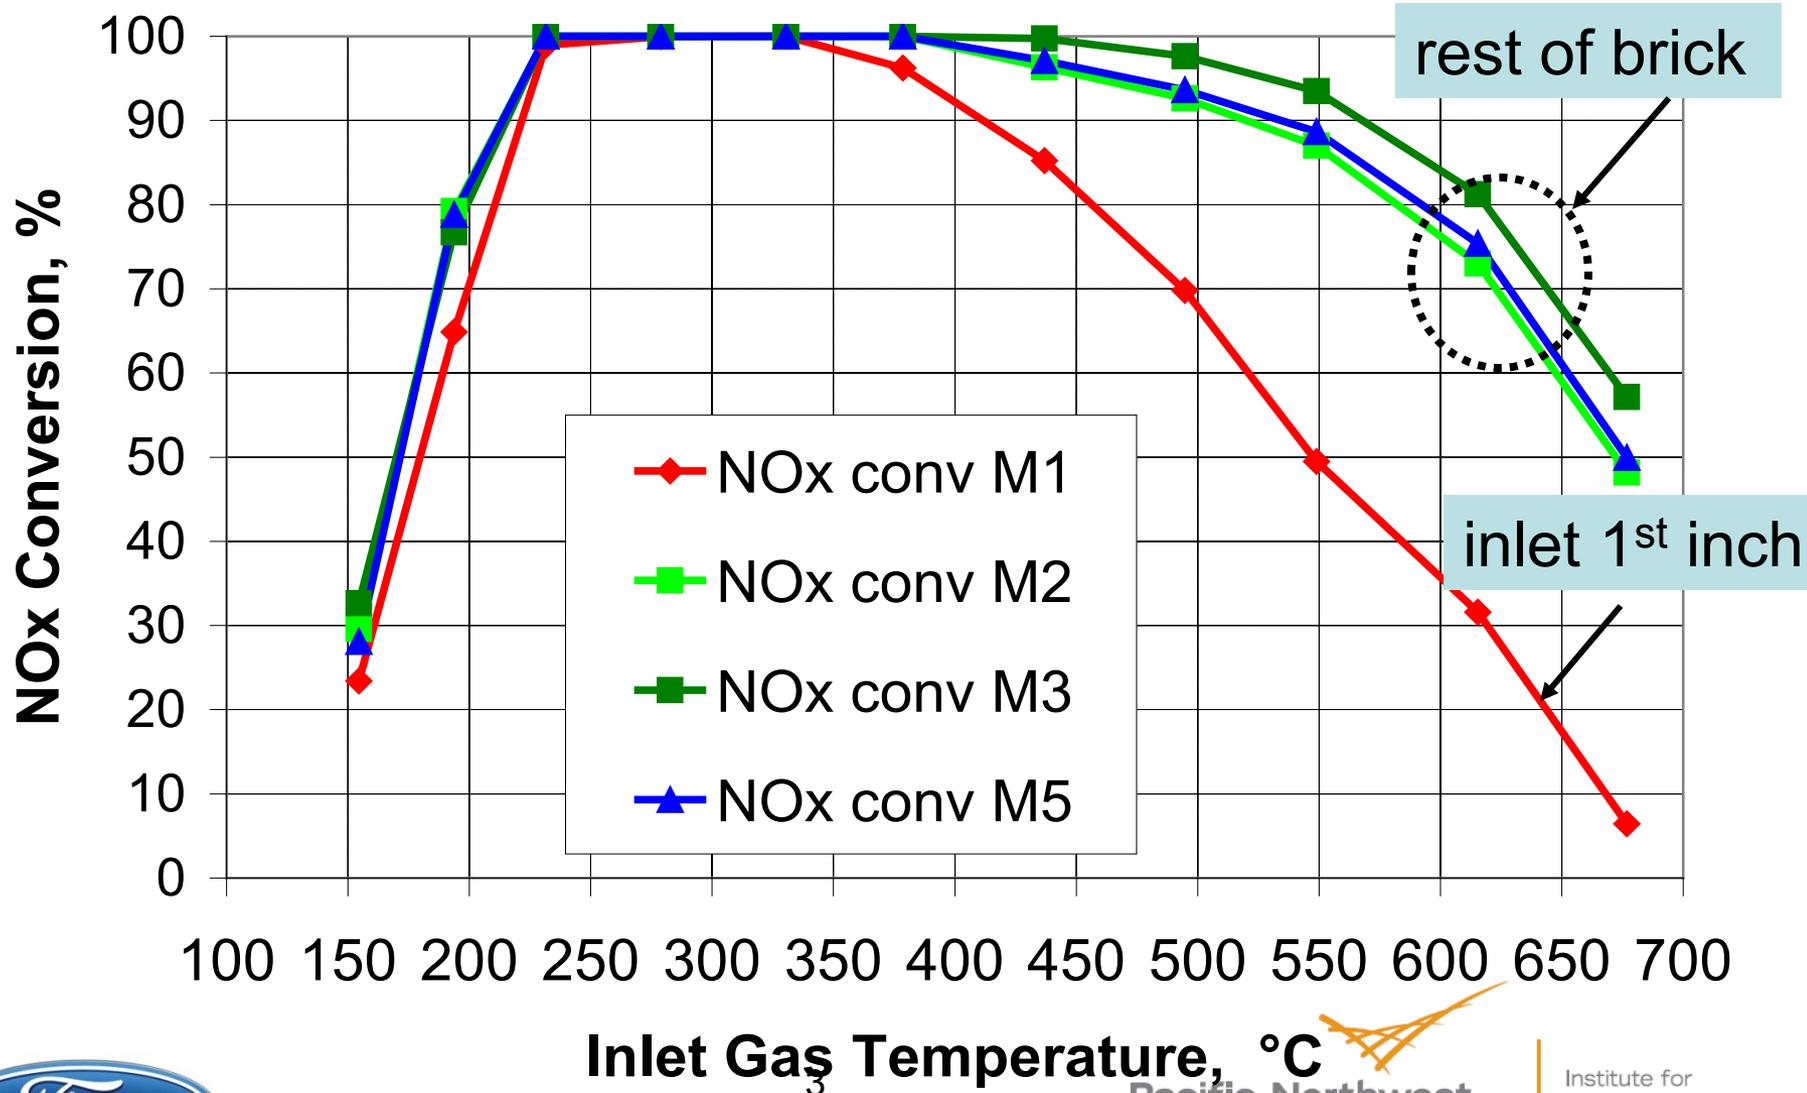
# Non-uniform NOx Conversion

NOx-NH3 SCR Steady State, SV=30K, 350ppm NO/350ppm NH3

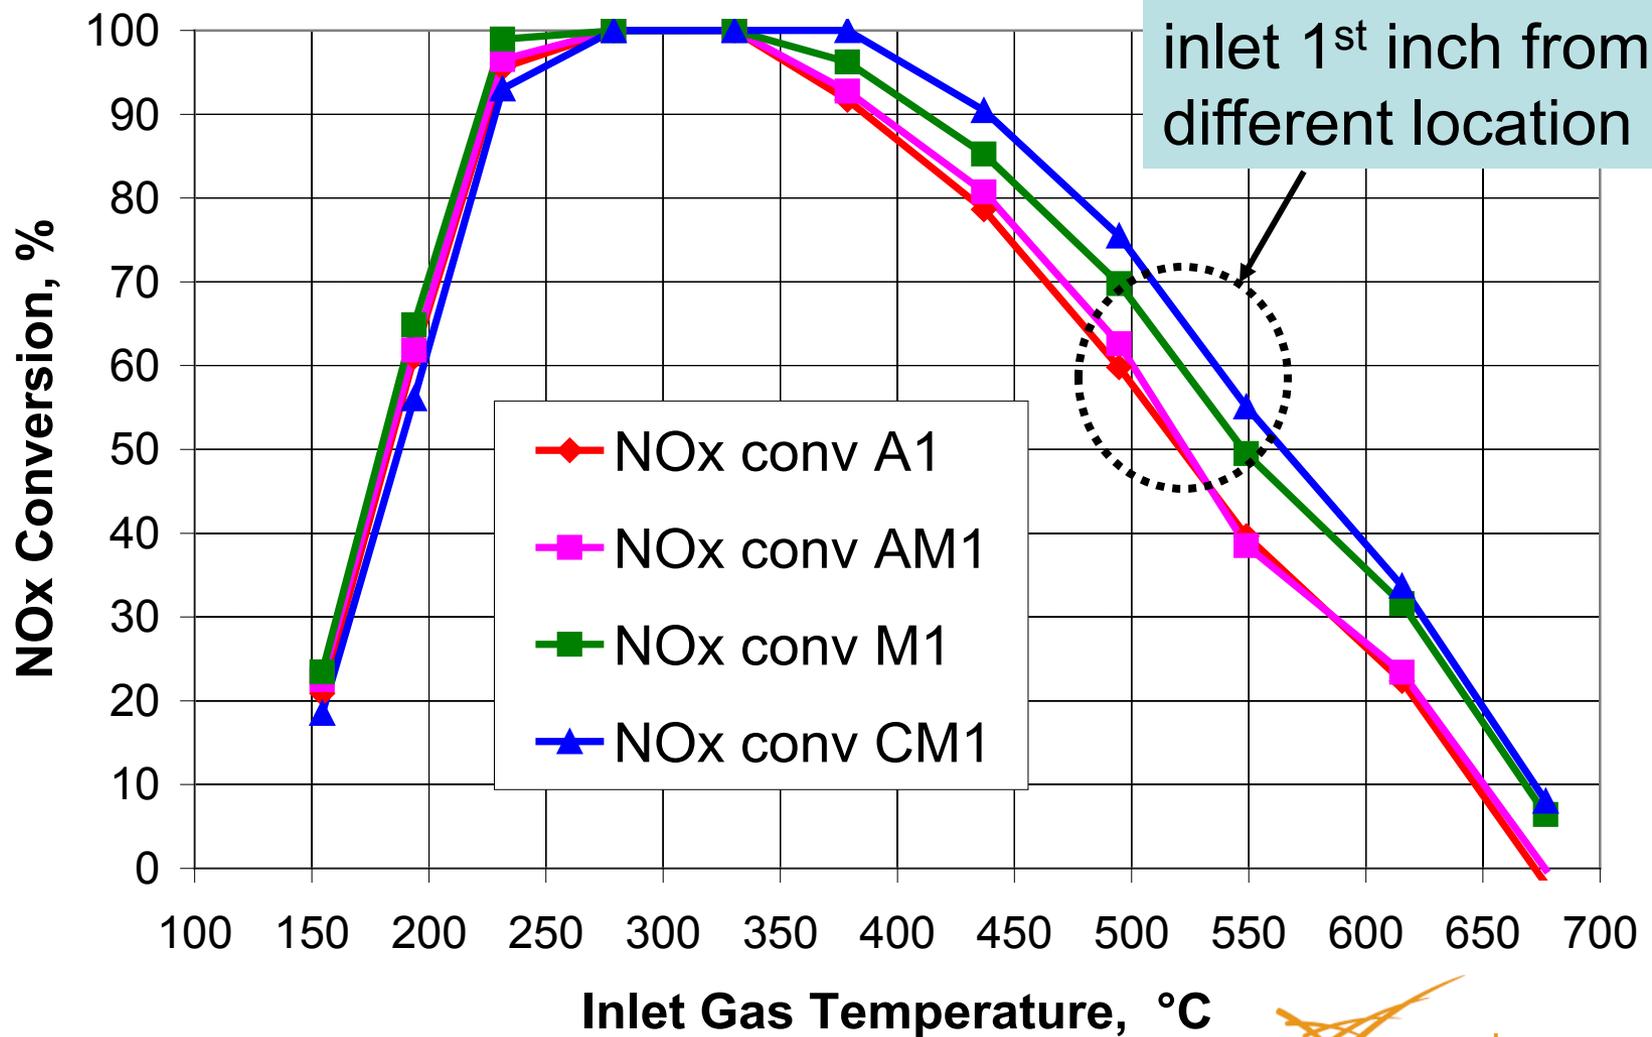
# 1<sup>st</sup> Inch Deactivated the Most

NO<sub>x</sub>-NH<sub>3</sub> SCR Steady State, SV=30K, 350ppm NO/350ppm NH<sub>3</sub>

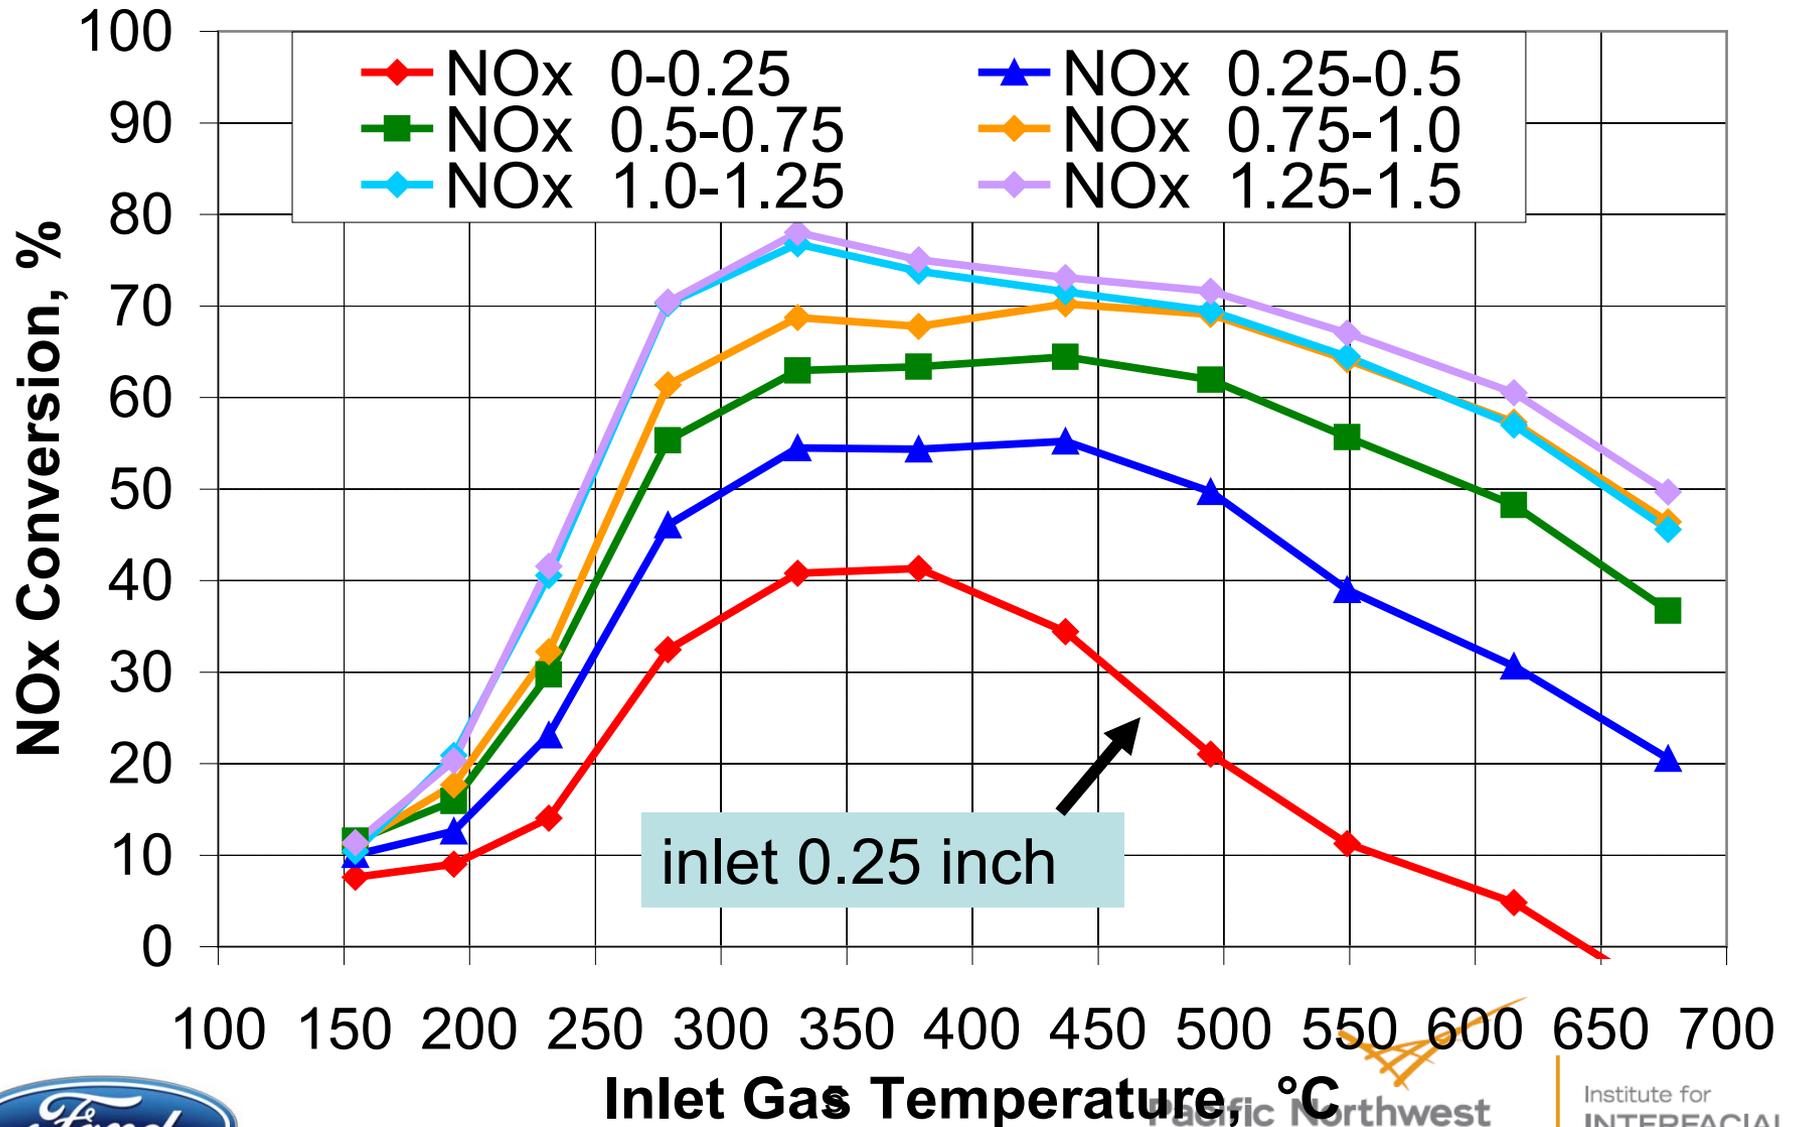
# Inlet Section: Non-uniform NOx Conversion

NOx-NH3 SCR Steady State, SV=120K, 350ppm NO/350ppm NH3

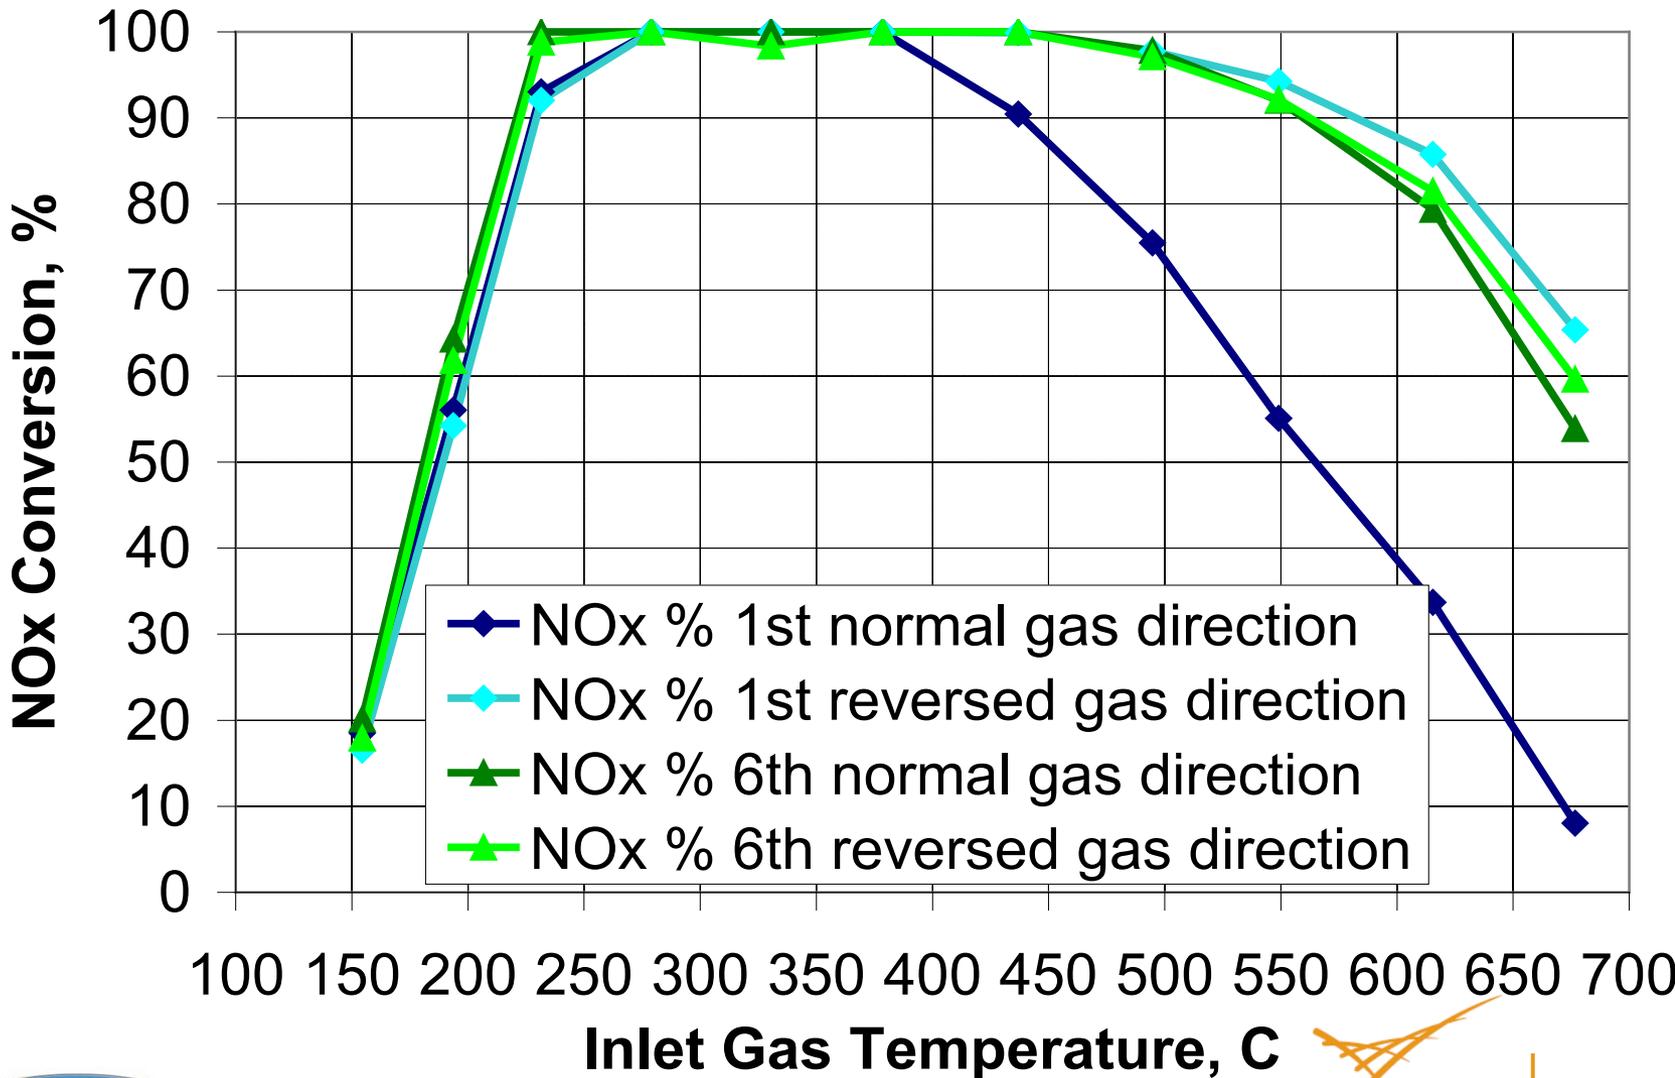
# 1st inch deactivation – the deterioration of NOx conversion on the 1st inch disappears after reversing the gas flow direction.

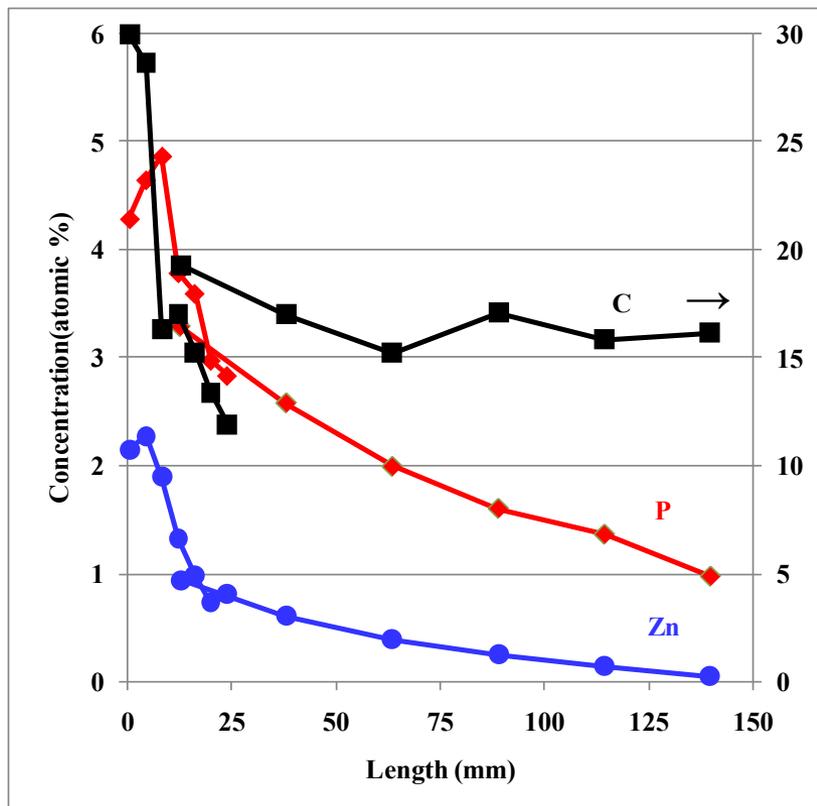
# 1st inch XPS&XRF – C, S, P, Zn

- Significant carbon deposition of front side (~ 7 % for fresh sample and ~ 1 % for lab aged sample).
- Carbon deposition may account for some activity loss, especially 1<sup>st</sup> run.
- P and Zn deposition on the inlet end of the monolith.
- Practically no sulfur in the samples.

XRF	<u>1st</u>	<u>2nd</u>	<u>3rd</u>	<u>4th</u>	<u>5th</u>	<u>6th</u>
<b>P</b>	0.043	0.020	0.015	0.010	0.009	0.006
<b>S</b>	0.006	0.006	0.005	0.005	0.005	0.004
<b>Zn</b>	0.008	0.003	0.003	0.002	0.002	0.002

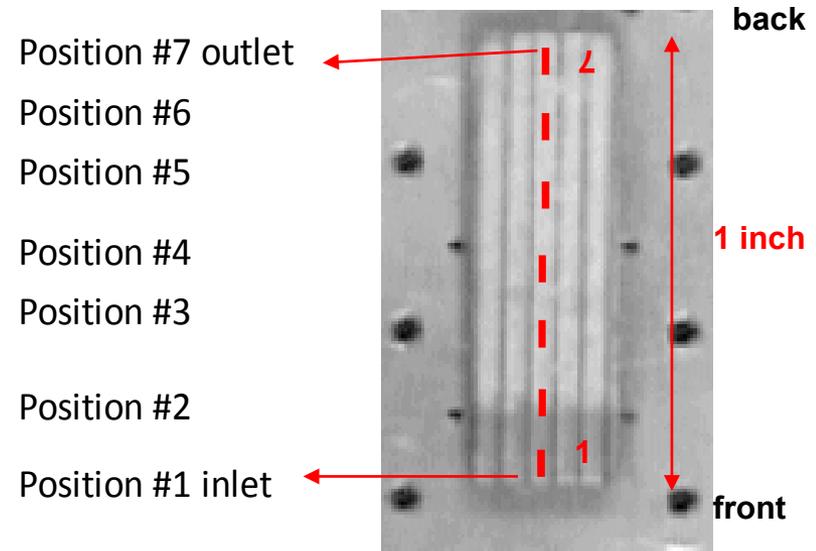
- #1 located 0.5 mm from front end
- Each spot spaced by 4 mm

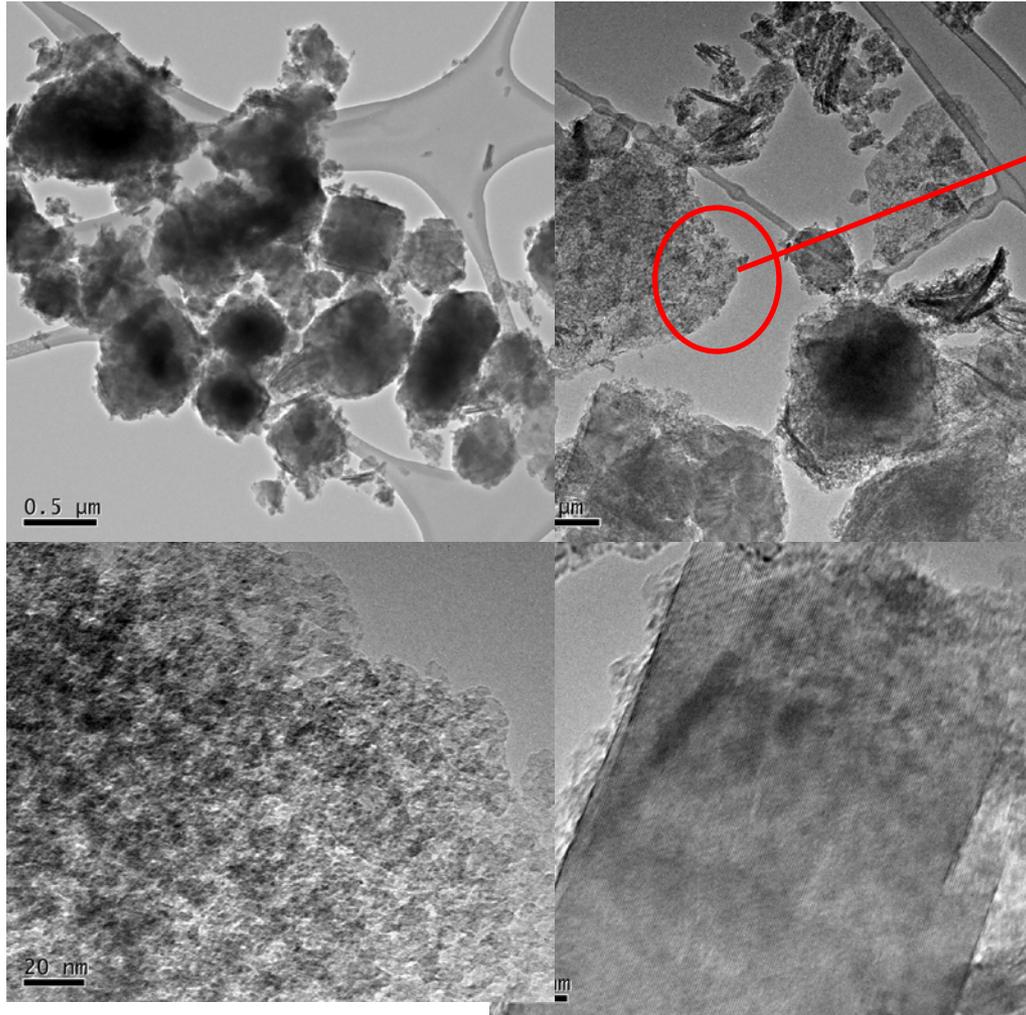
# 1<sup>st</sup> inch – TEM

- Morphology shows little change after engine aging other than perhaps including somewhat increased amorphous (or mixture with support(?)) areas.
- No evidence for Cu sintering

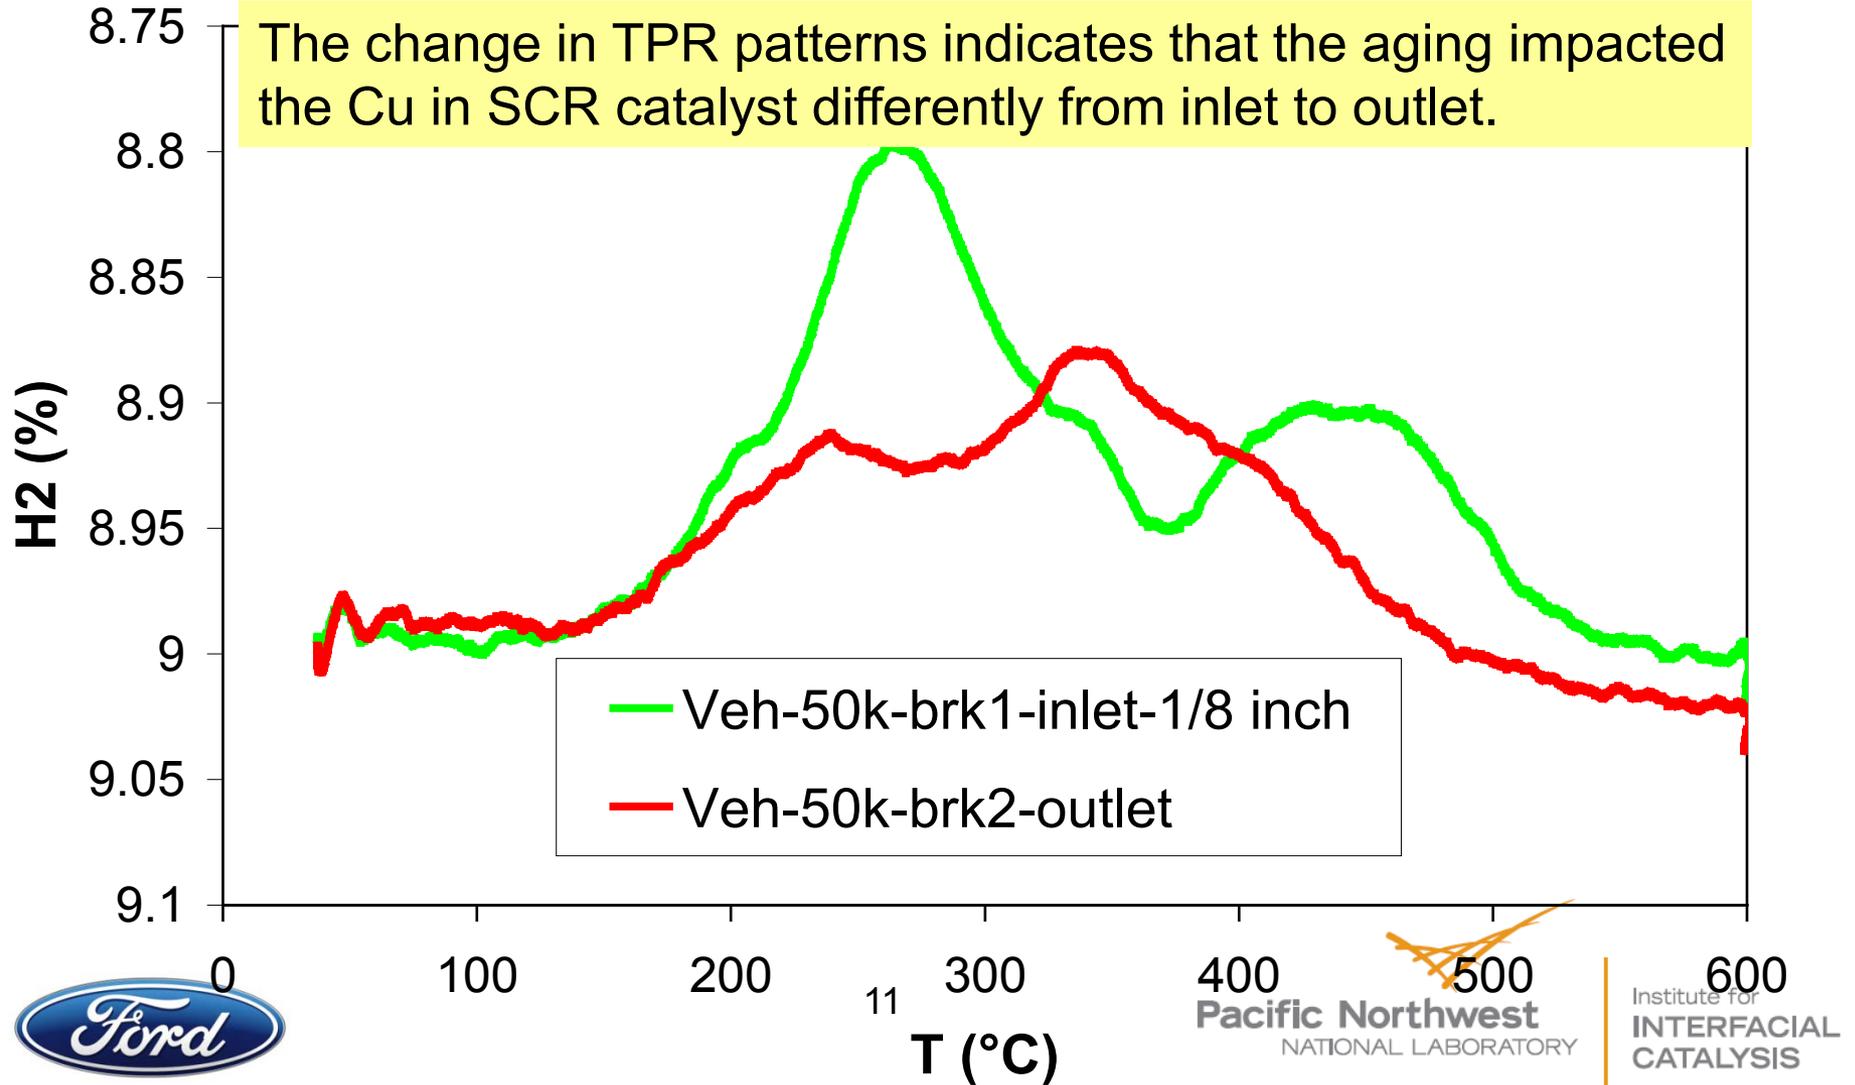
# 1<sup>st</sup> inch – TPR

TPR with 10°C/min to 600°C using 9%H<sub>2</sub>/Ar

The change in TPR patterns indicates that the aging impacted the Cu in SCR catalyst differently from inlet to outlet.
