PanTEX

Deluge System Activation Failure

Brian T. Rhodes, PXS0, SSO Fire Protection

Randy Lanham, B&W Pantex, Fire Protection Program Manager

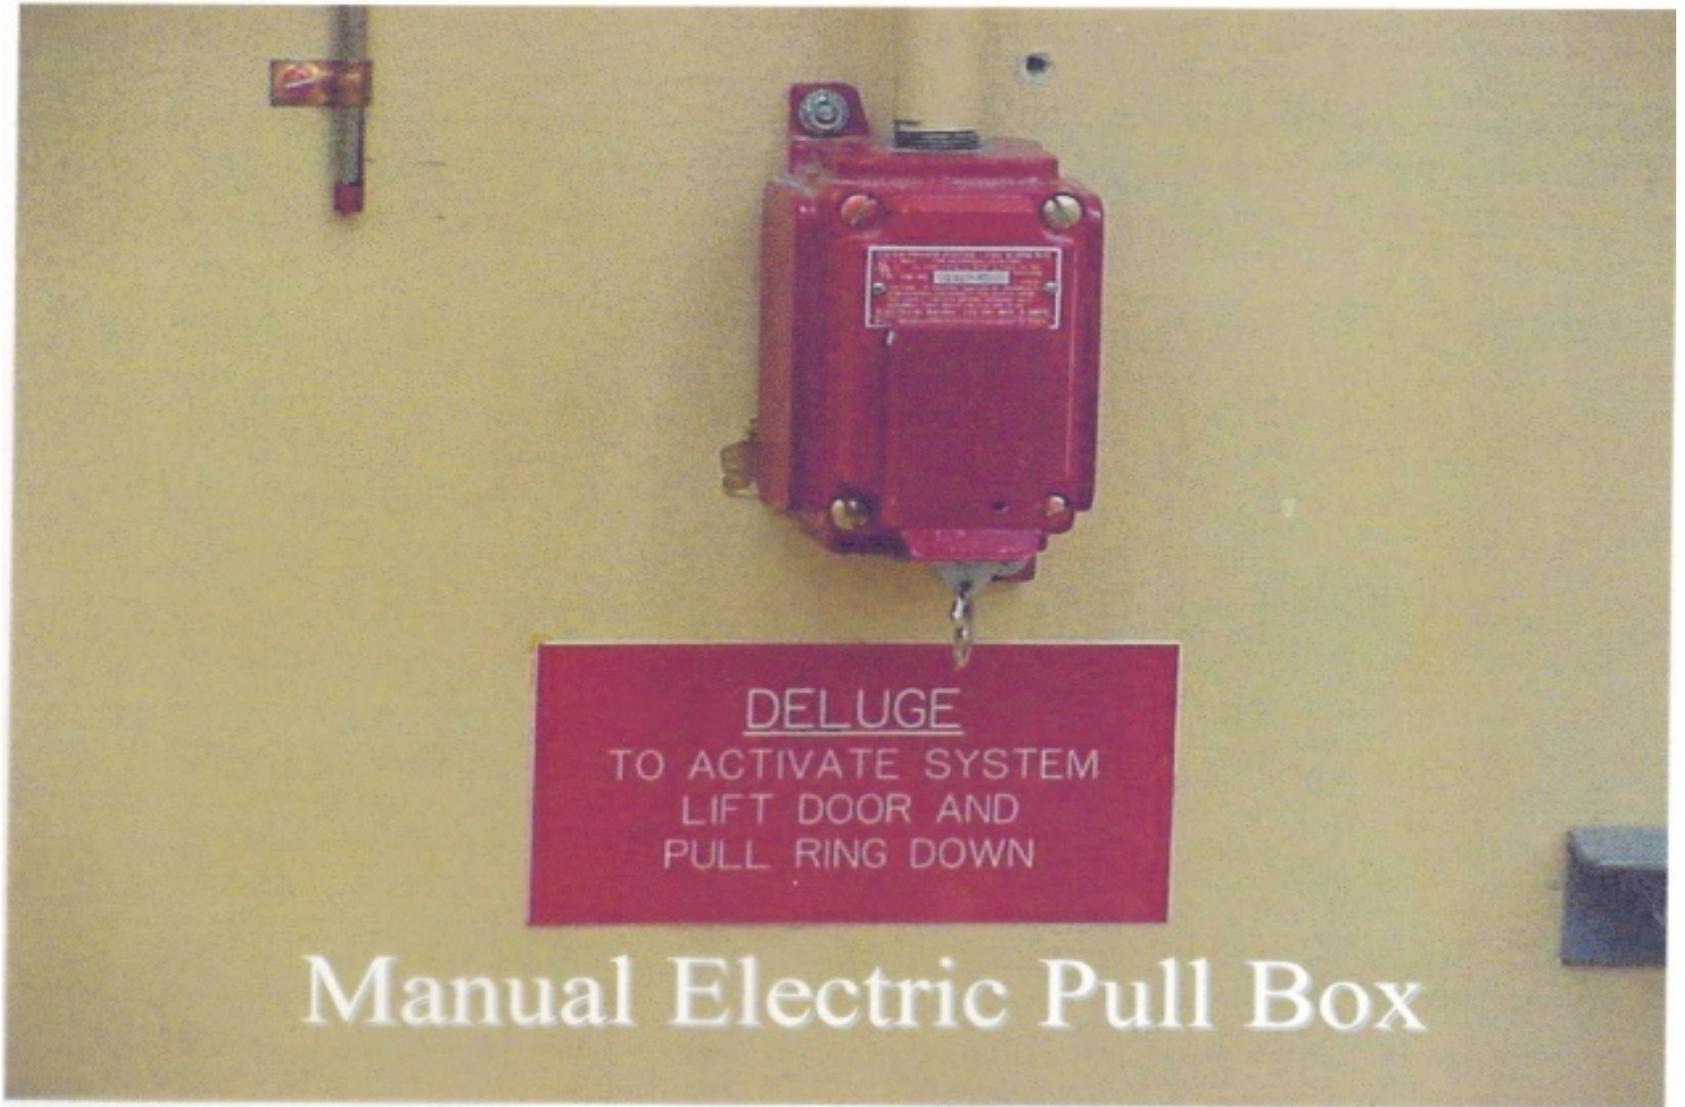
Manual Electric Pull Box

- The only pull box in the bay was a manual deluge release.
- After manual deluge release was activated the Deluge system did not release water.
- Fire alarm functioned and transmitted alarm to dispatch.

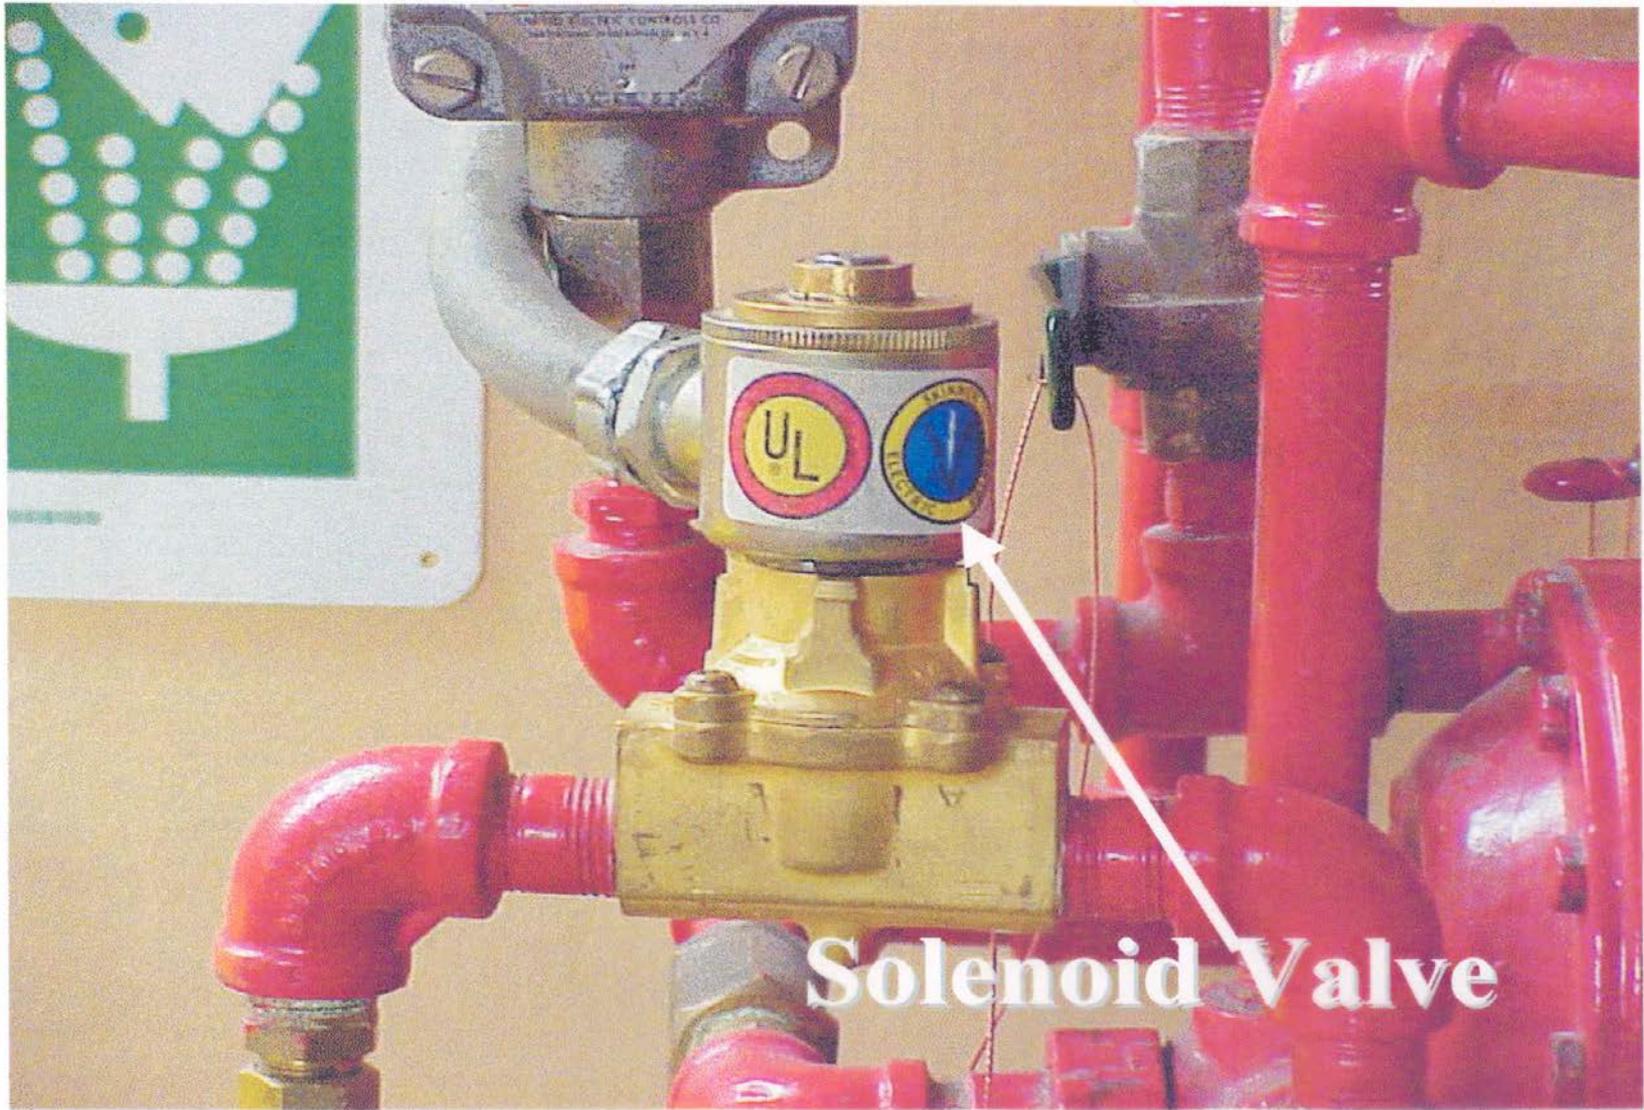
Solenoid Valve

- Fire Protection Engineering lead the effort of troubleshooting the failure.
- It was determined to be the solenoid valve was obstructing flow and preventing system activation.
- Solenoid has a torturous path for water flow

- Solenoid valve model no longer sold by manufacture since 1991
- Solenoid had an operating pressure of 150 psi. System pressure normally higher approximately 155-165 psi
- Valve still designed to operate with higher pressure, but might lead to premature diaphragm failure
- Problem identified in the NRC Information Notice 99-07

- First failure of a Deluge system solenoid valve at Pantex
- During system impairment for underground water main upgrade the system was out of service for 2 months in January 2012.
- Discovered corrosion on inside of solenoid valve which was the assumed failure of the valve.

- **Fire system restoration procedures should provide assurance of system operability**
- **Vendor testing information has changed (periodically to quarterly)**
- **Personnel should have questioning attitudes.**

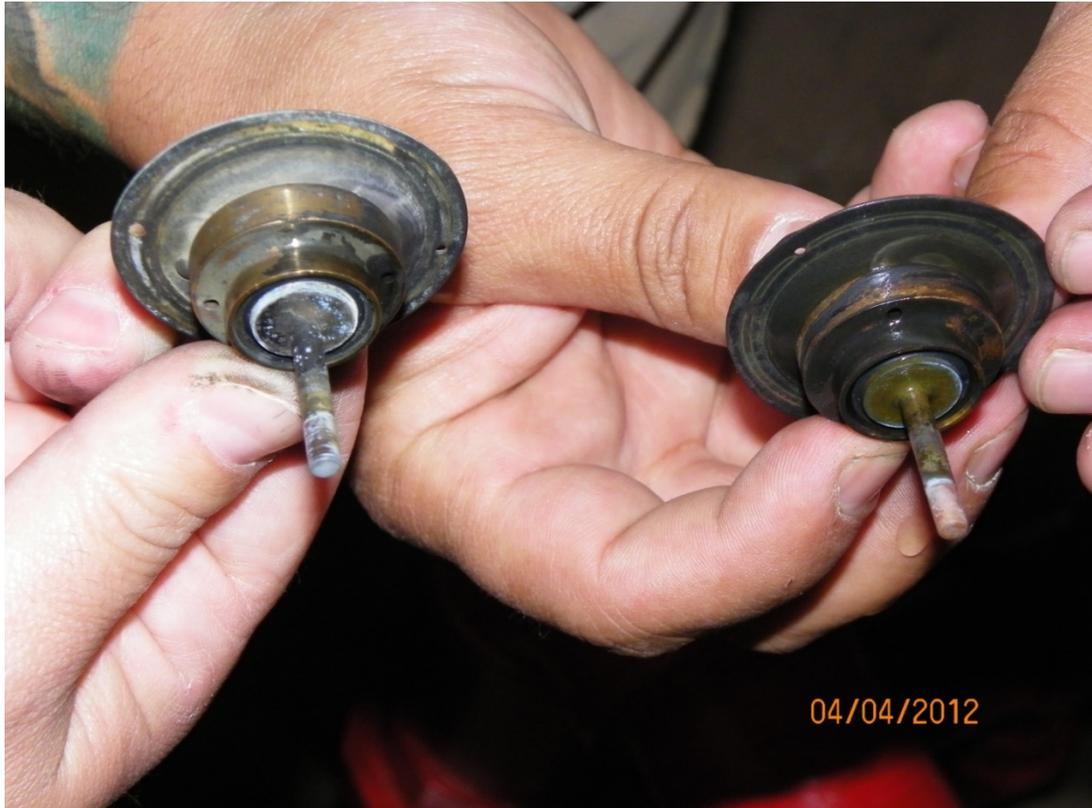
Solenoid Diaphragm and Pin (Suspect one on the left)

- **Troubleshooting included:**
 - Strainer inspections
 - Electrical checks at the solenoid and releasing module
 - Suspect solenoid was removed and tried in another facility with similar results
 - Suspect solenoid diaphragm and pin were successfully tested in a different valve body
