Accident Investigation Board

**Building 488 Tree Felling Injury at
Brookhaven National Laboratory**

March 5, 2011

**Brookhaven Site Office
U.S. Department of Energy
Upton, New York**

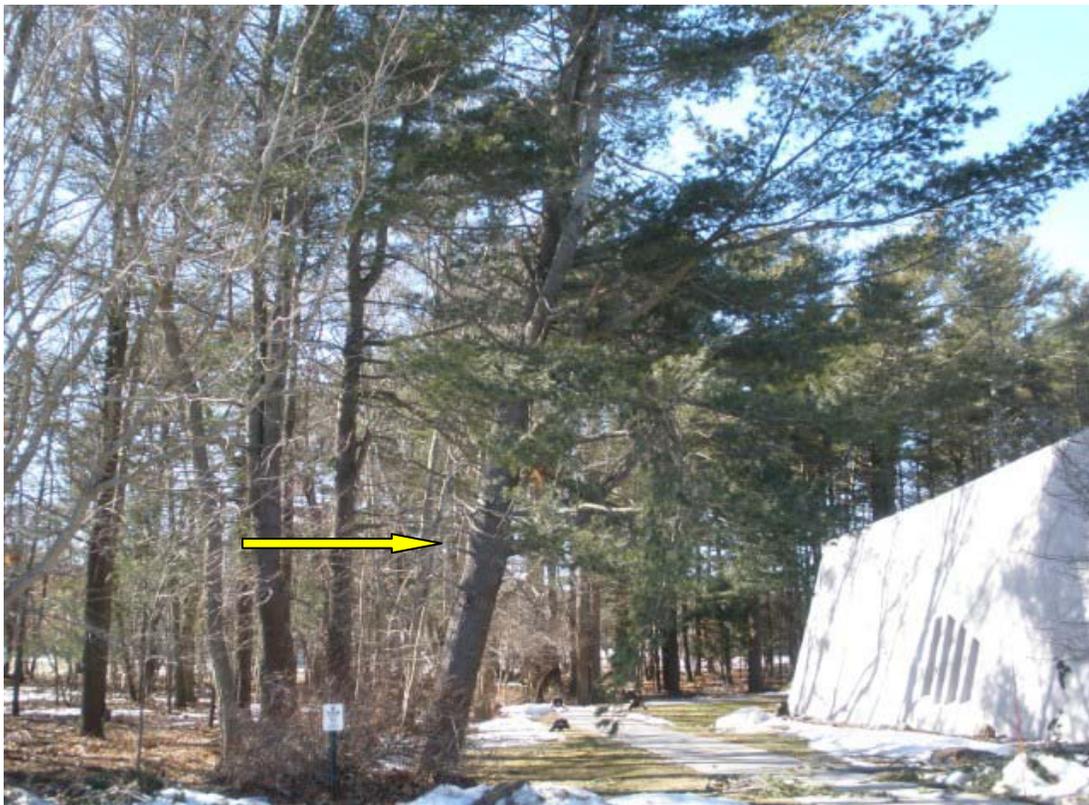
The tree involved in this accident was a white pine, approximately 60-feet tall, located on the south side of Berkner Hall (Building 488). The pine tree was leaning approximately 15 degrees from plumb to the north/northeast; toward Building 488 and over a nearby walkway.

Figure 1: Pine Tree to be Felled (February 2011)

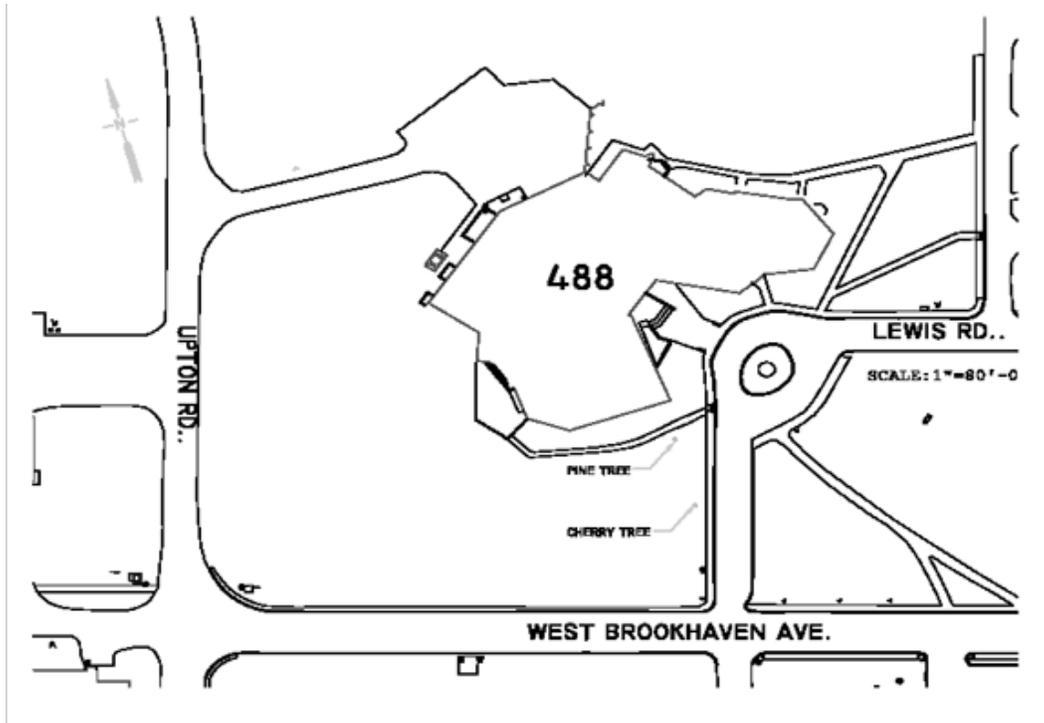
The need for removal of this pine tree originated from an informal employee safety concern which feared the leaning pine tree might fall onto and damage Building 488, and/or strike and injure pedestrians on the nearby walkway. Figure 1 details the location of the pine tree in relationship to the perimeter of Building 488.

Figure 2: Exterior of Building 488

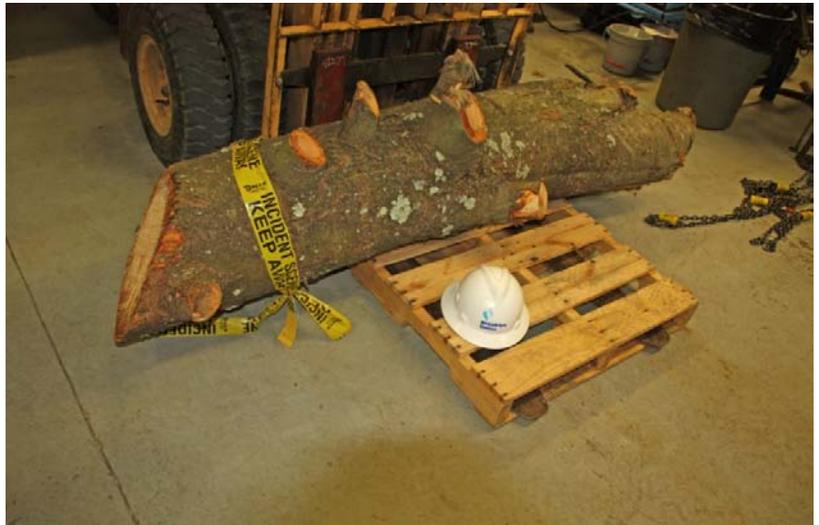
On Saturday, March 5, 2011 at approximately 10:20 a.m., a BNL BGUW was felling a pine tree with a 20-inch gas-powered chainsaw while elevated in a 60-foot articulating and telescoping boom lift (aerial lift) approximately 20-feet above the ground on the south side of Building 488. As the chainsaw cut through the tree trunk, an approximately 8-foot long, 18-inch diameter, 520 pound section of tree trunk fell toward the aerial lift, though the BGUW attempted to push the trunk section away using the left hand, it continued to fall where it struck the BGUW's right forearm. The trunk section compressed the BGUW's right forearm against the top railing of the aerial lift basket, and then fell to the ground. The severity of the resulting contact caused the BGUW's right hand to release hold of the idling chainsaw, which dropped the ground.

Figure 6: Trunk Section that Struck BGUW

As best can be determined by the facts collected by the AIB, the piece of trunk section struck the BGUW because the aerial lift basket was positioned at a place where gravity would cause the trunk section to fall. Though the trunk was leaning to the north/northeast (toward Building 488), it was believed that the BGUW expected the trunk section to fall away from the aerial lift basket after completing a downward angled (southeast to northwest) through-cut. As the through-cut was completed, gravity immediately allowed the already leaning trunk section to fall to the north/northeast.

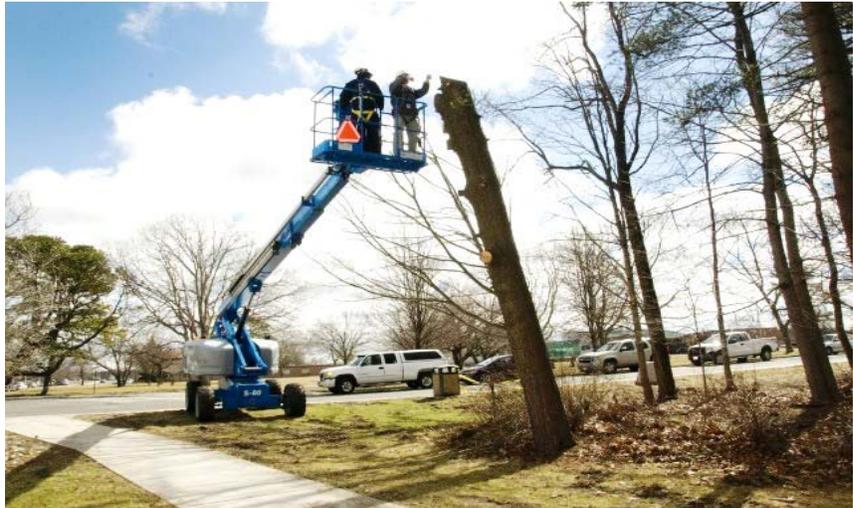
It was planned that BGUW-1 and BGUW-2 would fell the remaining approximately 20-foot trunk section from ground level after they removed a final trifurcated trunk section while in the aerial lift. This remaining trunk section would then be short enough that it would not strike Building 488 when felled. BGUW-2 positioned the aerial lift basket at the north/northeast side of the trunk at the direction of BGUW-1.

Figure 7: Position of the Aerial Lift at Time of Accident

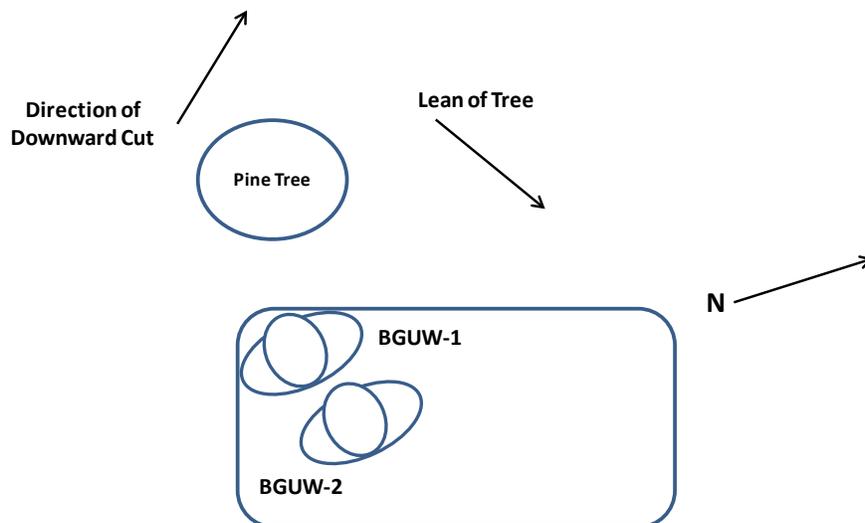
As BGUW-1 began cutting through the final section of tree trunk, BGUW-2 was standing immediately behind applying pressure to the tree trunk section being cut with the “push stick”. As the single through-cut was completed, the approximately 8-foot long, 18-inch diameter, 520 pound section of tree trunk fell towards the aerial lift basket and BGUW-1.

Figure 8: Position of Workers and Aerial Lift Basket at Time of Accident
