## Building America Case Study

# Monitoring of Double-Stud Wall Moisture Conditions in the Northeast

Devens, Massachusetts

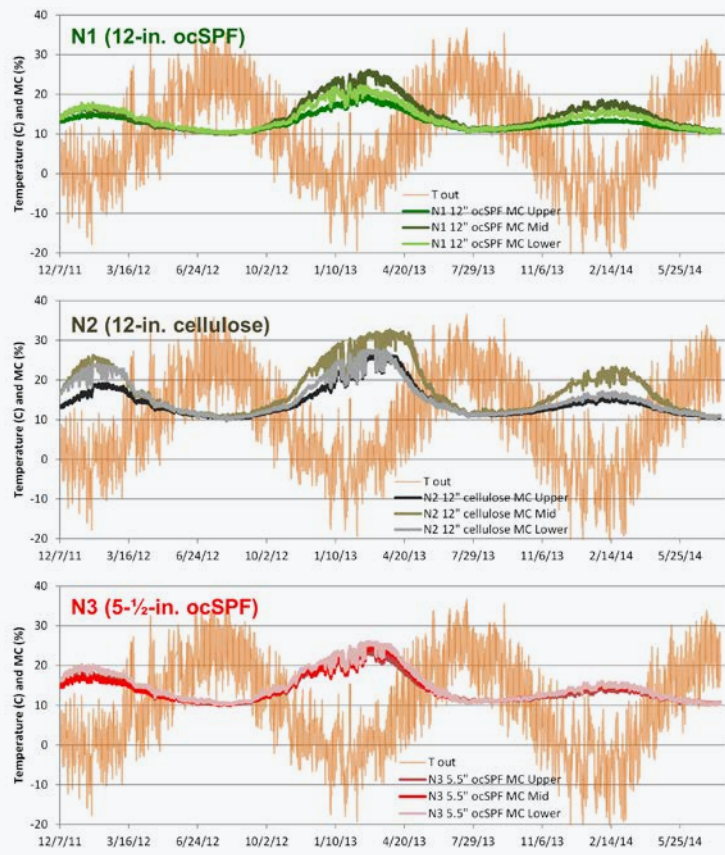
North side sheathing moisture contents with exterior temperature

Under “normal” interior conditions (functioning ventilation system, wintertime RH 10%–30%), ocSPF walls (both 12 in. and 5-½ in.) with latex paint as interior vapor control (Class III) showed low risk; all sheathing moisture contents (MCs) remained below 20%. However, the 12-in. cellulose wall had MCs that exceeded 20% on the north side.

Under high interior humidity loading (nonfunctional ventilation system, 40%–50% interior RH), all test walls showed MCs and sheathing–insulation interface RHs well into the high risk range. The cellulose walls showed particularly high MCs (sheathing that exceeded 30%), while the ocSPF walls showed MCs in the 18%–25% range. In addition, the monitoring showed evidence of liquid water condensation (which can result in quick degradation) in all walls, with substantial condensation in the cellulose walls.
