U.S. DEPARTMENT OF  
**ENERGY**

Legacy  
Management

# 2012 Annual Site Inspection and Monitoring Report for Uranium Mill Tailings Radiation Control Act Title I Disposal Sites

February 2013

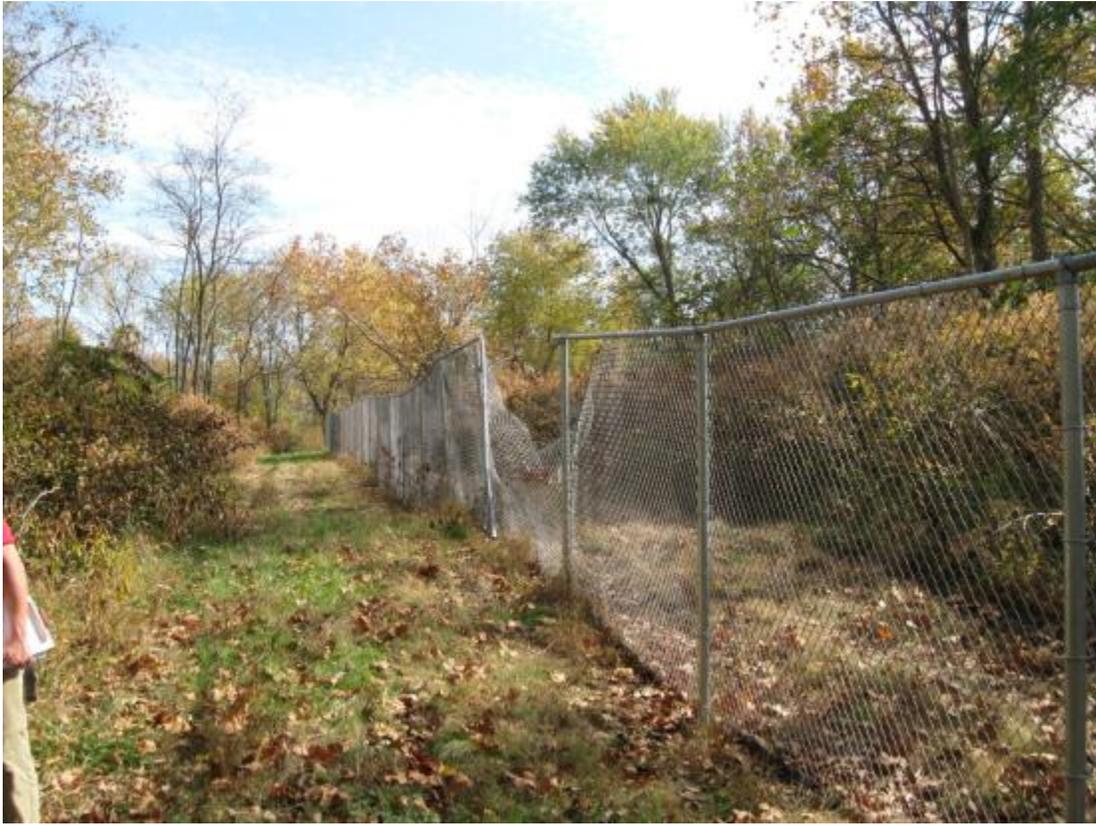
The chain-link security fence, replaced in 2007, remains in excellent condition, with the exception of a bent rail on the south fence (PL–1). The fence rail was damaged when a tree fell across it in 2011. The tree was safely removed from the fence shortly after being discovered. The top rail of the fence needs to be replaced. A vegetation-free corridor remains established along the fence line (PL–2). Several of the 17 perimeter signs mounted on the security fence have been damaged by bullet holes, but they remain serviceable (PL–3).

*BUR 10/2012. PL-1. Fence damage.*

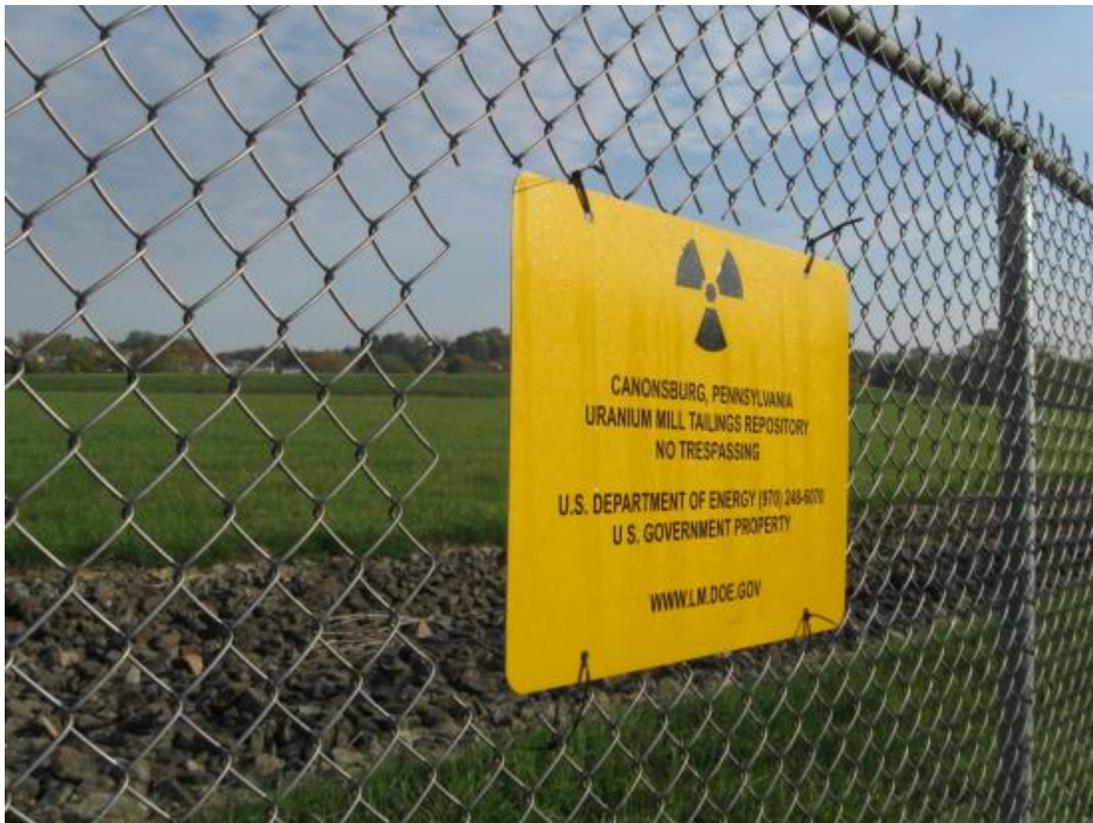
*CAN 10/2012. PL-4. Fence repair at perimeter sign P2.*

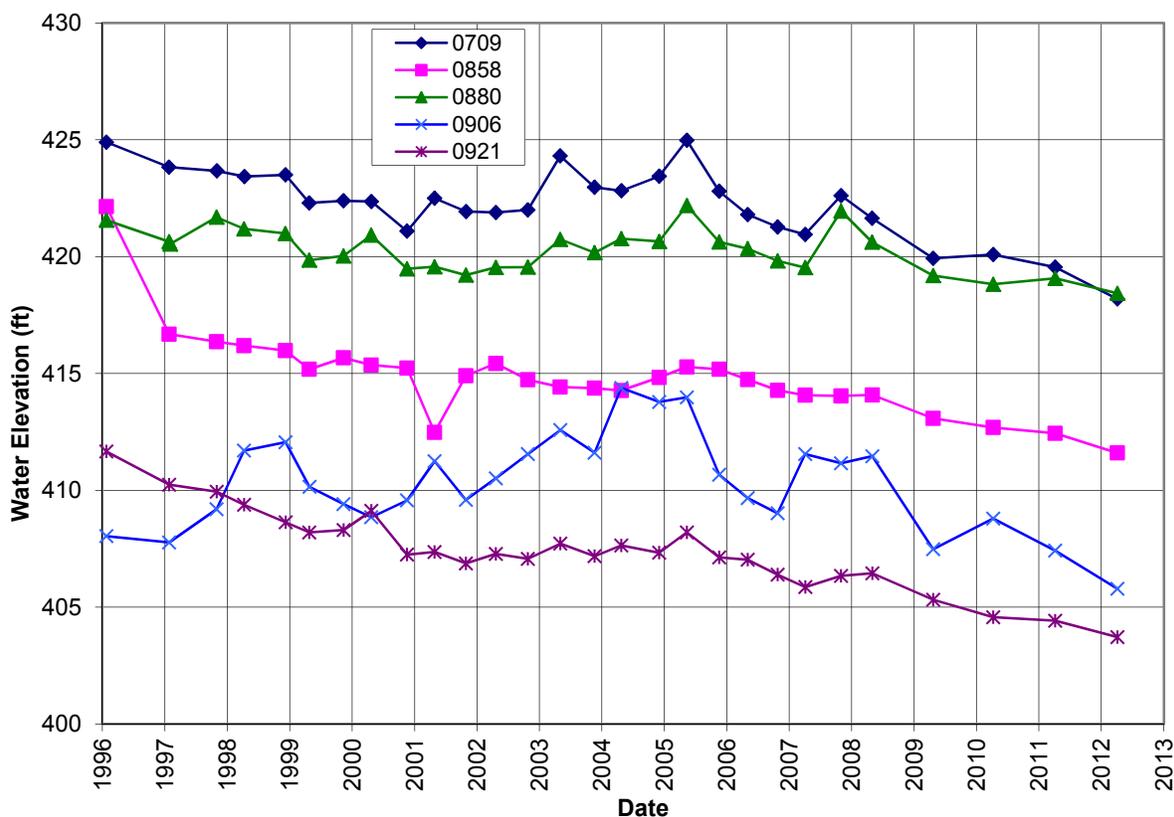
Figure 5–7. Water-Level Measurements at Cell Performance Monitoring Locations at the Falls City Disposal Site

Water levels measured in 2012 in the disposal cell performance network are all new measured lows for each well (Figure 5–7). Since 1996, groundwater levels in the disposal cell performance network wells have fallen slightly. The water level in monitoring well 0906 has fluctuated more than the other wells over the years. Monitoring well 0906 is directly downslope of the disposal cell, and the historical fluctuation may be the result of the infiltration of water shed by and conveyed away from the disposal cell, reflecting variations in annual precipitation. Other contributors that may influence local groundwater levels include (1) the dissipation of the processing-site-related groundwater mound beneath the disposal cell, and (2) the dissipation of transient drainage from the disposal cell.

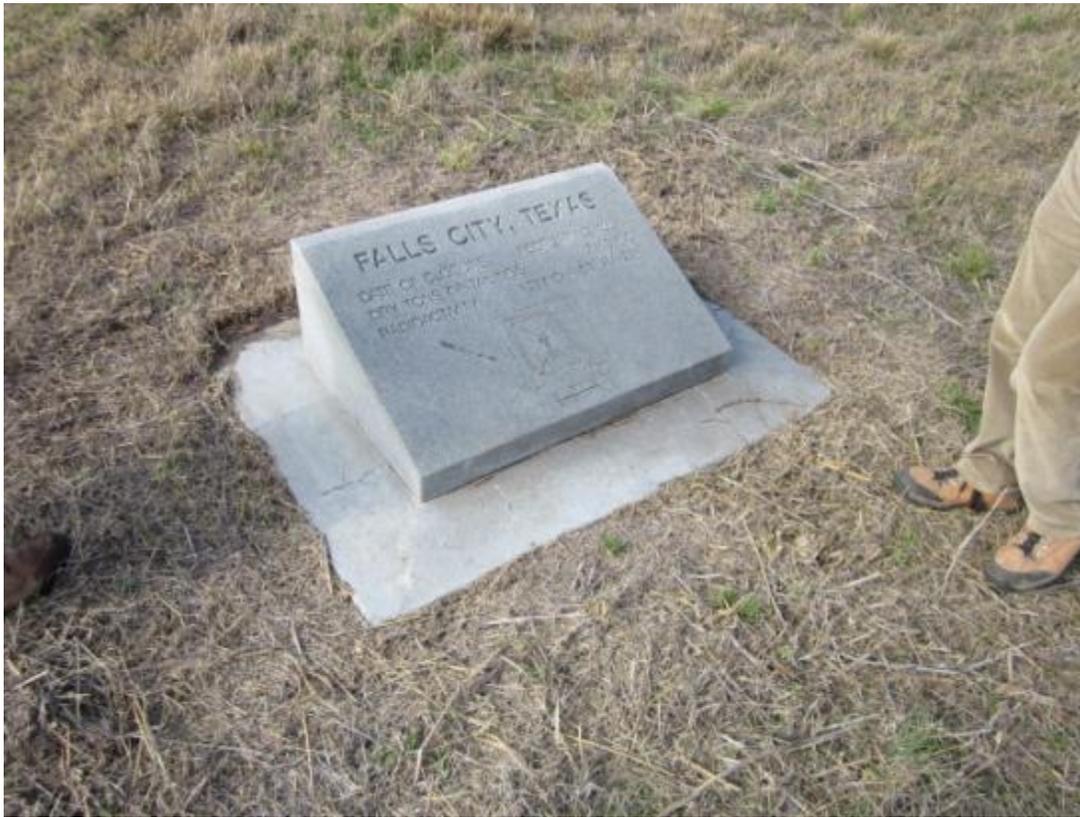
FCT 1/2012. PL-3. Site marker SMK-1; note cracks in concrete base.

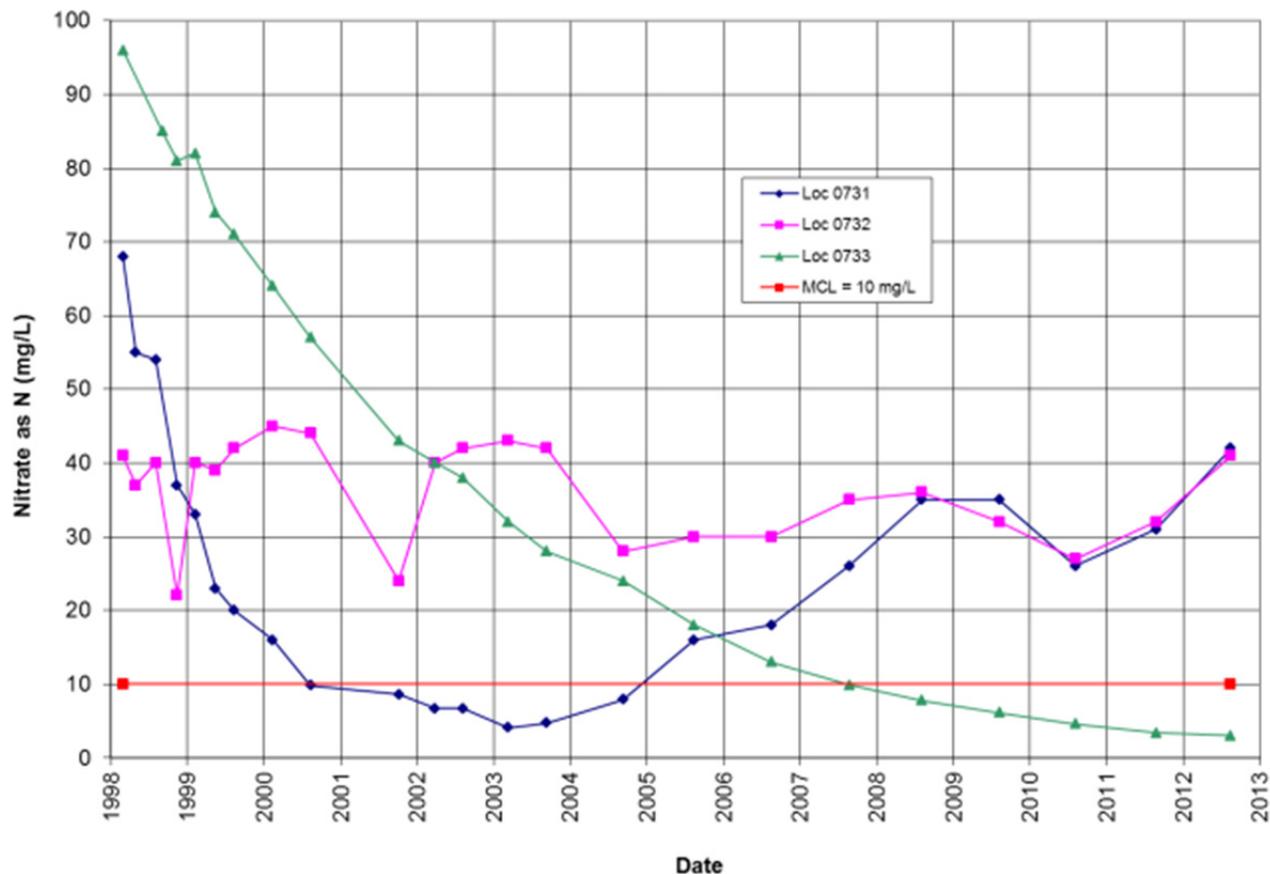
Figure 6–3. Time-Concentration Plots of Nitrate (as Nitrogen) in Groundwater at the Grand Junction Disposal Site

Nitrate (as nitrogen) concentrations in groundwater continued to exceed the MCL of 10 mg/L in the paleochannel monitoring wells (0731 and 0732) through 2012 (Figure 6–3). Concentrations in well 0731, following an initial steep downward trend, remained below the MCL from 2000 through 2004. In 2005 and continuing through 2011, concentrations steadily increased and remain above the MCL. Concentrations in well 0732, though varied, have consistently remained above the MCL since 1998. Concentrations in well 0733 continued a significant downward trend, dropping below the MCL in 2006, and reaching a low of 3 mg/L in 2012. Historically, the highest concentration of nitrate (96 mg/L) occurred in 1998 from disposal cell well 0733. In 2012, the concentration of nitrate has increased, and the nitrate levels in both paleochannel monitoring wells are very similar: 42 mg/L in well 0731 and 41 mg/L in well 0732.

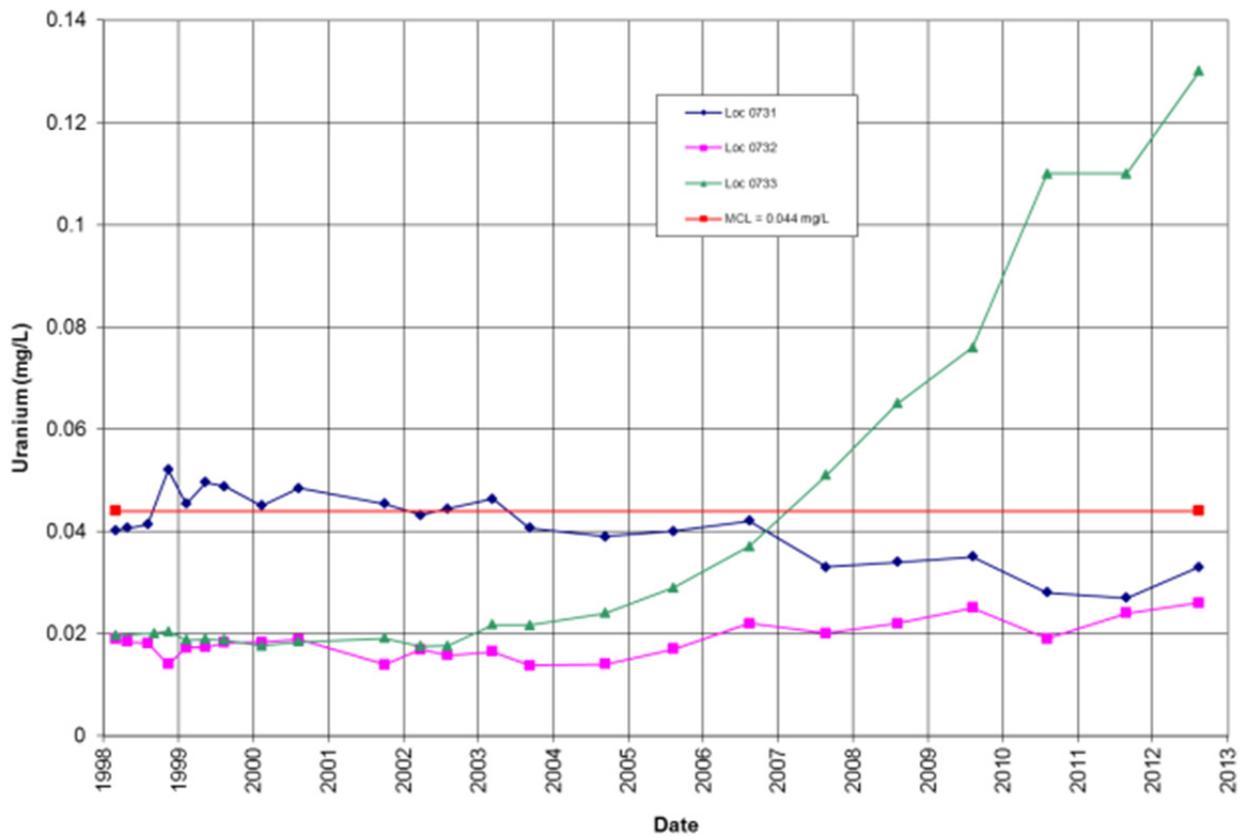
Figure 6-5. Time-Concentration Plots of Uranium in Groundwater at the Grand Junction Disposal Site

Uranium concentrations in groundwater were below the MCL of 0.044 mg/L in paleochannel monitoring wells 0731 and 0732, and were above the MCL in well 0733 (Figure 6–5). Concentrations in well 0731, after an initial increase above the MCL, have been below the MCL since 2003. Concentrations in well 0732 have remained relatively consistent. Concentrations in well 0733 remained relatively consistent through 2003, at which time an upward trend began, which leveled off at 0.11 mg/L for the 2010 and 2011 sampling events and increased slightly to 0.13 mg/L in 2012.

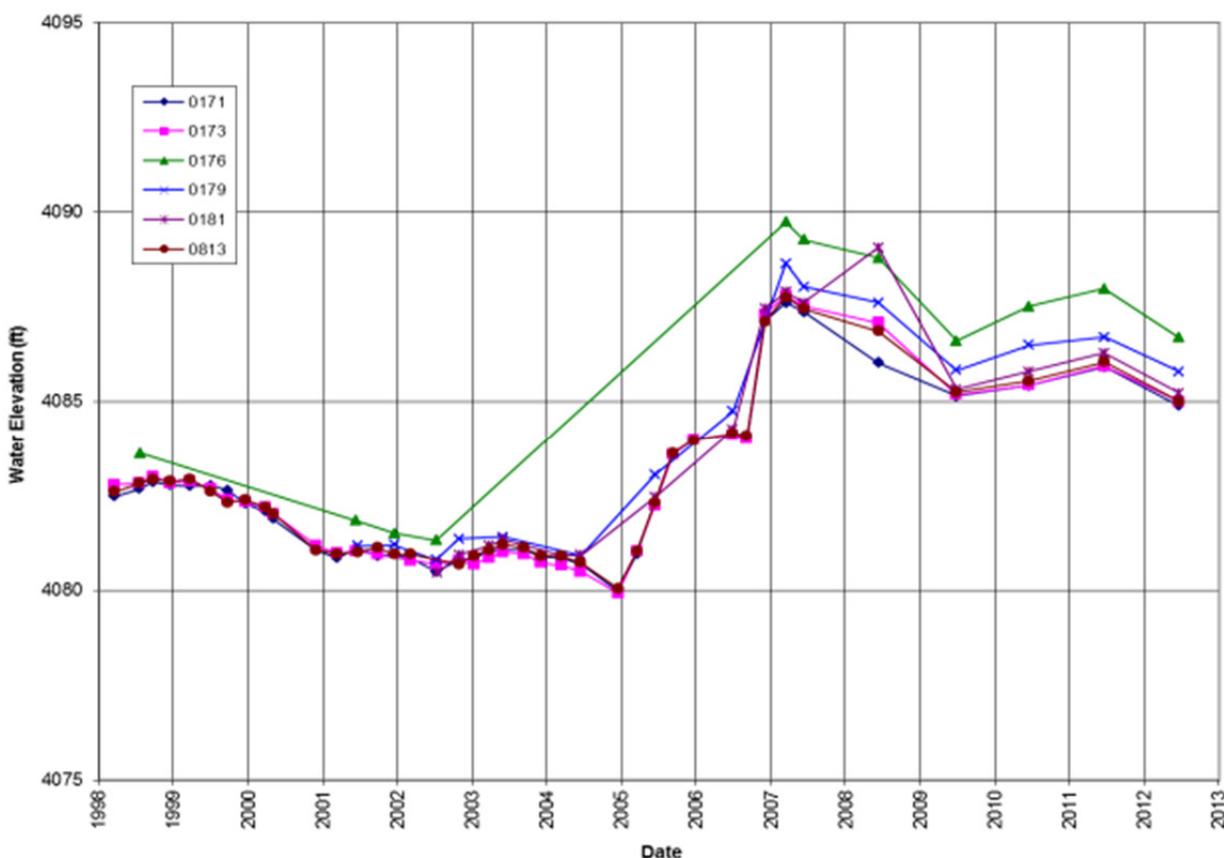
Figure 7–6. Groundwater Elevations at the Green River Disposal Site

Water-level hydrographs of the POC wells, completed in the middle sandstone aquifer, indicate that the groundwater elevation decreased approximately 3 feet overall from 1998 through 2004, and then increased approximately 8 feet between 2004 and 2007. Water levels have decreased approximately 2 to 3 feet since 2007, although slight increases occurred in 2010 and 2011 (Figure 7–6).

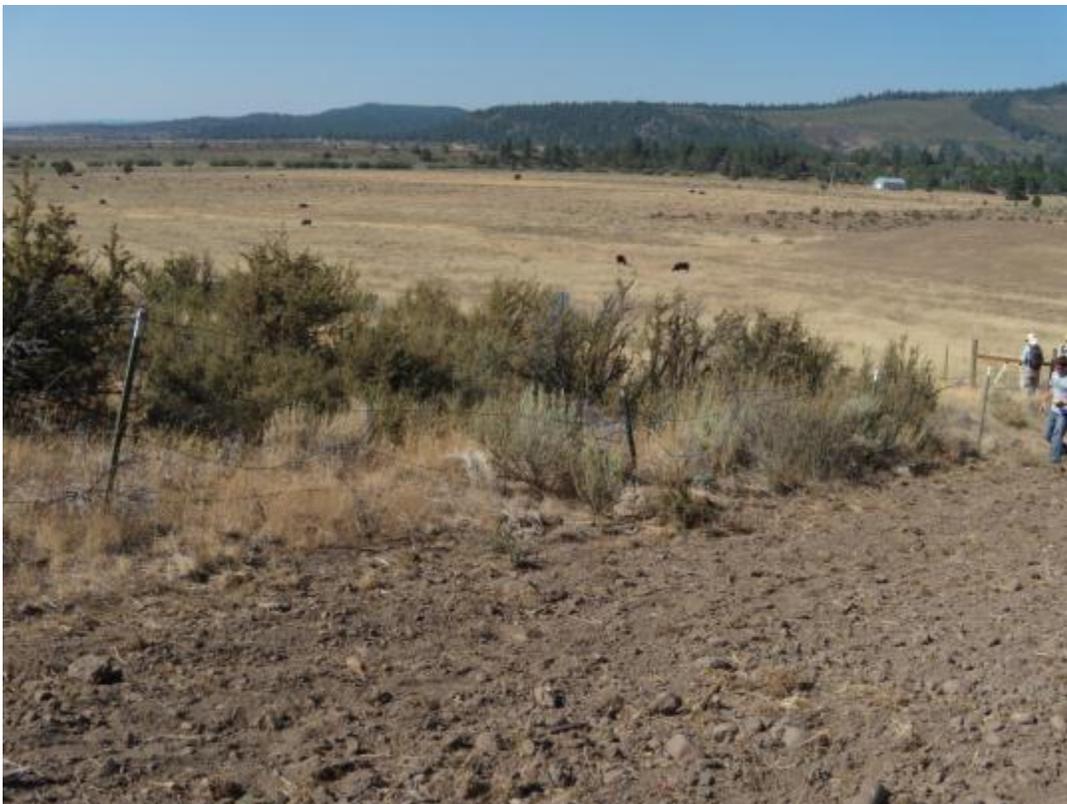
LKV 8/2012. PL-2. View to southwest of damaged north perimeter fence.

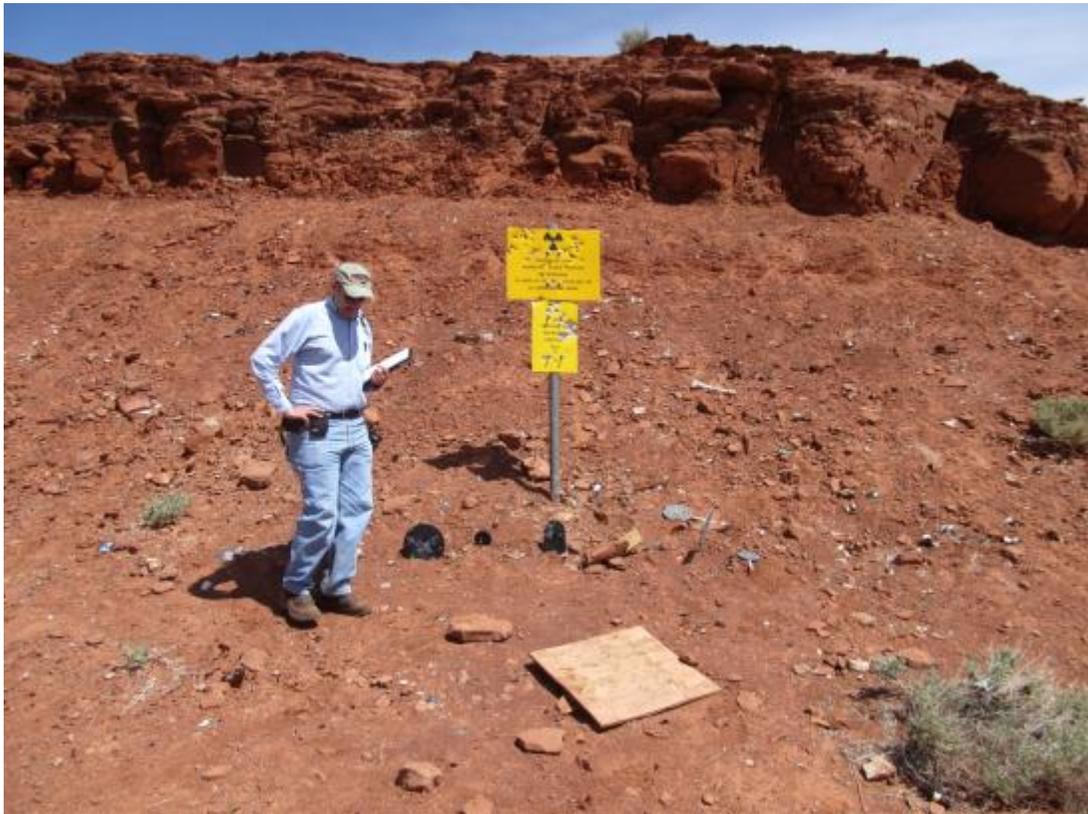
HAT 4/2012. PL-1. Photo of perimeter sign P20 with bullet damage.

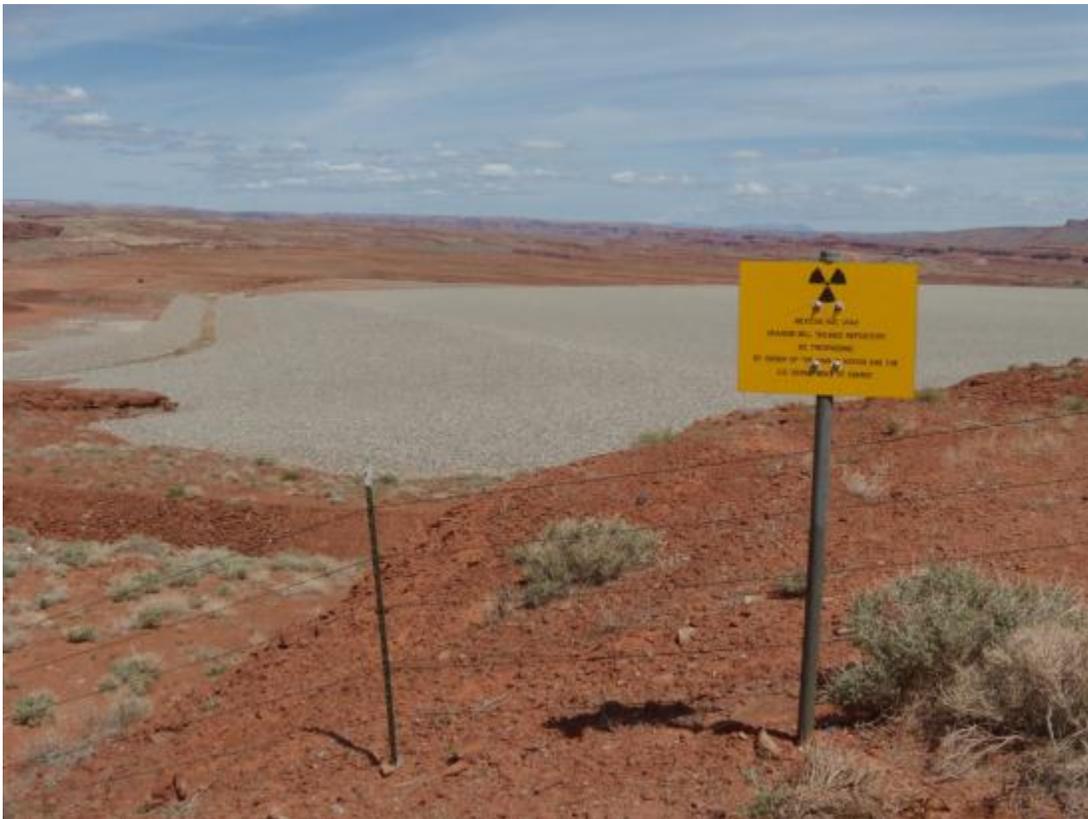
HAT 4/2012. PL-2. Missing radiation warning sign at perimeter sign P31.

| <b>Site</b> | <b>Chapter</b> | <b>Page</b> | <b>Index No.</b> | <b>Actions and Issues</b> |
|---|---|---|---|--|
| Mexican Hat, Utah | 12 | 12–7<br>12–7 | 12A<br>12B | Maintenance: missing radiological sign and warning sign to be replaced<br>Seep monitoring |

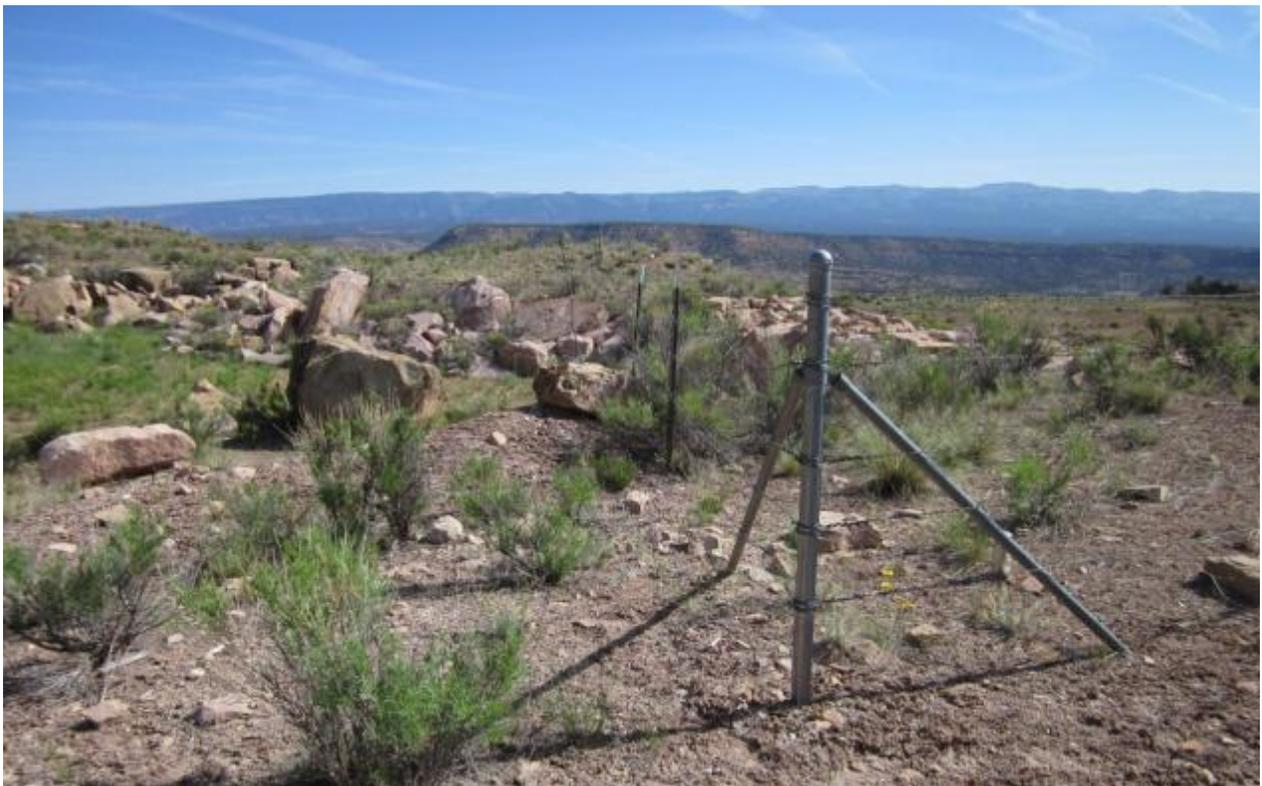
NAD 5/2012. PL-2. Broken fence strands near perimeter sign P21.

| <b>Site</b> | <b>Chapter</b> | <b>Page</b> | <b>Index No.</b> | <b>Actions and Issues</b> |
|---|---|---|---|--|
| Naturita, Colorado | 13 | 13–6<br>13–6 | 13A<br>13B | Maintenance: minor fence repair<br>Groundwater monitoring: next scheduled in 2014 |

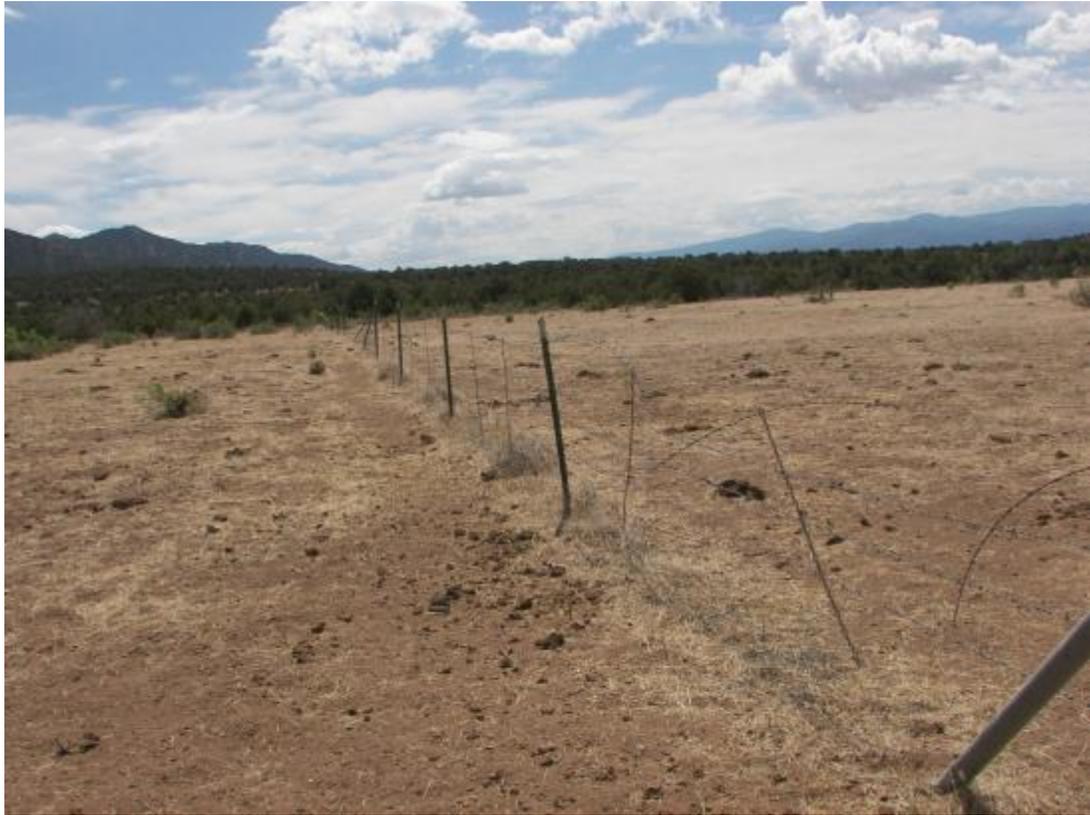
The barbed-wire perimeter fence that limits access to the site was damaged at the time of the inspection. The fence extends to the edge of steep-sided arroyos that bound the site on the east and west and act as a deterrent for easy access to the site. The barbed-wire personnel gate at the southeast corner of the site was open, a section of perimeter fence had been cut and folded back between perimeter signs P0 and P1, and some bent fence posts and broken or loose wires were found in many places along the fence. Cattle had heavily grazed inside the site boundary and around the perimeter of the cell. A comparison between vegetation inside the fence enclosing the evaporation pond (where no grazing had been done) and outside the fence shows the extent of grazing (PL–1). Other signs of deer and elk grazing in the revegetated areas adjacent to and inside the disposal cell site boundary were identified. Such grazing has occurred historically.

RFL 6/2012. PL-9. Section of damaged perimeter fence near perimeter sign P10.

| <b>Site</b> | <b>Chapter</b> | <b>Page</b> | <b>Index No.</b> | <b>Actions and Issues</b> |
|---|---|---|---|--|
| Rifle, Colorado | 14 | 14–8<br>14–8<br>14–8 | 14A<br>14B<br>14C | Maintenance: fence repairs to be performed<br>Maintenance: pump removal<br>Disposal cell pore water monitoring |

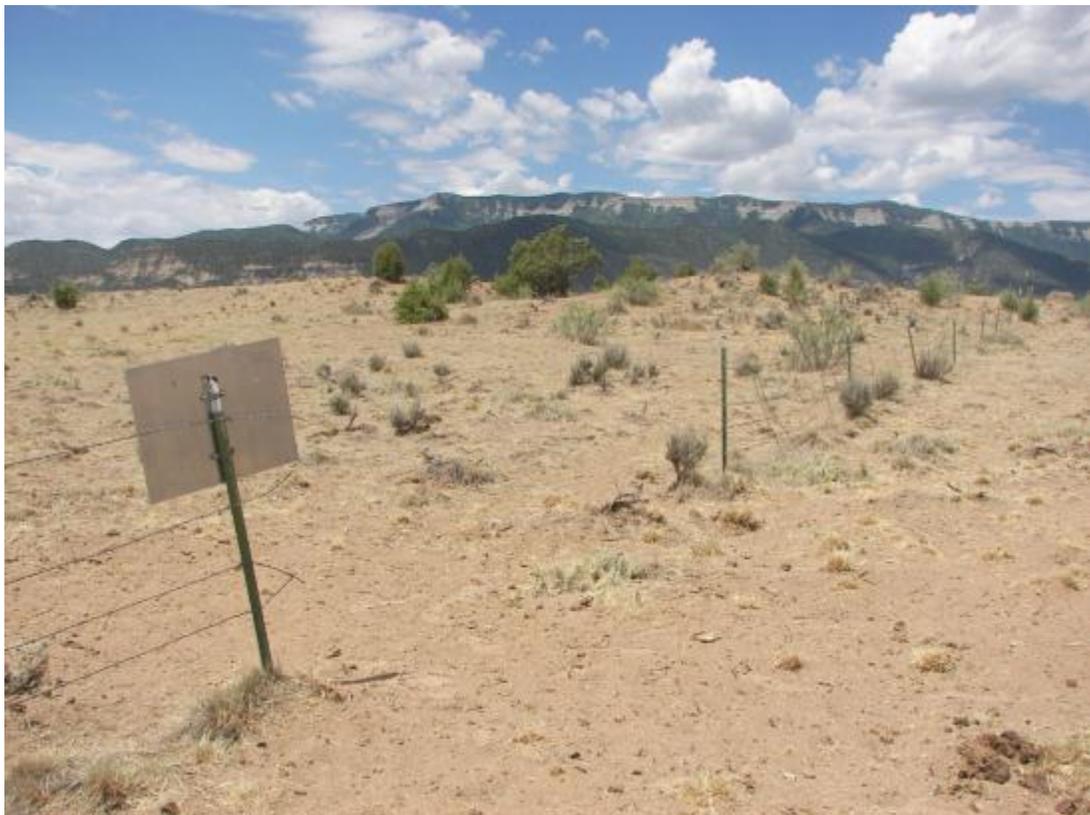
RFL 6/2012. PL-10. Fence cut and folded back near perimeter sign P1.

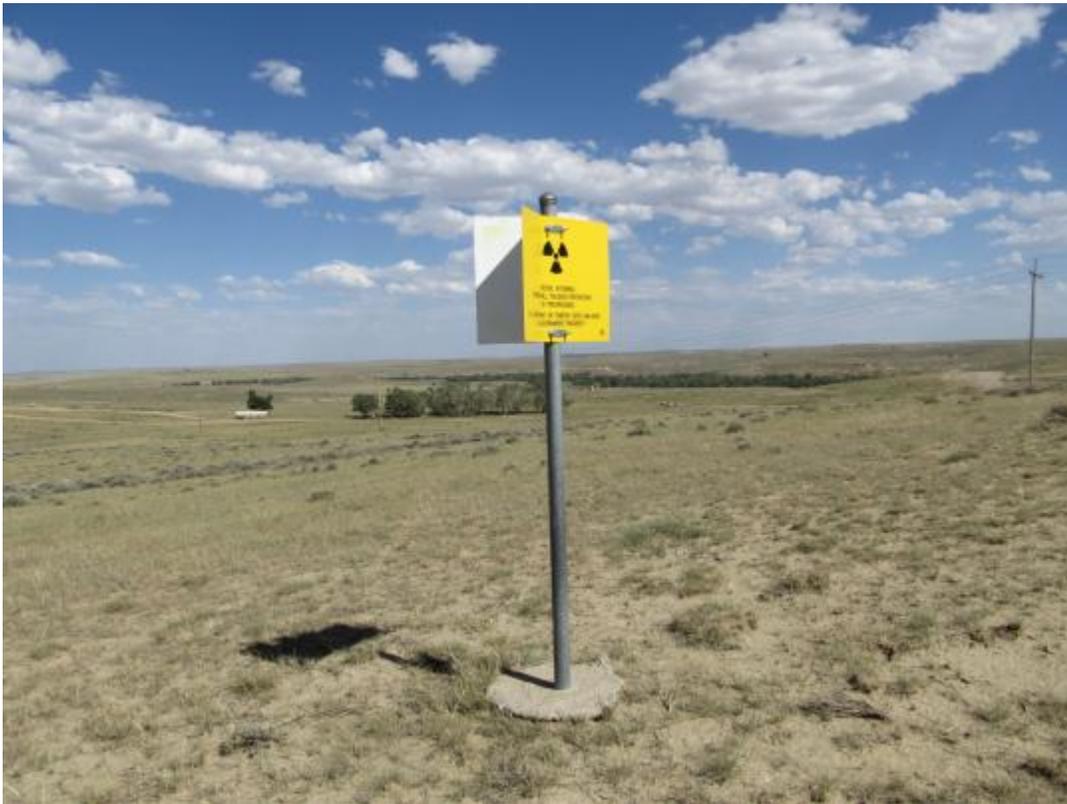
SPK 6/2012. PL-1. Perimeter sign P10 damaged by wind.
