Defect Analysis of Vehicle Compressed Natural Gas Composite Cylinder

A China Paper on Type 4 Cylinder,
translated and presented by
J. P. Hsu, PhD, Smart Chemistry

Reason for Defect Analysis of CNG Composite Cylinder

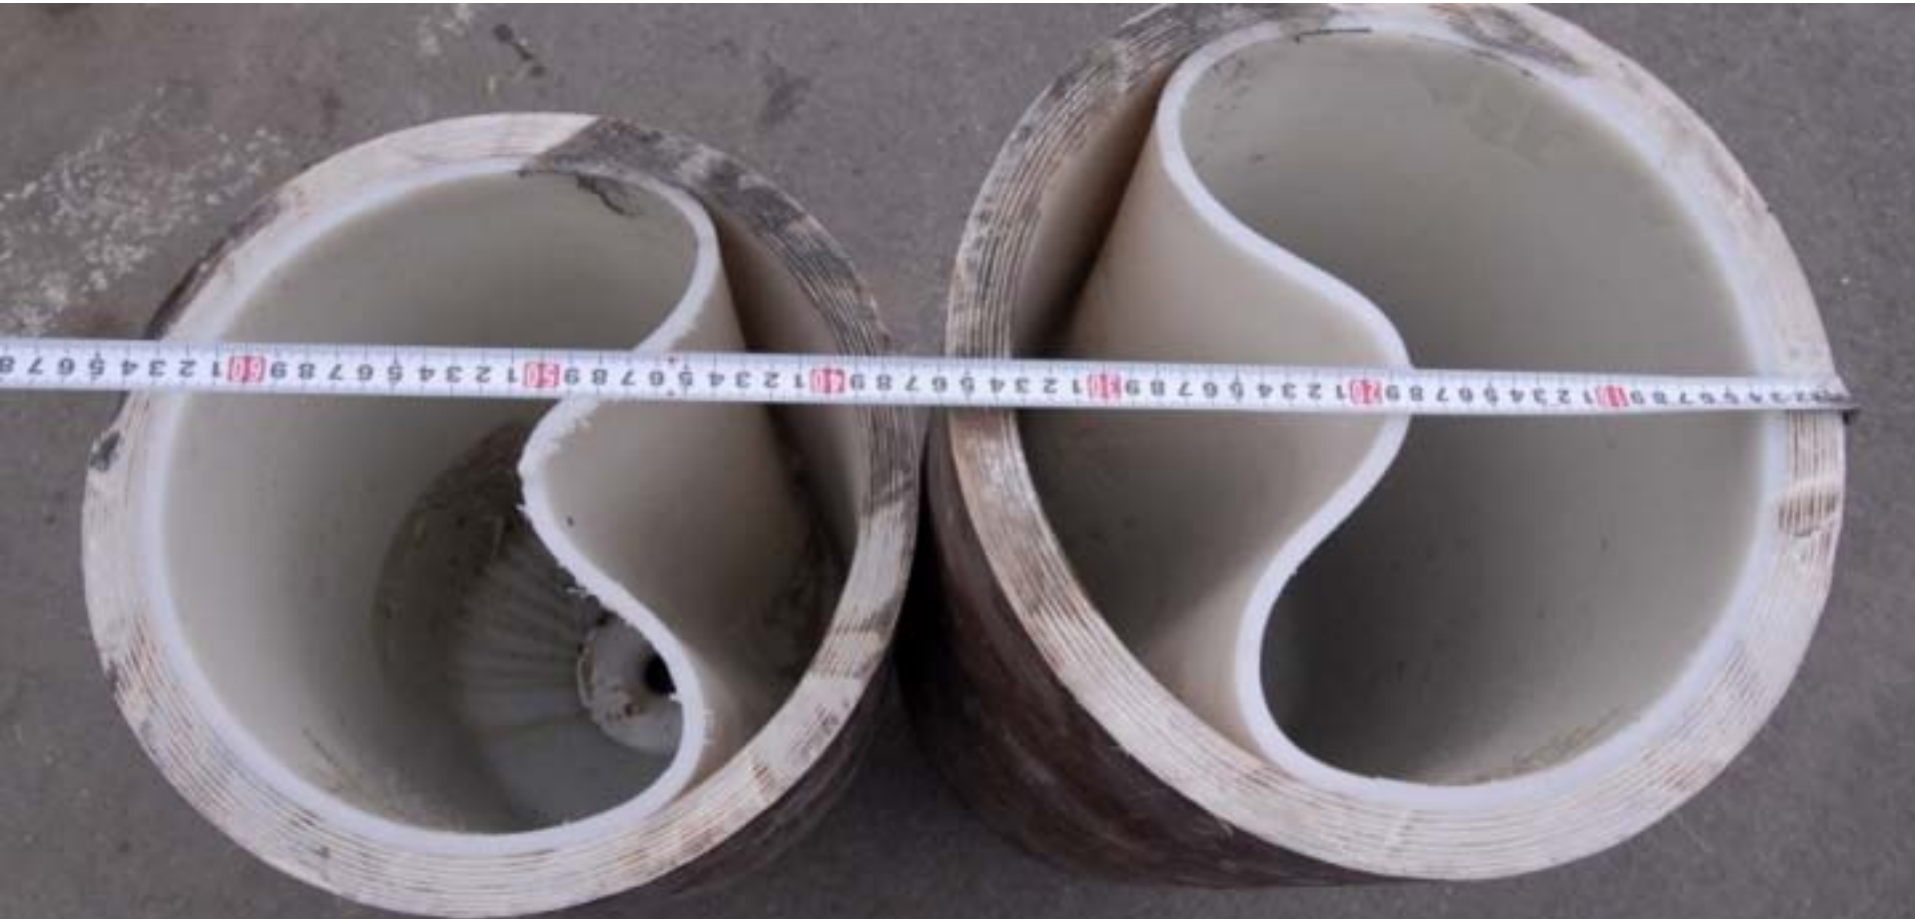
1. Crease on Internal Liner

Problems Found in Cylinder Liner

- **The difference in linear expansion coefficients and slow cylinder pressure and temperature cycle during the gas compressing and releasing processes are the direct causes for liner defect** - Since the linear expansion coefficient of internal liner is much larger than that of the external composite layer, the internal stress of the liner will gradually increase following the increasing in liner volume expansion. While the internal stress increases over a critical value, an unstable local area of the liner turns inward deformation. After many cycles, the extent of deformation exceeds the liner deformation limit, this will lead to damages and cracks.

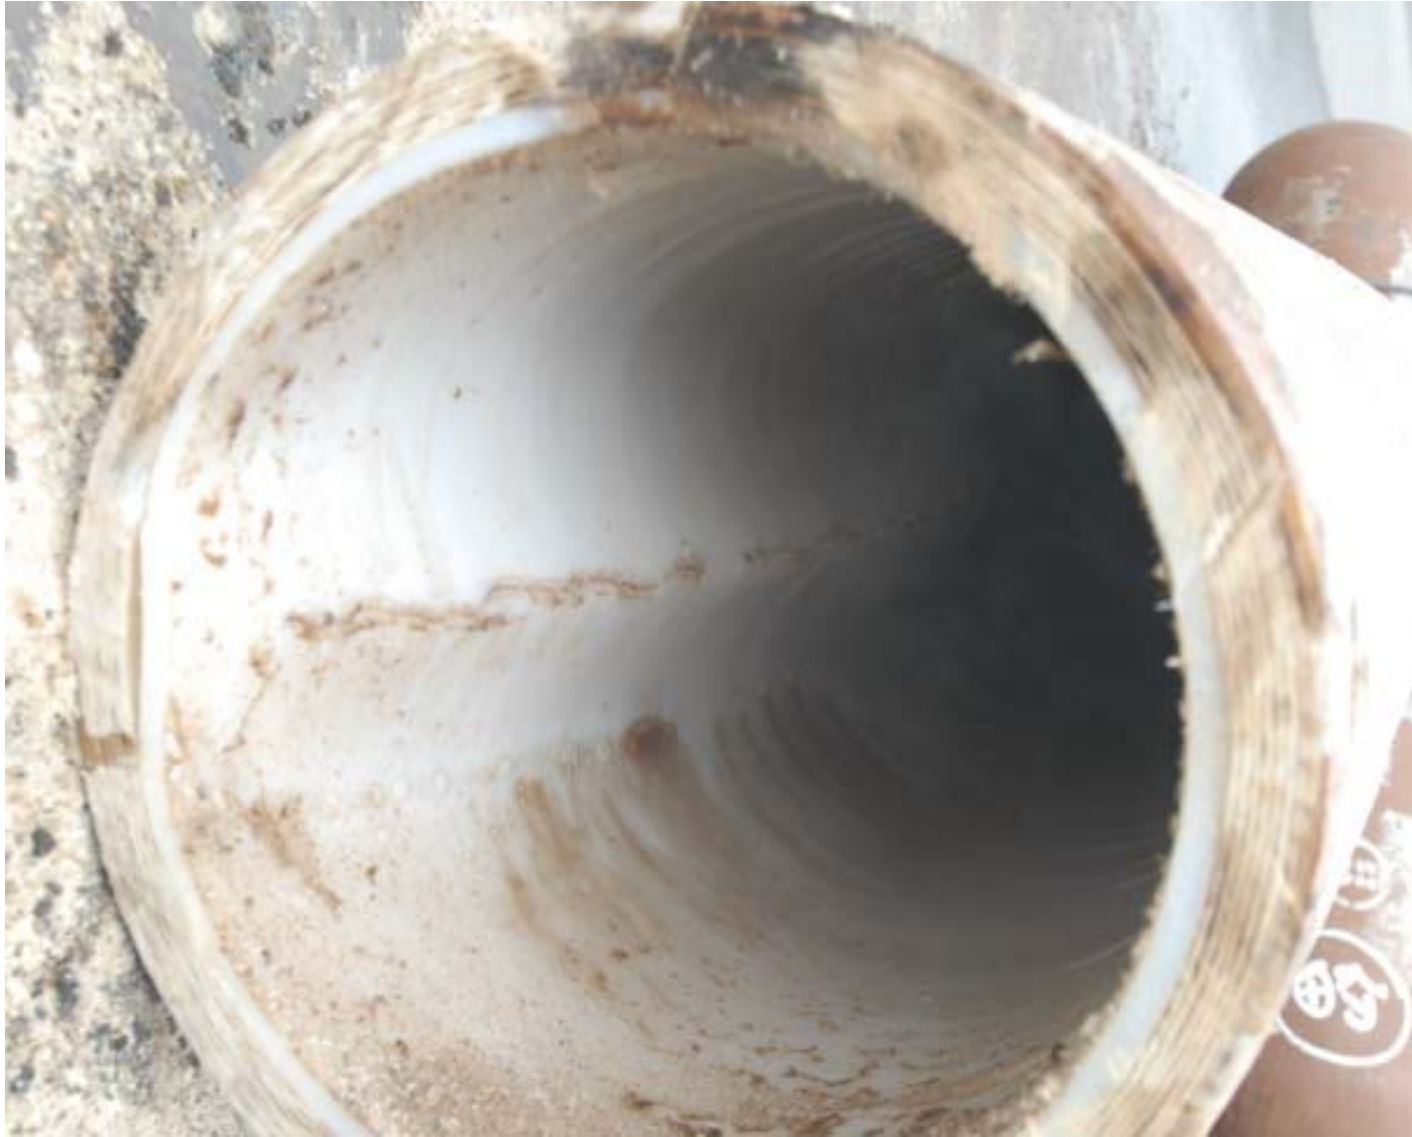
2. Noticeable Macro Crack on Cylinder Liner

Problems Found Cylinder Liner

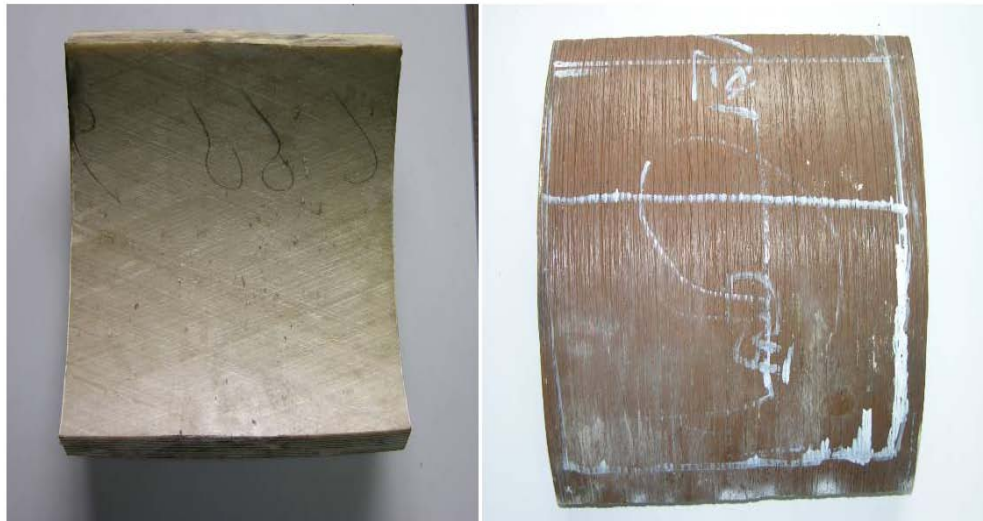
1. No bonding between Liner and Composite layer

Figure 8 Internal and External Surfaces of Cylinder Liner

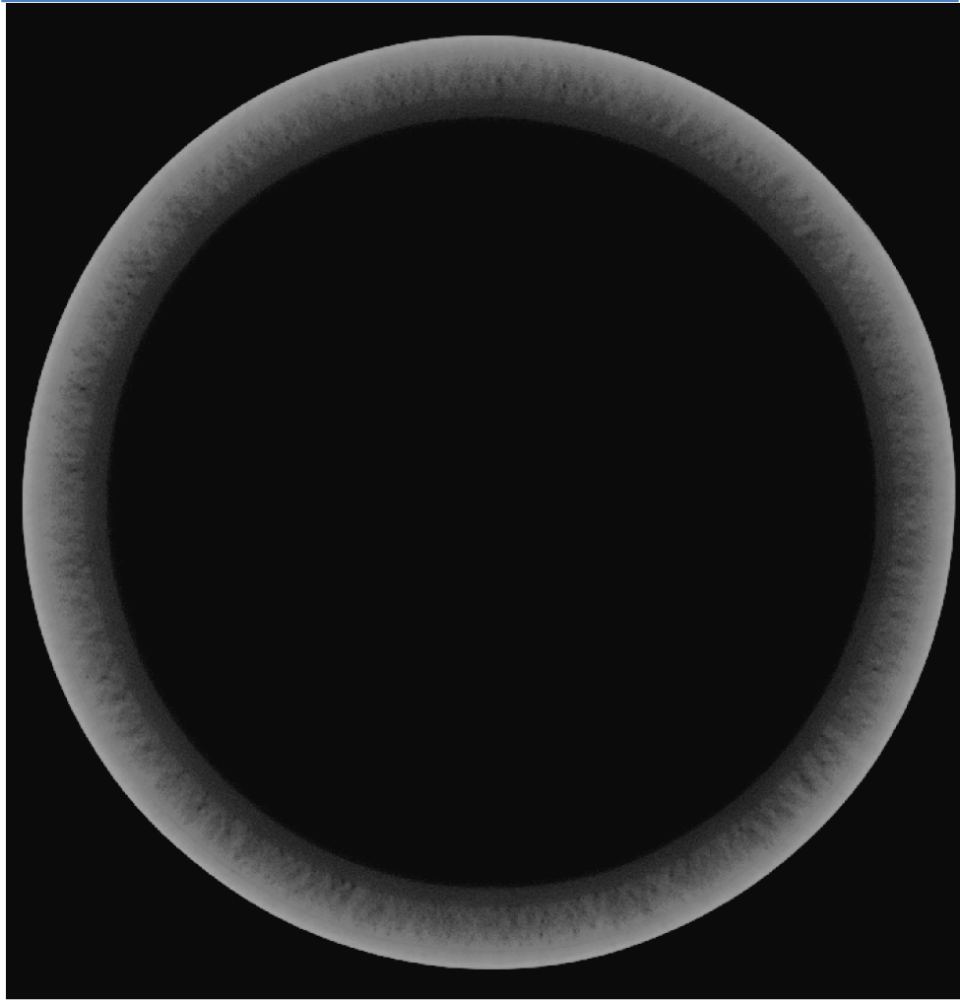
4.8MPa Pressure

2.3MPa Pressure

- Cylinder pressure $\geq 2.3\text{MPa}$, the internal liner maintains original structural condition and fits tightly the external composite layer, which always has uniform thickness and structure with no exception.
- Cylinder pressure drops to 1MPa , the internal liner has apparent crease deformation.
