NREL PV Module Reliability Workshop,
Golden, Feb 26/27, 2013

PID Failure of c-Si and Thin-Film Modules and Possible Correlation with Leakage Currents

Peter Lechner

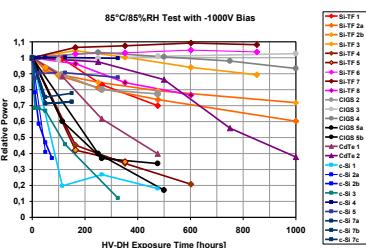
Indoor (climate chamber)

Leakage current (T-, RH-matrix)
Power loss (STC and low light)
Recovery

Bias -1000 V

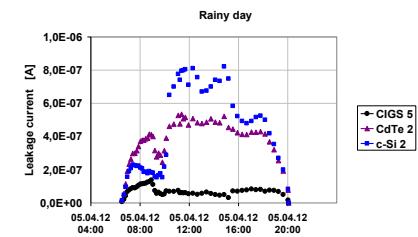
Field (Widderstall)

Leakage current (5min sampling)
Power loss (flasher)

Bias up to -800V (PV- Generator)

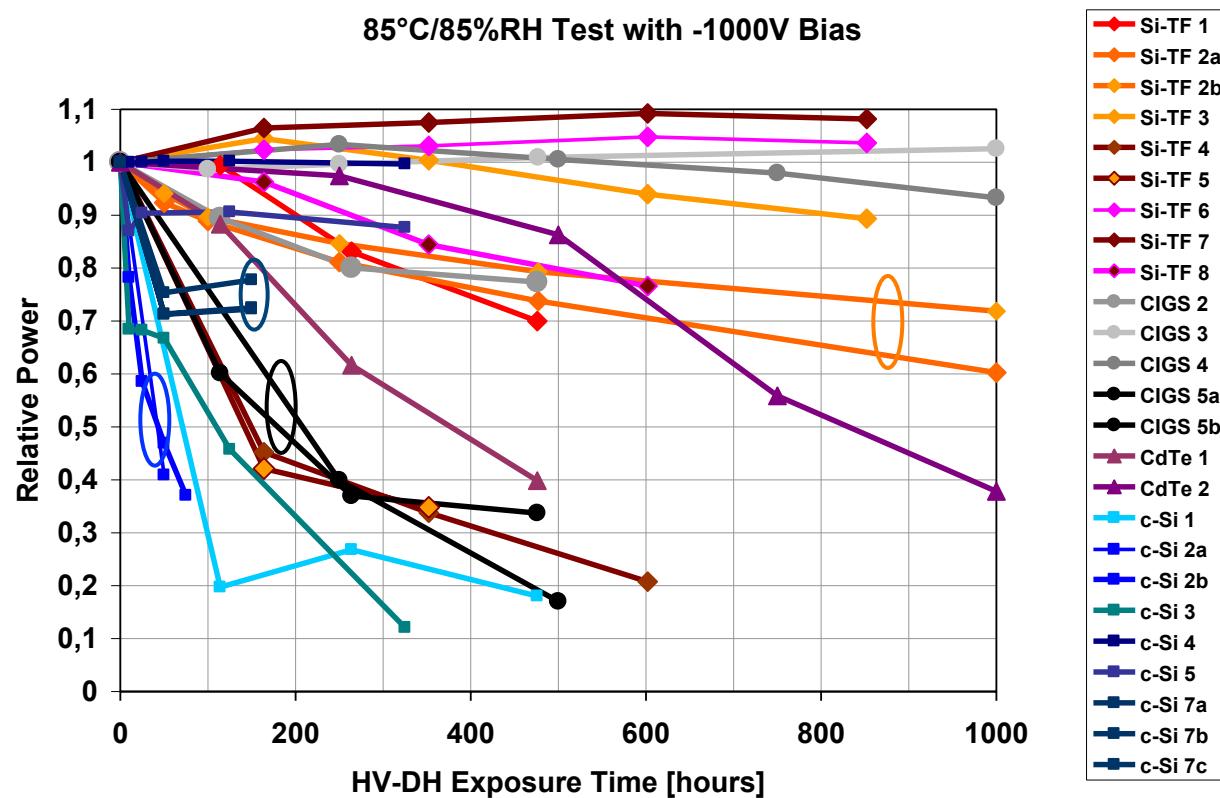
Module power after 85°C/85%-PID test: all technologies

- Wide variation from stable to highly PID susceptible
- Reproducibility of PID failure is quite o.k.

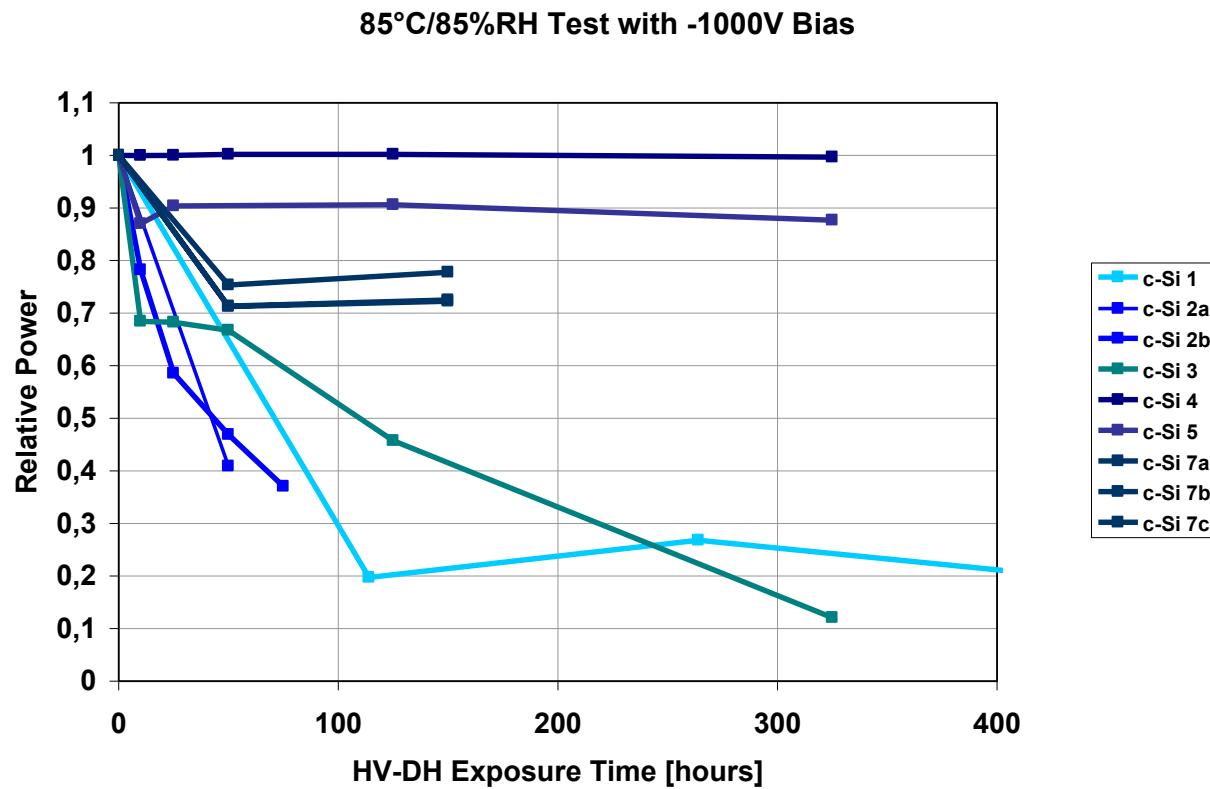
Module power after 85°C/85%- PID test: c-Si only

- Shunting occurs (loss of FF, Rsh, very bad at weak light)

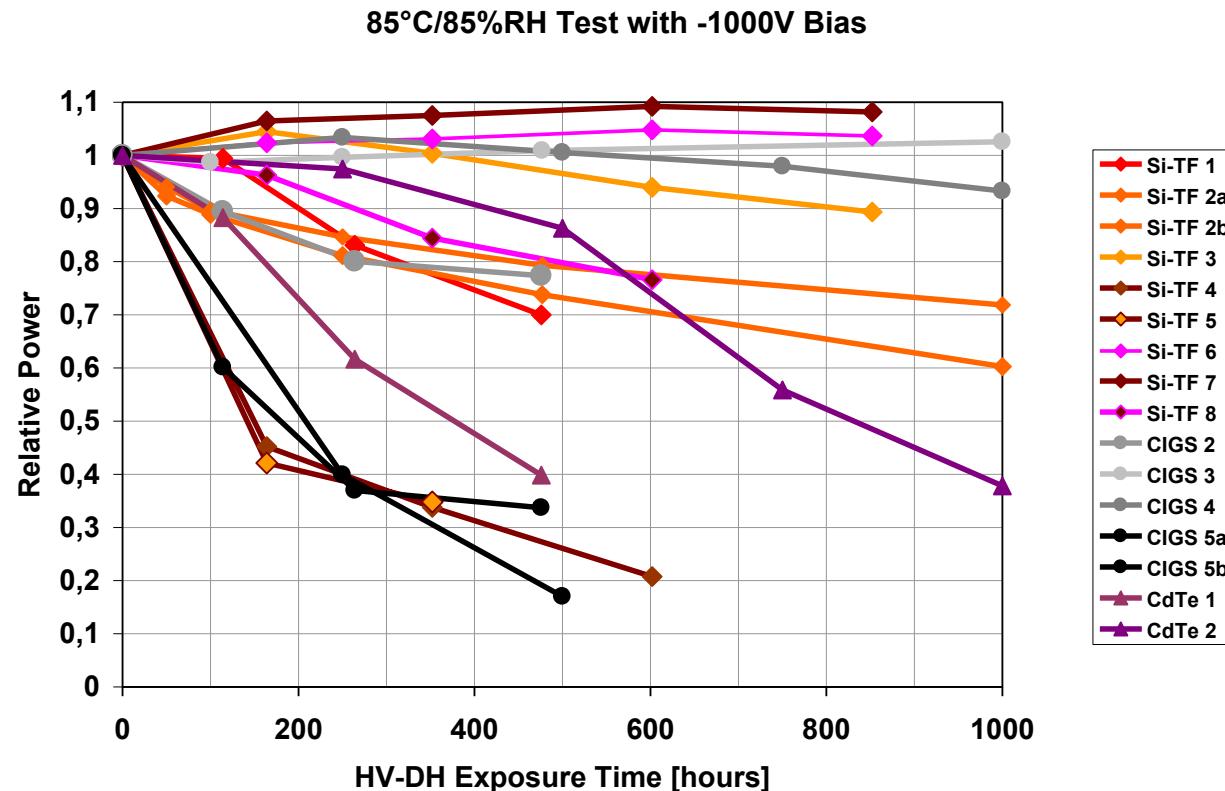
Module power after 85°C/85%- PID test: TF only

- TCO corrosion occurs for some Si-TF and CdTe products
- Shunting occurs for some CIGS products; no visual defects
- For most of the PID-susceptible TF modules grounding is mandatory

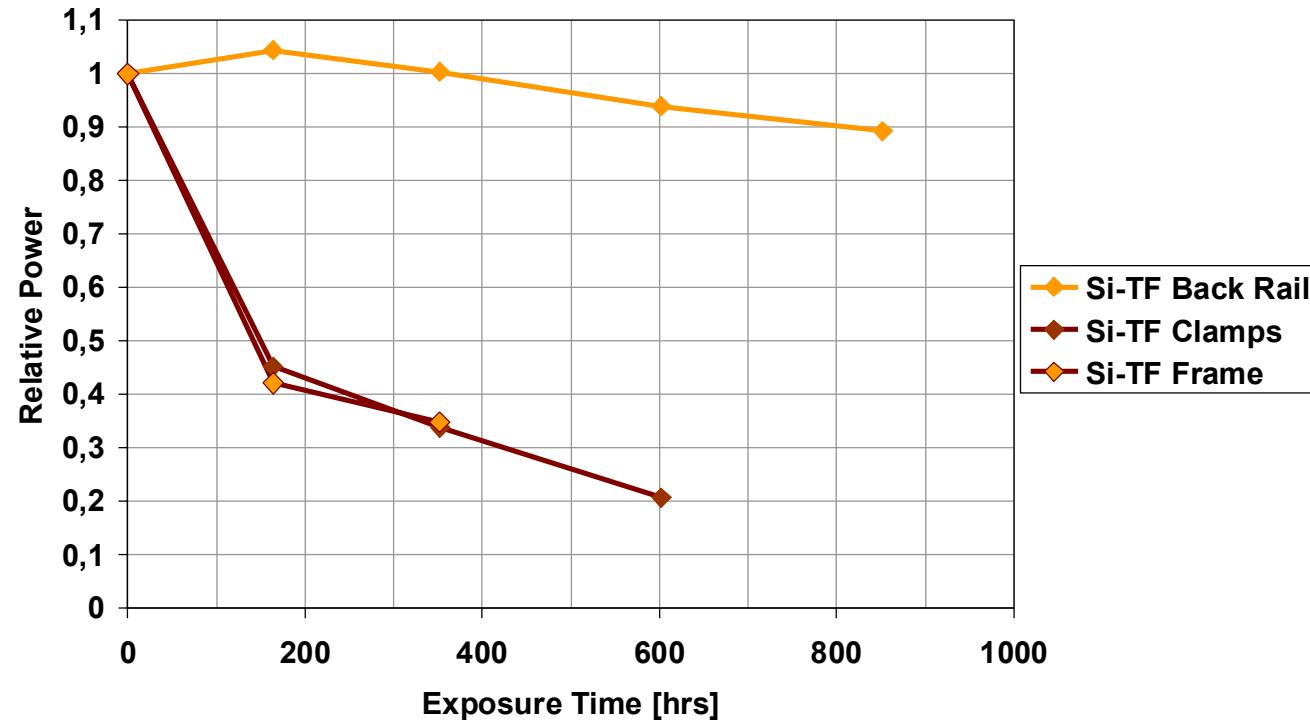
Optimization of PID-resistivity by choice of mounting: Si-TF module

85°C/85%RH Test with -1000V Bias

- Back Rail mounting reduces susceptibility for TCO-corrosion

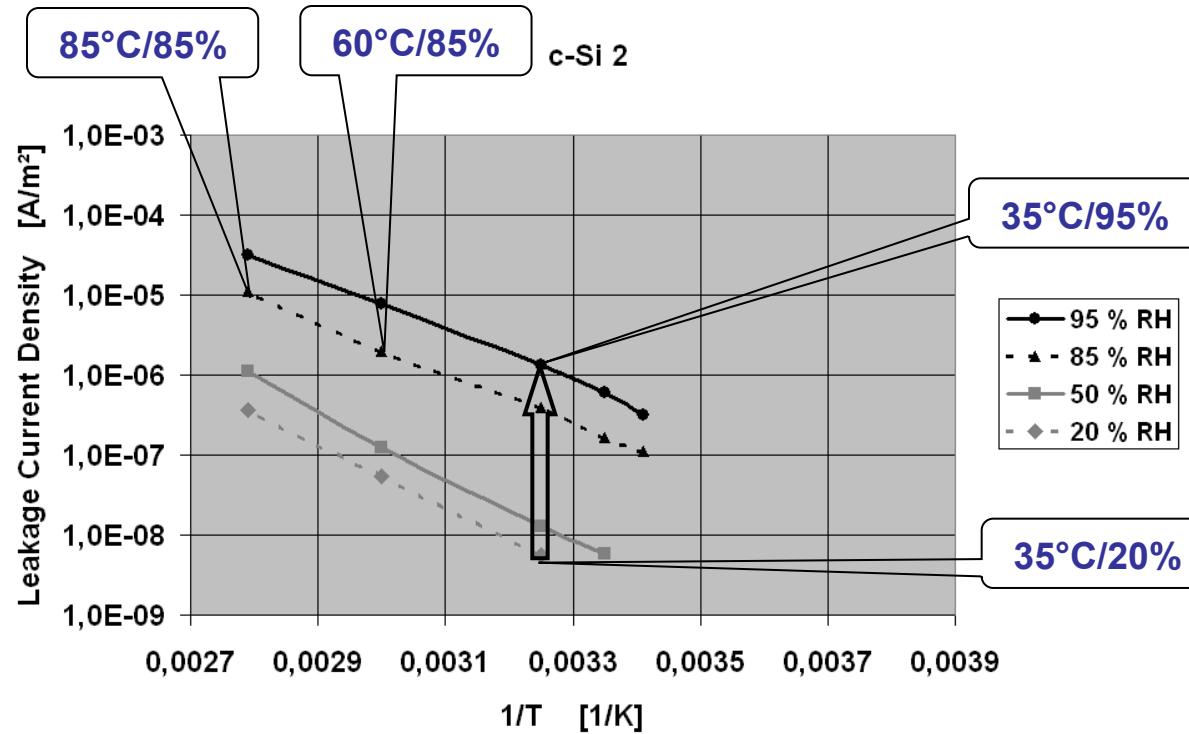
Arrhenius plot of leakage currents from the lab:

- Activation energy E_a typically between 0.6 and 0.8 eV
- Current is strongly dependent on humidity

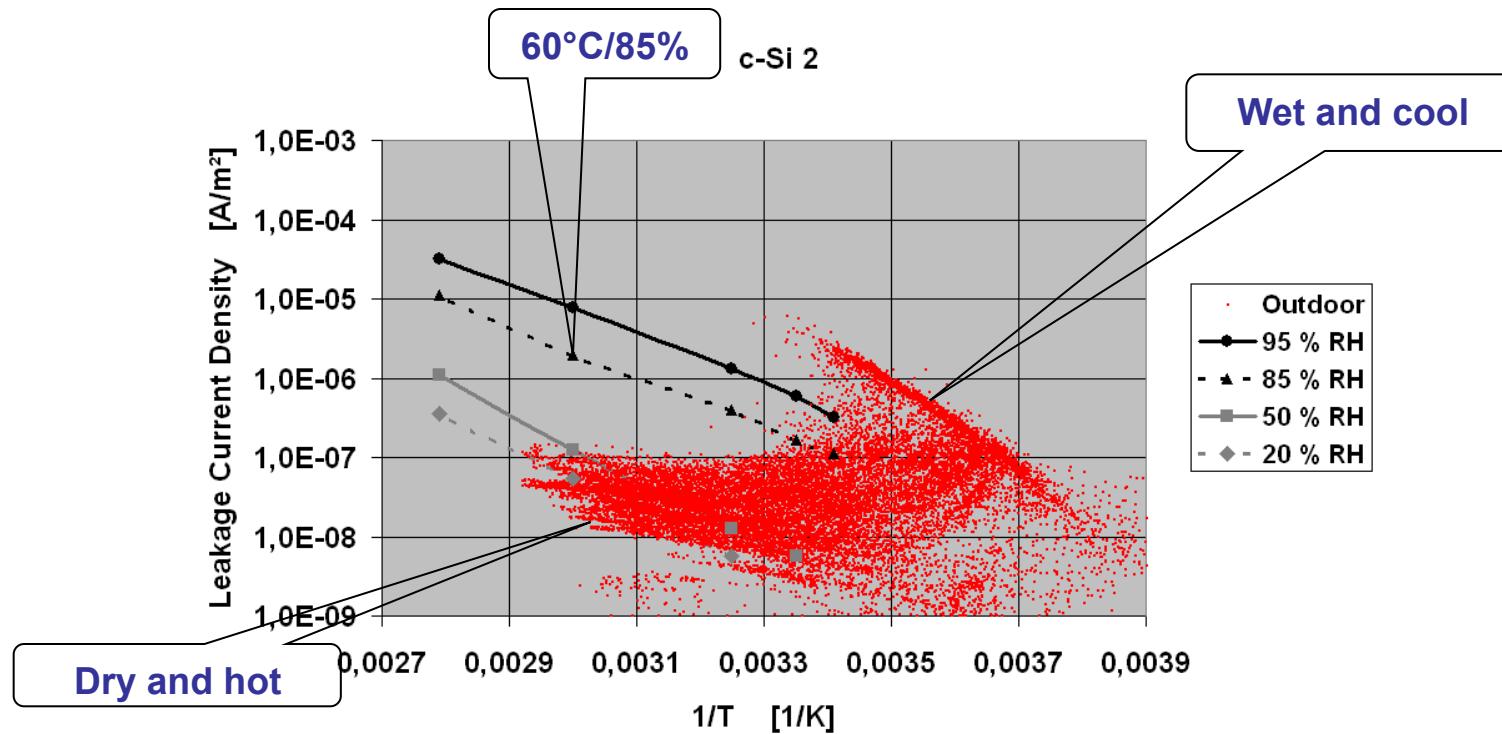
Superposition of chamber and field measurements Outdoor from Jan to Jul 2012

- High currents for wet and cool modules
- Low currents for dry and hot modules
- Moderate “acceleration” at $60^\circ\text{C}/85\%$ vs. “wet and cool”

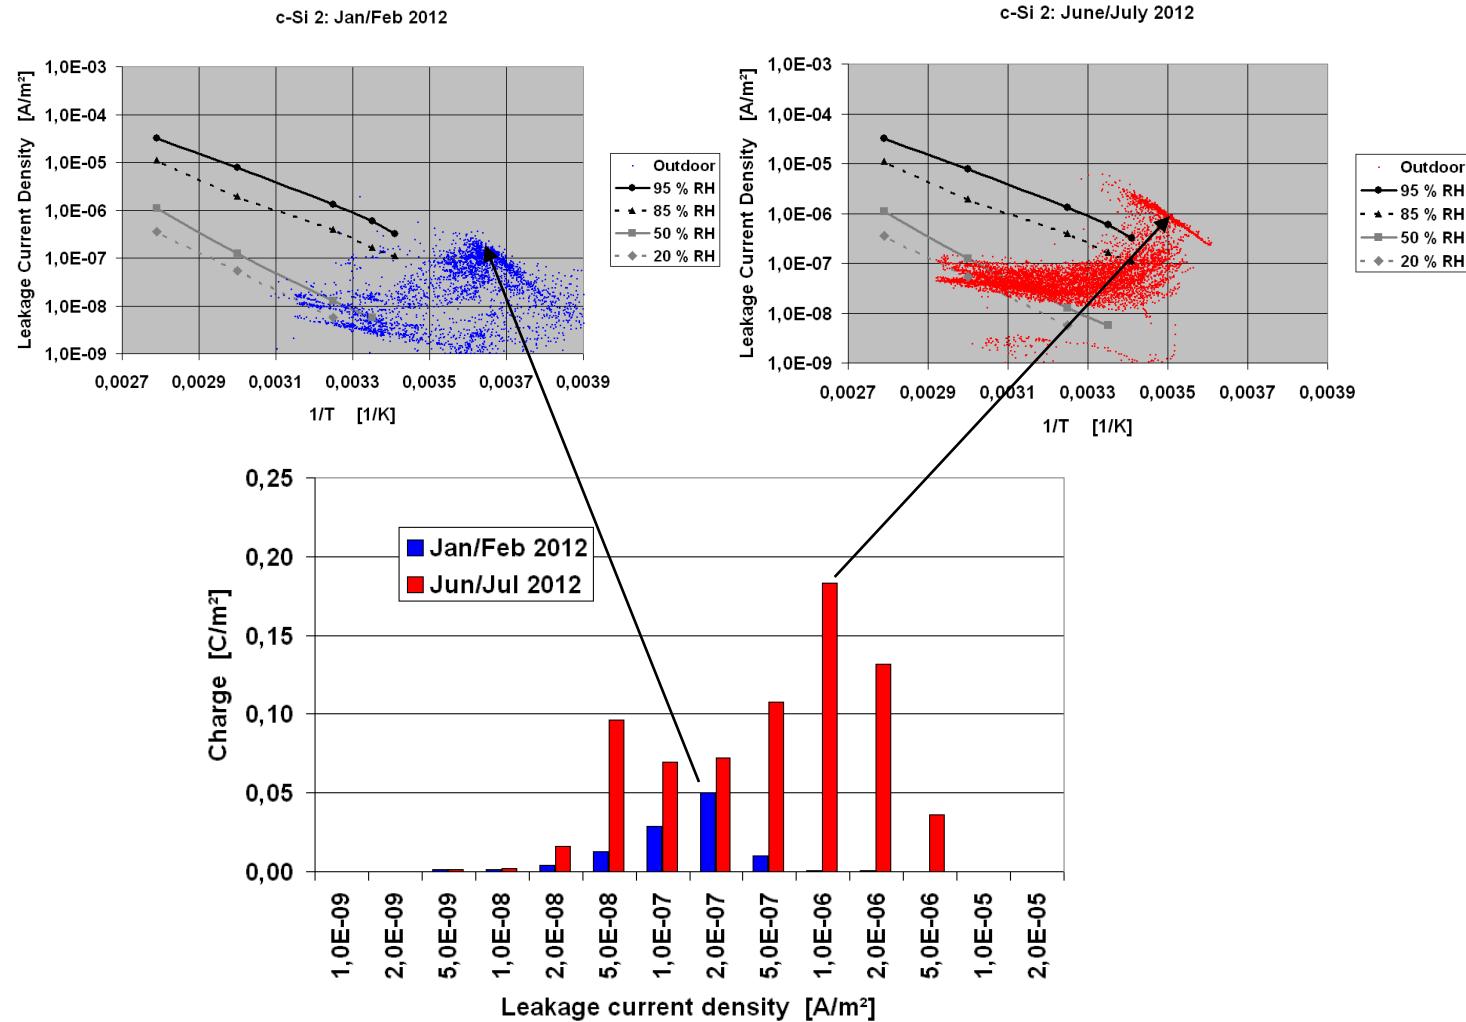
Summer/winter distribution of leakage currents and charge

- major contribution to transferred charge stems from wet/cool modules

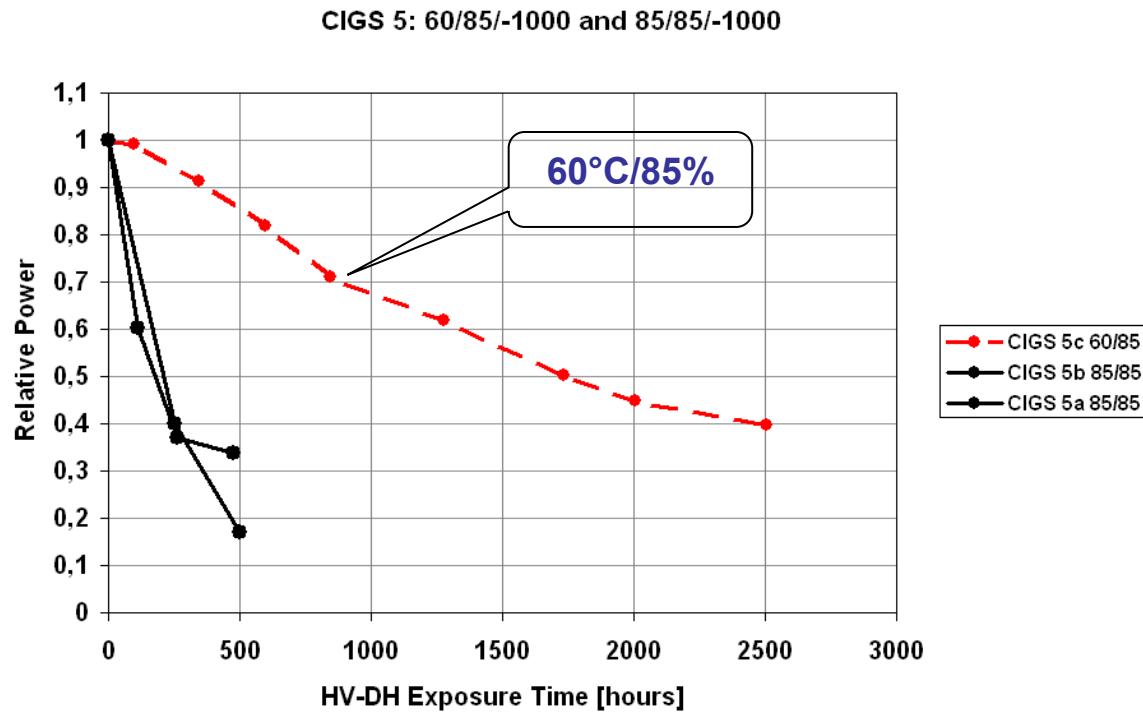
Example: CIGS 5

Power loss vs. time

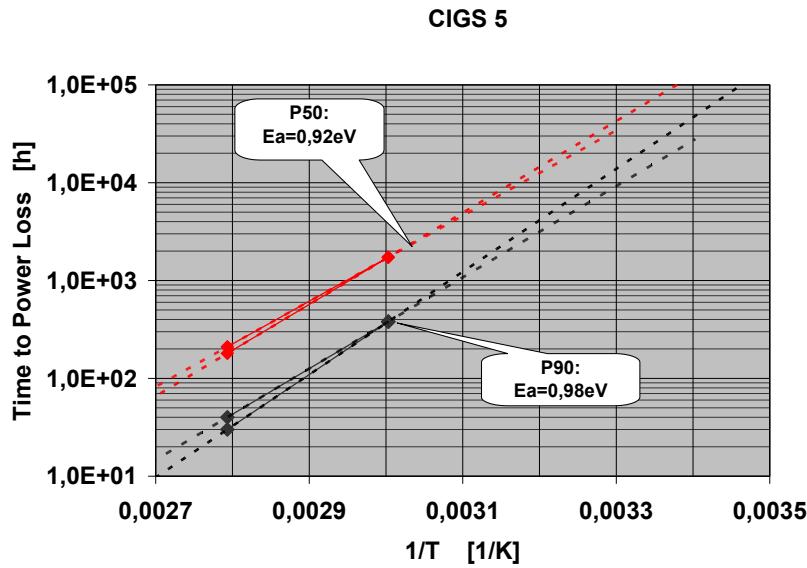
P-loss:
 $E_a = 0.92 \dots 0.98 \text{ eV}$

- E_a similar for P-losses and temperature activated leakage current

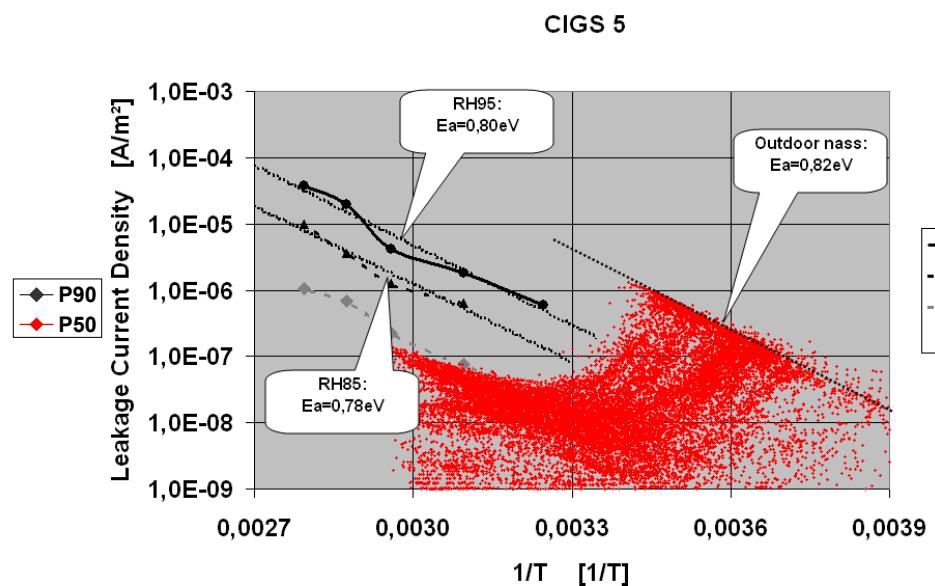
Leakage current:
 $E_a = 0.78 \dots 0.82 \text{ eV}$

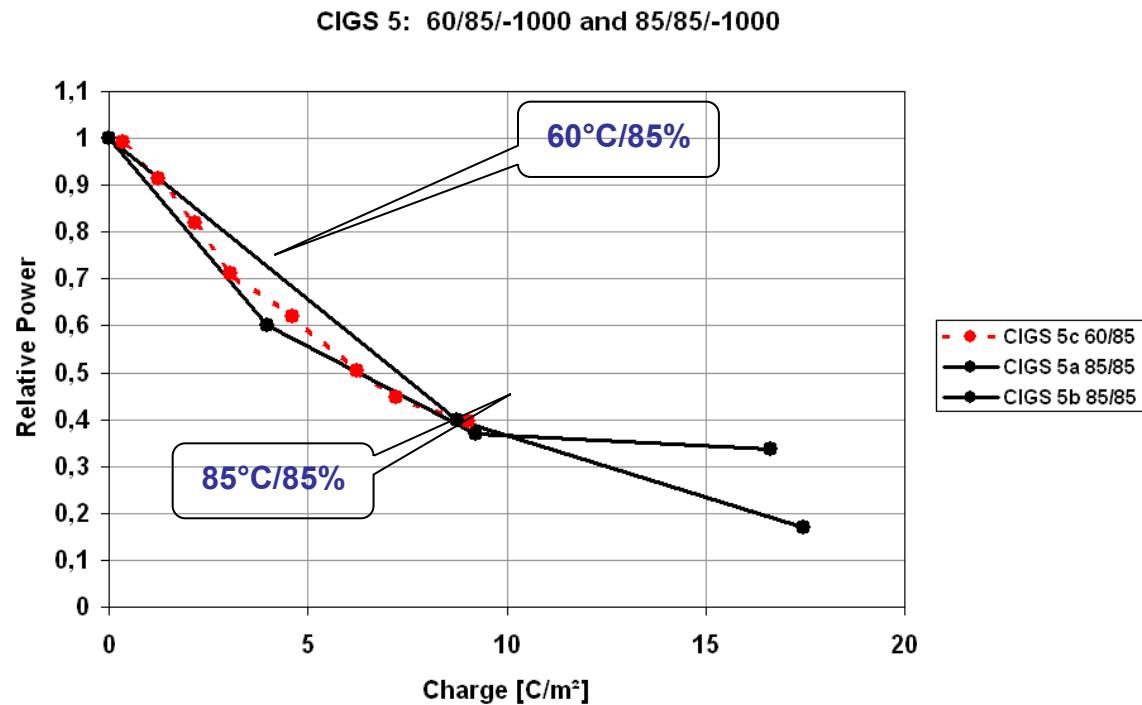
PID vs. charge CIGS 5

- Match of PID with transferred charge
- Field sample also seems to match with charge (not shown)

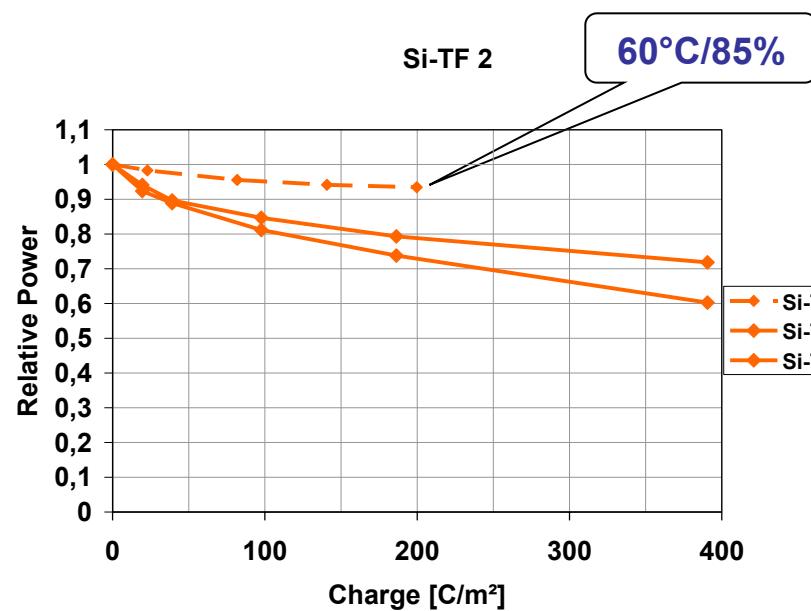
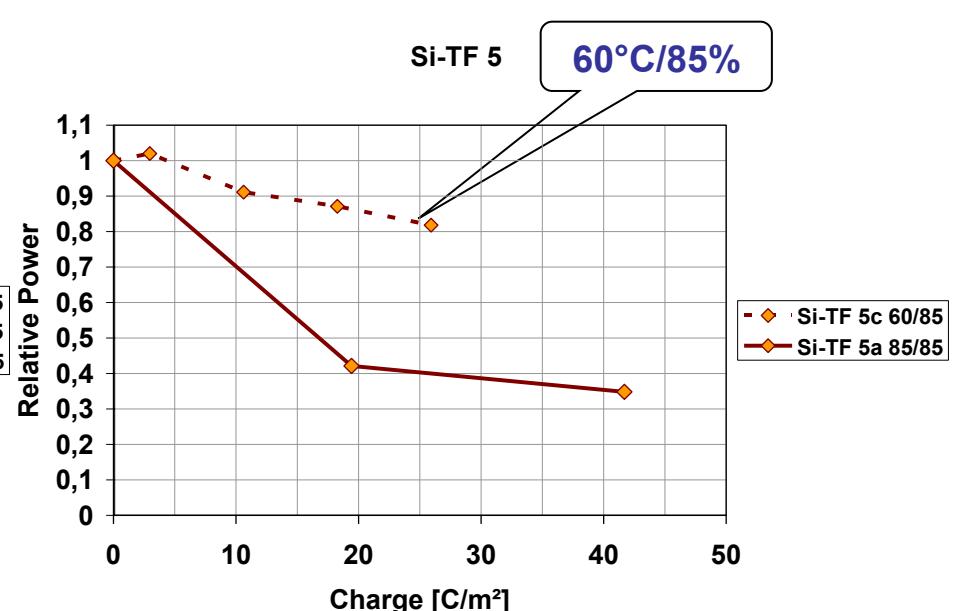
(2) Si-TF

- No match of PID (TCO-corrosion) with transferred charge for Si-TF
- $E_a = 1.1 \text{ to } 1.2 \text{ eV}$ for power loss, much higher than E_a for leakage current
- Moisture ingress probably limiting at low temperature

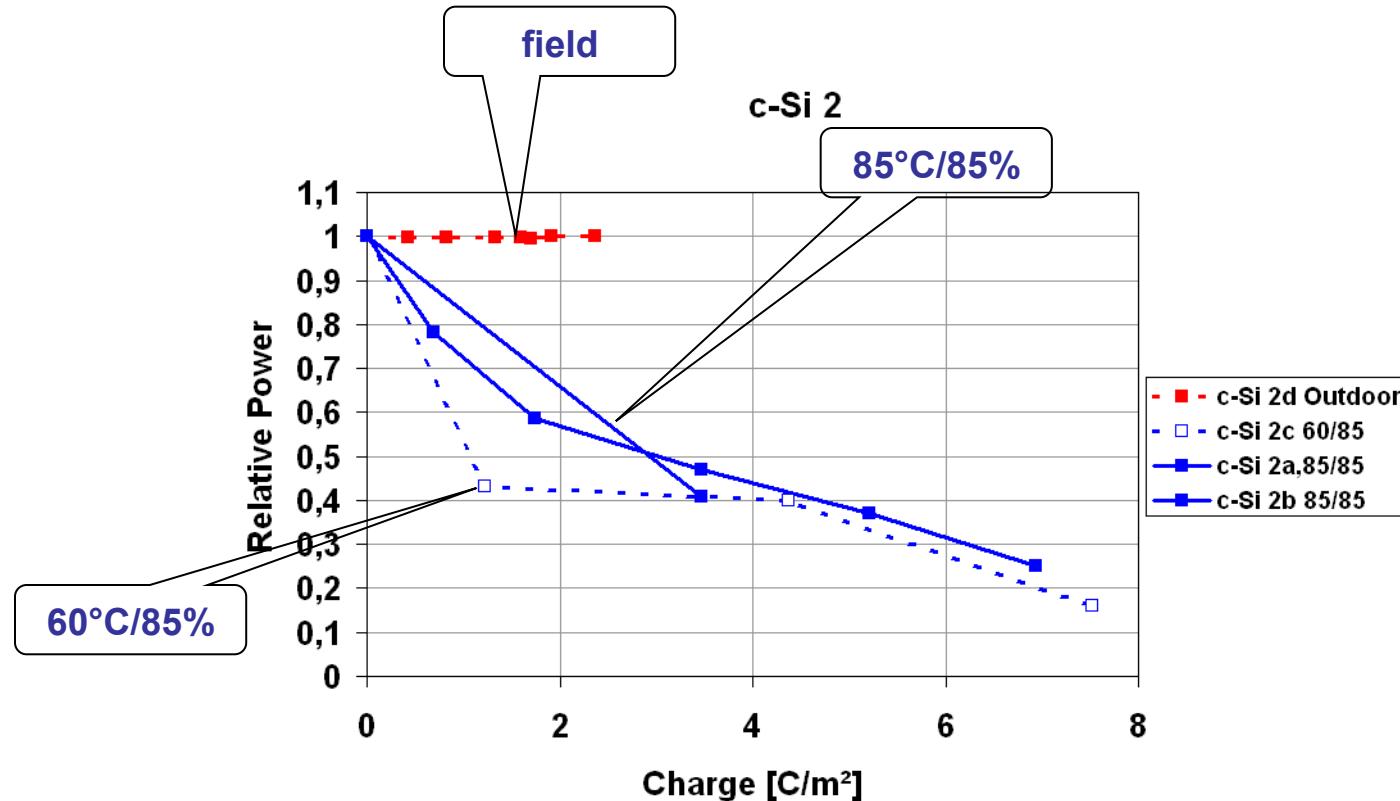
(3) c-Si

- Possible match of PID with charge for 60/85 and 85/85
- No PID after more than 1 year in the field
- Module type failed IEC62804 test

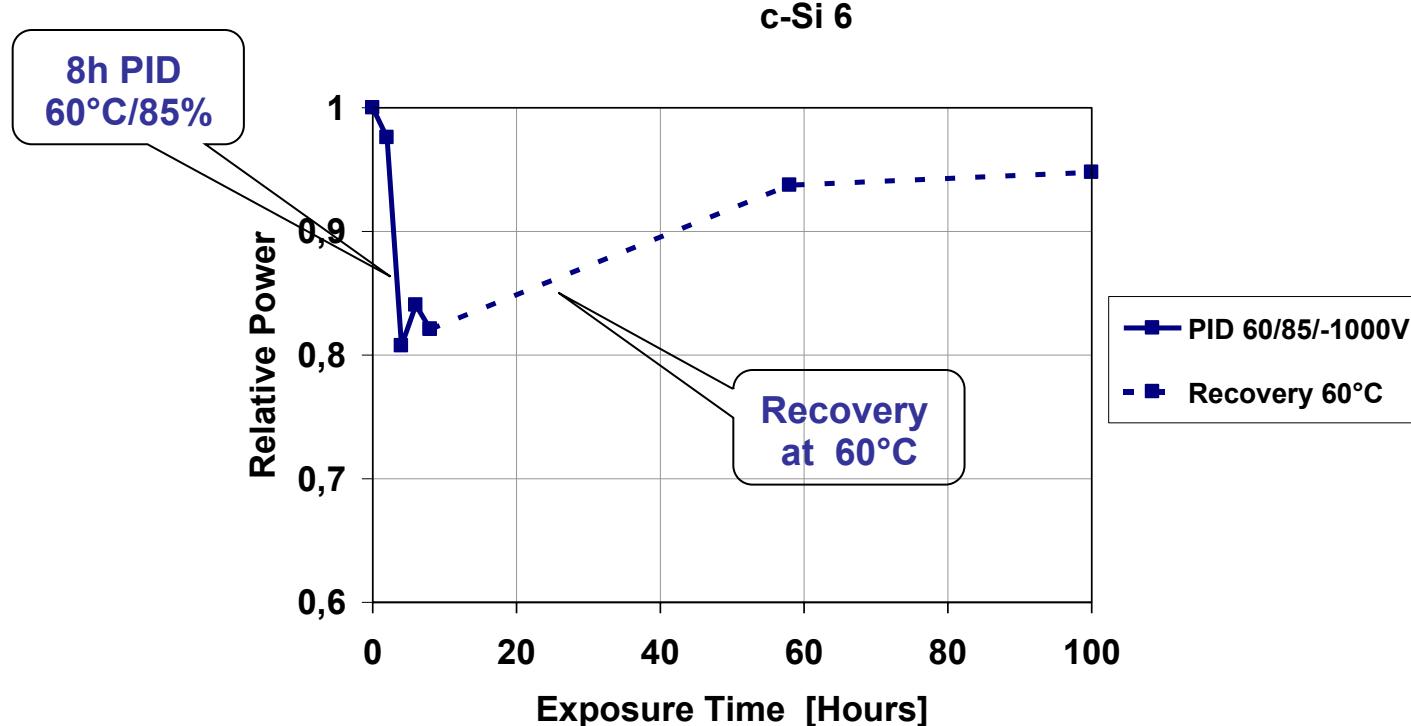
Thermal recovery of c-Si after PID stress

- Thermal recovery at low temperature is relevant for c-Si
- Is important for the field behaviour of c-Si:
balance between periods of leakage current driven PID
and temperature driven recovery

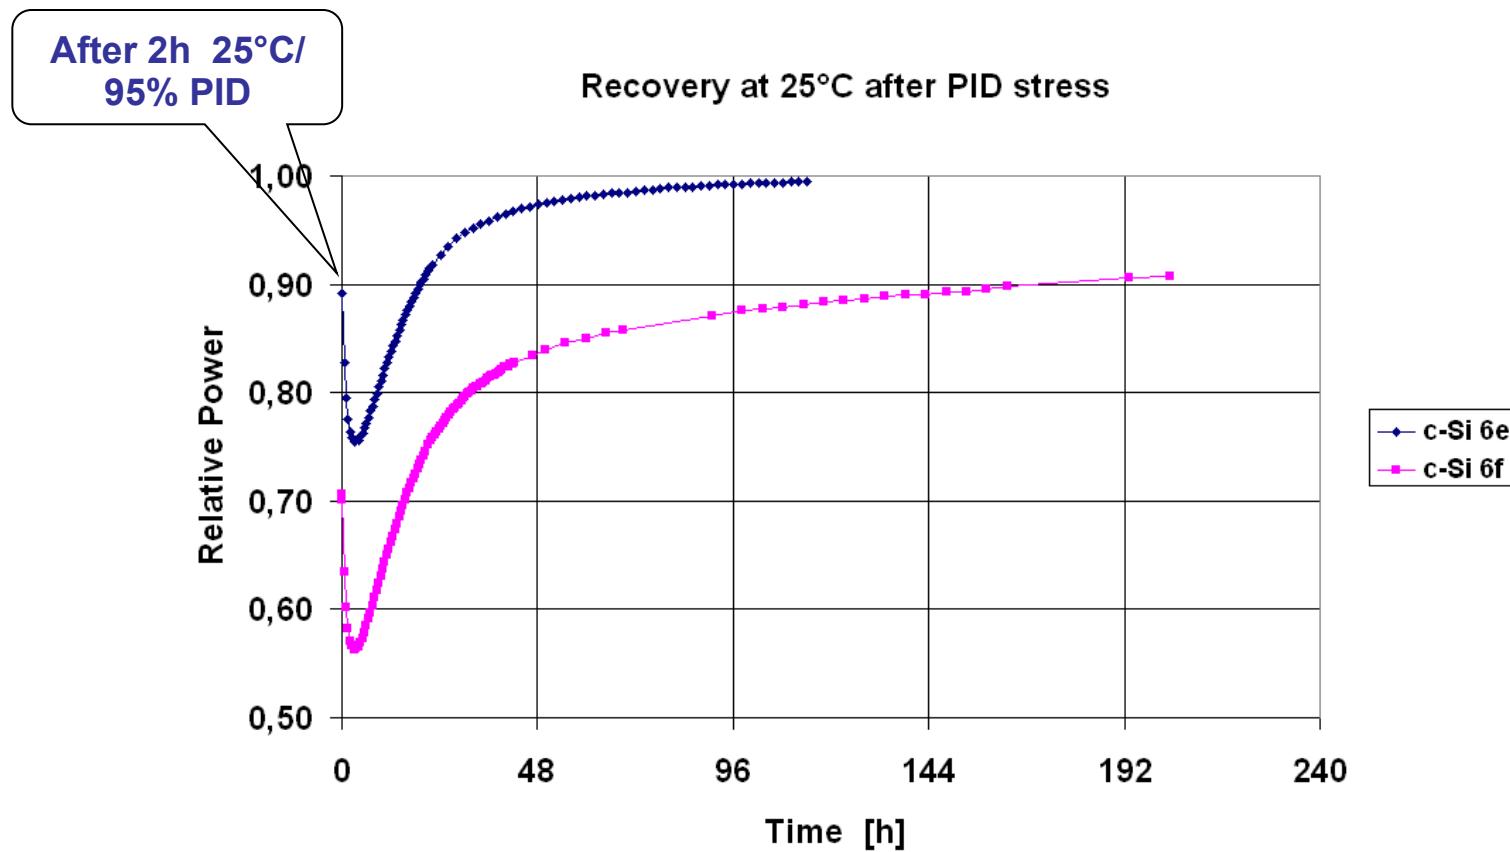
Thermal recovery of c-Si after PID stress (2)

- Relevant recovery even at 25°C possible
- Acceleration at higher T
- E_a is 0.7 to 0.8 eV

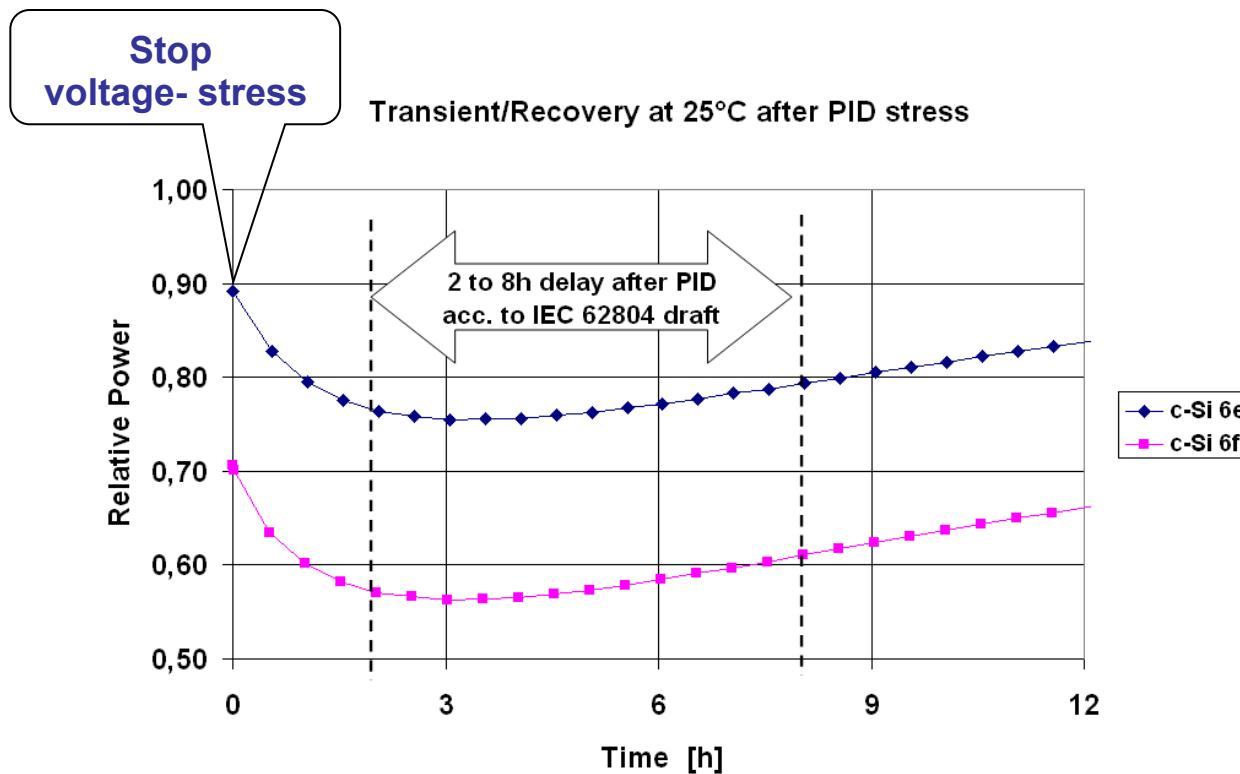
Thermal recovery of c-Si after PID stress (2)

- After stop of PID: power degradation continues for hours
- Within the 2 to 8h period after stress (62804 draft): power is not stable
