# **Materials Issues Associated with EGR Systems**

Michael J. Lance, C. Scott Sluder, and  
Hassina Bilheux

Oak Ridge National Laboratory

# **Project Objective: Provide information to industry EGR engineers about fouling deposit properties**

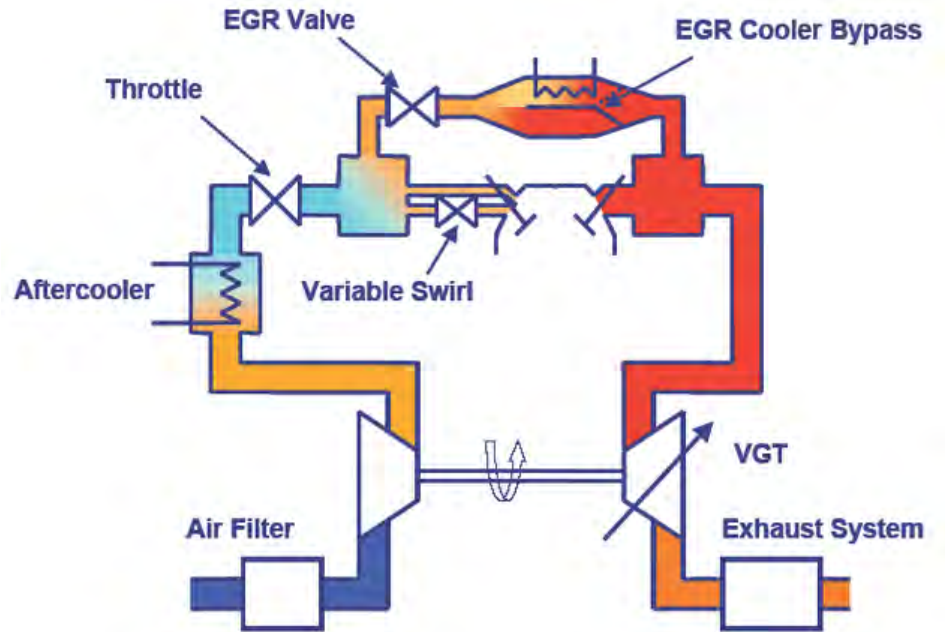
- High-pressure EGR is the dominant  $\text{NO}_x$ -reduction technology.
- Exhaust gas laden with PM flows through the EGR cooler which causes deposits to form through thermophoresis and condensation.
- The deposit thermal conductivity is very low, which reduces the effectiveness of the EGR system. The deposit growth will also increase the pressure loss leading to a decrease in engine efficiency.
- Increasing demands placed on the technology by more stringent  $\text{NO}_x$  emissions, advanced combustion, increasing use of non-petroleum-based fuels, and engine/aftertreatment system optimization requirements are leading to expansions of the technology into operational conditions that are relatively unknown or known to be problematic.

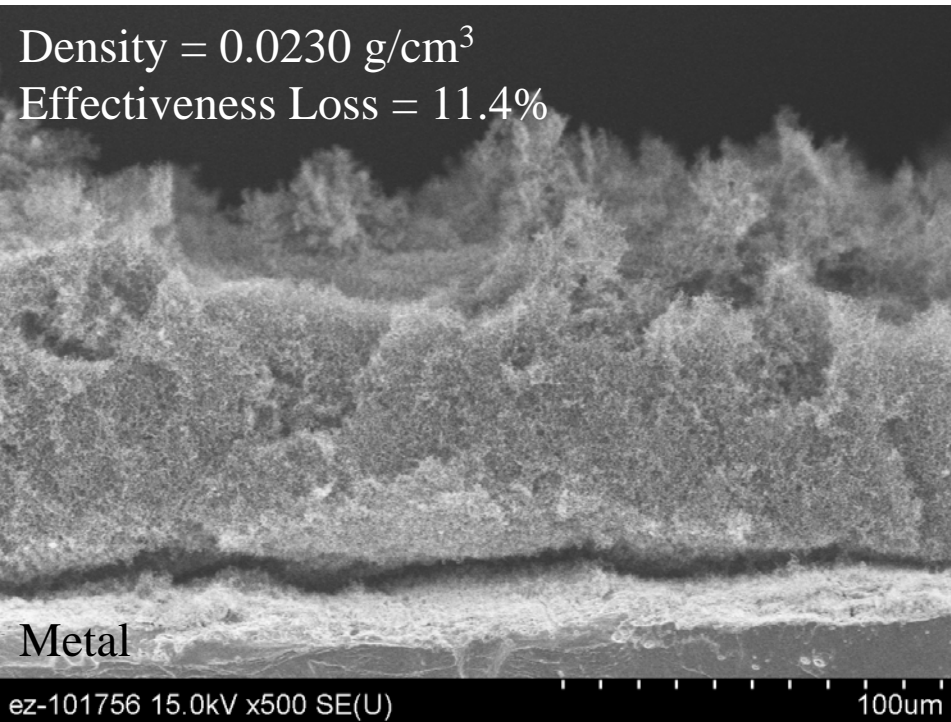
## Light-Duty Condition:

2.6 Bar BMEP, ~225 C inlet, 144 ppm HC,  
95 ppm NO<sub>x</sub>, 1.36 FSN

Density = 0.0230 g/cm<sup>3</sup>  
Effectiveness Loss = 11.4%

- Both deposits were generated at 1500 rpm and a EGR flow rate of ~30 SLPM for 4 hours. Coolant temperature was 90 C.
- The heavy-duty deposit was thicker and had a lower density than the light-duty condition which increased the effectiveness loss.

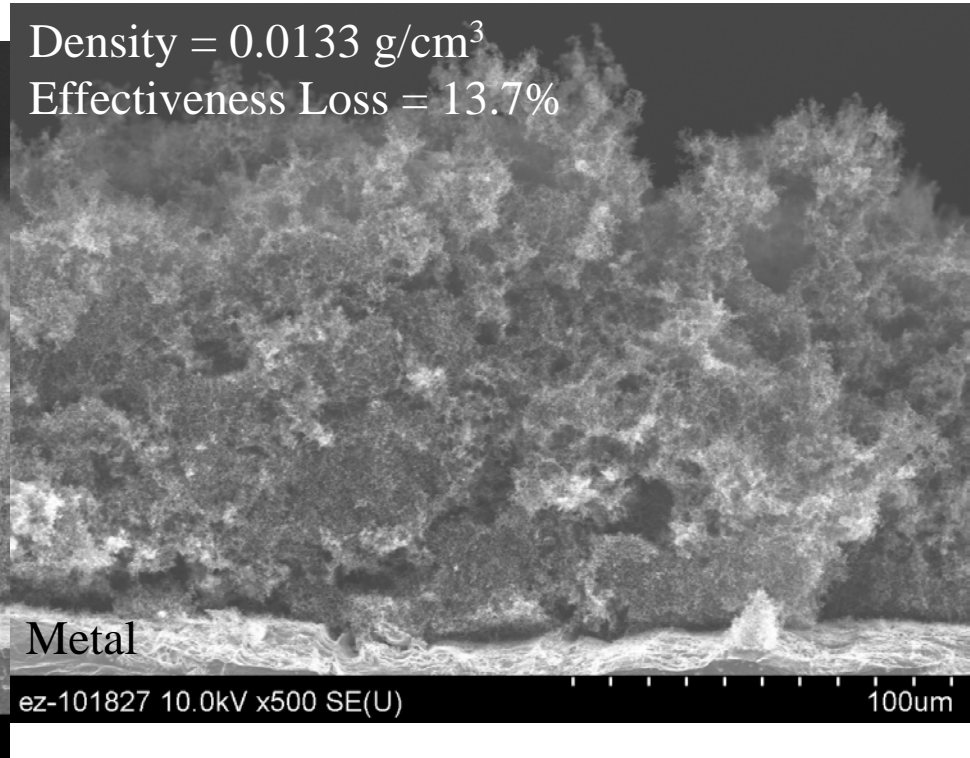
## Heavy-Duty Condition:

7-8 Bar BMEP, ~325 C inlet, 28 ppm HC  
310 ppm NO<sub>x</sub>, 0.97 FSN

Density = 0.0133 g/cm<sup>3</sup>  
Effectiveness Loss = 13.7%

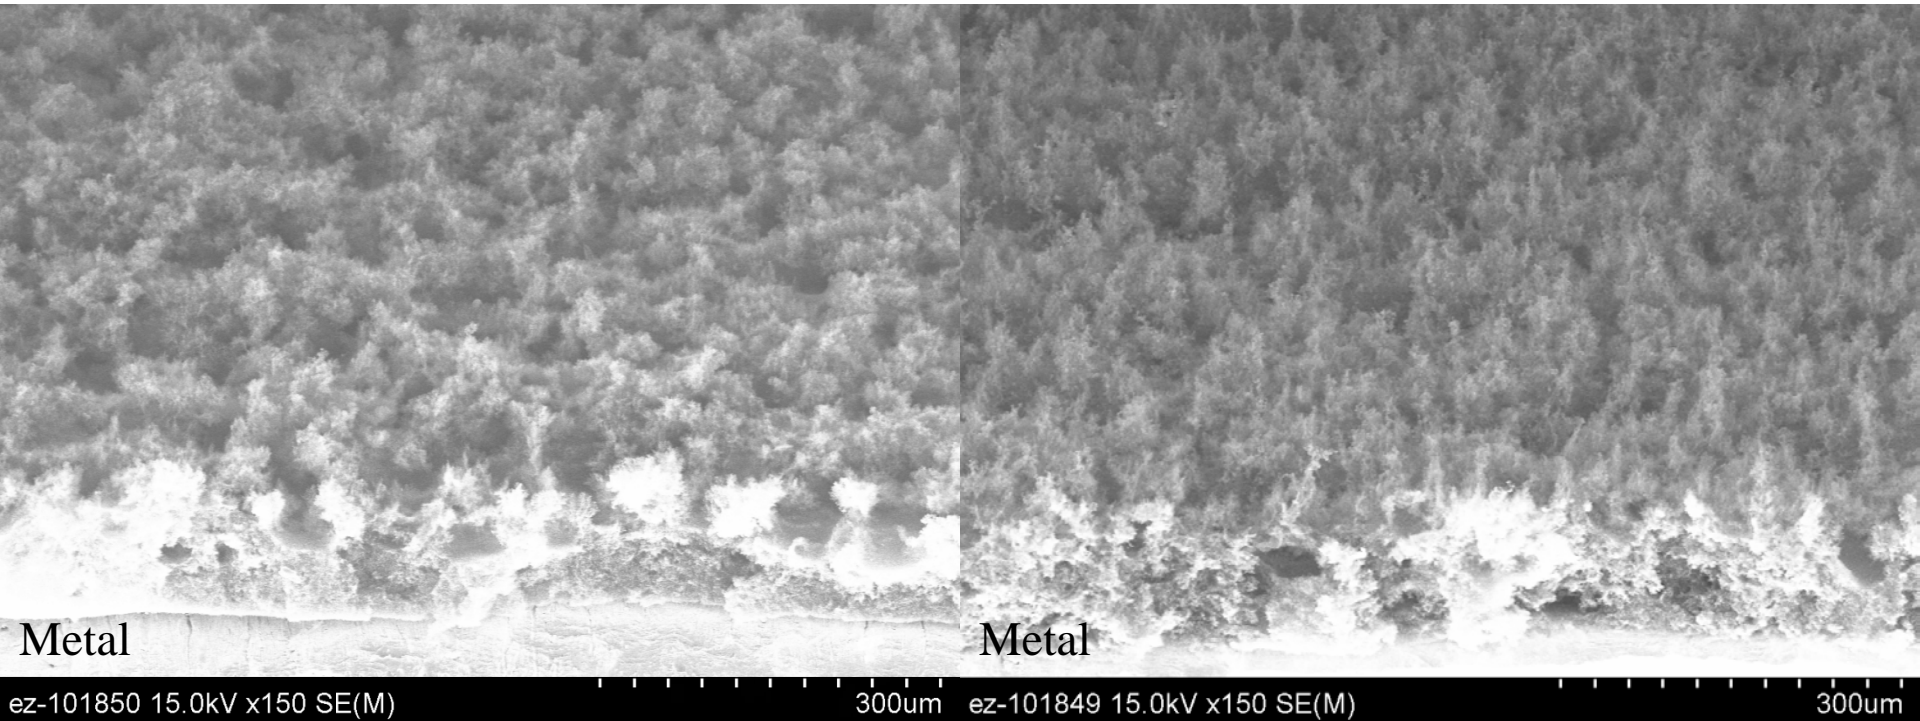
Light-Duty Condition

Heavy-Duty Condition

- Images of the surface collected at a 20° tilt.
- The light-duty sample has a clumpier surface whereas the heavy-duty sample appears more dendritic. These longer dendrites of the HD sample apparently allow more large-scale pores to form during deposition.
- This project will proceed by addressing both the light-duty and heavy-duty diesel communities.

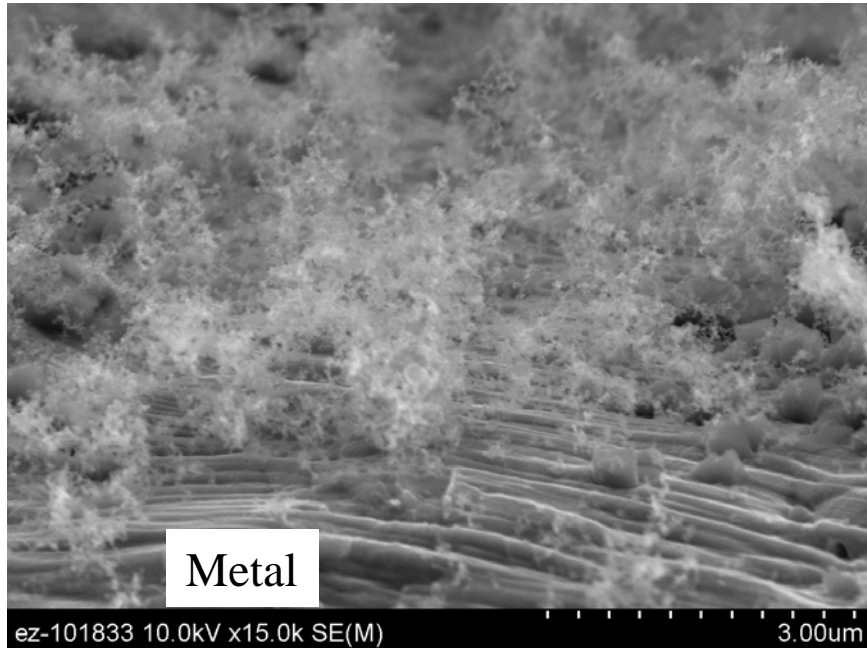
Metal-Deposit Interface

- After delamination, PM remains on the metal, indicating that the fracture plane is within the deposit, not at the deposit/metal interface.
- Large-scale pores (1000 times larger than the primary PM size) form during deposition.

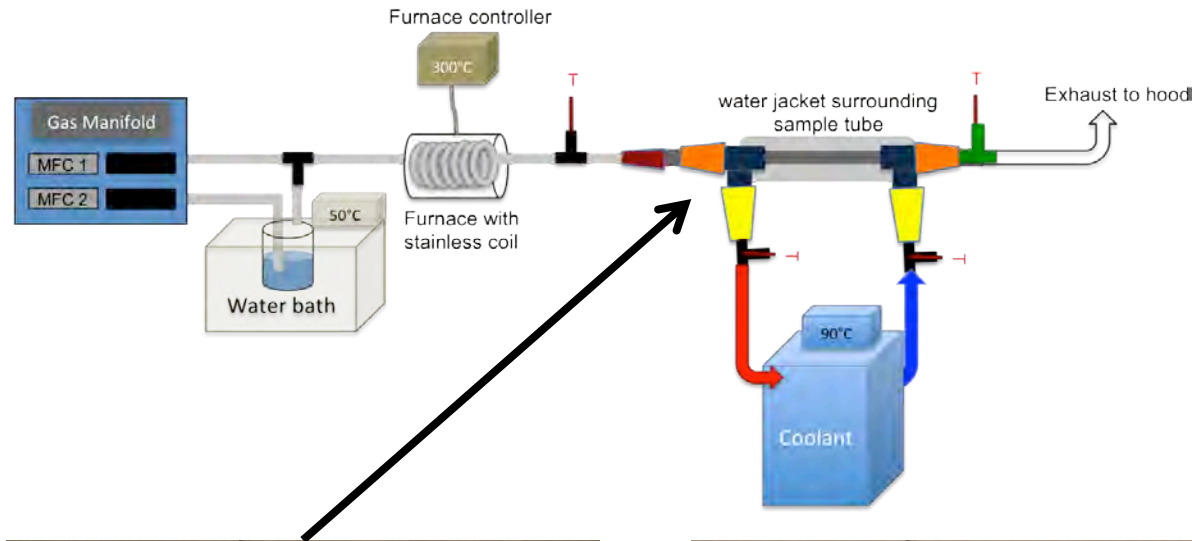
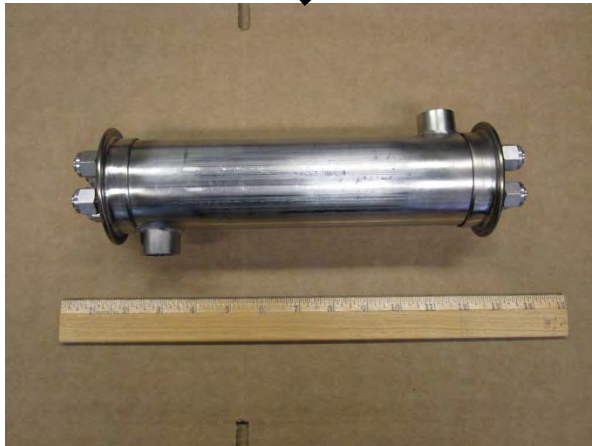
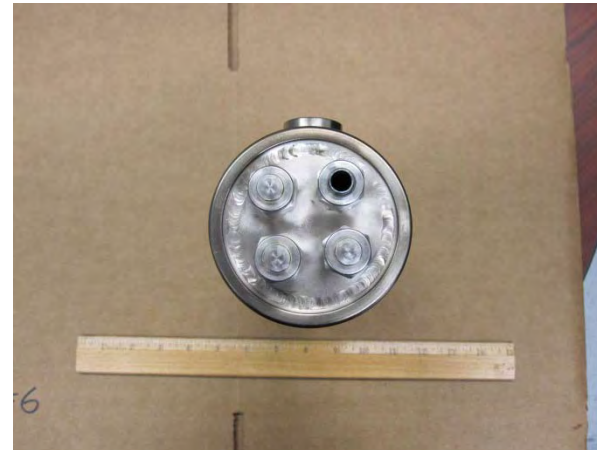
# Bench-top Tube Reactor for Deposit Aging

- Samples generated with our engine are aged in a tube reactor and the changes in the deposit properties and microstructure are monitored.
- Inlet and coolant temperature, gas flow rate, water and HC content are controlled.

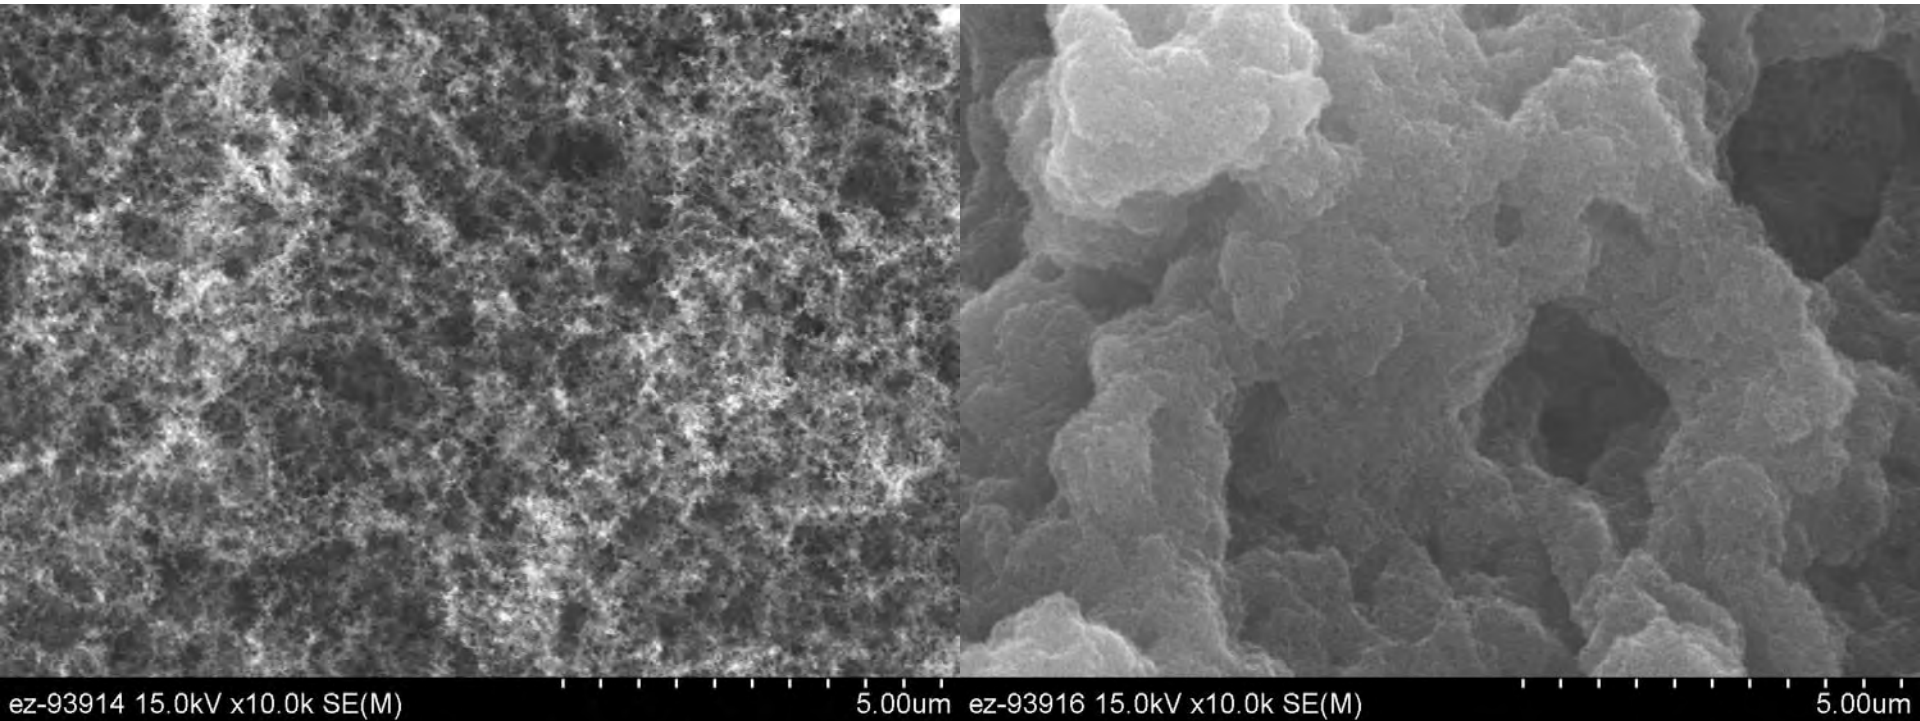
Light-Duty Deposit

After Water Immersion and Drying

- Thermal conductivity is controlled mainly by deposit density. Since the deposit starts off with such a low density, there is the potential to dramatically improve its properties by collapsing the PM microstructure.
- Deposit microstructure shows a dramatic shrinkage following water immersion.
- Changing the engine operating conditions so as to condense water or HC on the deposit may regenerate the fouled cooler.

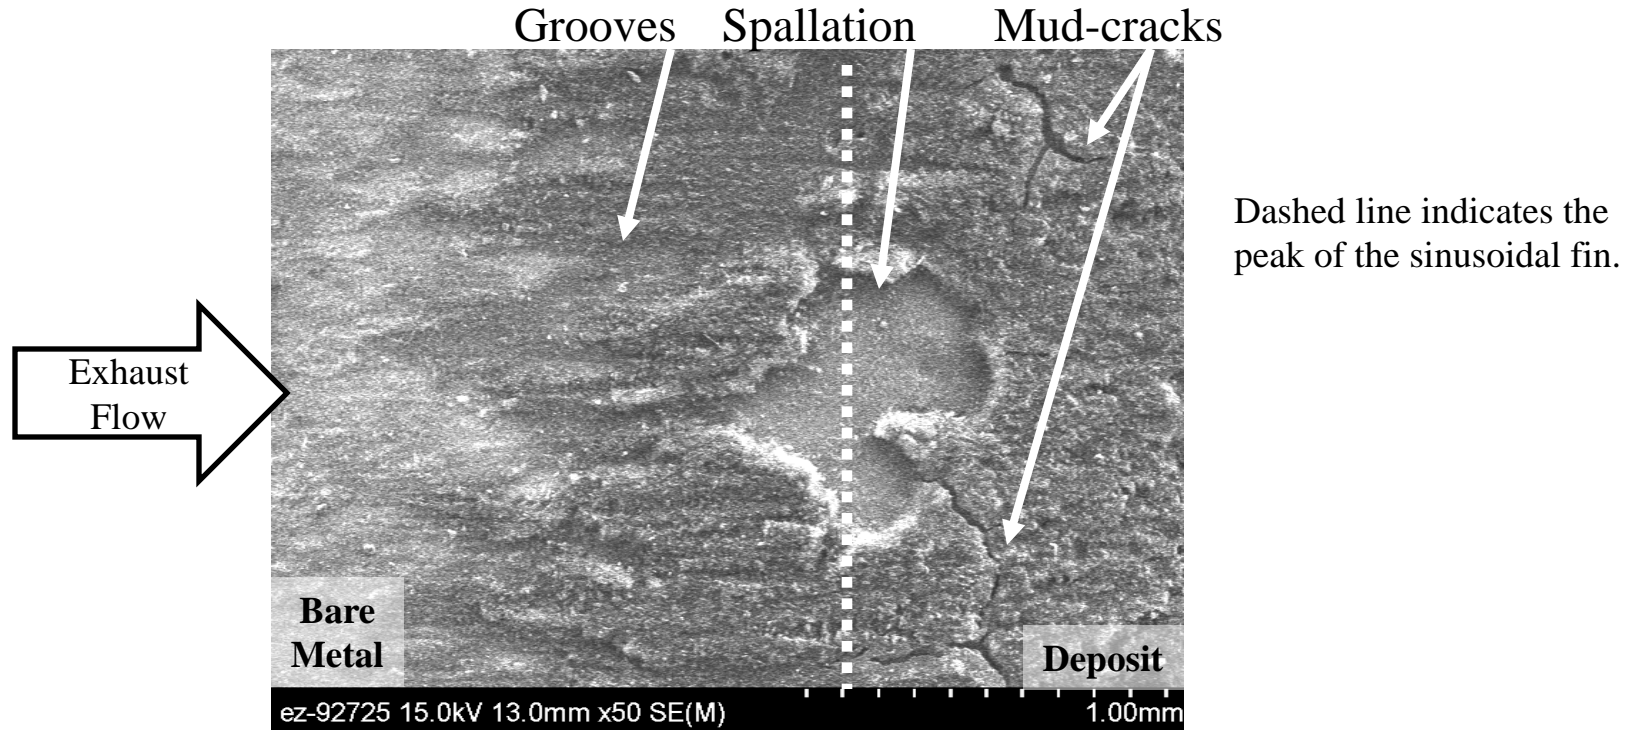
# Three Common Deposit Removal Mechanisms

- Longitudinal grooves, mud-cracks and spallation have been observed on many coolers, suggesting that the deposit is shrinking by some mechanism. This may be the origin of spontaneous regeneration that has been reported by many EGR consortium members.
- Communication of Results to Broader Community:
  - Two DEER meetings (oral)
  - Nine Diesel Crosscut Team Meetings
  - Two SAE meetings (Excellence in Oral Presentation Award)
  - Two Global Powertrain Conference Meetings
- Work has generated follow-on-funding from two EGR consortium members and the US Army.

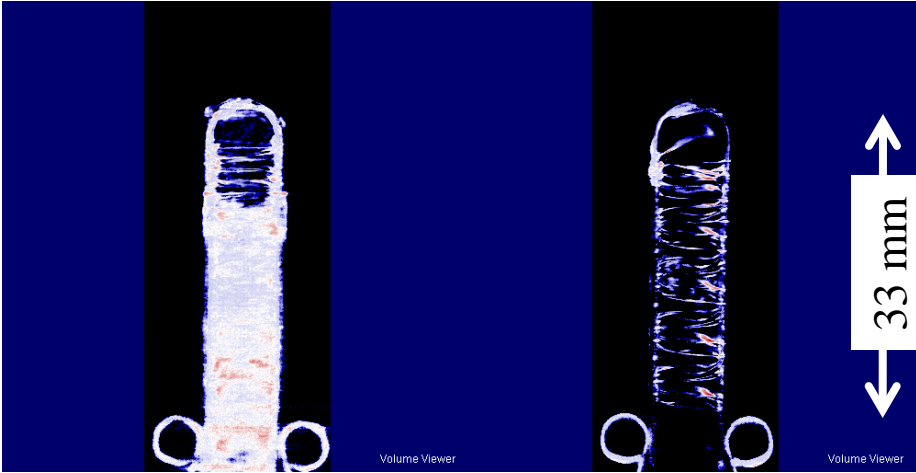
Cooler #3

Fouled

Cleaned

- Neutrons are strongly attenuated by hydrogen which allows for non-destructive imaging of the deposit through the metal.
- The two coolers with the most HC were selected for neutron tomography.
- 720 2-D projections of the cooler sections were acquired by rotating the sample around its axis of symmetry.
- The spatial resolution was  $\sim 70 \mu\text{m}$  which may soon improve to  $35 \mu\text{m}$ .

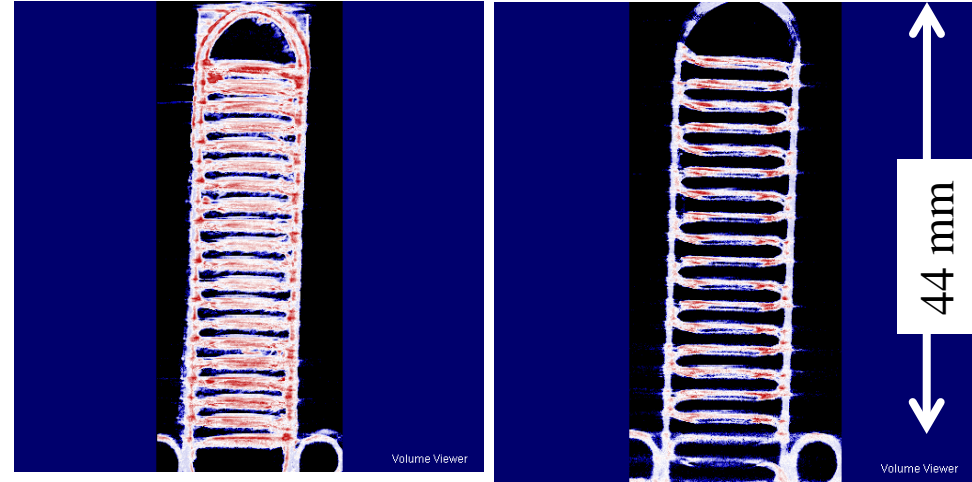
Cooler # 5

Fouled

Cleaned

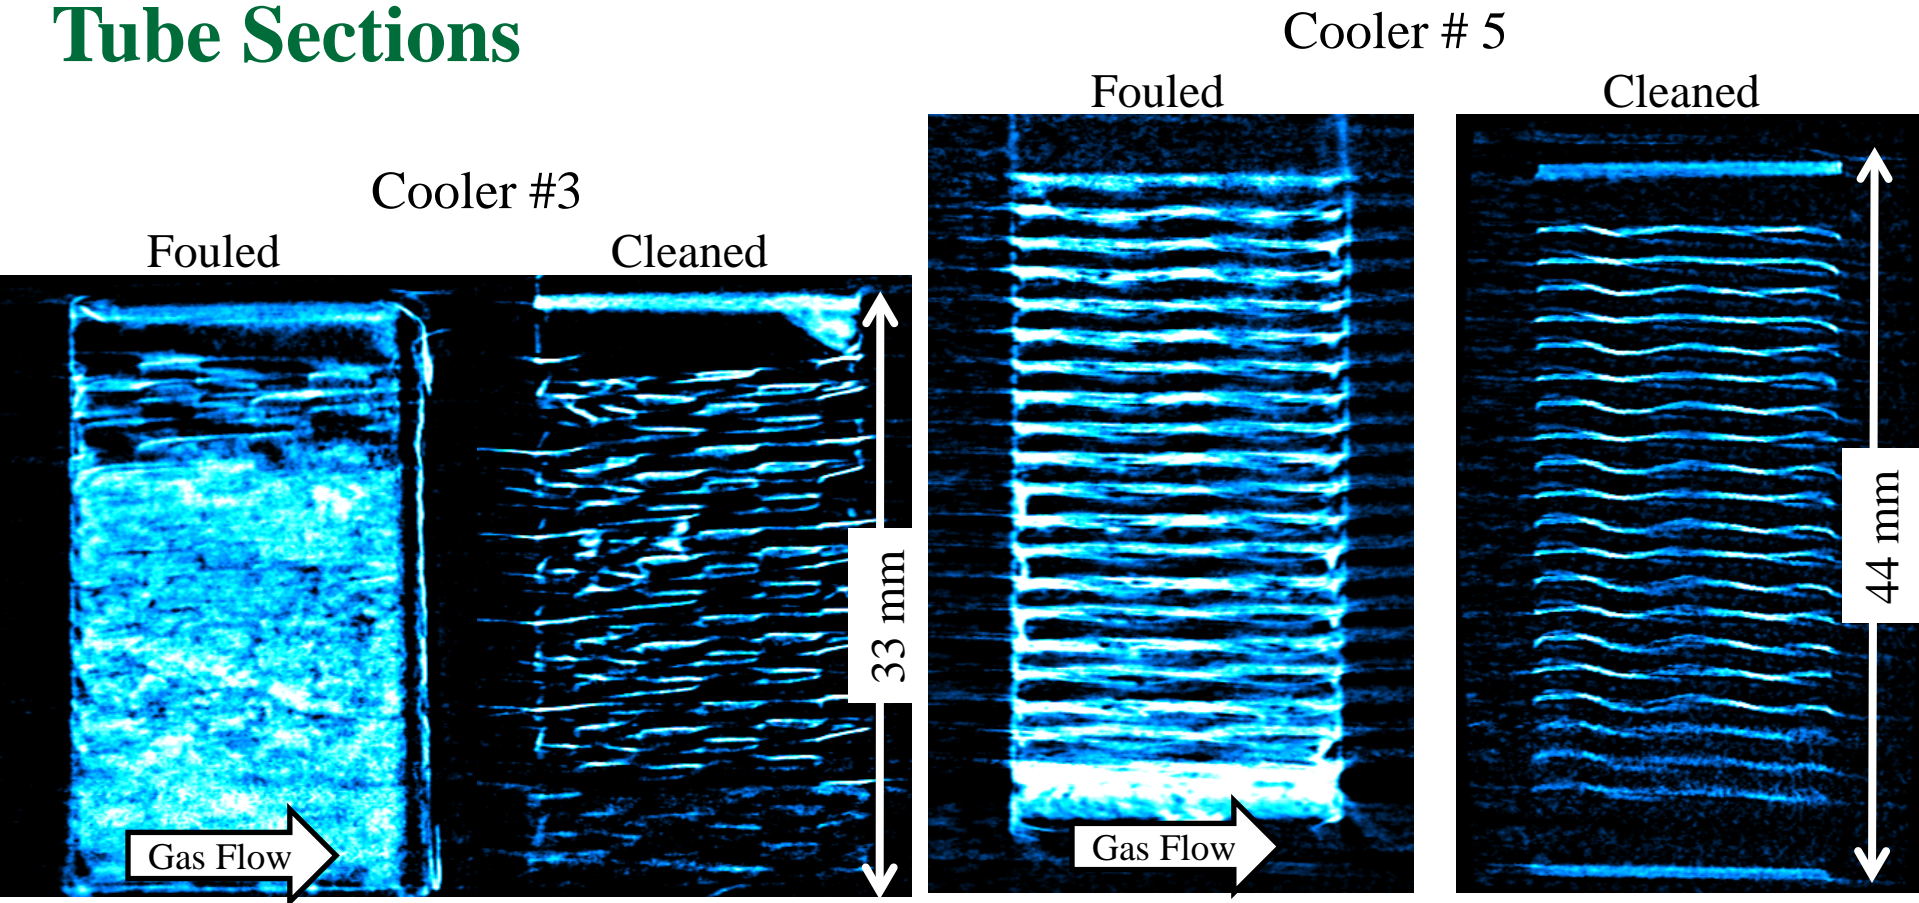
33 mm

44 mm

Gas Flow

- The resolution was not high enough to measure thickness directly but we can still gather useful information about the deposit location relative to the heat exchanger geometry.
- A new project funded by the US Army (partnering with Modine) is focusing on the effects of internal heat exchanger geometry on fouling.
- Dr. Jens Gregor (Associate Professor of Radiology, UT Graduate School of Medicine) has been contracted to develop software to aid in the reconstruction and image processing.

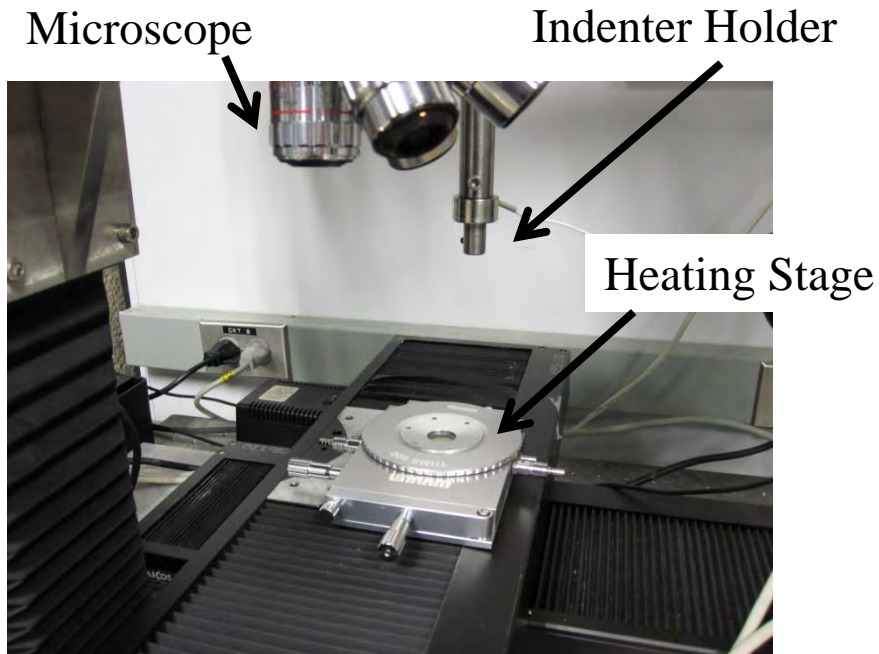
# Mechanical Properties: Instrumented Indentation

- Load-Displacement curve of deposit on a metal substrate can be measured as function of temperature.
- A crushing strength can be measured that will allow us to approximate fracture strength.
- Deposit stiffness can be estimated from the slope of the curve.
- Mechanical properties measurement is critical for understanding removal mechanisms.
