# Post-Test Analysis of Lithium-Ion Battery Materials at Argonne National Laboratory

J. Bareño, N. Dietz-Rago, I. Bloom  
DOE Annual Merit Review  
May 14, 2013  
Washington, DC

Project ID: ES166

## Case Study: Aging of Cells Containing Toda HE5050 and 5-V Spinel Electrodes

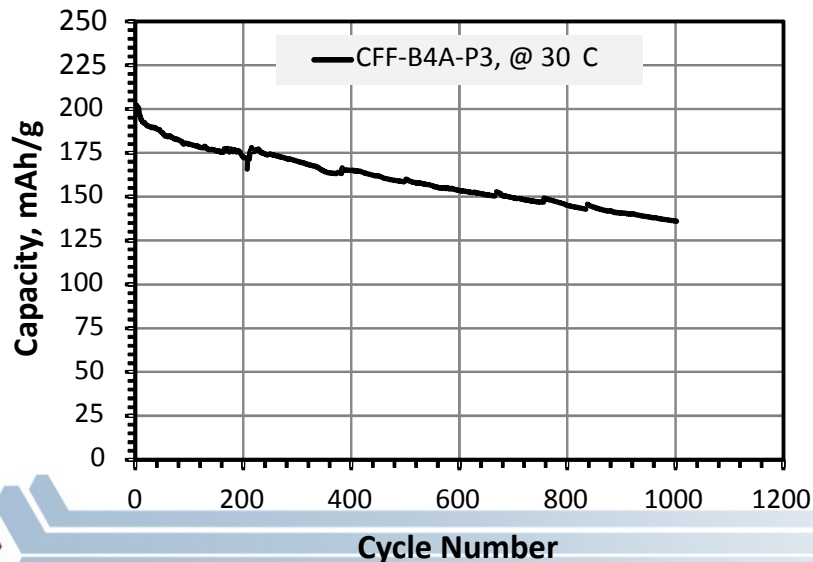
(Toda HE-5050) vs. Graphite (ConocoPhillips A12)

- Cells were made and tested in ANL's Cell Fabrication Facility
- Cell chemistries
  - Toda HE5050:  $\text{Li}_{1.2}\text{Ni}_{0.15}\text{Mn}_{0.55}\text{Co}_{0.1}\text{O}_2$  positive; 1.2 M  $\text{LiPF}_6$  in EC:EMC (3:7 by wt); and graphite negative
  - 5-V Spinel:  $\text{LiNi}_{0.5}\text{Mn}_{1.5}\text{O}_4$  positive; 1.2 M  $\text{LiPF}_6$  in EC:EMC (3:7 by wt); and graphite negative
- Cells were cycled at C/2 rates at different temperatures

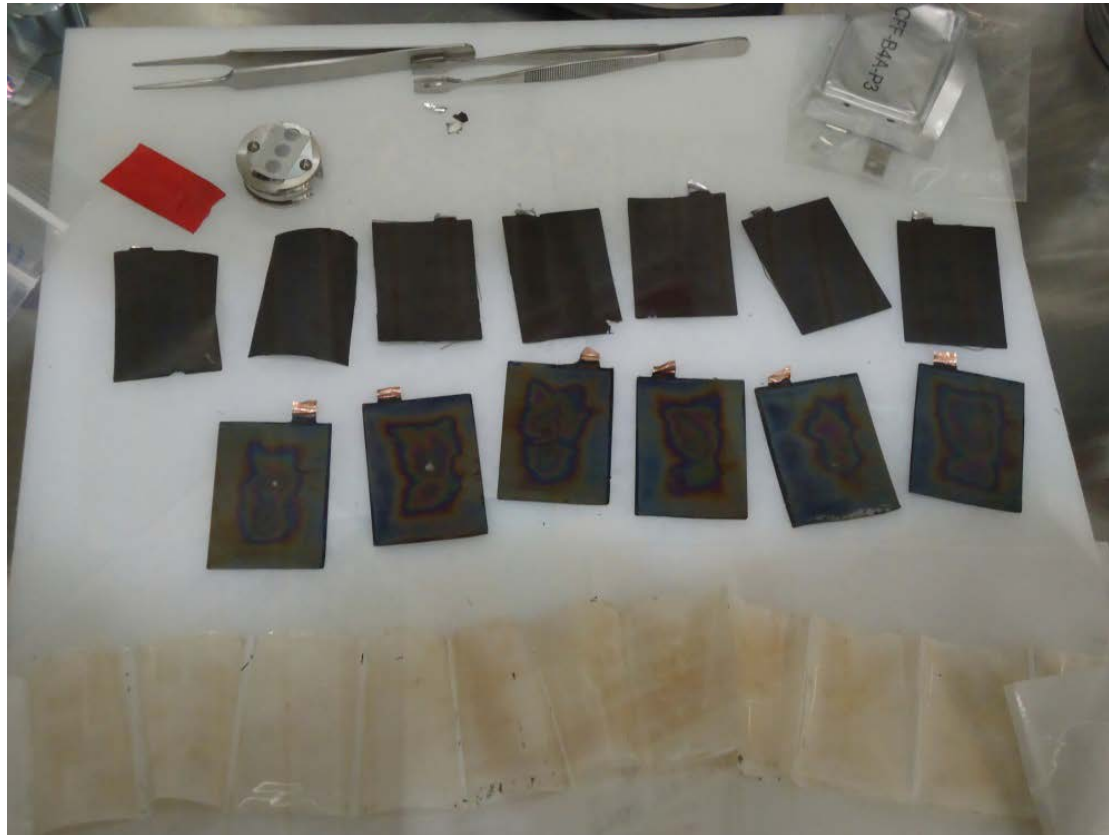
- Initial disassembly in Ar-filled glove box
- HE5050: Gross observations: some staining on the separator; well-adhered laminates; staining pattern on the surfaces of both electrodes

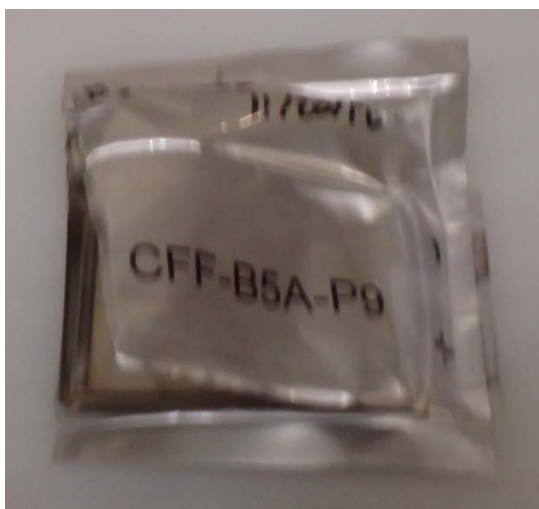
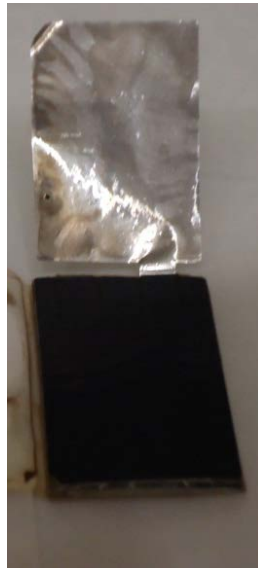
- Cell containing 5-V spinel
  - After cycling at 55°C, pouches were inflated; disassembly in a glove box shows poor adhesion of laminates to foil. The laminates possessed good mechanical strength

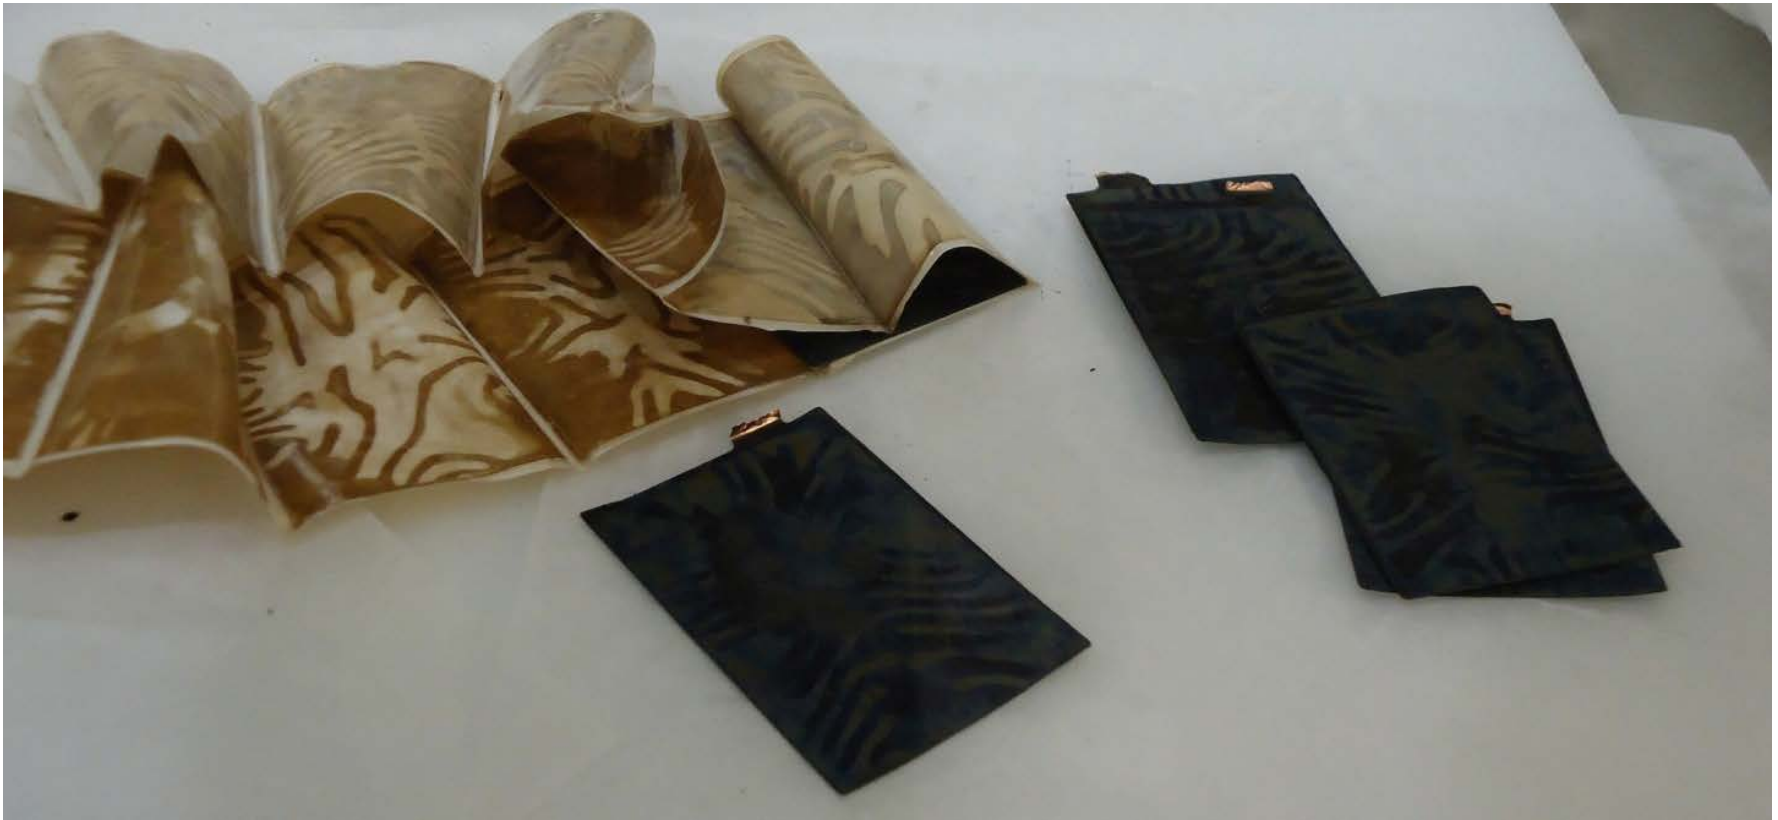
- Further disassembly of spinel-containing cell shows unusual “Zebra” staining pattern on separator and anode

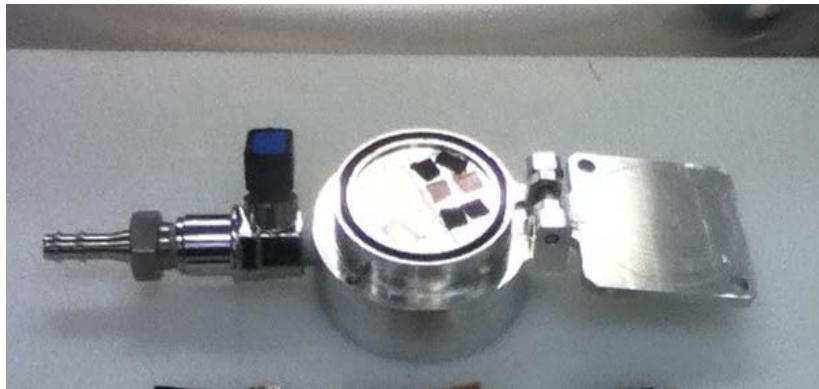
*SEM vacuum sample holder for transfer of air-sensitive samples from glove box to SEM column*

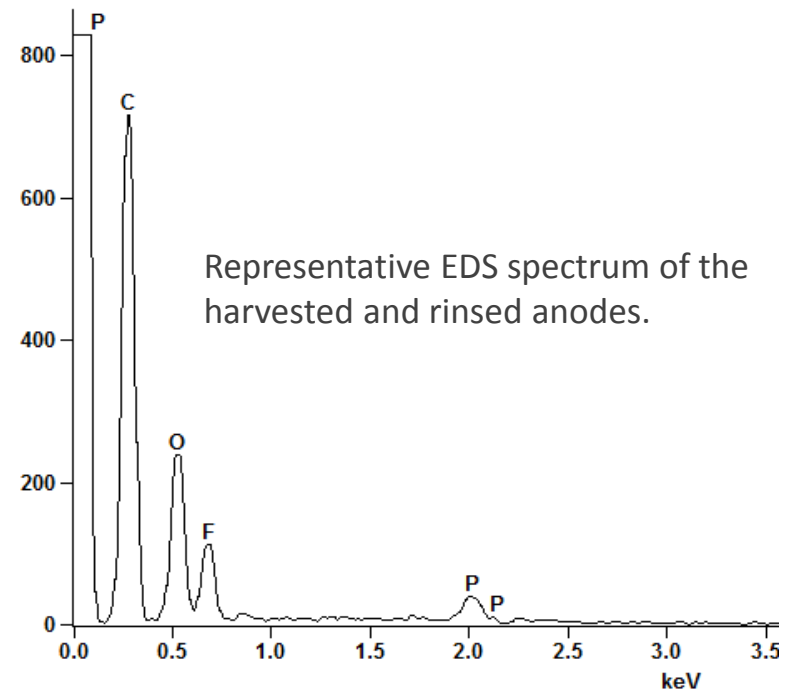
### HE5050 Anode Surface

EDS results indicate the presence of insoluble reaction products that formed with the  $\text{LiPF}_6$  electrolyte salt during cycling.

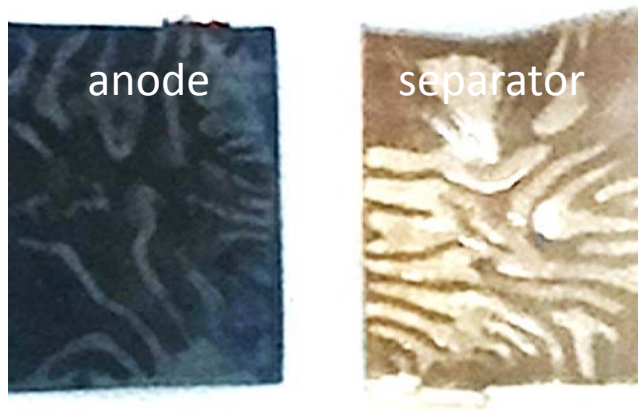
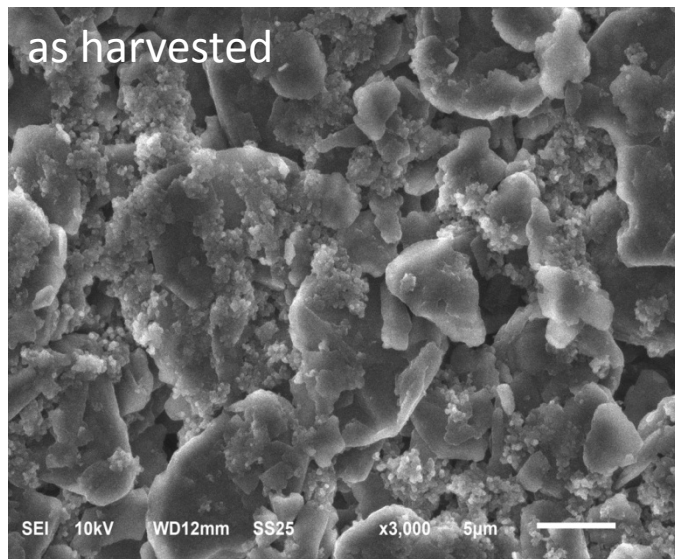
The spinel anode and separator have a “zebra” pattern distinguished by light and dark areas.

There are no resolvable microstructural differences between the harvested and rinsed anode surfaces.

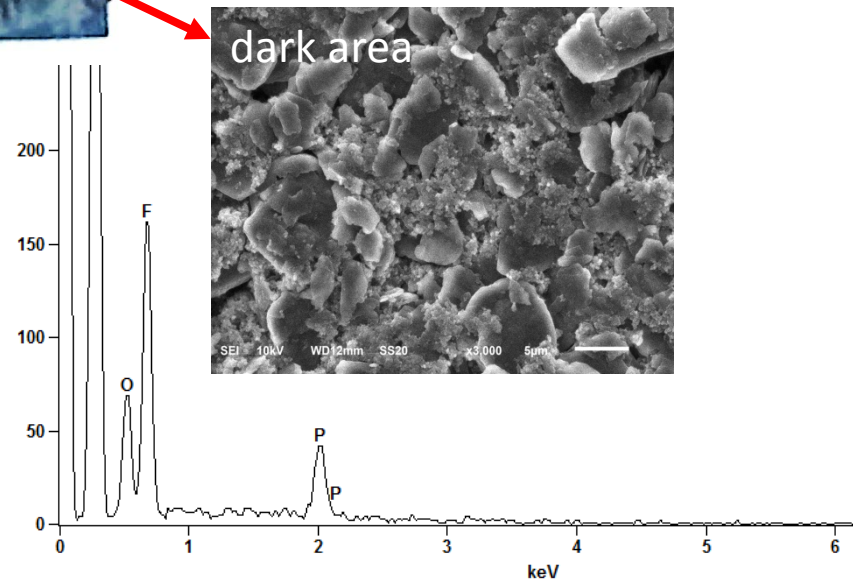
Element Line	Net Counts	Weight %	Weight % Error	Atom %
CK	3231	38.72	+/- 0.70	50.32
OK	704	17.02	+/- 1.57	16.60
FK	1398	33.93	+/- 1.41	27.88
PK	556	10.33	+/- 0.65	5.21
Total		100.00		100.00

Element Line	Net Counts	Weight %	Weight % Error	Atom %
CK	4149	50.05	+/- 0.77	61.72
OK	410	11.68	+/- 1.68	10.81
FK	1144	30.43	+/- 1.38	23.72
PK	382	7.85	+/- 0.66	3.75
Total		100.00		100.00

EDS shows the same composition but with more F and P associated with the light areas. This could represent regions with higher concentrations of reaction products formed with the  $\text{LiPF}_6$  electrolyte salt during cycling.

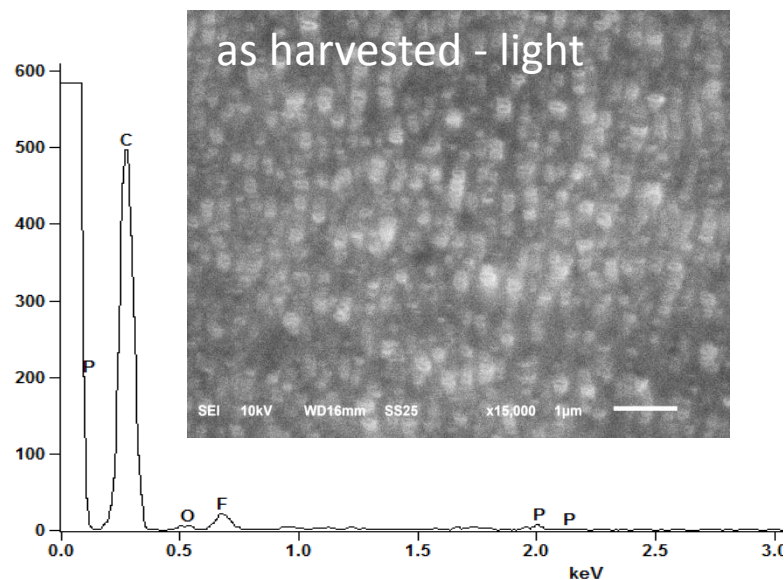
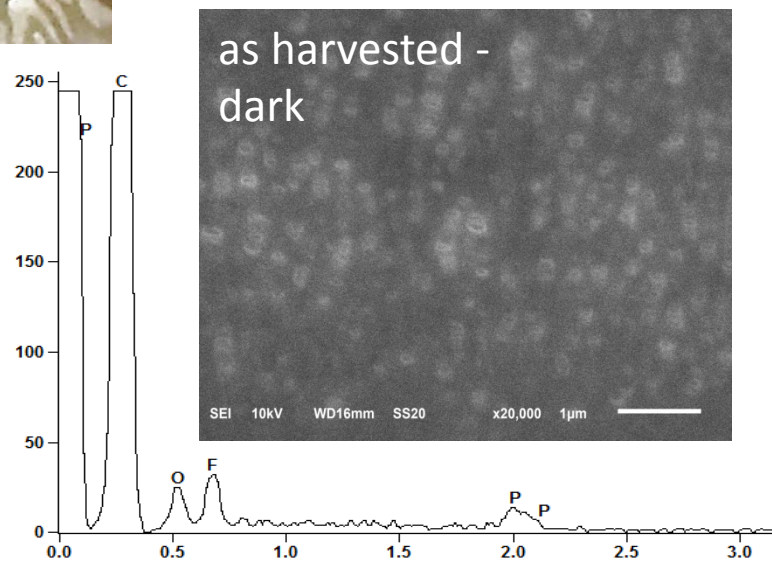
Element Line	Net Counts	Weight %	Weight % Error	Atom %
CK	3153	83.45	+/- 1.30	89.19
OK	23	2.24	+/- 1.17	1.79
FK	150	11.82	+/- 1.02	7.99
PK	42	2.49	+/- 0.53	1.03
Total		100.00		100.00

Element Line	Net Counts	Weight %	Weight % Error	Atom %
CK	4463	79.20	+/- 1.05	86.36
OK	116	6.82	+/- 1.06	5.58
FK	163	8.06	+/- 1.19	5.56
PK	164	5.93	+/- 0.80	2.51
Total		100.00		100.00

EDS shows the same composition but with more F associated with the light areas. This could represent regions with higher concentrations of reaction products formed with the  $\text{LiPF}_6$  electrolyte salt during cycling and could correspond to the light areas on the anode.

Stripes could be from the uneven distribution of electrolyte during fabrication or uneven current distribution during testing.

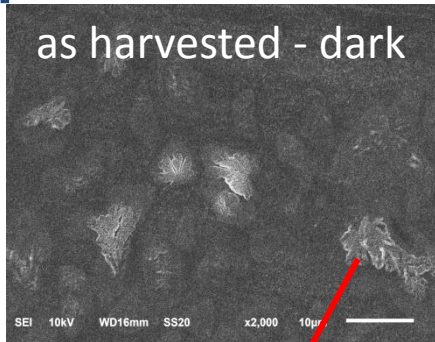
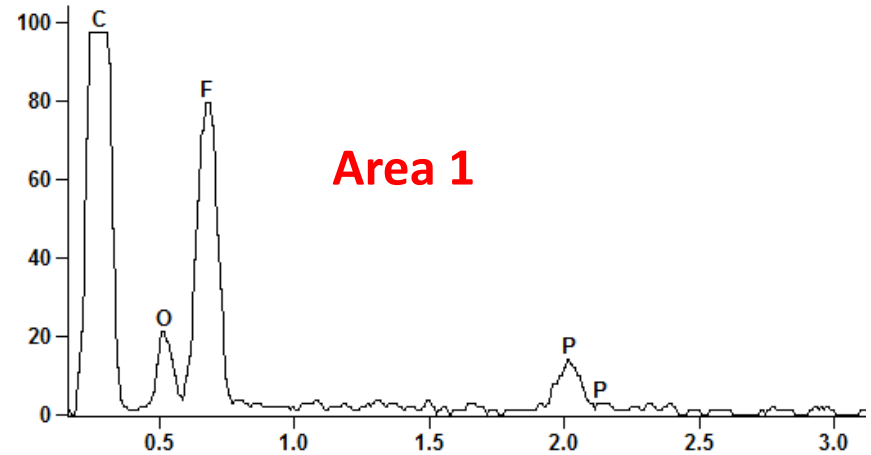
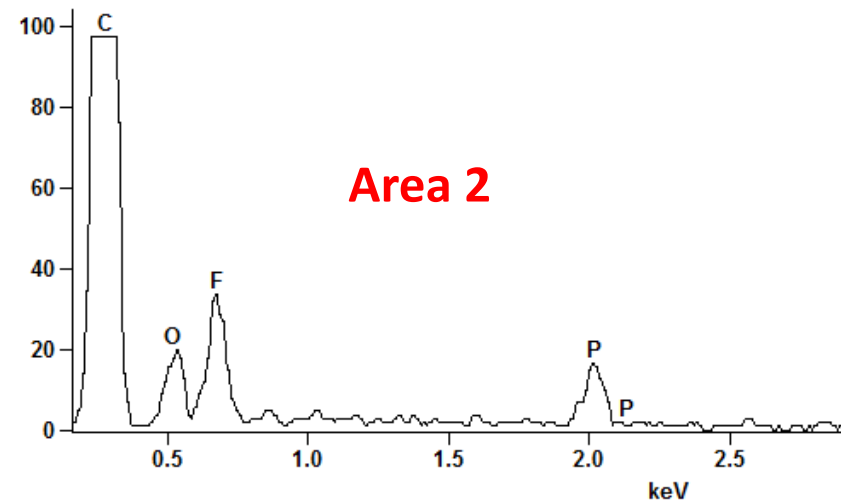
Both areas have the same composition but the lighter regions are significantly higher in F.

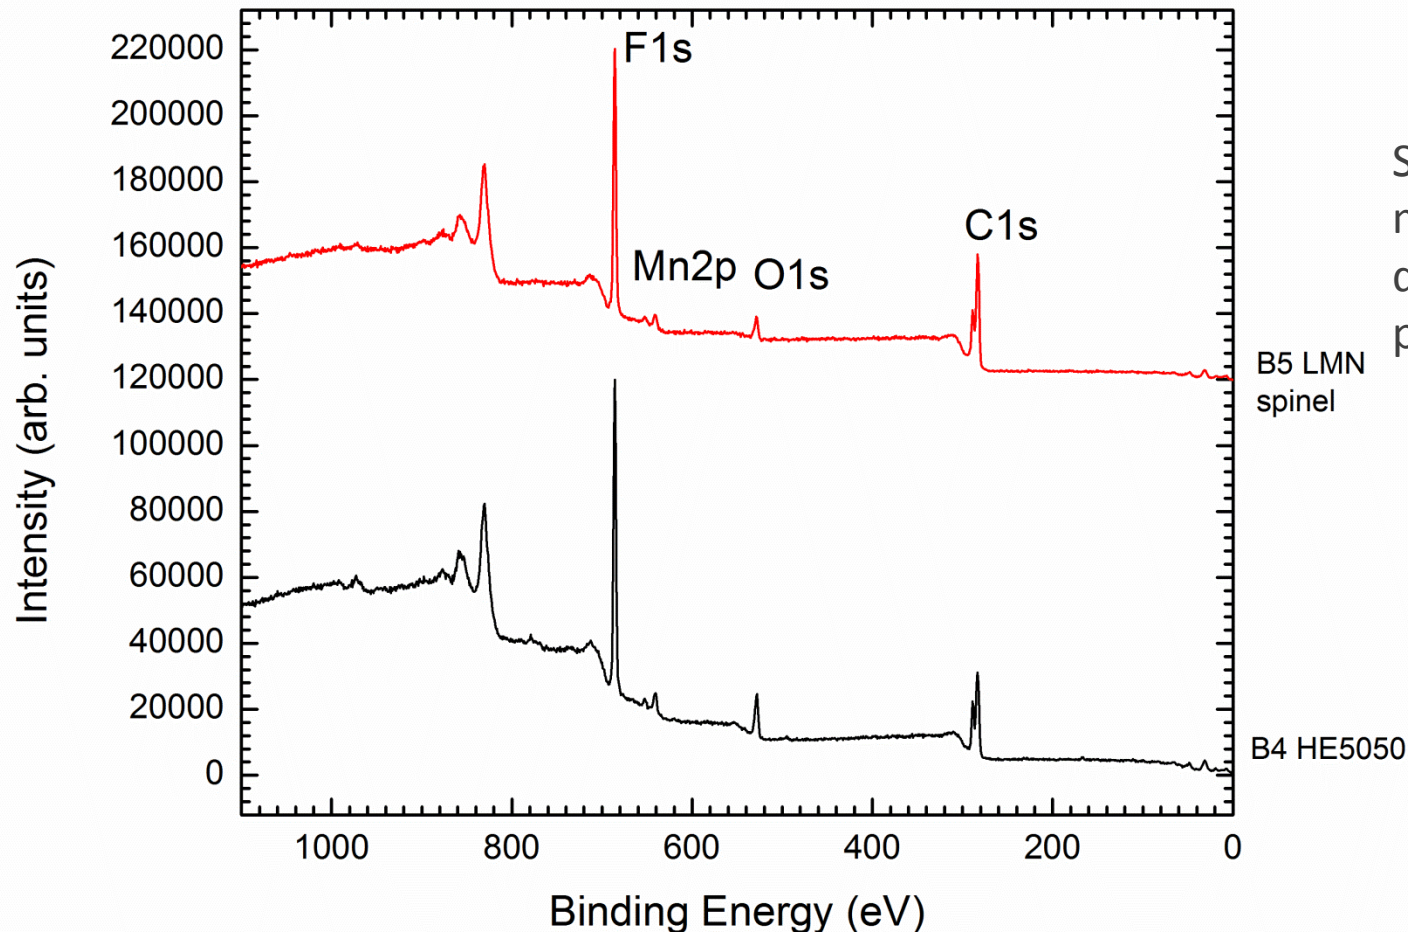
CFF Pristine Cathodes

Signals from transition metals are diminished due to coating of particles with binder
