# **Solder Joints of Power Electronics**

**Oak Ridge National Laboratory**

**May 21, 2009**

# Accomplishments: A Commercial Package Was Thermally Cycled To Examine Degradation

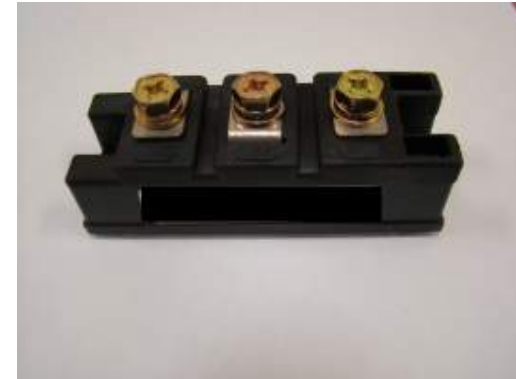
Commercial Diode Module

- Commercially available 600V/100A diode modules rated for maximum junction temperature of 150°C were procured
- Modules were thermally cycled between -65°C and +150°C as per JEDEC standards in single environmental chamber
- Electrical characteristics were measured at periodic intervals by removing module from the chamber to observe degradation, if any

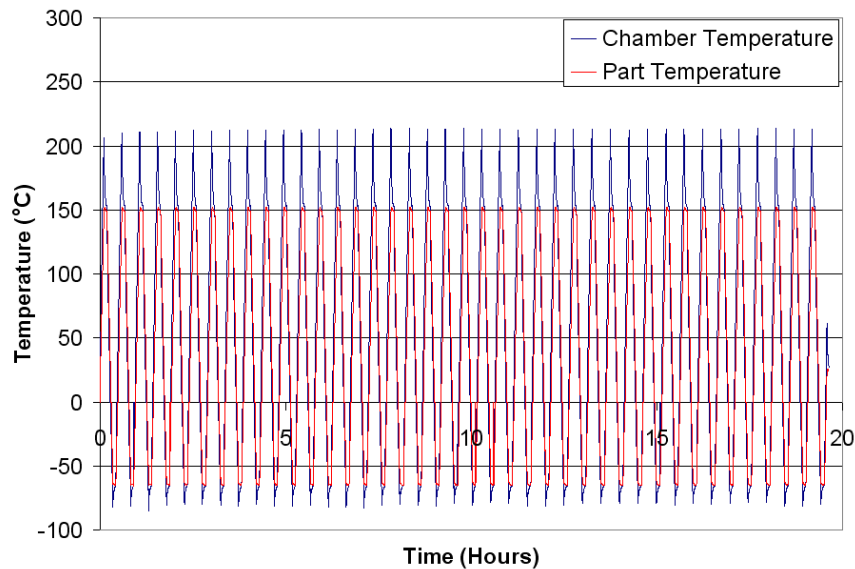
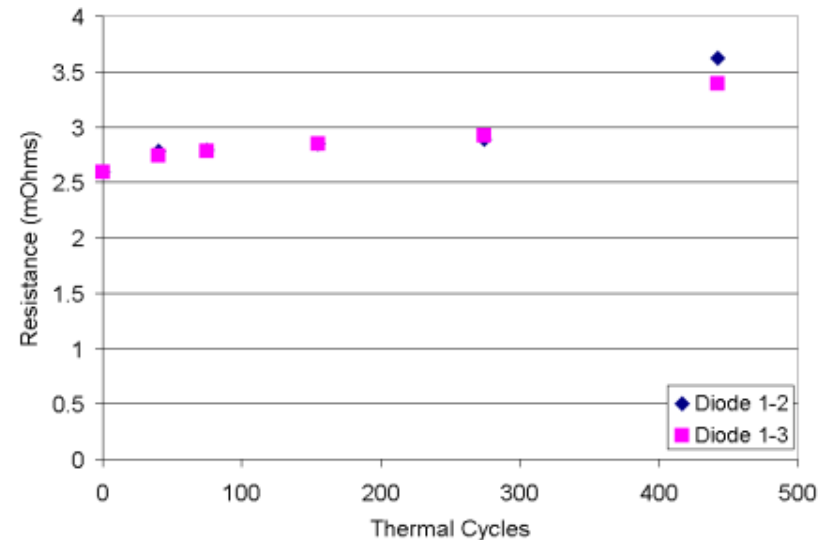
- Forward resistance increases after thermal cycles between 150°C and -65°C
- Diode characteristics were altered after thermal cycling

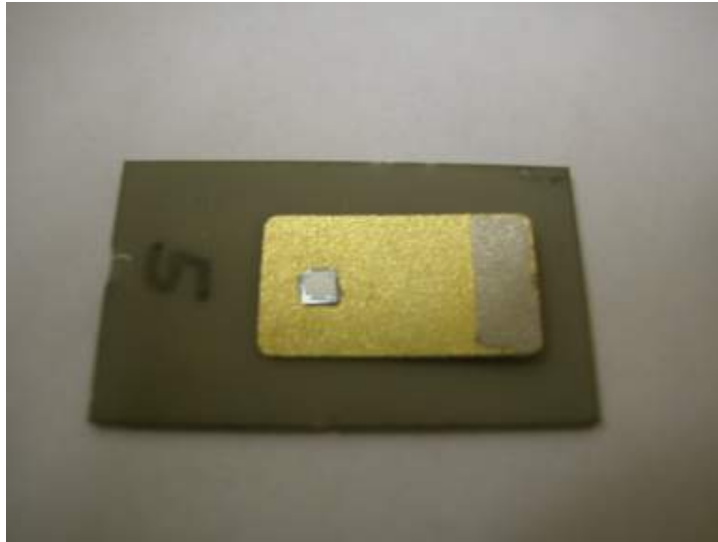
# Delamination of Copper Layer From AlN in the DBC Was Observed

Bending of the Cu was observed with delamination progressing from an edge

- Coefficient of Thermal Expansion (CTE) mismatch present in DBC

- Environment may affect the performance of AlN DBC
  - Further work is required to understand the delamination and its control
