Roll-to-Roll Electrode Processing NDE for Advanced Lithium Secondary Batteries

Oak Ridge National Laboratory

June 18, 2014

Project ID
ES165

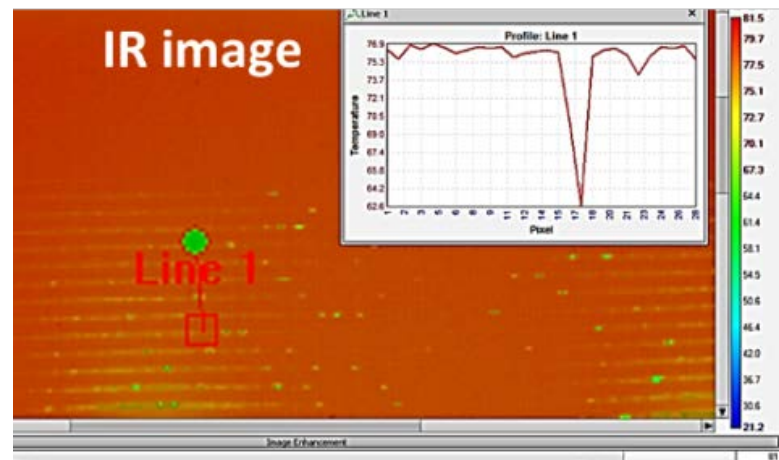
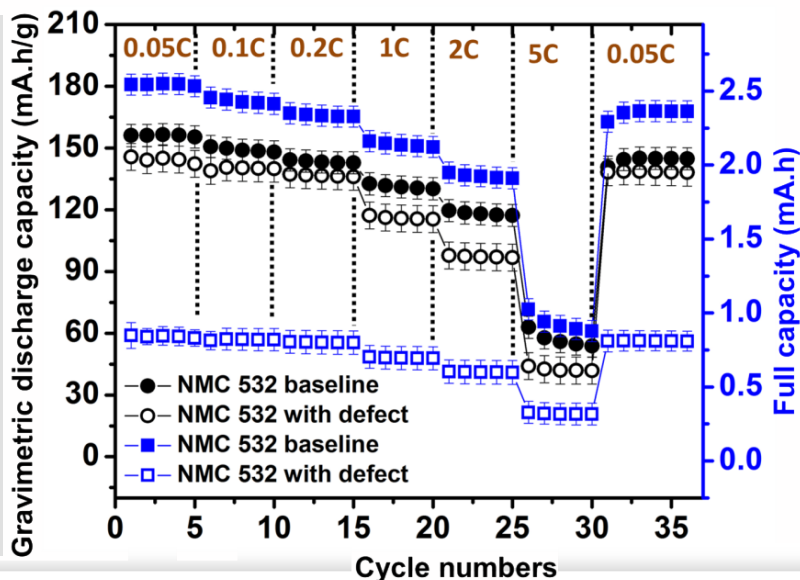
Technical Accomplishments – Exaggerated Cathode Coating Non-Uniformity Causes Capacity Loss and Efficiency Decrease

Active material amount is ~50% lower.

10-20% lower specific capacity.

60-70% lower full cell capacity.

- Cathode agglomerates did not have a great effect on full cell discharge capacity, but aggravated cycle efficiency.
- Excessive metal particle contaminants (in this case, Co powder) have an extremely negative effect on performance, especially at higher C rates.
- Exaggerated cathode coating inhomogeneities (strips with missing coating) result in disproportionate drops in cell total capacity.
- Examination of effects of pinholes, divots, and Al foil pieces is in progress.
- Inhomogeneous cathode coating (especially missing areas and agglomerates) leads to unbalanced N/P ratio, which affects gravimetric capacity and reduces Coulombic efficiency.

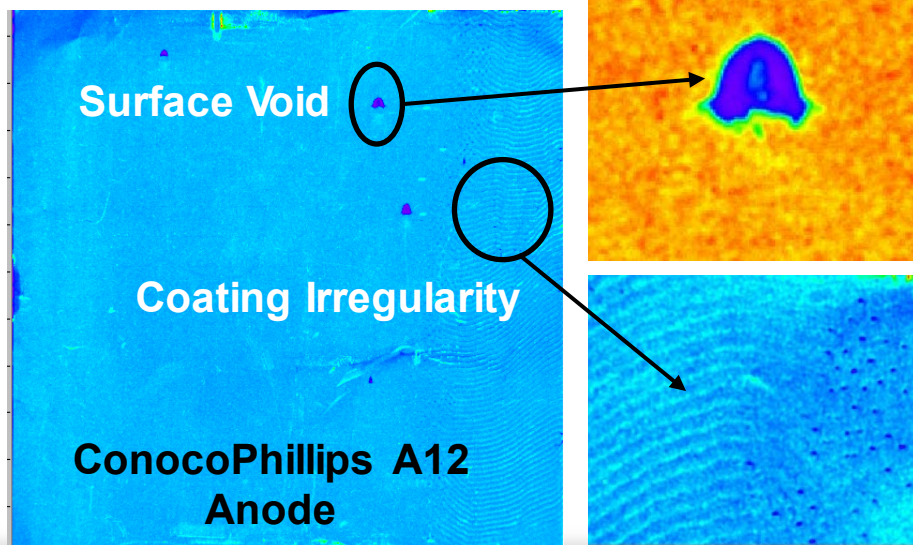
- Evaluate and develop technique for LIB electrode surface structure and morphology.

- Completed feasibility testing with Baseline ABR anode and cathode samples.
- Demonstrated imaging of electrode surface structure.

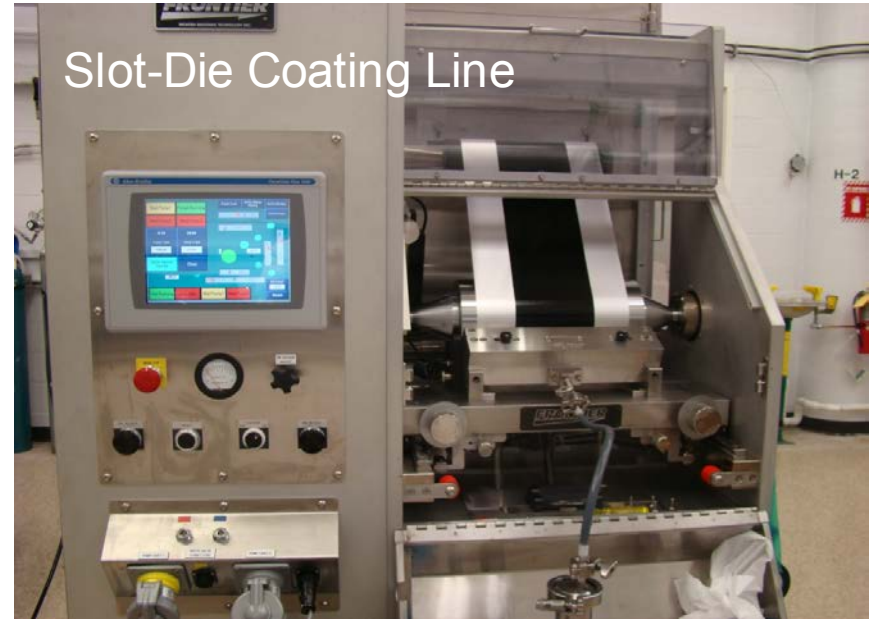
Slot-Die Coating Line

9 Heating Zones
-2 IR Lamps
-7 Convective Air Zones

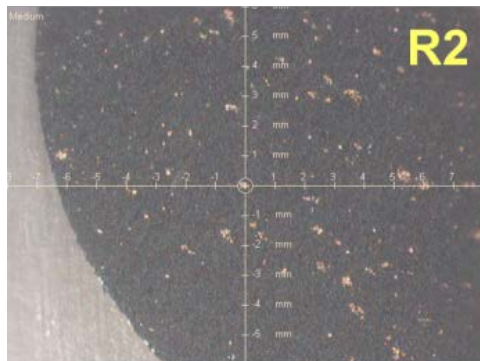
Identification of Cu Powder Contaminants

- A small amount of Cu powder was sprinkled over a NMC 532 cathode and identified by off-line XRF.
- Proof-of-concept established, but identification of isolated metal particles at high line speed by in-line XRF would be extremely difficult.
