BNL CNG Release Investigation

NFS14 Workshop

May 6, 2014

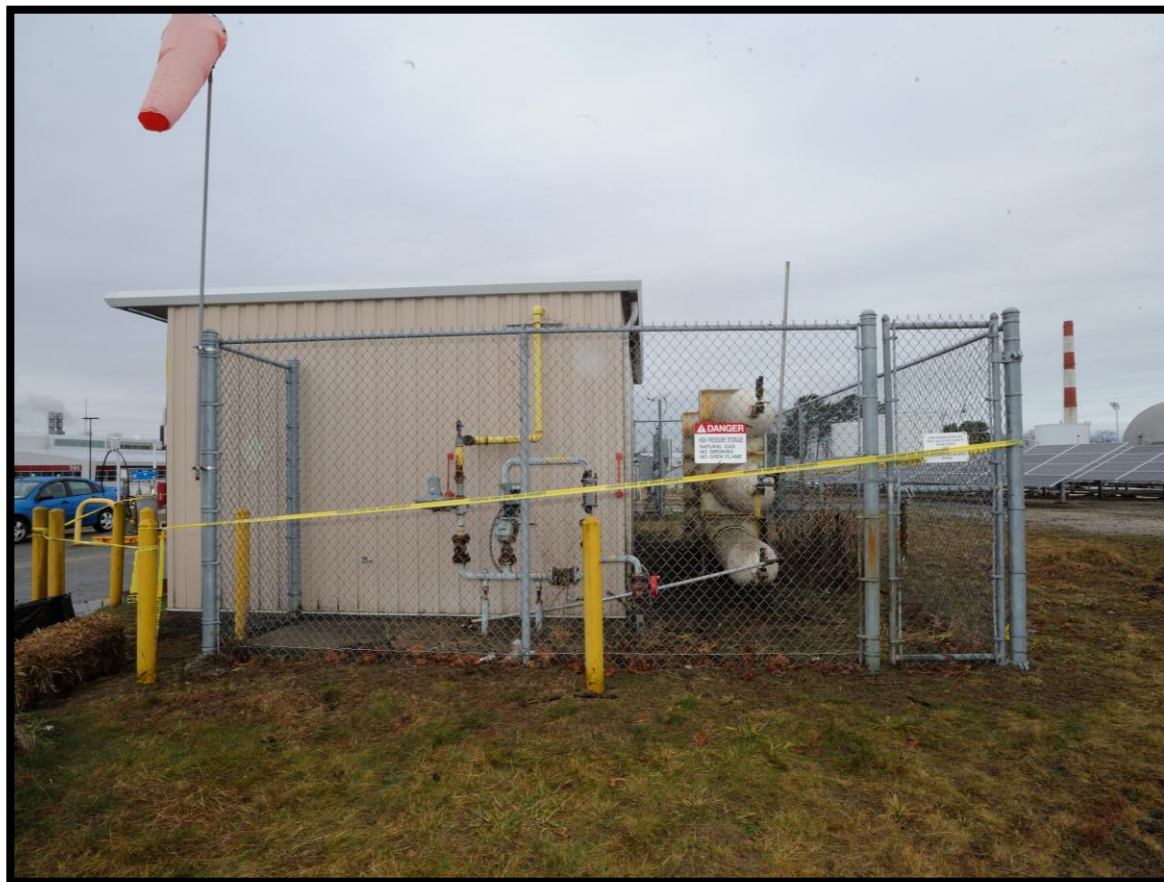
- Right (East) side

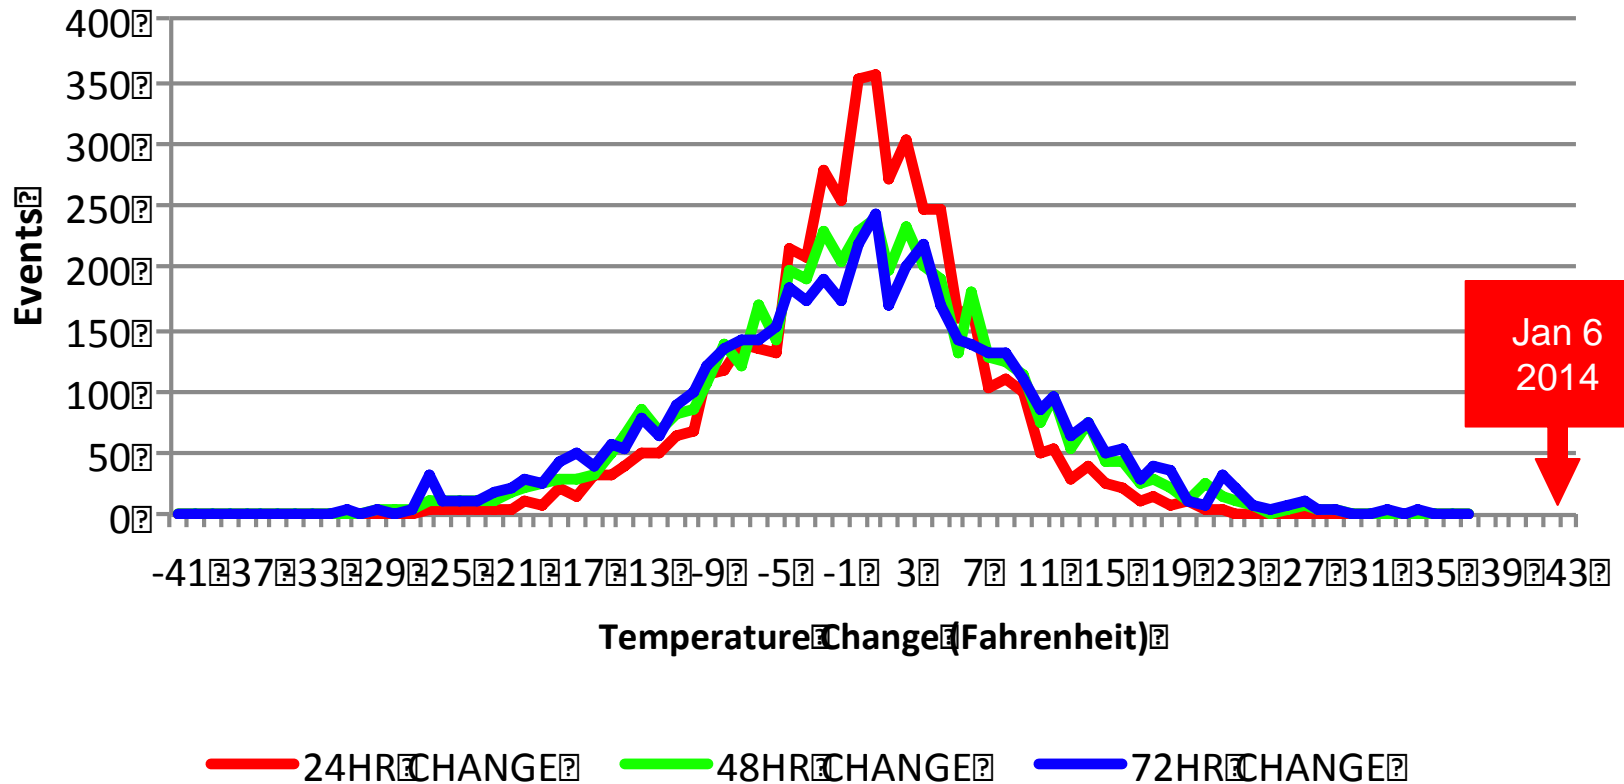
Temperature Change on The CNG System Based On Recorded High Temperatures at BNL From 2001-2013

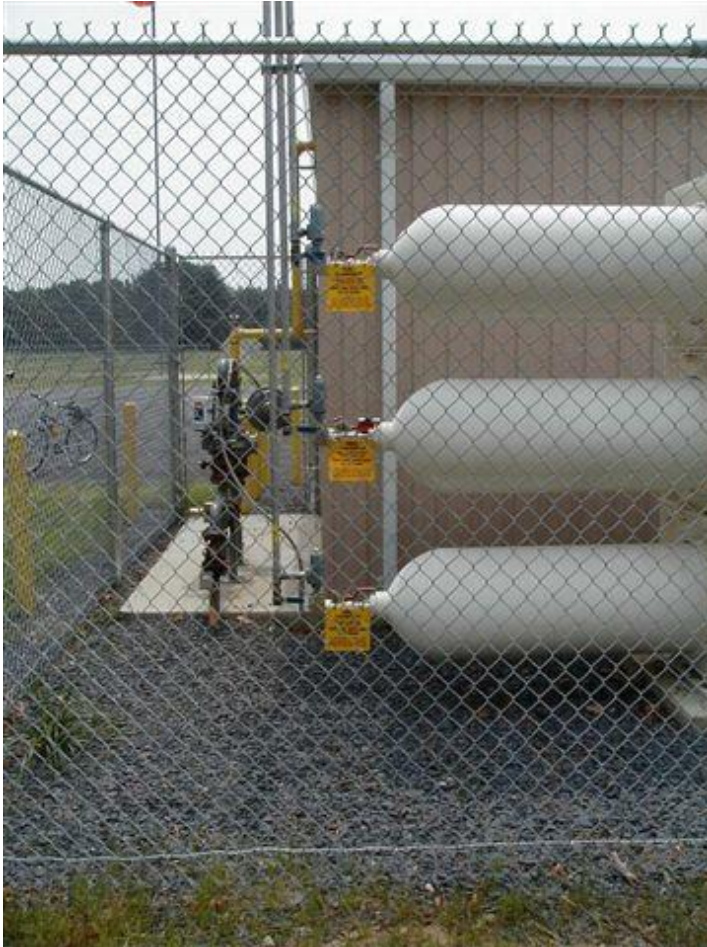
Pressure Relief Valve Vent Design

2001 DESIGN

3. Design and install inlet and outlet pressure relief valve piping, fittings, and support system at Building 522 as approved by a New York State Licensed Professional Engineer.

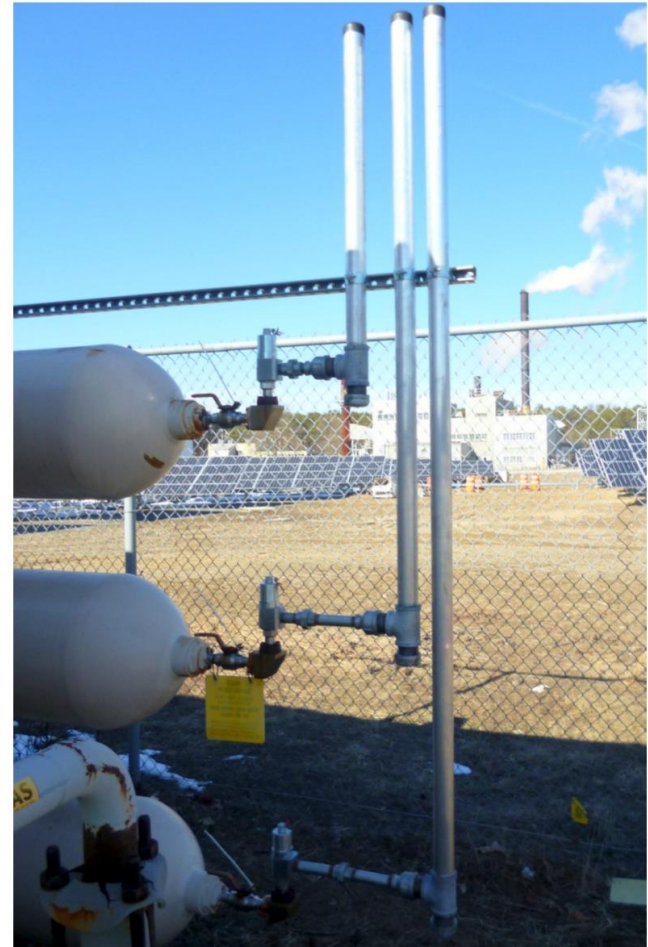
2014 CURRENT
