# Yuma Border Patrol Area Lighting Retrofit

Final LED System Performance Assessment of  
Trial and Full Installation

April 2018

Prepared in support of the DOE Solid-State Lighting Technology GATEWAY program

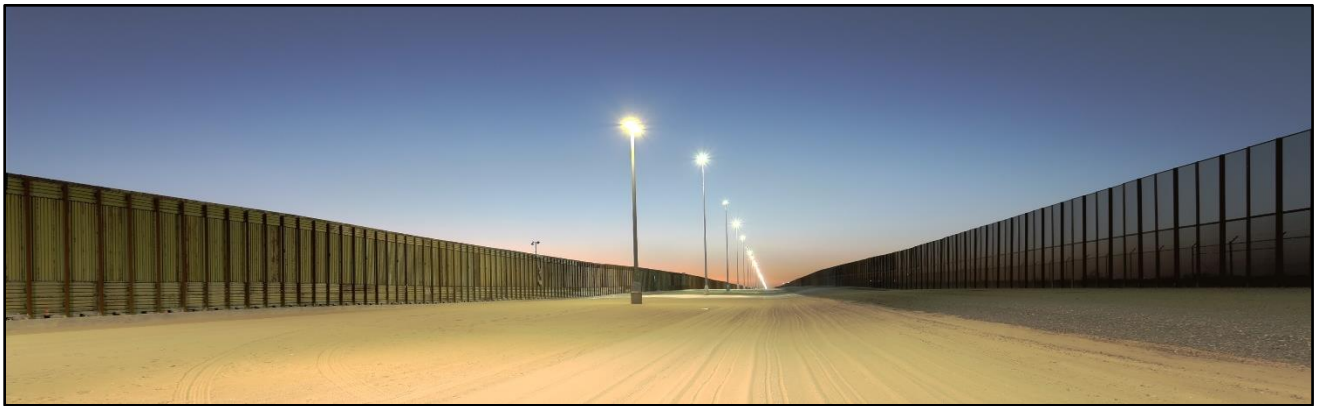
**Figure 1. Trial Demonstration Site on the U.S.-Mexico Border.**

Photo looking west from the east end of the 7.2 mile area between poles 204 (not pictured) and 203 (pictured, front). The QMH luminaires are mounted on the poles at a height of 64 ft and the LED luminaires are mounted at 40 ft—a difference that is visible in this image. The primary fence (south) is on the left and the secondary (north) fence is on the right.

The LED luminaires were designed to provide uniform illumination from a 40 ft pole height. Pole 203 is shown in Figure 1, with the incumbent lighting system trailing into the distance toward the POE. Two LED luminaires replaced three 1000 W QMH luminaires on each pole, pictured in Figure 2. The LED system was designed to replace only the two outer QMH luminaires because the middle luminaire was not operational and the amount of light provided by the two QMH luminaires was considered acceptable. The goal of the ESPC was to replace the QMH lighting system with an alternative that achieves a minimum energy savings of 50% while maintaining existing light levels.

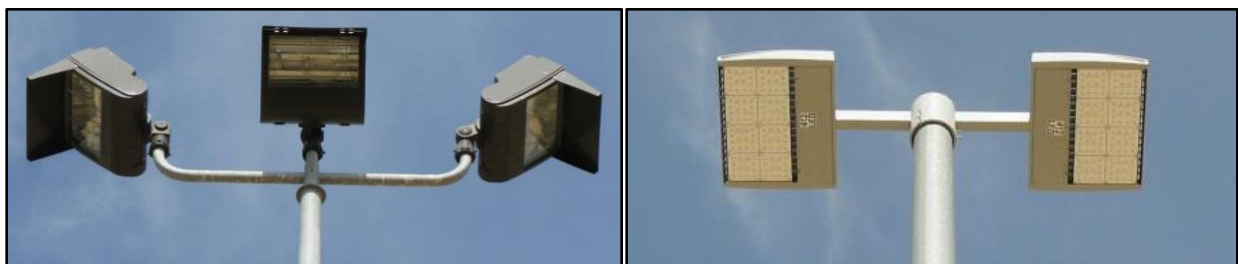
**Figure 2. Incumbent QMH Luminaires (left) and LED Luminaires (right).**

A custom tenon was necessary to fit the diameter of the pole after the pole height was reduced to 40 ft, because the diameter of the tapered pole widened from top to bottom. The QMH luminaires were originally installed with the lens tilted up from horizontal and shielded with visors to minimize stray light. In contrast, the LED luminaires were installed with luminous aperture horizontal (i.e., not tilted upward).

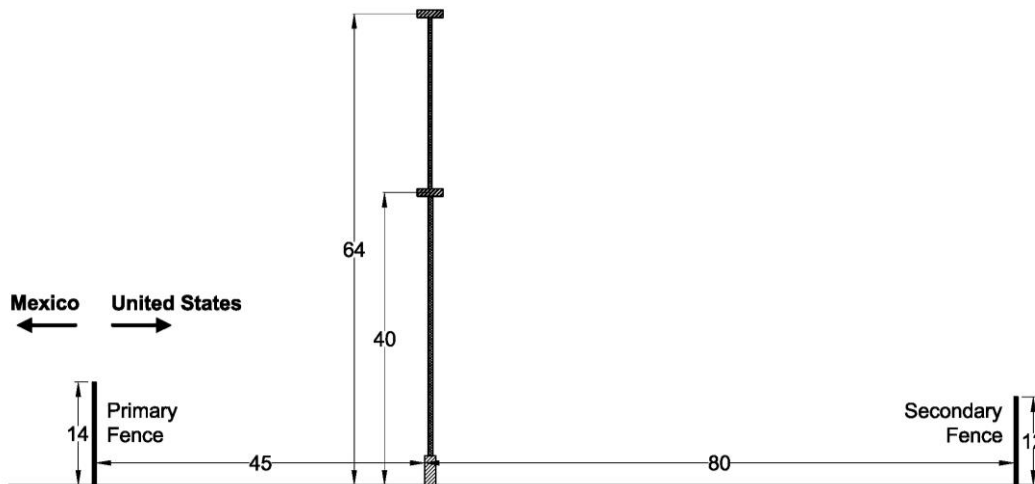
**Figure 3. Schematic Elevation of the Yuma Sector Border Patrol Area East of the San Luis Port of Entry.**

The dimensions are representative of the 7.2 mile border area east of the POE. All dimensions are in feet. The elevation near the secondary fence was about 2 to 4 ft higher than the base of the concrete pole pedestal.

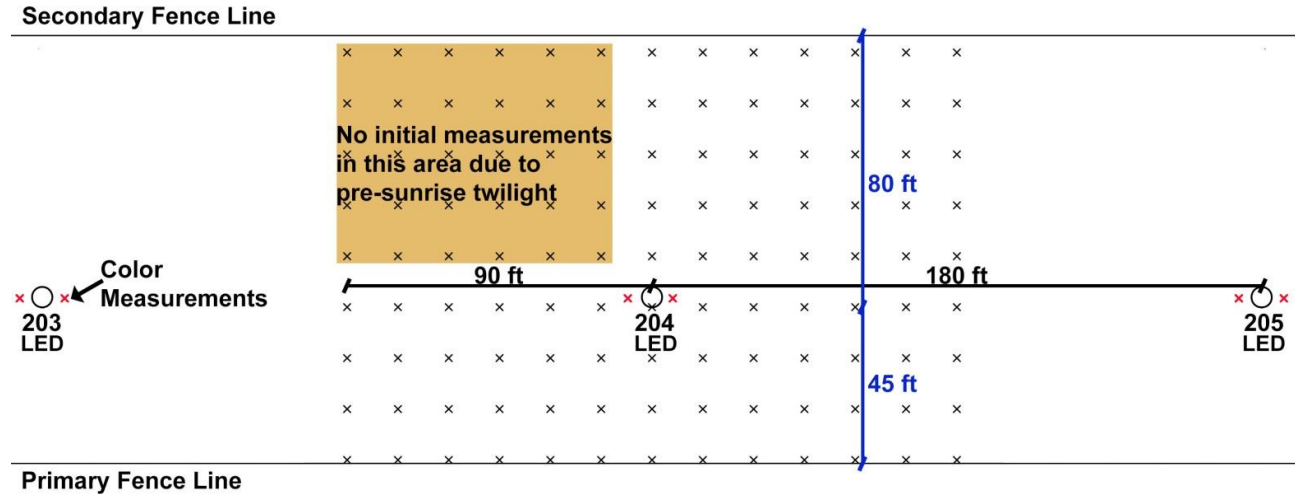
**Figure 4. Layout of Grid Measurements.**

The measurements between poles 203 and 205 were recorded in a rectangular grid from the middle of the primary (south) face of the concrete pole pedestal at pole 204, with uniform 15 ft spacing in both directions. The horizontal measurements were recorded approximately 9.5 in. above the ground and the illuminance meter was leveled for each measurement with a tripod head. Vertical illuminance measurements were recorded at heights of 4 and 8 ft at each fence, in line with each column of horizontal illuminance measurements. A single color measurement was recorded under each LED luminaire at pole 204, 4 ft above the ground (36 ft below the luminaire). The same methodology was applied when measuring illuminance at other poles on the site.

For pole 204 measurements, a total of 117 horizontal and 52 vertical measurements were recorded between poles 203 and 205, centered on pole 204. The measurements extended 90 ft east (halfway toward pole 205) and 90 ft west (halfway toward pole 203) of pole 204. Only 81 initial horizontal measurements were recorded because pre-sunrise twilight was reached before the measurements were completed. After the full installation of the second-generation luminaires, the measurements were recorded between pole 200 and 201.

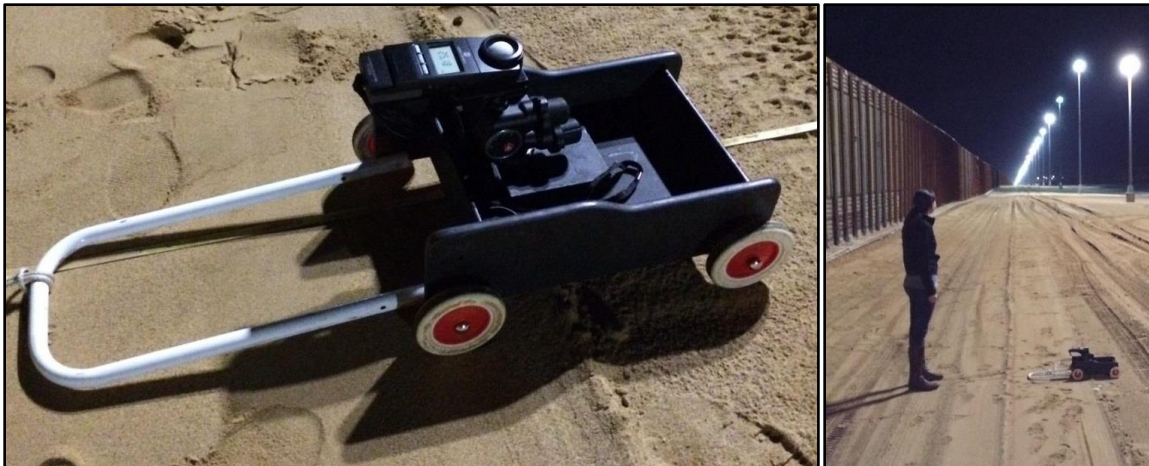
**Figure 5. Illuminance Measurement Wagon.**

The illuminance meter was mounted on a tripod head, and the tripod head was attached to the base of the wagon. The knobs of the tripod head were used to adjust the front and lateral tilt of the illuminance meter to level the meter—with reference to the tripod head's leveling bubble.

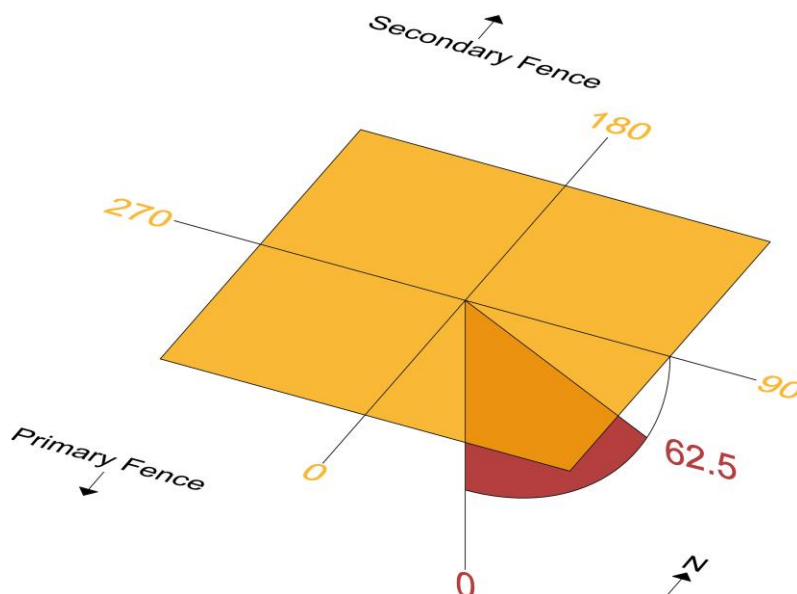
**Figure 6. Luminaire Orientation Schematic.**

The horizontal angles (gold) are used to describe the photometric performance of the luminaire, and the 62.5° vertical angle (red) is illustrated in the 90° horizontal plane. View is from above.

After 7000 hours of operation, the research team decided to conduct full testing of the two first-generation luminaires on pole 204. The luminaire removed from the east side of pole 204 is designated luminaire A herein, and the luminaire removed from the west side is designated luminaire B. The removed luminaires were driven to Phoenix, AZ (to minimize disruption of the dirt) for the first laboratory test conducted by LightLab in Phoenix, AZ to closely estimate the field conditions prior to the luminaires being packed and shipped to the Eaton laboratory in Georgia. The results of the testing done at both laboratories are shown in Table 3, with a description of the orientation of the luminaire in Figure 6.

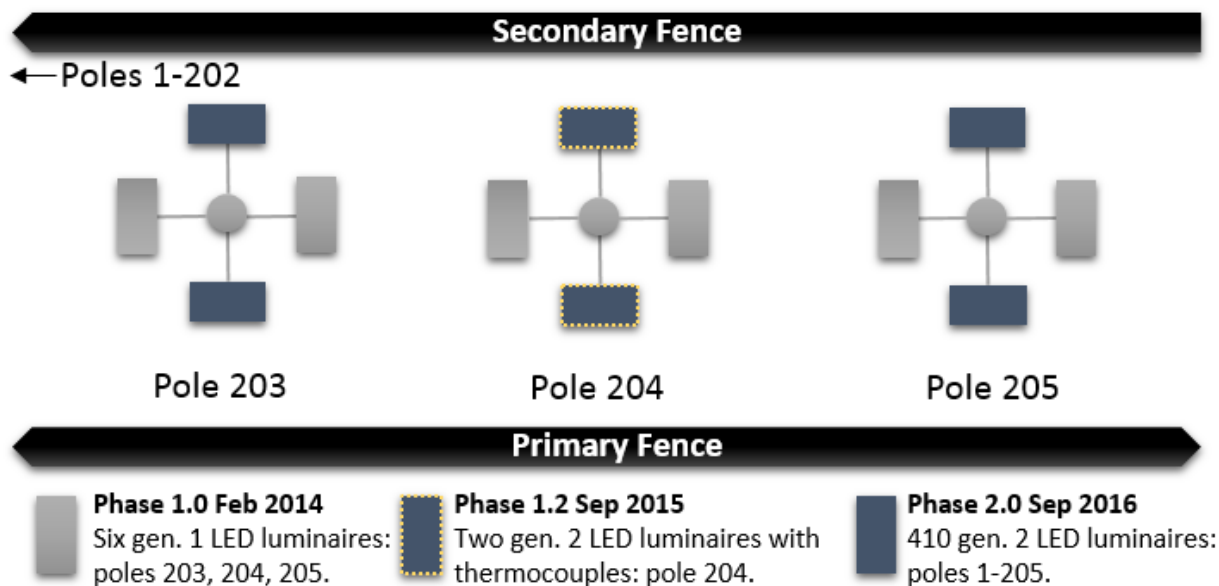
**Figure 7. LED Luminaire Installation Schematic.**

The trial installation of six first-generation luminaires occurred in February 2014, with two of the first-generation luminaires replaced in September 2015 with two second-generation luminaires on pole 204 that had additional thermocouples for monitoring. In September 2016, the remaining four first-generation luminaires and the two second-generation luminaires with thermocouples were replaced by six second-generation luminaires as part of the full installation of over 400 luminaires along the 7.2 miles east of the San Luis POE.

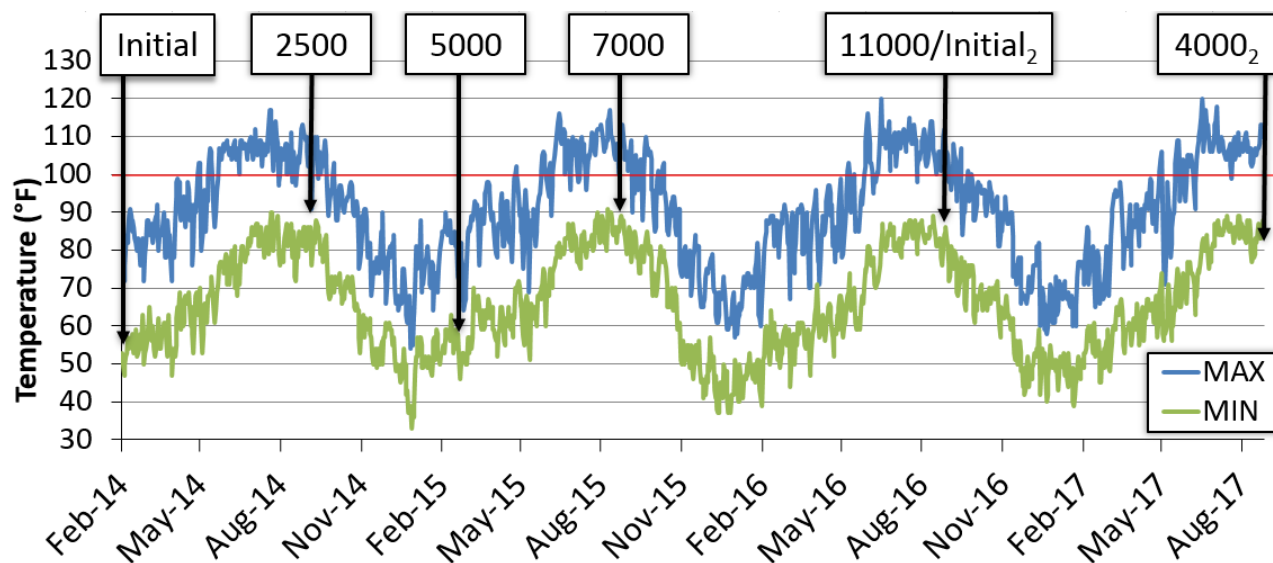
Figure 8. Measurement Timeline.

This timeline illustrates the time of year when each measurement occurred between February 2014 and August 2017. Also shown are the maximum (blue) and minimum (green) daily temperatures. The subscript “2” indicates the measurements of the second-generation luminaires that were part of the full installation.

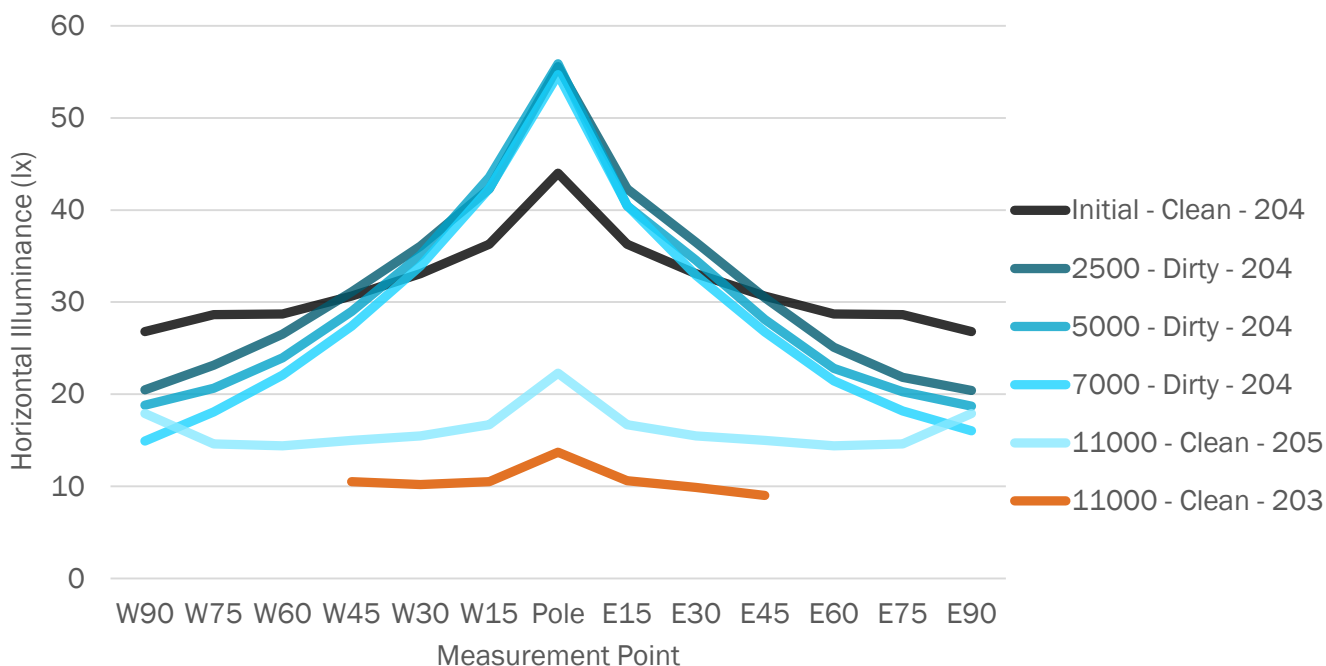
**Figure 10. Measured Illuminances along East-West Line Centered at Pole 204 at Four Different Measurement Times, and for Poles 205 and 203 at 11000 Hours.**

The trial installation luminaires were initially clean, and then cleaned again at 11000 hours. The numeric values in the labels along the horizontal axis indicate the distance from the pole in feet, and the letter indicates the direction from the pole. Illuminance values were normalized for a 25 °C (77 °F) condition.

As discussed in Section 3.1 and illustrated in Figure 10, the measured illuminances decreased on average during the initial 7000 hours of operation for the first-generation luminaires installed as part of the initial three pole, six luminaire trial installation. A change in the distribution of illuminance was also recorded, with illuminances near the pole increasing while those farthest from the pole decreased considerably. In the previous Yuma report,<sup>13</sup> it was concluded that these changes in illuminance were mostly, if not completely, caused by dirt depreciation, based on the nature of the measured illuminances and on LM-79 testing of two luminaires that were removed from the site and tested in both dirty and clean conditions.

As shown in Figure 10, measured illuminance in the area surrounding the first-generation luminaires installed in February 2014 decreased considerably at 11000 hours of operation in a clean state compared to the values measured at 7000 hours in a dirty state. The four remaining first-generation luminaires were removed from the site after the 11000-hour measurements and replaced with the second-generation luminaires as part of the full installation. The removed luminaires were sent to Eaton's testing laboratory for further evaluation. Eaton evaluated possible losses of light output, including driver performance and degradation in luminaire optical materials due to causes such as etching from windblown sand and discoloration or deformation due to extreme thermal conditions. The results of those evaluations did not yield any clear evidence of damage that might help explain the field-measured data.

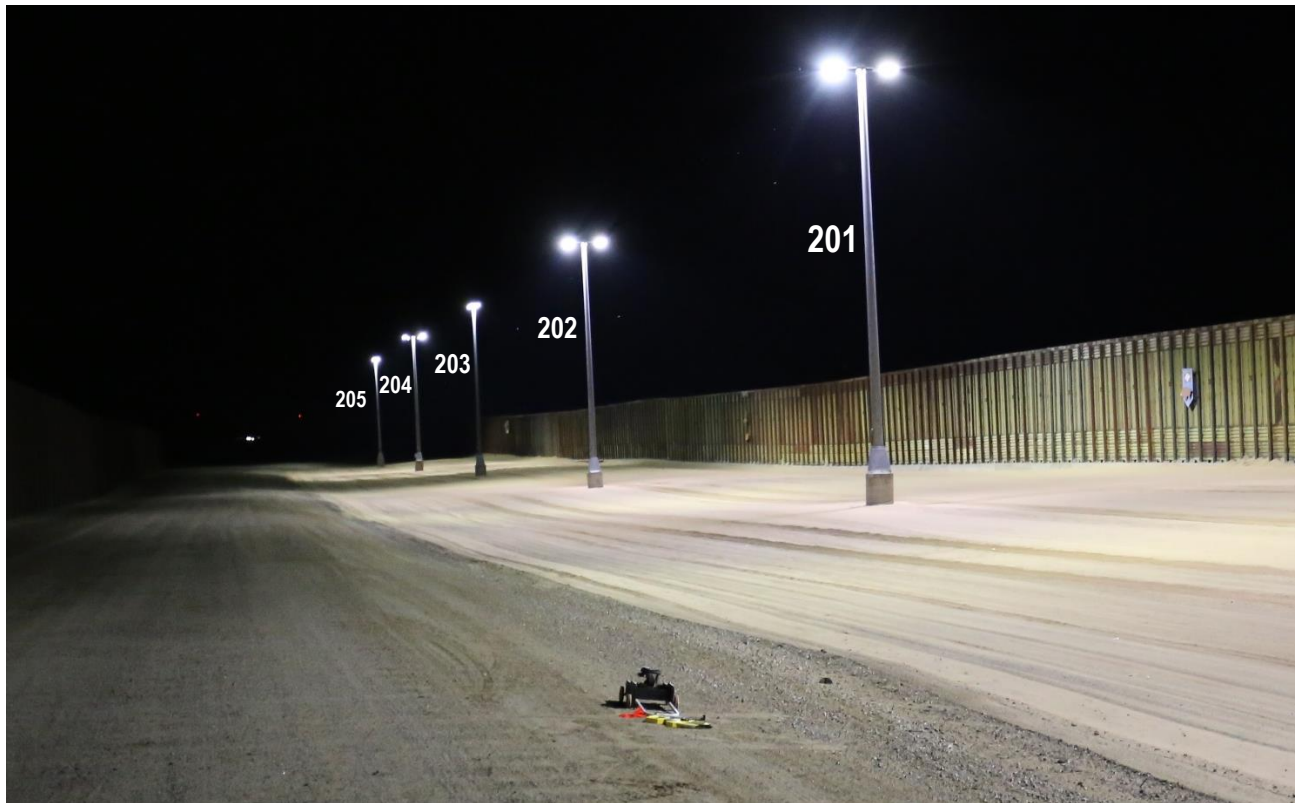
**Figure 11. Yuma Sector Border Area: First- and Second-Generation LED Luminaires.**

This photo was taken looking east from the area near pole 201 in September 2016. The second-generation luminaires installed in September 2016 as part of the full installation are on poles 201 and 202. The thermocoupled second-generation luminaires installed in September 2015 are on pole 204. The first-generation luminaires installed in February 2014 are on poles 203 and 205. Visible in this photo is a cooler color of sand near poles 201 and 202, and a warmer color of sand farther from the poles. This photo also shows the darkness surrounding pole 203 due to the depreciated output of its luminaires; the area around Pole 205 is relatively dark for the same reason, but also because it is the last pole in this 7.2 mile stretch of border east of the POE.

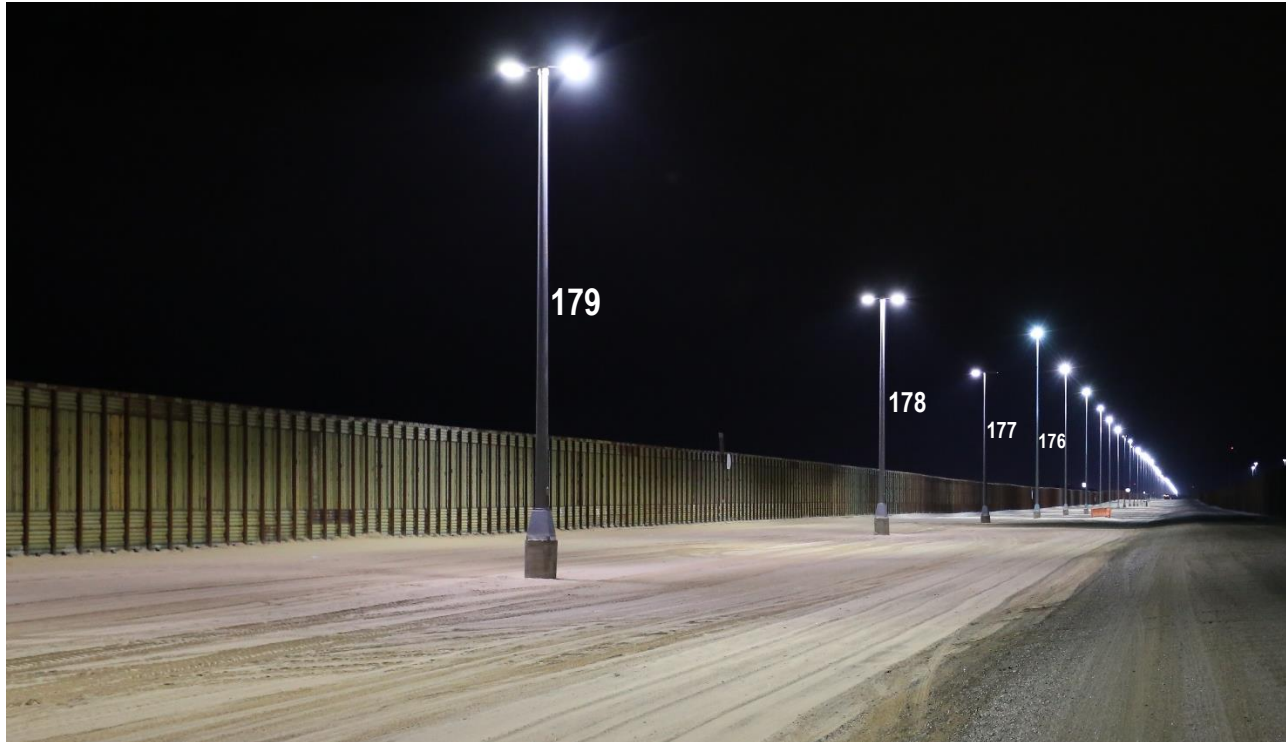
**Figure 14. Yuma Sector Border Area: Second-Generation LED Luminaires and Incumbent QMH Luminaires.**

Photo was taken looking west from the area near pole 179 in September 2016 during full installation of second-generation LED luminaires. The LED luminaires are on poles 179-177, with the incumbent QMH luminaires on poles 176 and beyond. Visible in this photo is a cooler color of sand near pole 179 and then a warmer color of sand farther from the pole. Pole 177 has only one luminaire operating, with a dark area between pole 177 and the secondary fence. Installation of luminaires only happened during the day.

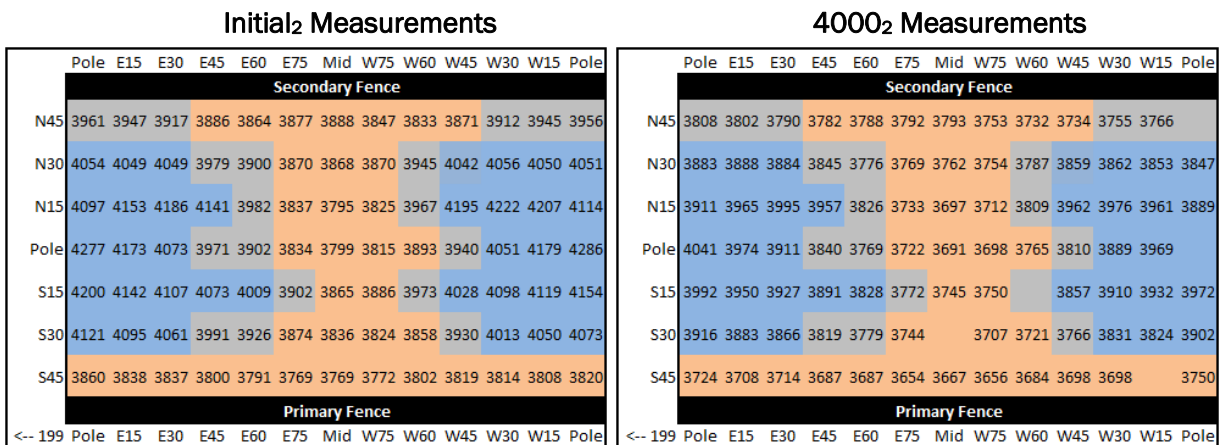
**Figure 15. Second-Generation LED Lighting System CCT Measurements: Initial<sub>2</sub> and 4000<sub>2</sub>.**

Poles 200 and 201 are located on the midline of the left and right measurement edges. The square colors represent the range of the initial<sub>2</sub> measurements, generally representing CCT values: orange < 3900 K, 3900 K ≤ gray ≤ 4000 K, blue > 4000 K. In comparison to the initial<sub>2</sub>, the cool color temperatures shifted more than the warm color temperatures, with all of the CCTs decreasing in color temperature by an average of 152 K. Some 4000<sub>2</sub> measurements were not recorded, indicated by a blank box.

The SPD was recorded with the Konica Minolta CL-500A Illuminance Spectrophotometer<sup>8</sup> at each measurement point along with the initial<sub>2</sub> and 4000<sub>2</sub> illuminance measurements. The SPD measurements were recorded on a horizontal plane at about 6 ft above ground after the illuminance measurement was recorded.<sup>9</sup> SPD measurements were not recorded at the same points as the illuminance measurements for the first-generation luminaires as no visual difference in color was noted; however, the second-generation luminaires produced visually noticeable differences in color on the sand that seemed to change based on distance of the illuminated point (as opposed to viewer) from the pole as can be seen in the photograph in Figure 14. The calculated CCT values from these SPD measurements are displayed in Figure 15, with corresponding chromaticity diagrams shown in Figure 16. The average shift in CCT between the initial<sub>2</sub> and 4000<sub>2</sub> color measurements was 152 K. Comparing the initial and 4000<sub>2</sub> measurements reveals a shift in chromaticity across all data points with an average  $\Delta u'v' = 0.0081$  and a maximum  $\Delta u'v' = 0.0117$ . The measured CCT was also plotted in comparison to the angle from nadir to the measurement point, showing that the higher CCTs were closer to the pole and the lower CCTs were farther from the pole. This relationship between angle from nadir and CCT remains after 4000<sub>2</sub> hours of operation, with an overall shift to lower CCTs.

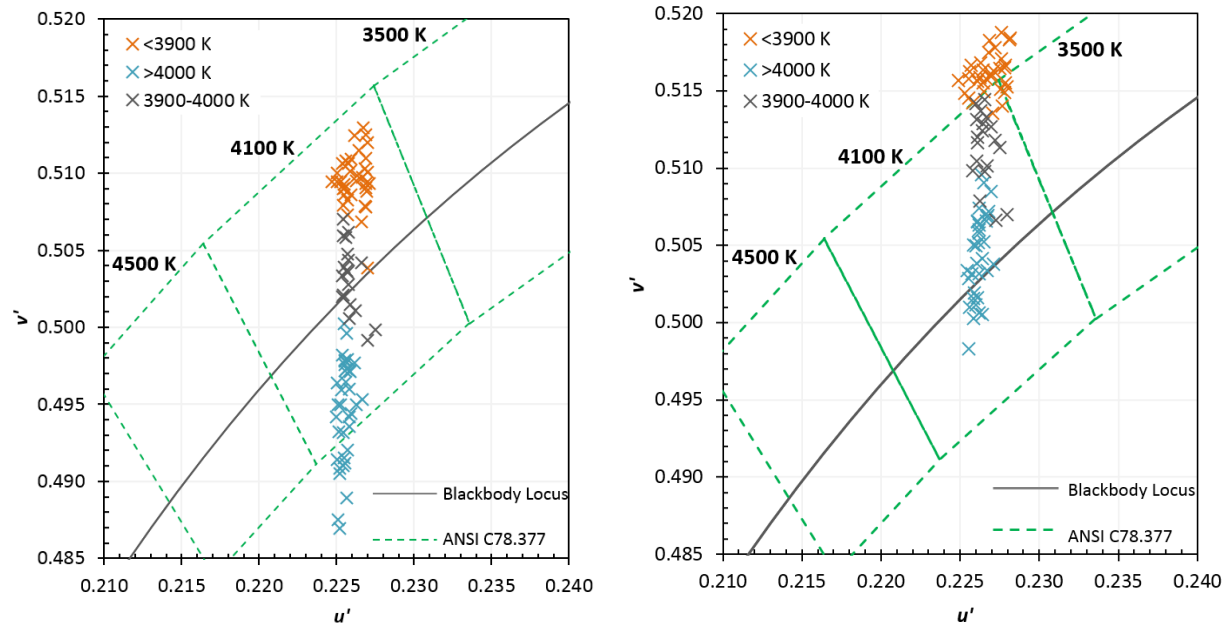
**Figure 16. Second-Generation LED Lighting System Chromaticity: Initial<sub>2</sub> (left) and 4000<sub>2</sub> (right).**

The chromaticity coordinates are plotted on the CIE 1976 Chromaticity Diagrams (u', v'). The diagrams are scaled to isolate the 4100 K range of the ANSI C78.377-2017 bin, outlined in green. Colored data points represent the initial<sub>2</sub> CCT values as shown in Figure 15: orange < 3900 K, 3900 K ≤ gray ≤ 4000 K, blue > 4000 K.

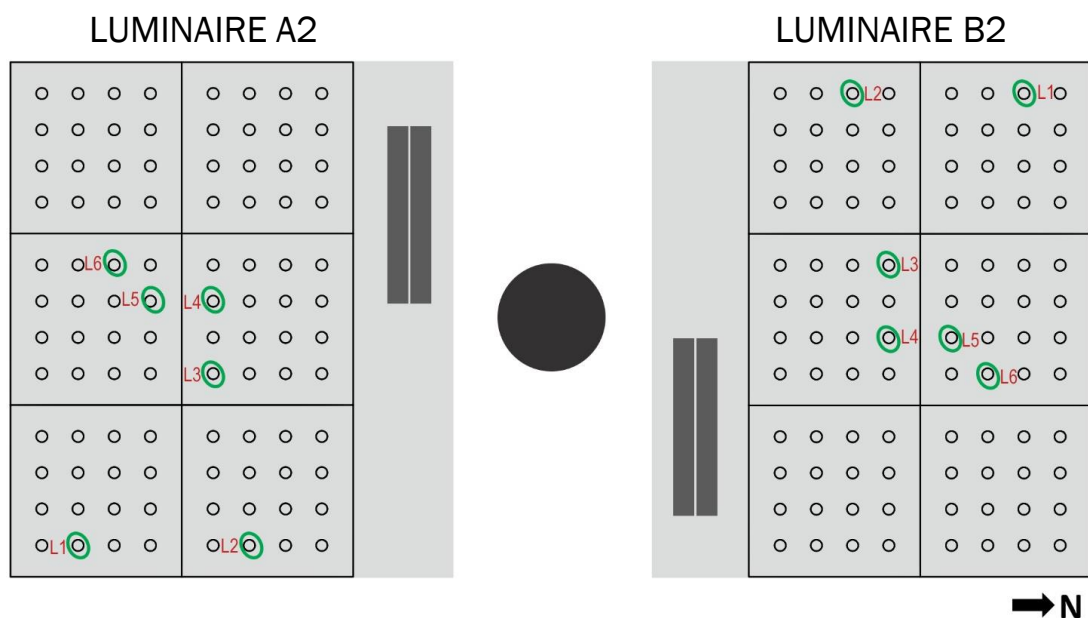
Figure 17. LED Thermocouple Placement Schematic.

The green ovals indicate the six LED packages in each luminaire that had thermocouples installed on the TMPL<sub>ED</sub>. The view of the luminaires is from below. The dark gray rectangles indicate the general location of the two drivers per luminaire, and the solid black circle represents pole 204. When the next-generation luminaires were added to the pole, they were oriented 90° relative to the luminaires they replaced for optimal performance. The next-generation luminaires have six squares and an optical design that differs from the original LED luminaires.

Each luminaire had eight internal thermocouples: one placed at the temperature measurement point (TMPL<sub>ED</sub>) of each of six LED packages (locations shown in Figure 17), one attached to the interior top surface of the luminaire housing, and one attached to the temperature measurement point (TMPPS) of one of the two LED drivers per luminaire.<sup>12</sup> An additional thermocouple measured the ambient air temperature outside each luminaire, for a total of nine thermocouples per luminaire (18 per pole).

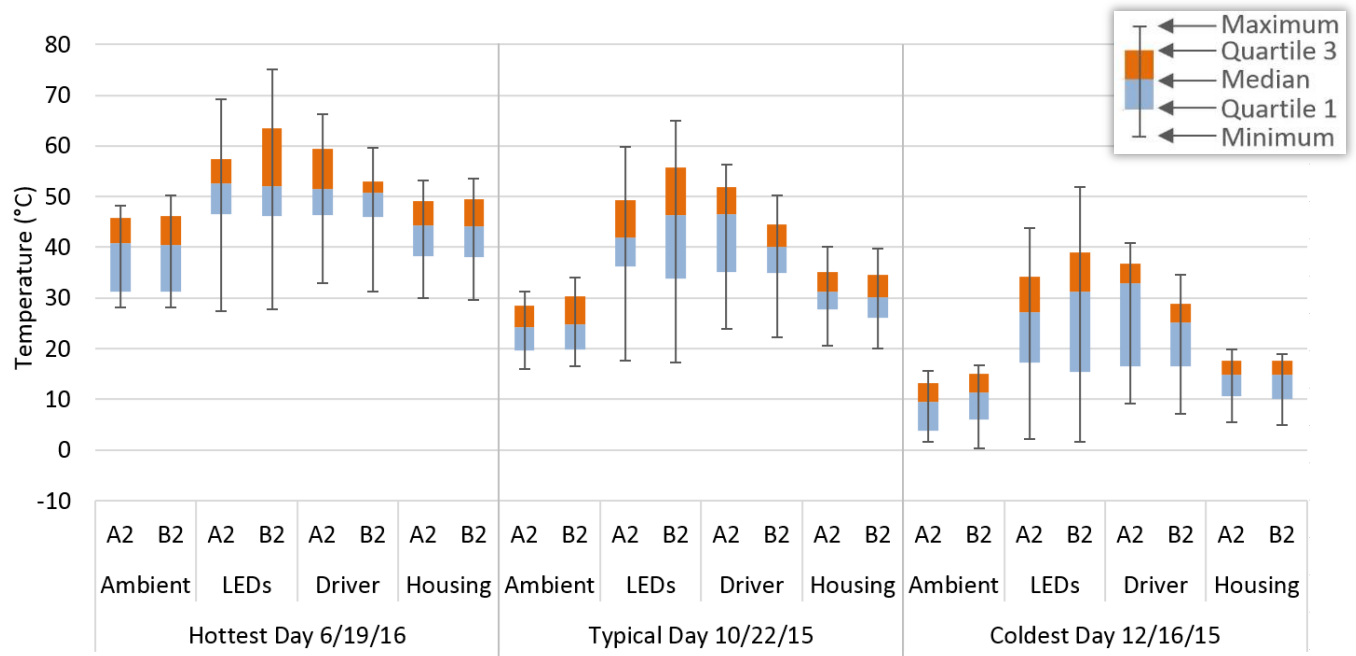
**Figure 18. Temperature Measurement Box and Whisker Plot: September 25, 2015, to September 19, 2016.**

The box-plot shows the temperatures on the hottest day, a typical day, and the coldest day. The ends of the whiskers represent the maximum and minimum of all of the 1-minute interval data. The typical day was defined as the day that was close to the averages of the daily max, min, and average temperatures during this 361-day time period.

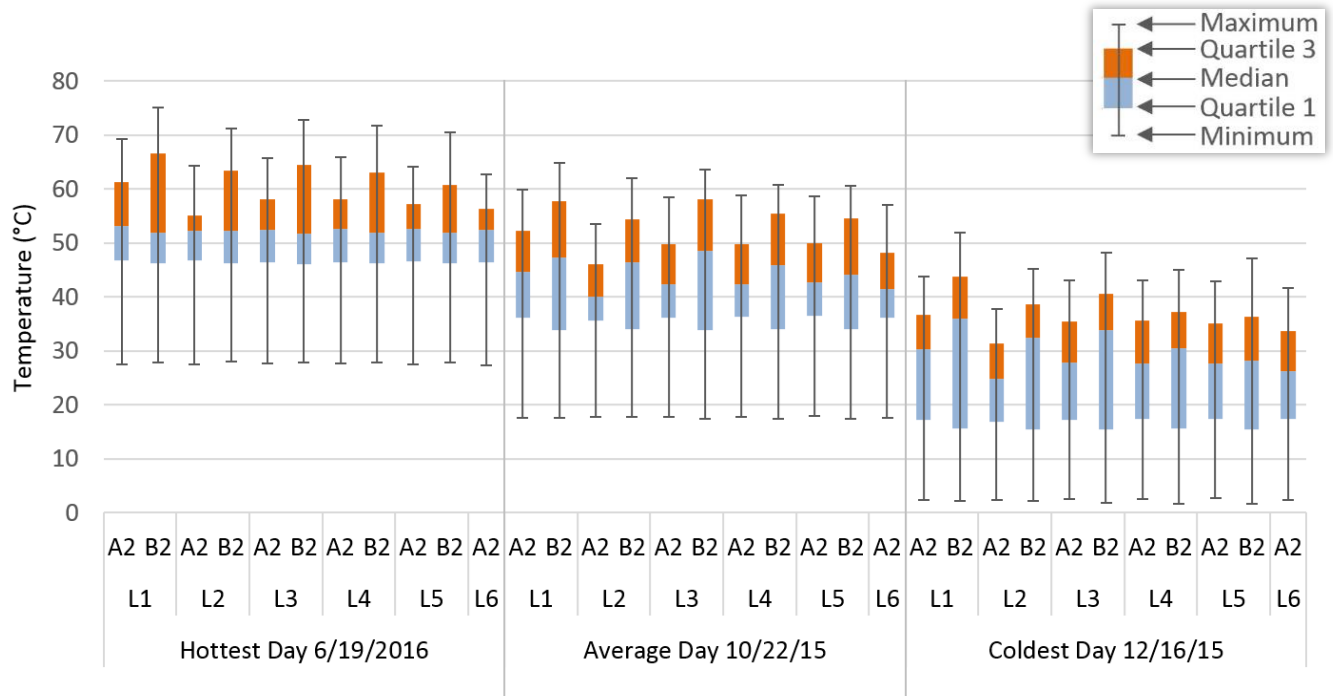
**Figure 19. LED Temperature Measurement Box and Whisker Plot: September 25, 2015, to September 19, 2016.**

The box-plot shows the range of temperatures on the hottest day, a typical day, and the coldest day. The ends of the whiskers represent the maximum and minimum of the 1-minute interval data. B2 L6 was not included in the analysis. The typical day was defined as the day that was close to the averages of the daily max, min and average temperatures during this 361-day time period.

Figure 19 disaggregates the LED package data, showing the variation in temperature between the LED packages. The measured LED packages at the outer edge of the luminaire are L1 and L2, and the remaining measured LED packages are located in the center of the luminaire. L1 reached temperatures similar to the inner LED packages (L3, L4, L5, L6), while L2 tended to operate at slightly lower temperatures. The L6 temperature measurements are not included for luminaire B2 in this report as data from this thermocouple were very different from the other thermocouples, perhaps due to a faulty thermocouple or improper placement of the thermocouple.

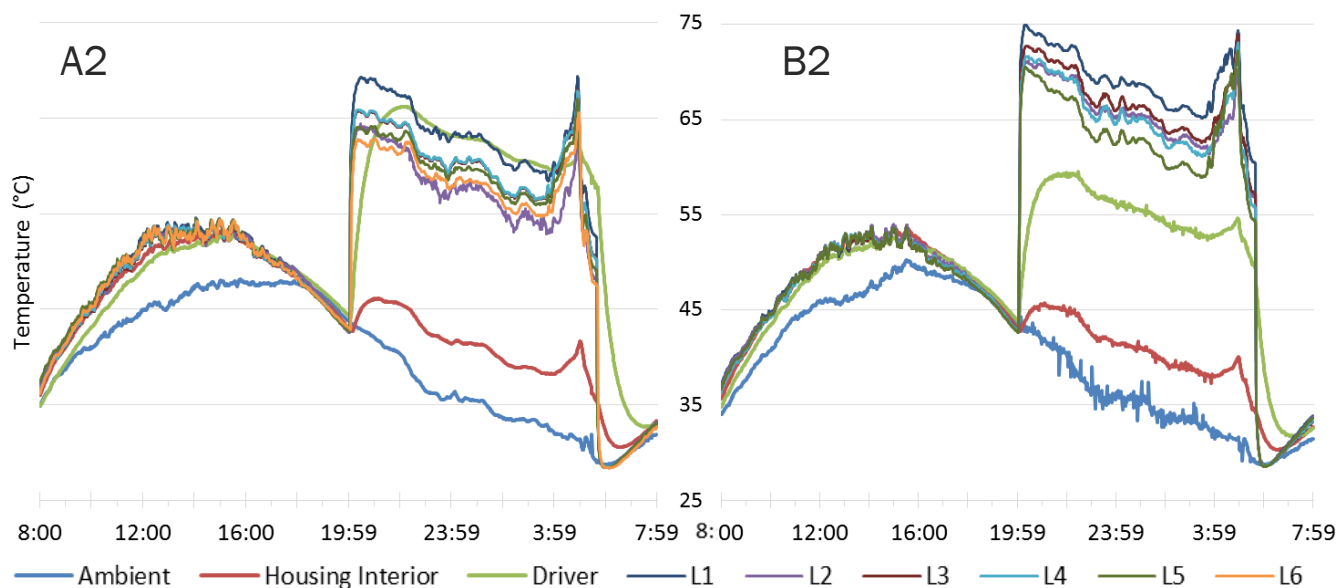
**Figure 20. Thermocouple Measurements: June 19, 8:00 a.m., to June 20, 7:59 a.m., 2016.**

The 1-minute-interval thermocouple measurements for the hottest ambient temperature day recorded for luminaires A2 and B2.

The change in temperatures over the span of the hottest day (June 19, 2016) and into the morning of the next day is plotted in Figure 20. The LED packages operated at temperatures similar to the driver temperature in luminaire A2, and operated above the driver temperature in B2. The LED packages tended to respond similarly to changes throughout the day, and were influenced by minor changes in ambient temperature during operation. The ambient and housing temperatures were higher during the day, when the luminaires were not operating, than at night, when the luminaires were operating. The driver and LED packages were hottest at night when the luminaires were operating. The effect of solar radiation is also evident in the plot; as the sun rose, the difference in temperature widened between the luminaire components and the ambient temperature, and as the sun set, the temperatures narrowed again until the luminaires began operating.

As shown previously in Figure 20, the measured LED temperatures often exceeded 65°C in the B2 luminaire when it was operating during the night of June 19, 2016, and were generally about 5°C lower in luminaire A2. Notably, the LED temperatures in both luminaires often exceeded 50°C when the luminaires were not operating during the day on that date. Figure 24 shows that the LED temperatures in both luminaires during the daylight hours on June 19, 2016 (when the luminaires were off) actually exceeded the LED temperatures during the nighttime hours on December 22, 2015 (when the luminaires were on).

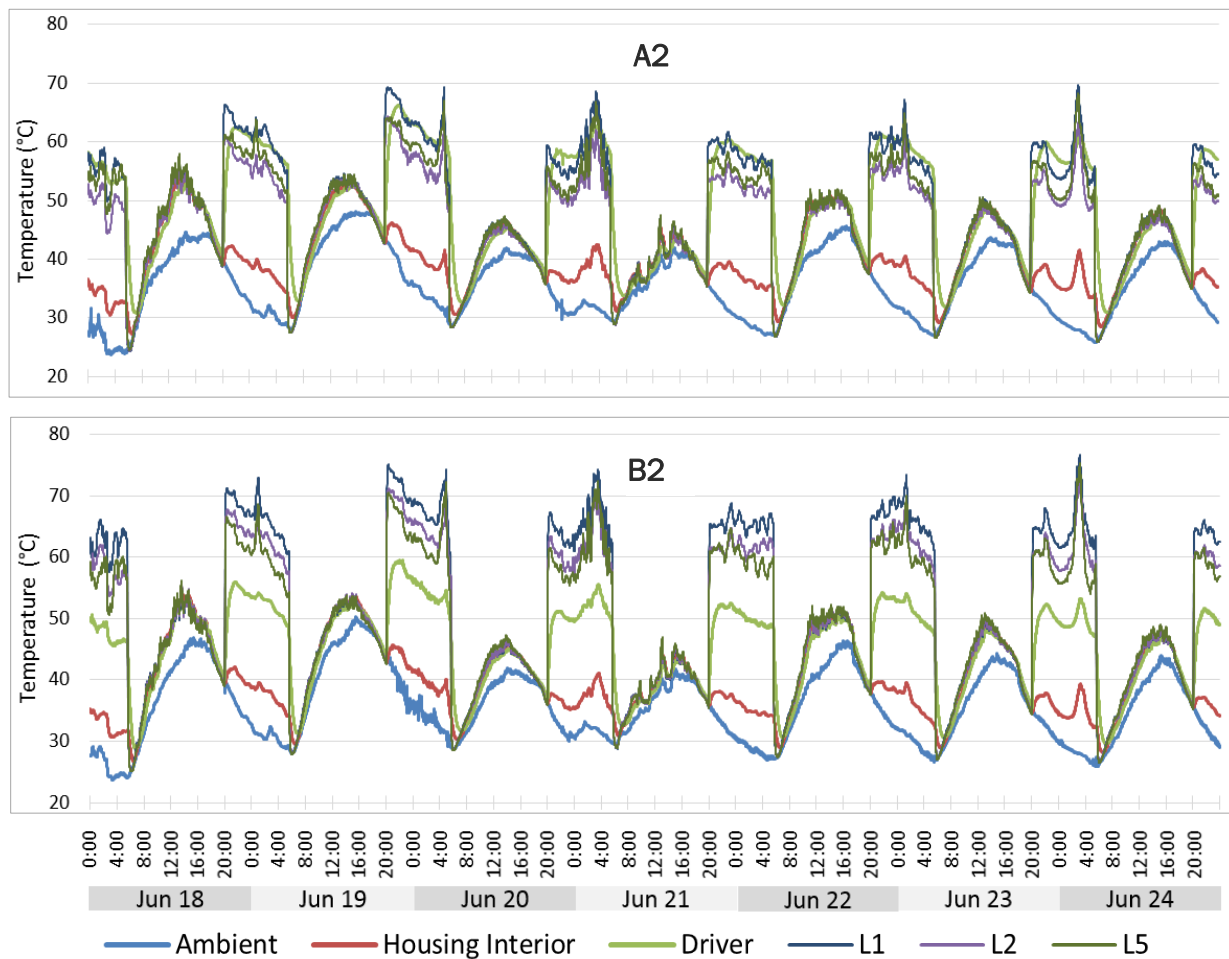
**Figure 21. Thermocouple Measurements: June 18 to June 24, 2016.**

The 1-minute-interval thermocouple measurements for the hottest ambient temperature week recorded for luminaires A2 and B2. Only L1, L2, and L5 are shown to aid visibility of the temperature. L1 is typically the hottest, although it is located on the outside of the luminaire along with L2, which is typically the coolest. L5 varies between the temperatures of L1 and L2.

The temperatures from June 18 to 24, 2016, are plotted in Figure 21. This is the hottest week, with an average daily maximum temperature of 44°C (111°F). The temperature pattern remained similar throughout the week. The temperatures of the A2 LEDs during the day on June 18 were similar to the temperatures earlier that morning when the luminaire was operating. The temperatures of the LEDs when the luminaires were not operating often came close to the same temperatures as when the luminaires were on during the week. The temperatures of the LEDs in B2 reached above 70°C (158°F).

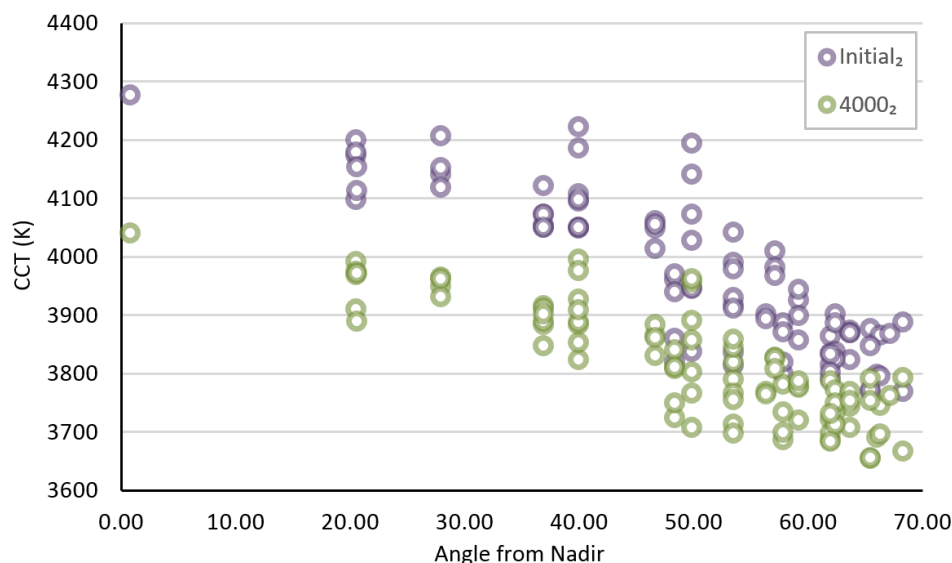
**Figure 23. CCT at Initial<sub>2</sub> and 4000<sub>2</sub> Hours of Operation versus Angle from Nadir to Measurement Point.**

The CCT measured at each point is plotted versus the angle from nadir to measurement point. CCT decreased over time at all angles.

Figure 23 illustrates both the CCT change over time and the CCT change over angle, and shows the systematic decrease in CCT over the first 4000 hours of operation for each of the measurement points. The measured color variations over time exceeded those that would be expected based on LM-80 data for the LEDs, and exceeded those reported for most of the installations evaluated in the earlier GATEWAY report on interior projects. While determining the root cause of these variations is beyond the scope of this project, other published data<sup>16</sup> may offer possible explanations. These reports identify high ambient and operating temperatures as factors which may contribute to color shift in LED packages, and provide color shift data from accelerated testing methods that are similar to the color shift measured in Yuma. These accelerated testing methods were conducted at elevated temperature and humidity levels, which do not replicate the conditions at Yuma, but they do indicate the possible effects of environmental conditions on the degradation processes associated with color shift. The actual junction temperatures experienced by the LEDs are determined by a combination of the ambient conditions and the thermal design of the luminaire; determining those separate effects was not possible for this project.

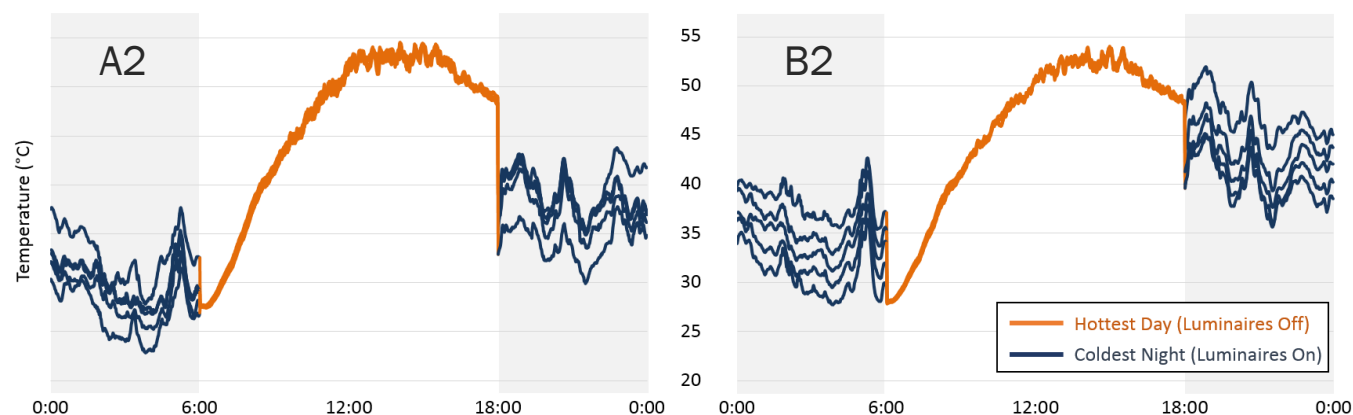
**Figure 24. Comparison of June 19, 2016, with Luminaires Off (orange) and December 22, 2015, with Luminaires On (blue).**

This figure shows the temperature of the LEDs in two luminaires (A2 and B2) over a 24-hour period, broken into two parts: the orange representing when the luminaires were *not* operational during the day on June 19, 2016 (the warmest date recorded), and the blue representing when the luminaires were operating during the night on December 22, 2015 (the coldest date recorded). The measured LED temperatures when the luminaires were off on the warmest day exceeded those when the luminaires were on during the coldest night.
